Repair Hints

Service-Level 3 & 4

1100

RH-18

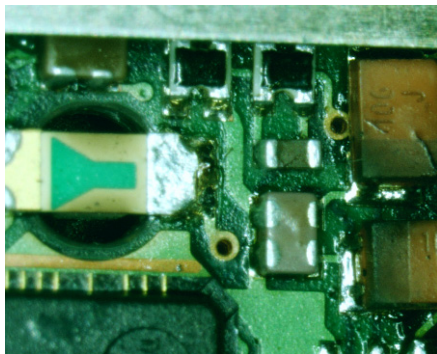
"rework" done with uncontrolled hot air

All replaceable (not underfilled) μ BGA components must be renewed after removing. Reflow with uncontrolled hot-air fan is strictly forbidden! It is also not recommended only to reflow the old μ BGA using a μ BGA rework station! μ BGA must only be soldered with NMP approved μ BGA rework machines (e.g. Zevac/ OK-Metcal/ Martin) to get durable solder joints.

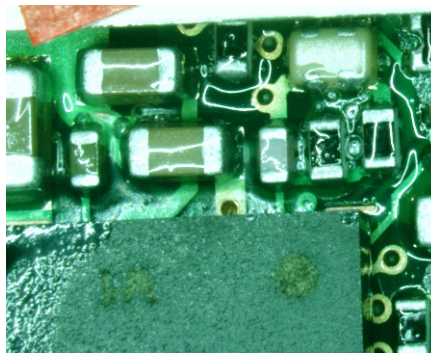
PWB drowned in flux

Use only recommended flux type and an appropriate amount of it – avoid drowning the PWB in flux as this will lead to additional faults!

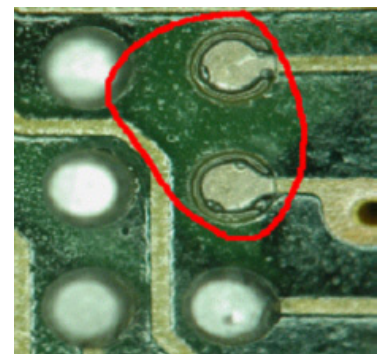
oxidated soldering

After removing a μ BGA check soldering points; if necessary rework oxidated solderings (broken balls) carefully by tinsplating these areas with few flux and a hot soldering iron. Before placing a new component remove the tin and clean the PWB; e.g. with help of solder wick and flux cleaner such as "Kontakt LR".
