**Nokia Customer Care**  
**2112 (RH-57) Series Transceivers**

# **Troubleshooting – Antenna**

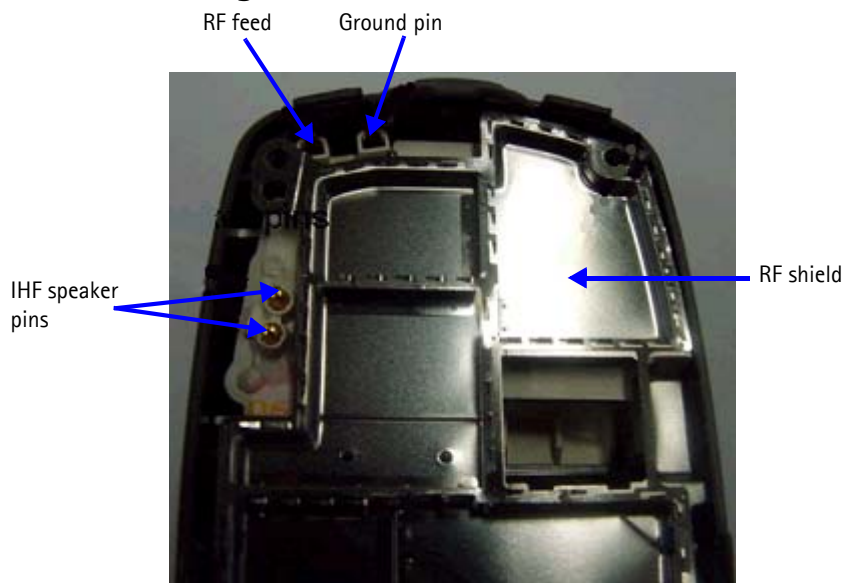
Figure 2: Model 2112 chassis assembly

If no internal antenna is installed, the antenna gain is degraded by more than 25 dB.

- If the internal antenna is missing, install a new one.
- If the radiator looks obviously damaged, replace the internal antenna.

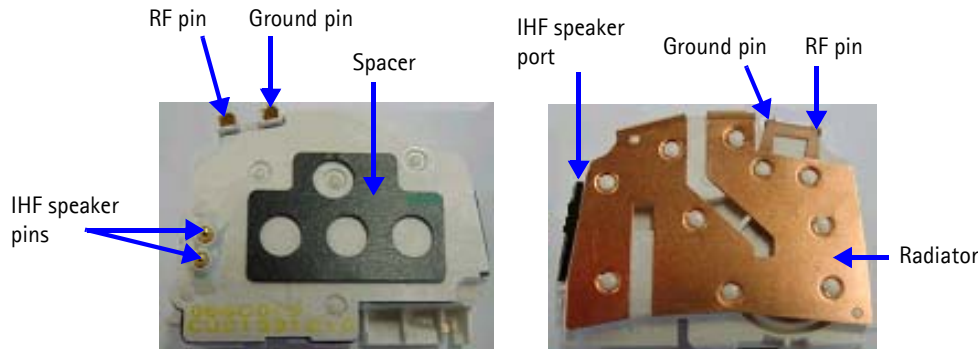
Figure 3: Top (left) and bottom (right) views of the 2112 (RH-57) internal antenna

If the RF feed does not touch the PWB, then the antenna gain will degrade by more than 25dB. If the ground pin does not touch the PWB, then the antenna gain may degrade from 5–10 dB.

Replace the internal antenna if any of the following situations apply:

- Either the RF feed pin or ground pin are broken or bent such that either pin will not touch the PWB
- The springs for the RF or ground pin appear damaged
- The slot in the radiator has a significantly different shape
- Obvious damage to the radiator (e.g., dents, corrosion)
- The pin is stuck or has excessive friction in the plastic tube/guiding feature resulting in the spring not working properly
- Either of the IHF speaker pins is damaged or if the IHF speaker is nonfunctioning

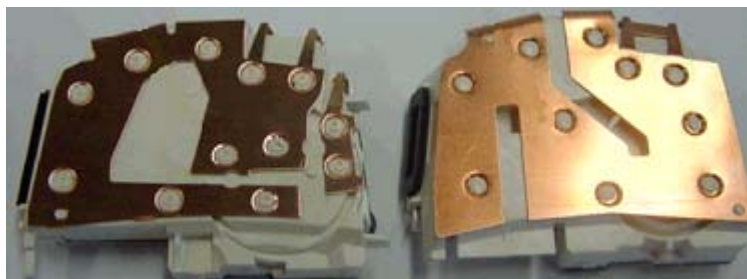
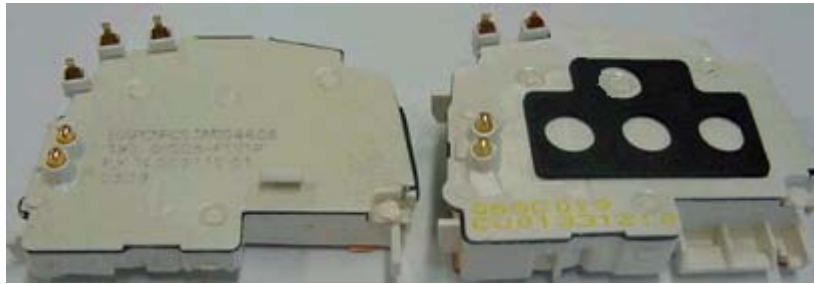
Figure 4: Top views of the 3100 (RH-19) (left) and 2112 (RH-57) (right) antennas

The 2112 and 3100 antennas are similar in appearance. The important visual difference in the antennas is that the slot pattern is very different. Also, the 2112 antenna is thicker than the 3100 antenna and also has a spacer on its back side.

If the wrong antenna is installed, install the correct one.

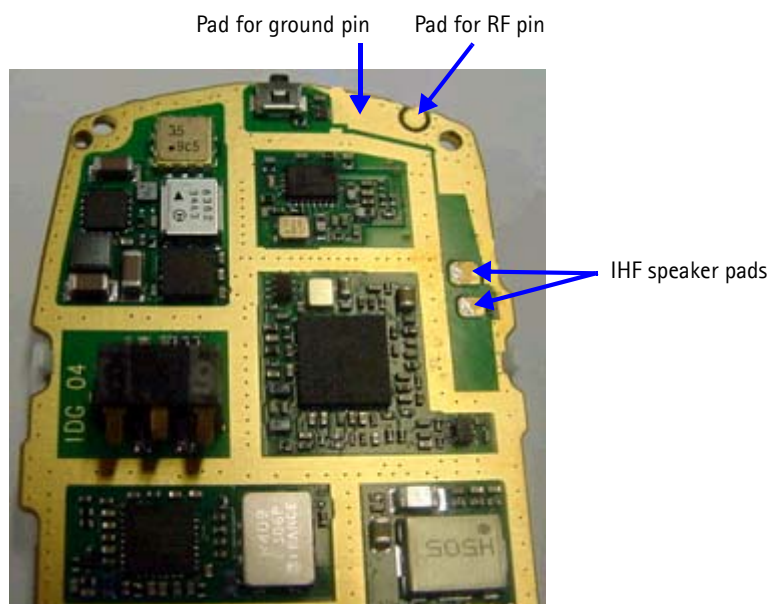
Figure 6: PWB layout of RF feed and ground pads and IHF speaker pads

If the RF feed pad is obstructed, removed, or covered, the RF feed pin will not touch the PWB and the antenna gain will degrade by more than 25 dB. If the ground pad is obstructed, removed, or covered, the ground pin will not touch the PWB and the antenna gain may degrade by about 5–10 dB.

If the Internal Hands Free (IHF) speaker pads are obstructed, removed, or covered, the IHF speaker will not produce sound.

- If corrosion is present or the pad is missing, replace the PWB and the phone.
- If either pad is obstructed or covered, clear or clean the pad.

- If corrosion is present or the pad is missing, replace the the PWB and the phone.
- If either pad is obstructed or covered, clear or clean the pad.

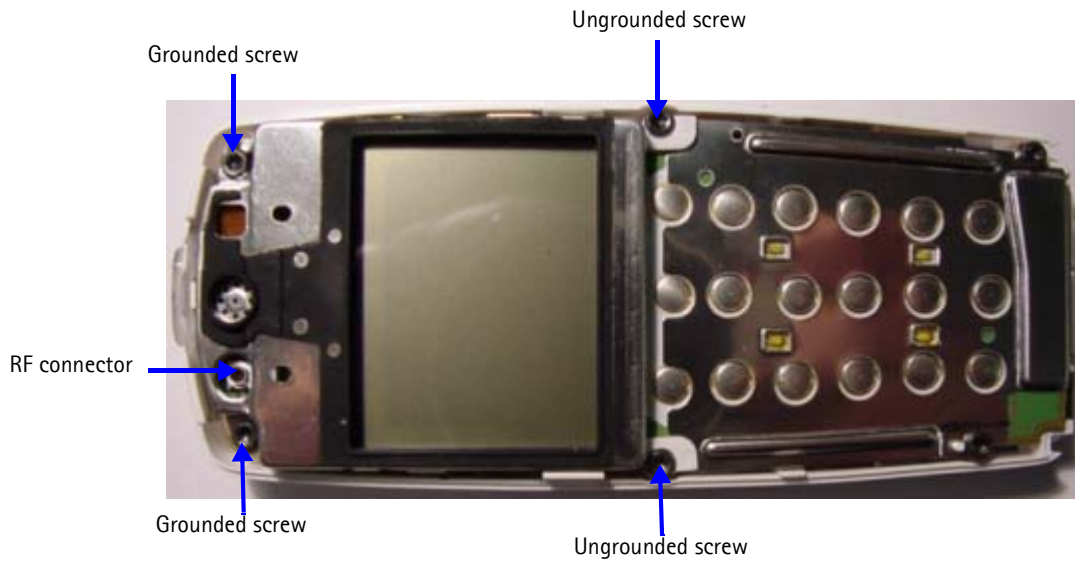
**Figure 7: Display assembly**

Note that the display frame is grounded to the PWB through the two top screws. The grounding of the display frame impacts the radiation performance of the phone.

The middle screws should not touch the metal in the LCD frame, the metal shield over the keypad, the PWB, or the RF shield. When driving in these screws, be sure to drive them in straight. If the screws are driven in at an angle, it is much more likely that the screws will touch the PWB or the RF shield. If the screws touch, the antenna performance could change by about 1 dB.

- If the screws are loose, then tighten them.
- If the screw bosses are stripped, replace the chassis.
- If the screws are missing, install new ones.

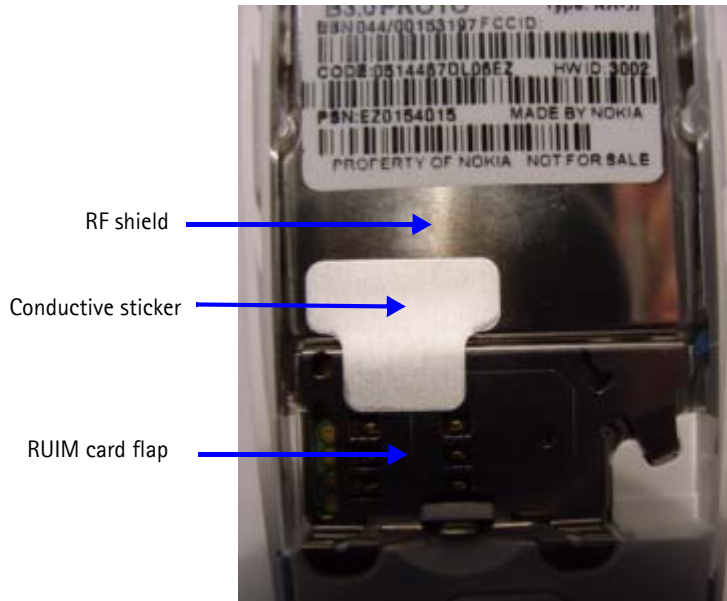
**Figure 8: Conductive sticker grounding RUIM card flap to RF shield**

The RUIM card flap needs to be grounded to the RF shield with a conductive sticker (see Figure 8). If the sticker is damaged or missing, then the radiated sensitivity could be reduced by 4–8 dB.

If the RF shield needs to be disassembled from the chassis, the sticker may be damaged because the sticker needs to be removed to change the antenna module or the RUIM card flap.

- If the conductive sticker is missing or ripped, replace the sticker.

- If you replace the RUIM card flap or RF shield, replace the type labels and conductive sticker.
- You may need to replace the RF shield and all the labels because the conductive sticker is located underneath other labels.
