**Nokia Customer Care
2118 (RH-77)
Mobile Terminal**

**Antenna Description and
Troubleshooting**

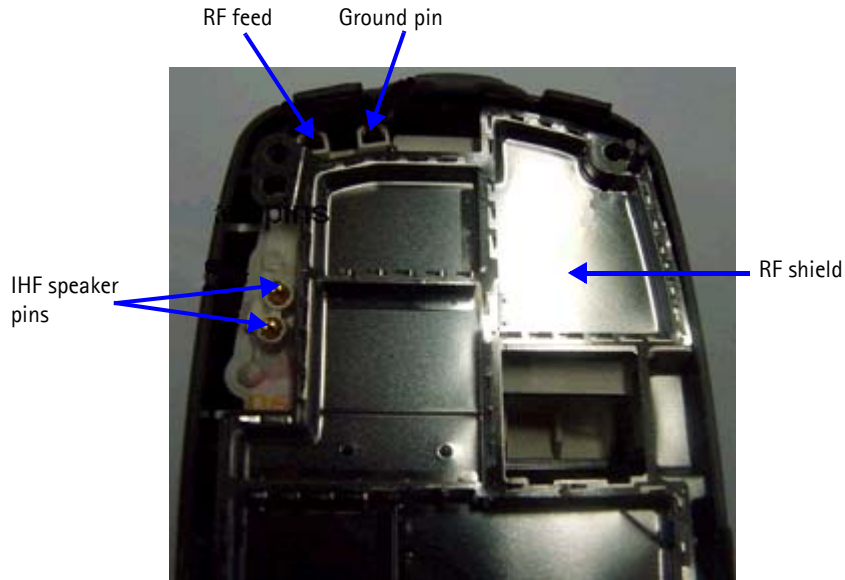
Figure 1: Chassis assembly

If no internal antenna is installed, the antenna gain is degraded by more than 25 dB.

- If the internal antenna is missing, install a new one.
- If the radiator looks obviously damaged, replace the internal antenna.

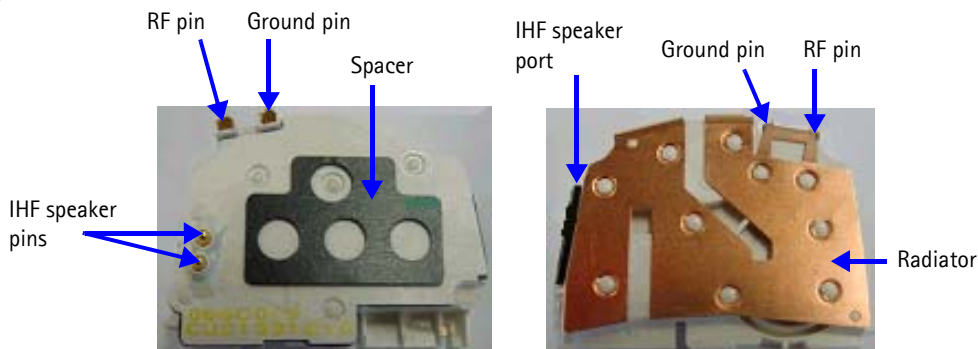
Figure 2: Top (left) and bottom (right) views of the 2118 (RH-77) internal antenna

If the RF feed does not touch the PWB, then the antenna gain will degrade by more than 25dB. If the ground pin does not touch the PWB, then the antenna gain may degrade from 5–10 dB.

Replace the internal antenna if any of the following situations apply:

- Either the RF feed pin or ground pin are broken or bent such that either pin will not touch the PWB

- The springs for the RF or ground pin appear damaged
- The slot in the radiator has a significantly different shape
- Obvious damage to the radiator (e.g., dents, corrosion)
- The pin is stuck or has excessive friction in the plastic tube/guiding feature resulting in the spring not working properly
- Either of the IHF speaker pins is damaged or if the IHF speaker is nonfunctioning

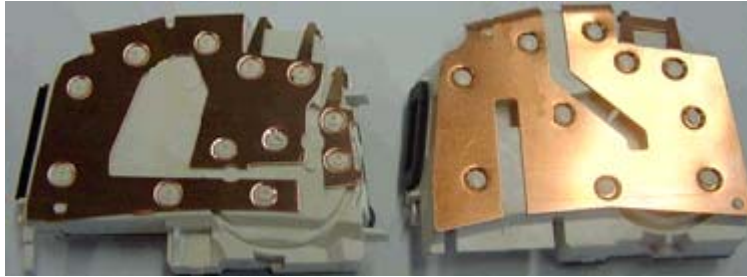
Figure 3: Top views of the 3100 (RH-19) (left) and 2118 (RH-77) (right) antennas

The 2118 and 3100 antennas are similar in appearance. The important visual difference in the antennas is that the slot pattern is very different. Also, the 2118 antenna is thicker than the 3100 antenna and also has a spacer on its back side.

If the wrong antenna is installed, install the correct one.

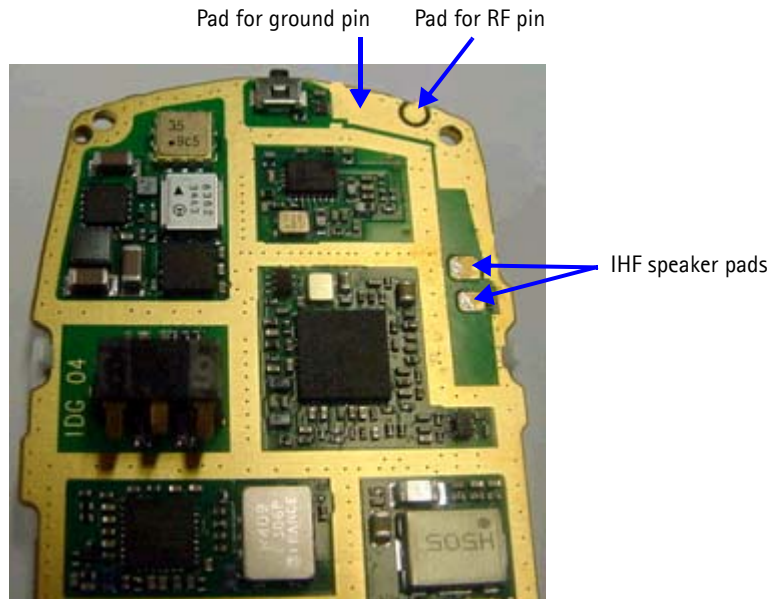
Figure 5: PWB layout of RF feed and ground pads and IHF speaker pads

If the RF feed pad is obstructed, removed, or covered, the RF feed pin will not touch the PWB and the antenna gain will degrade by more than 25 dB. If the ground pad is obstructed, removed, or covered, the ground pin will not touch the PWB and the antenna gain may degrade by about 5–10 dB.

If the Internal Hands Free (IHF) speaker pads are obstructed, removed, or covered, the IHF speaker will not produce sound.

- If corrosion is present or the pad is missing, replace the PWB and the mobile terminal.
- If either pad is obstructed or covered, clear or clean the pad.

- If corrosion is present or the pad is missing, replace the the PWB and the mobile terminal.
- If either pad is obstructed or covered, clear or clean the pad.

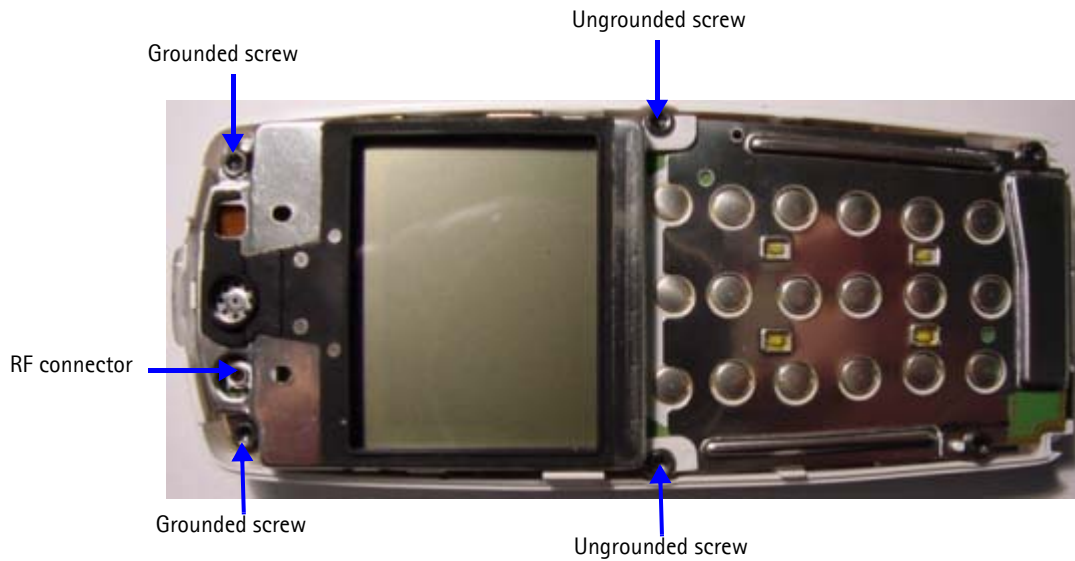
Figure 6: Display assembly

Note that the display frame is grounded to the PWB through the two top screws. The grounding of the display frame impacts the radiation performance of the mobile terminal.

The middle screws should not touch the metal in the LCD frame, the metal shield over the keypad, the PWB, or the RF shield. When driving in these screws, be sure to drive them in straight. If the screws are driven in at an angle, it is much more likely that the screws will touch the PWB or the RF shield. If the screws touch, the antenna performance could change by about 1 dB.

- If the screws are loose, then tighten them.
- If the screw bosses are stripped, replace the chassis.
- If the screws are missing, install new ones.

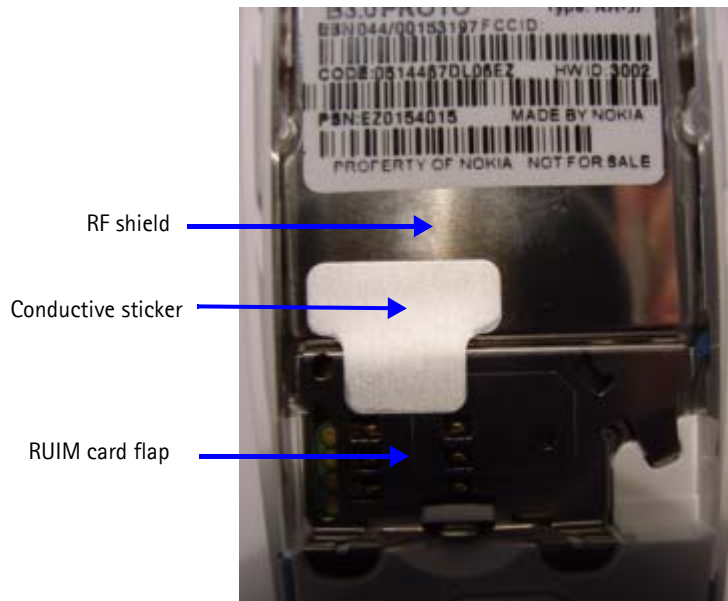
Figure 7: Conductive sticker grounding RUIM card flap to RF shield

The RUIM card flap needs to be grounded to the RF shield with a conductive sticker (see Figure 7). If the sticker is damaged or missing, then the radiated sensitivity could be reduced by 4–8 dB.

If the RF shield needs to be disassembled from the chassis, the sticker may be damaged because the sticker needs to be removed to change the antenna module or the RUIM card flap.

- If the conductive sticker is missing or ripped, replace the sticker.

- If you replace the RUIM card flap or RF shield, replace the type labels and conductive sticker.
- You may need to replace the RF shield and all the labels because the conductive sticker is located underneath other labels.
