CCS Technical Documentation RH–17 Series Transceivers

# **Troubleshooting — Antennas**

This troubleshooting guide addresses potential failures that will affect the antenna performance of the RH-17 phone, and how to correct these failures.

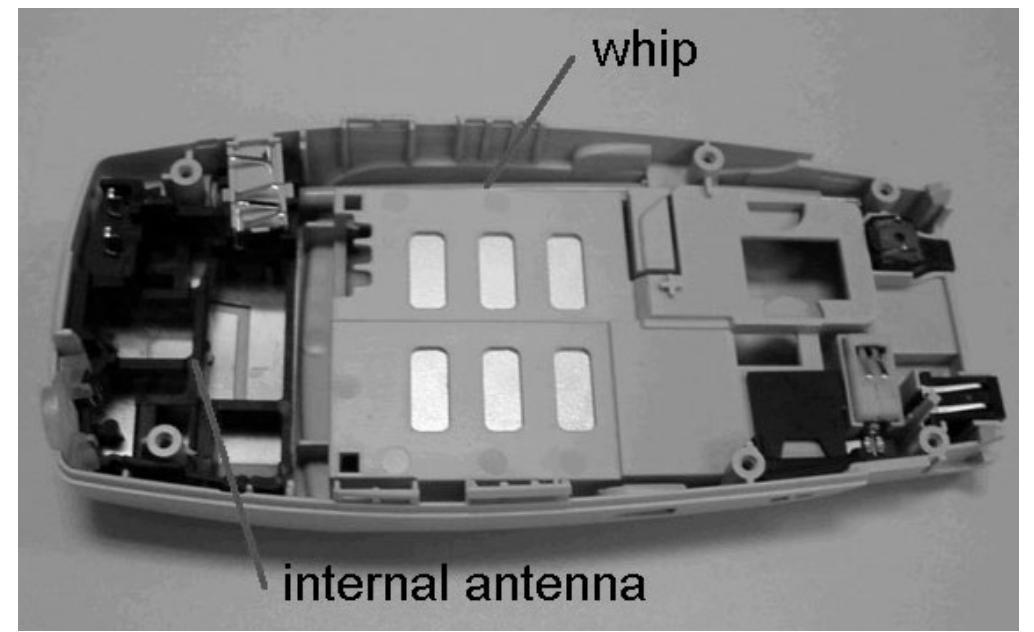
Figure 4: RH-17 D-cover assembly Note that the whip antenna must be inserted prior to inserting the internal antenna.

If no antenna is installed, the antenna gain will be degraded by more than 25 dB.

If the internal antenna is missing, install one. If the radiator looks obviously damaged, then replace the internal antenna.

If the whip antenna is missing, then remove the internal antenna, install a whip, and reinstall the internal antenna.

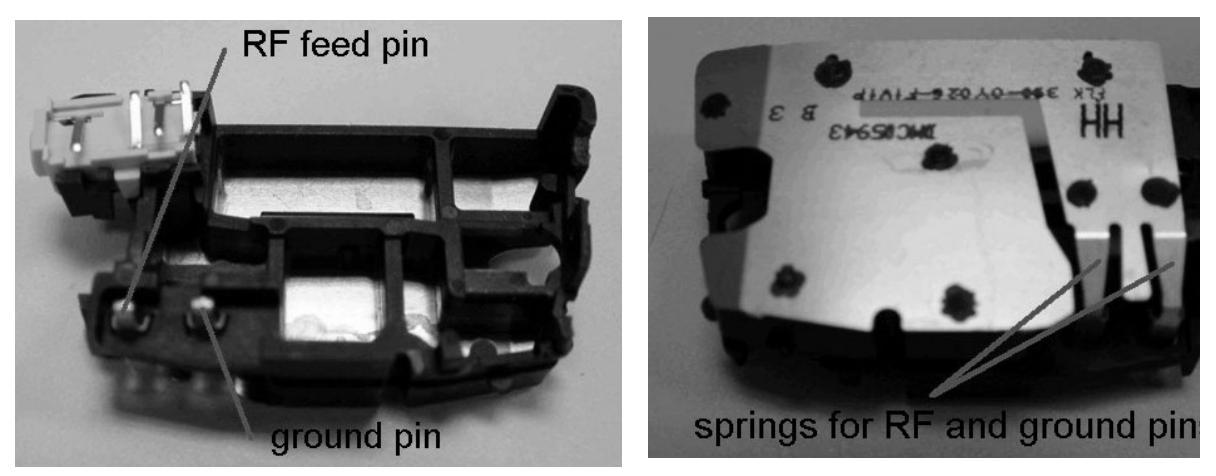
Figure 5: Top and Bottom View of the RH-17 Internal Antenna If either the RF feed pin or ground pin are broken, or bent such that either pin will not touch the PWB, then the internal antenna must be replaced. If the springs for the RF or ground pin appear damaged, then the internal antenna must be replaced. If the slot in the radiator has a significantly different shape, then the correct internal antenna must be installed. Be aware that the shape of the slot can vary slightly. The length of the horizontal slot can vary by a few millimeters, because the antennas are tuned for each batch of plastic frames. If there is any other obvious damage to the radiator (dents, corrosion), then the antenna should be replaced. If the pin gets stuck or has excessive friction in the plastic tube/guiding feature, then the spring will not work properly, and the antenna should be replaced.

If the RF feed doesn't touch the PWB, then the antenna gain will degrade by more than 25 dB. If the ground pin doesn't touch the PWB, then the antenna gain may degrade about 5 dB to 10 dB.

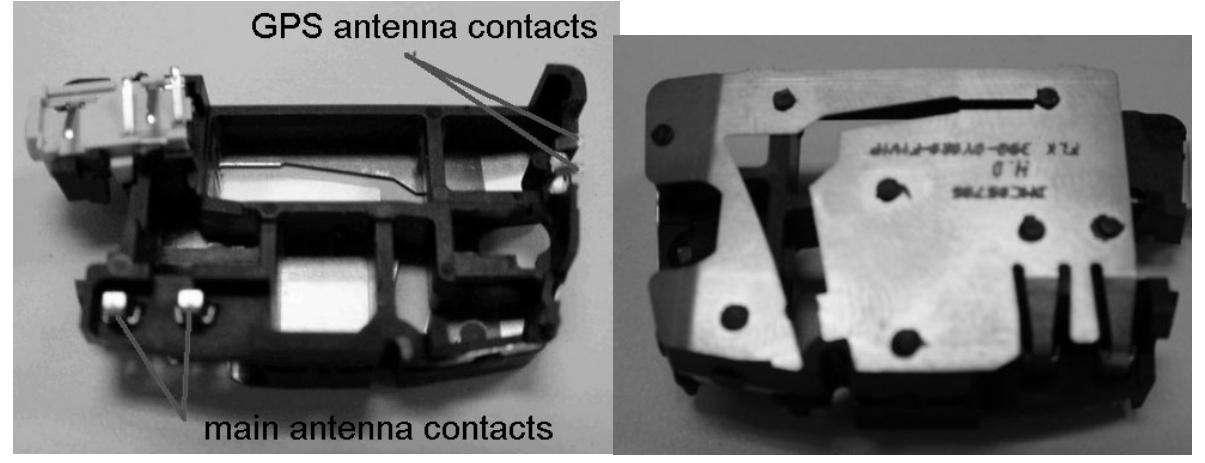
Figure 6: Top and bottom view of RH-3 antenna

The RH-17 and RH-3 antennas share the same mechanical interface with the D-cover. As a result, either antenna may be installed in either phone. The important differences visually in the antennas are that the slot pattern is very different, and there also is a GPS antenna present in the RH-3 which is absent in the RH-17.

Installing an RH-3 antenna in the RH-17 phone will change the antenna gain by a few dB at 850 MHz, and the phone will not be compliant with FCC submission. Installing a RH-17 antenna in a RH-3 phone will degrade the PCS performance by at least 6 dB, as the RH-17 antenna is not tuned for PCS. In addition, if an RH-17 antenna is installed in the RH-3, GPS will degrade by about 25 dB as the RH-17 doesn't have a GPS antenna.

If the wrong antenna is installed, install the correct one.

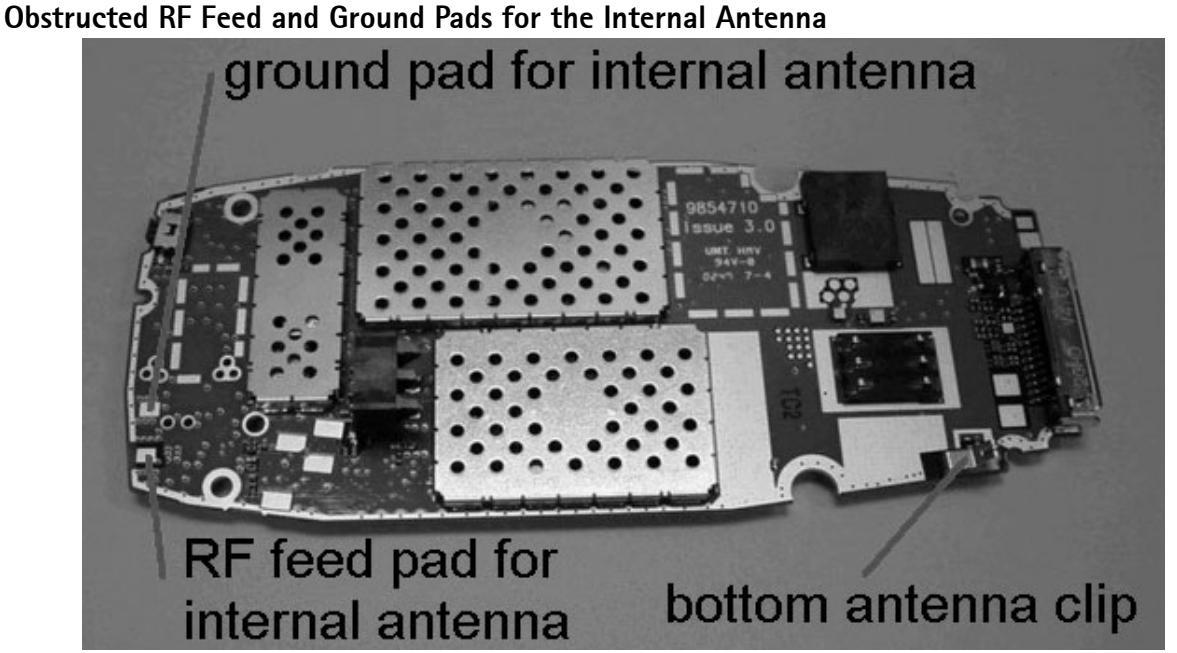
Figure 7: PWB layout of RF feed and ground pads, and bottom antenna clip If the RF feed pad is obstructed, removed, or covered, then the RF feed pin will not touch the PWB and then the antenna gain will degrade by more than 25 dB. If the ground pad is obstructed, removed, or covered, then the ground pin will not touch the PWB, and then the antenna gain may degrade about 5 to 10 dB. If corrosion is present or the pad is missing, then most likely the PWB and phone needs to be replaced. In either pad is obstructed or covered, the pad should be cleared and/or cleaned.

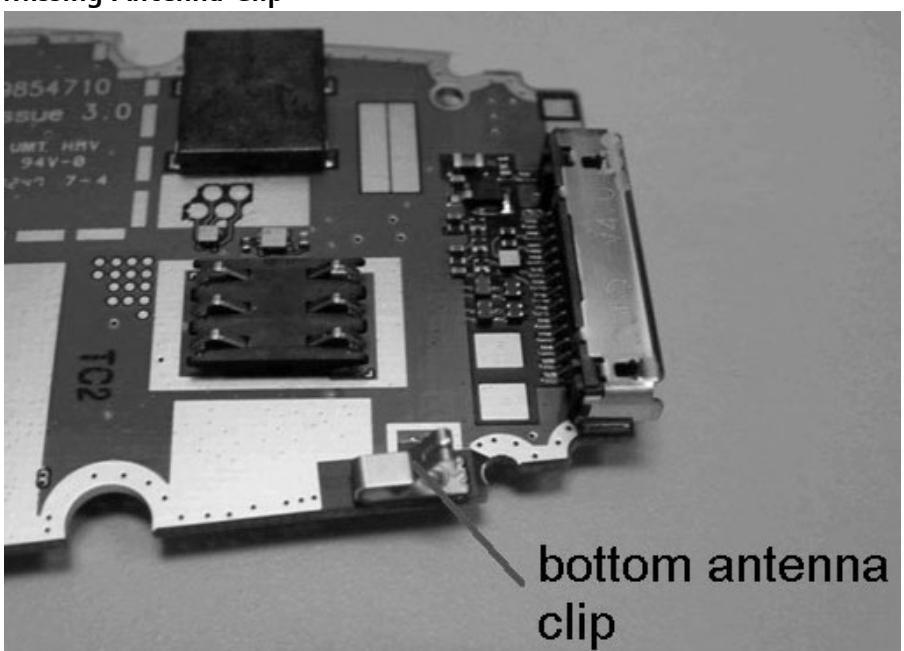
Figure 8: Bottom antenna clip

If the bottom antenna clip does not contact the whip stopper, when the whip is fully retracted, then the internal antenna gain will degrade by about 4-5 dB in the RX portion of CELL band. If the antenna clip is installed backwards, is damaged, or is missing, then install a new bottom antenna clip in the correct position.

Figure 8 shows the bottom antenna clip. The detuning circuit is right next to the bottom antenna clip. If the detuning circuit is not installed properly, then the internal antenna gain will degrade by about 4–5 dB in the RX portion of CELL band. The detuning circuit consists of a 1nH coil inductor. If the inductor is missing, then install one. If the induc-

tor is installed upside down, then the pads are not soldered to the PWB and the inductor needs to be flipped and soldered correctly.

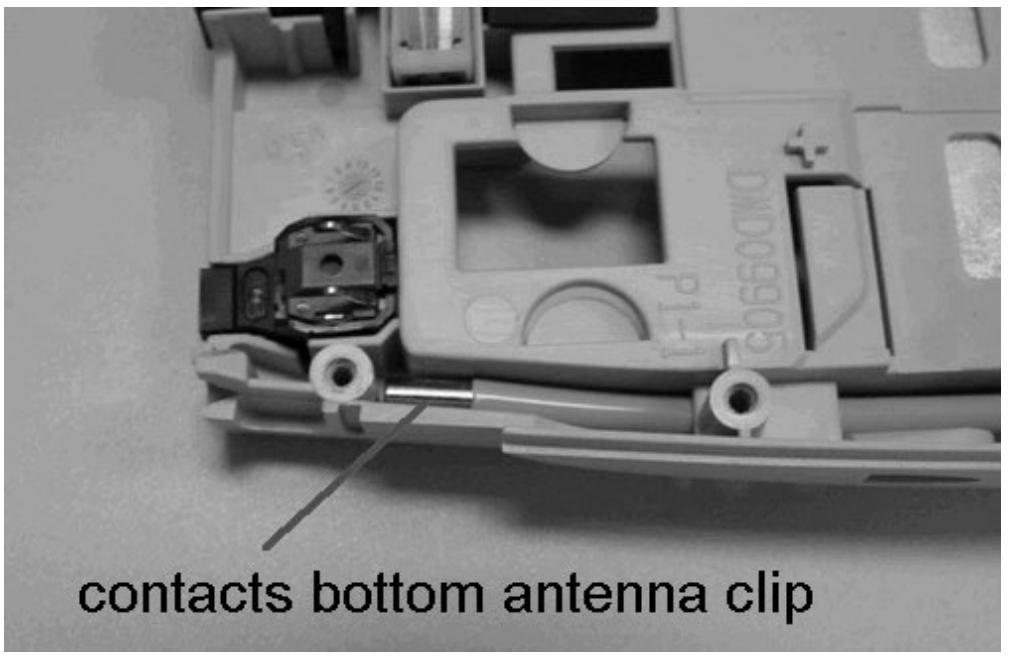
Figure 9: Whip stopper as shown when the whip is fully retracted If the whip stopper is corroded or blocked by the whip straw, then the whip assembly needs to be replaced. If the whip stopper is obstructed or dirty, then the obstruction and/or dirt needs to be removed. If the whip stopper doesn't properly contact the bottom antenna clip, then the internal antenna gain will degrade by about 4–5 dB in the RX portion of CELL band.

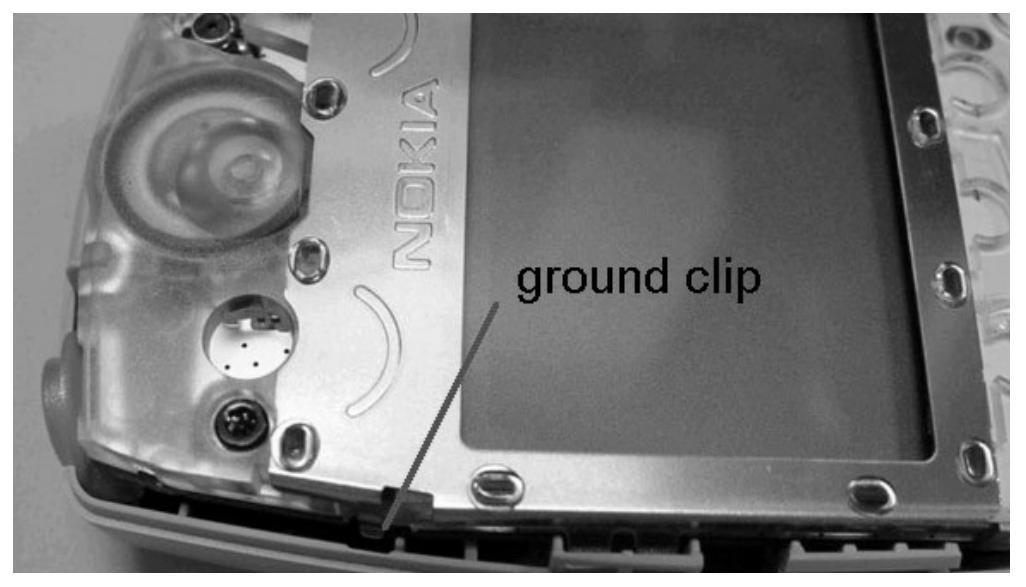
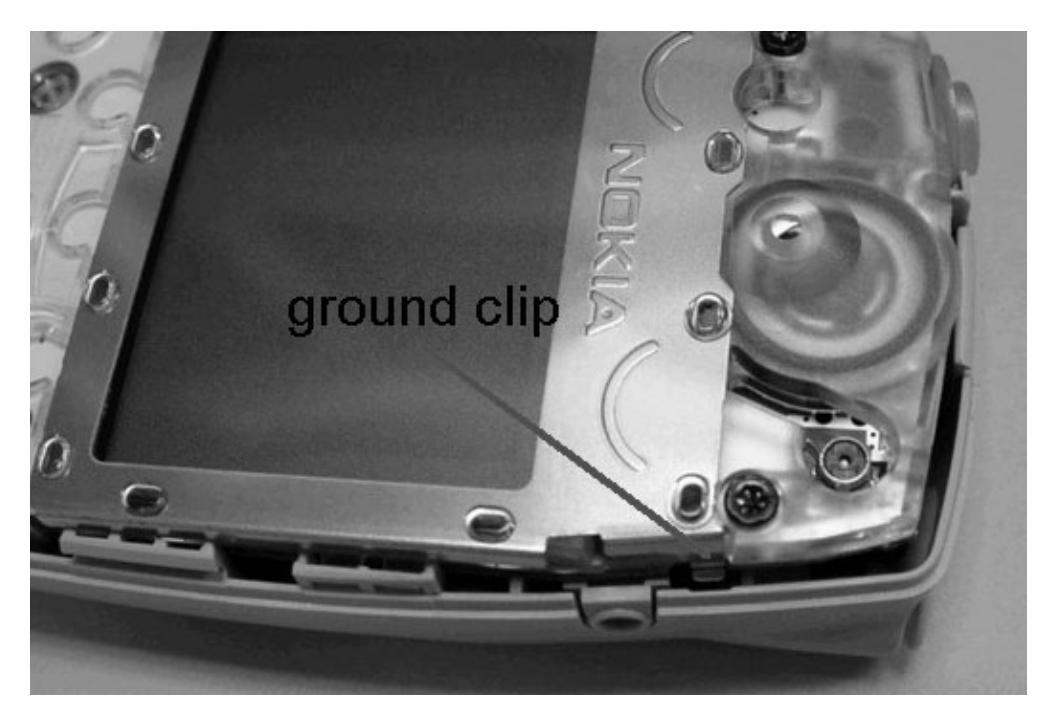
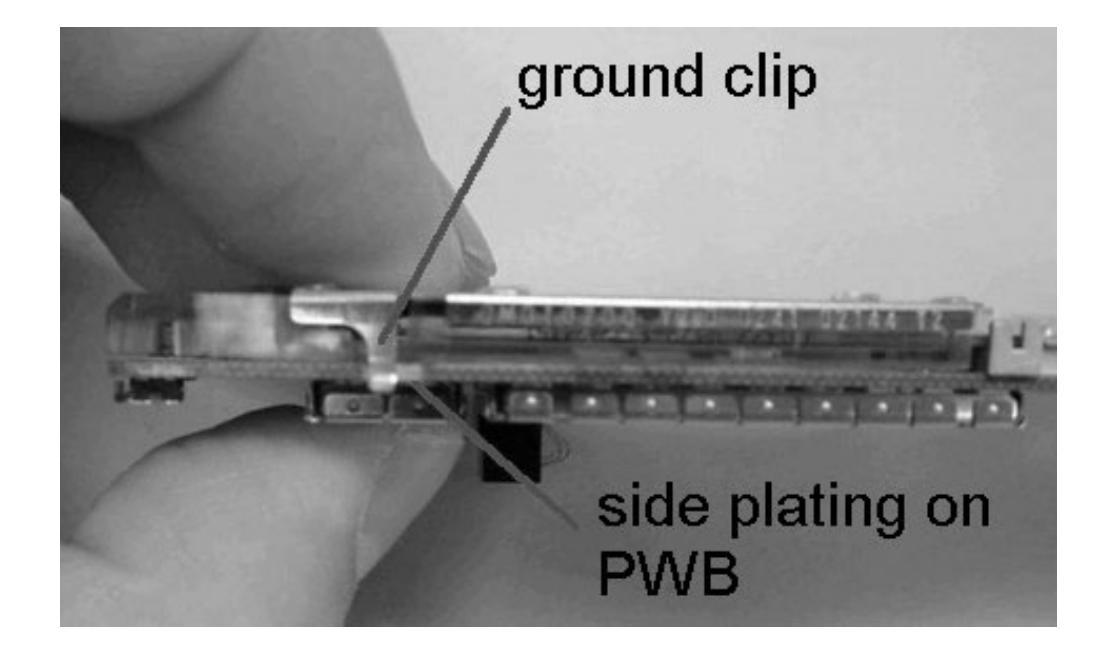
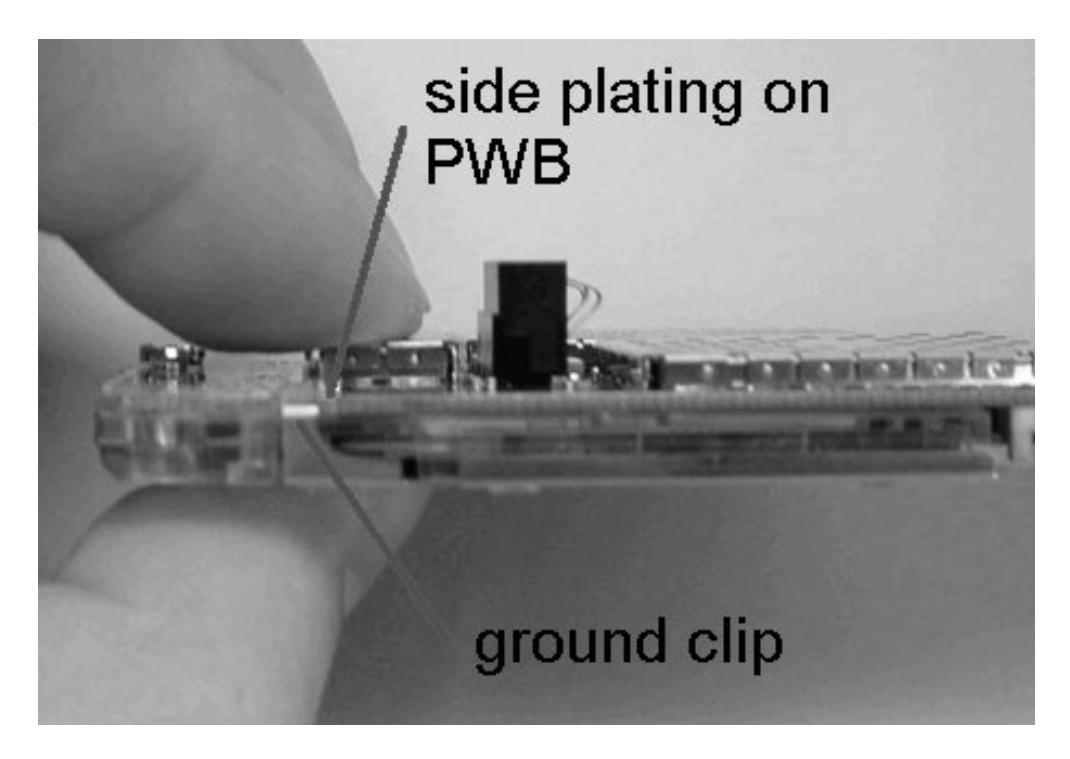
Note that the display frame is grounded to the PWB through the two ground clips. The grounding of the display frame will impact the radiation performance of the phone. If the clips are not touching the PWB, or are corroded, or obstructed, then the display frame should be replaced.

Figure 11: Ground clip on the left side of the display frame

Figure 12: Ground clip on the right side of the display frame

Figure 13: Contact between left ground clip of display frame and side plating of PWB.

Figure 14: Contact between right ground clip of display frame and side plating of PWB.

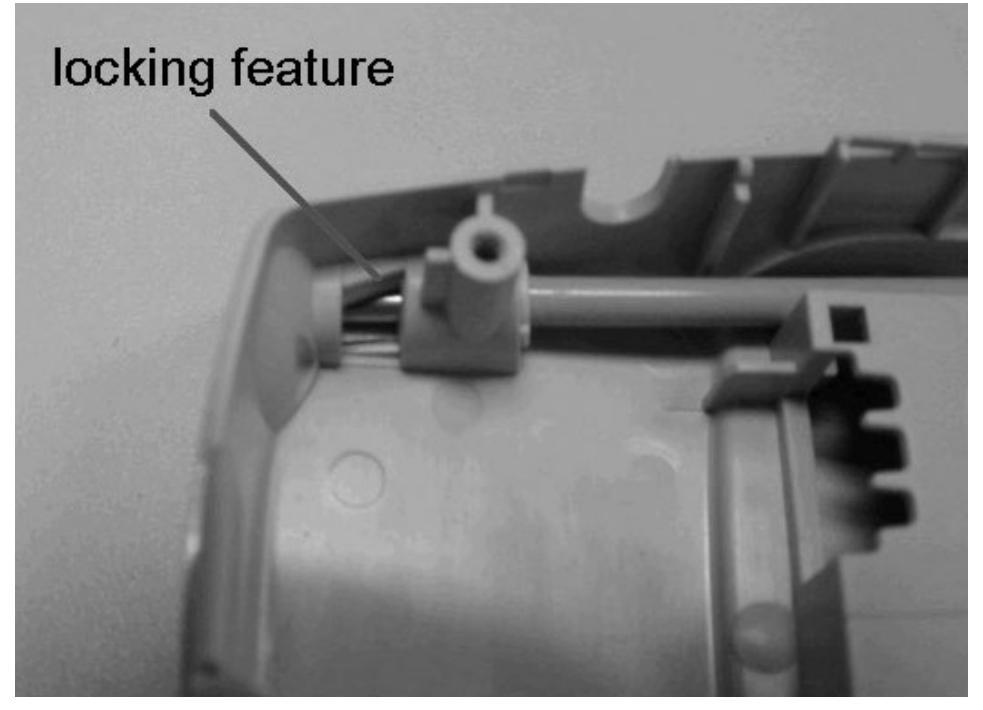
Figure 15: Locking feature for whip

The whip is locked into the D-cover when the internal antenna frame is installed. There is feature in the plastic frame of the internal antenna that interlocks with the locking feature of the whip. The whip plug has the locking feature, and also has a "key" that is supposed to make it difficult to install the whip plug with the wrong rotation. If the whip plug does get installed with the wrong rotation, then the whip will not be visible as seen through the locking feature as shown in Figure 15. In this case, if the whip cannot be removed, then the D-cover assembly will need to be replaced. Otherwise, simply replace the whip.

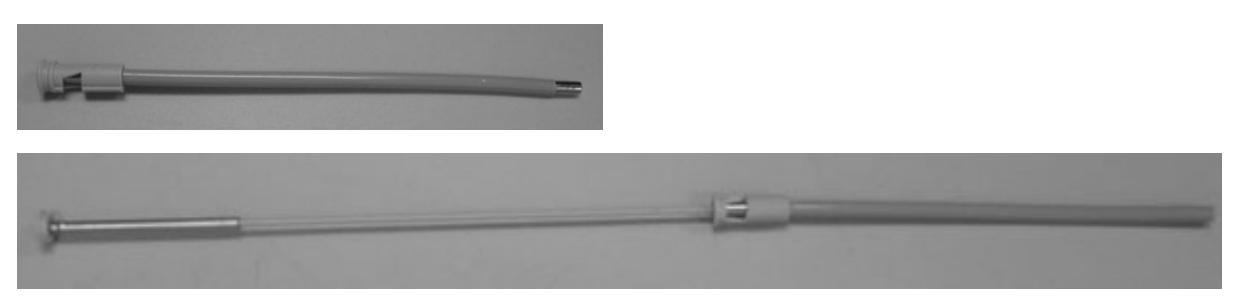
Figure 16: Whip stand alone in retracted and extended positions The above figure shows what the whip should look like when it is retracted and extended. If the whip is damaged, simply use another.
