Repair Hints

Service-Level 3 & 4

2650

RH-53

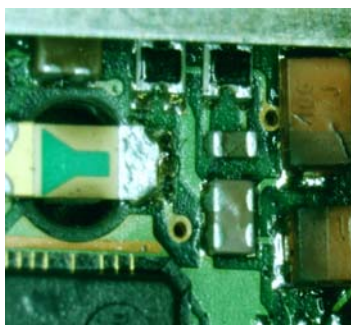
All replaceable (not underfilled) μ BGA components must be renewed after removing. Reflow with uncontrolled hot-air fan is strictly forbidden! It is also not recommended only to reflow the old μ BGA using a μ BGA rework station! μ BGA must only be soldered with NMP approved μ BGA rework machines (e.g. Zevac/ OK-Metcal/ Martin) to get durable solder joints.

"rework" done with
uncontrolled hot air

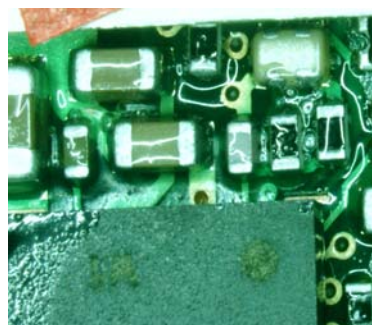
Check soldering points after removing a μ BGA; if necessary rework oxidated solderings (broken balls) carefully by tinplating these areas with few flux and a hot soldering iron. Before placing a new component remove the tin and clean the PWB; e.g. with help of solder wick and flux cleaner such as "Kontakt LR". Use only recommended flux type and an appropriate amount of it – avoid drowning the PWB in flux as this will lead to additional faults!

PWB drowned in flux

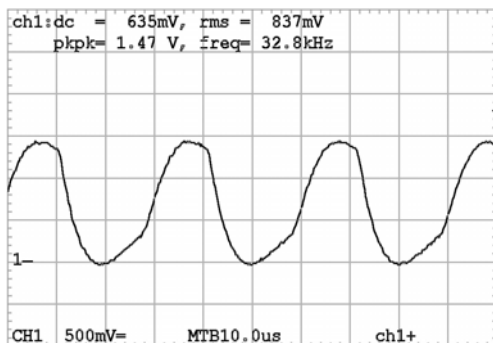
Fig.1: 32.678kHz at C209

- Check battery voltage at both sides of L260 – L262 and L263 – L265, ~4VDC
- Check 32.768kHz oscillator B200; voltage at both sides of crystal B200 usually is 0.5VDC; signals measured with an oscilloscope should appear as shown below:

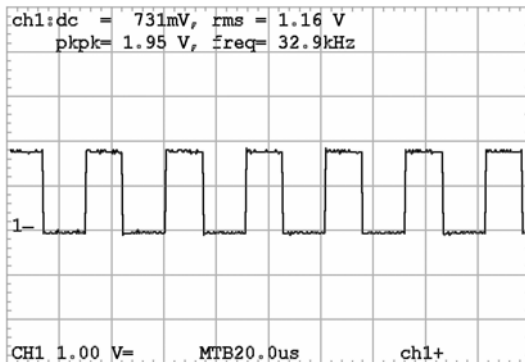
Fig.3: 32kHz sleepclock at J404

- Check sleepclock at UPP and 26MHz system clock at B600. Oscillator signals have to appear on the oscilloscope as shown below:

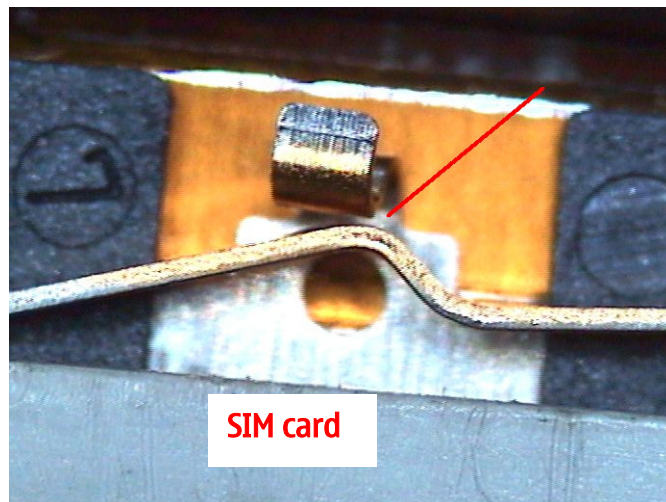
If SIM removal detection switch appears as shown in the picture below after having inserted SIM card, change LCD can Assy (A2).

Not closed detection switch with inserted SIM card

Do not try to bend the detection switch back into right position!!!
