**Nokia Customer Care
3125 (RH-61) Series Transceivers**

**Antenna Description and
Troubleshooting**

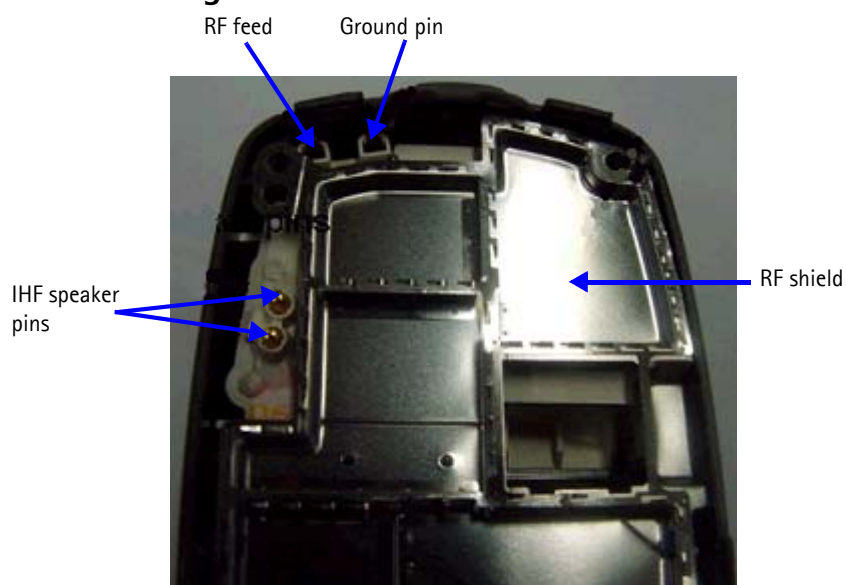
Figure 2: 3125 chassis assembly

If no internal antenna is installed, the antenna gain will degrade by more than 25 dB.

- If the internal antenna is missing, install a new one.
- If the radiator looks obviously damaged, replace the internal antenna.

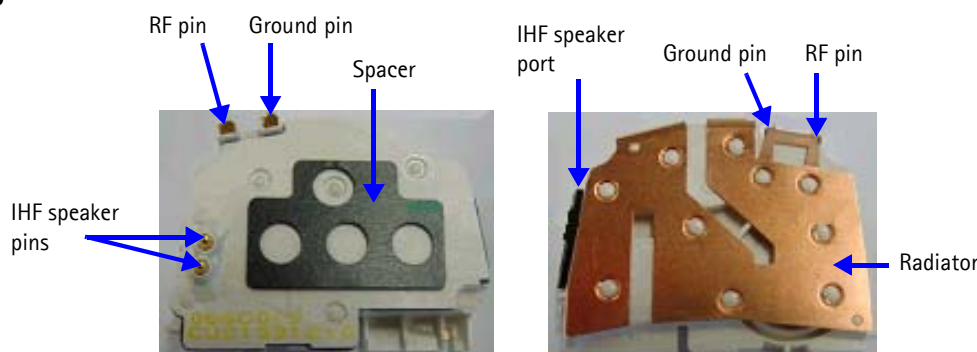
Figure 3: Bottom (left) and top (right) views of the 3125 internal antenna

If the RF feed does not touch the PWB, then the antenna gain will degrade by more than 25dB. If the ground pin does not touch the PWB, then the antenna gain may degrade from 5–10 dB.

Replace the internal antenna if any of the following situations apply:

- Either the RF feed pin or ground pin are broken or bent such that either pin will not touch the PWB
- The springs for the RF or ground pin appear damaged
- The slot in the radiator has a significantly different shape
- Obvious damage to the radiator (e.g., dents, corrosion)
- The pin is stuck or has excessive friction in the plastic tube/guiding feature resulting in the spring not working properly
- Either of the IHF speaker pins is damaged or if the IHF speaker is not functioning

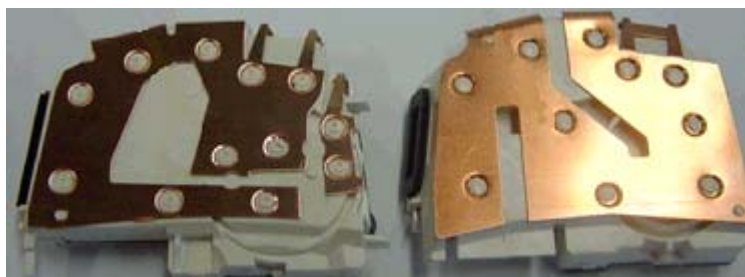
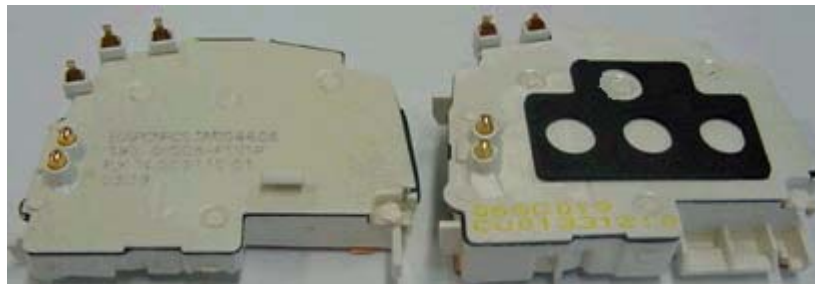
Figure 4: Top views of the 3100 (RH-19) (left) and 3125 (RH-61) (right) antennas

The 3100 and 3125 antennas are similar in appearance. The important visual difference in the antennas is the slot pattern. Also, the 3125 antenna is thicker than the 3100 antenna and has a spacer on its back side.

- If the wrong antenna is installed, install the correct one.

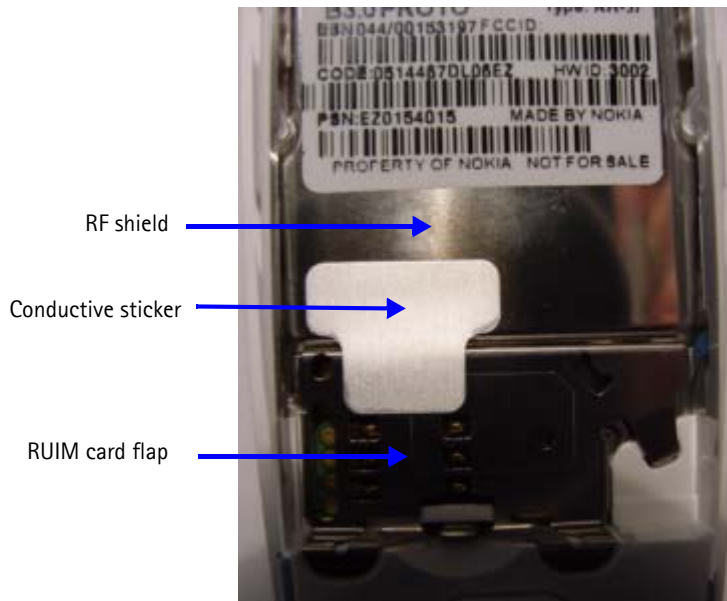
Figure 8: Conductive sticker grounding RUIM card flap to RF shield

The RUIM card flap needs to be grounded to the RF shield with a conductive sticker. The shape and location of the conductive sticker is shown in Figure 8. If the sticker is damaged or missing, then the radiated sensitivity could be reduced by 4–8 dB.

- If the conductive sticker is missing or ripped, replace the sticker.
