**Nokia Customer Care
3155/3155i (RM-41), 3152 (RM-61)
Mobile Terminal**

Antenna Description and Troubleshooting

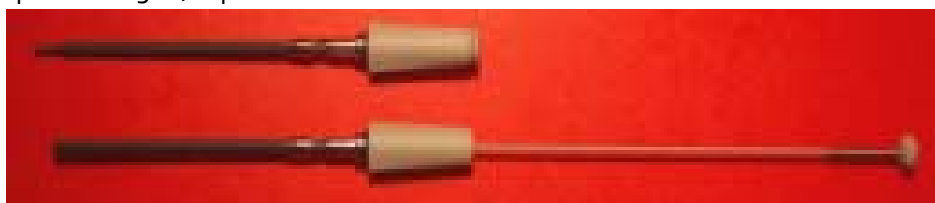
Figure 3: Whip stand-alone in retracted and extended positions

[Figure 3](#) shows what the whip must look like when it is retracted and extended. If the whip is damaged, replace it.

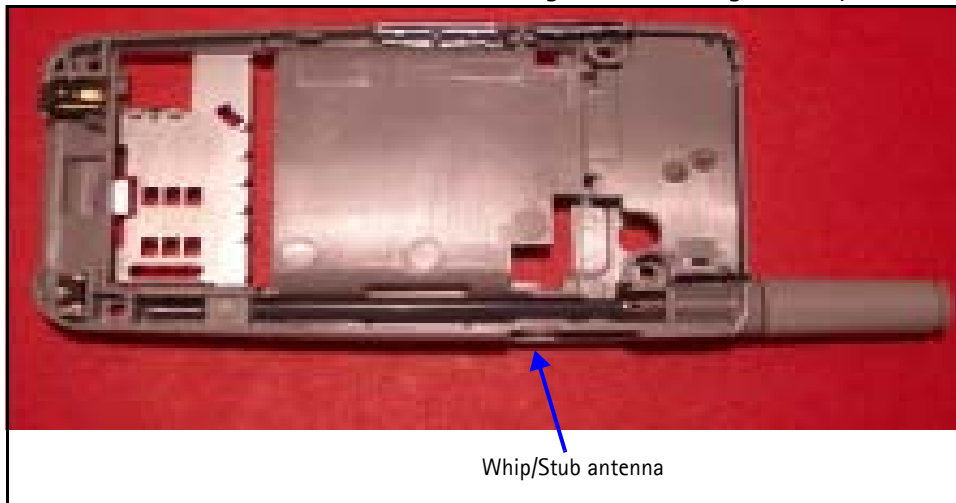
Figure 4: D-cover assembly

The internal antenna and whip are assembled into the D-cover as shown in [Figure 4](#). If no internal antenna is installed, the antenna gain will be degraded by more than 25 dB.

- If the whip antenna is missing, install one.
- If any part of the whip/stub antenna looks obviously damaged, then replace the whip/stub antenna.

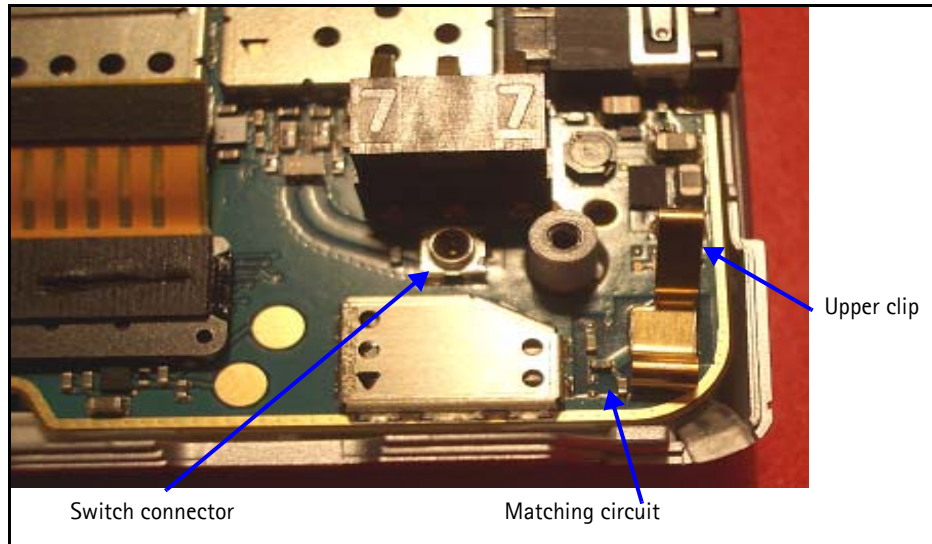
Figure 6: PWB layout of the RF feed pad and the matching circuit

If any portion of the upper clip is obstructed, removed, or covered, the antenna connector will not make contact with the PWB and the antenna performance will degrade. If the antenna connector does not touch clip, the antenna gain will degrade by more than 25 dB.

The matching circuit is right next to the upper clip. The matching circuit consists of a shunt inductor of 12nH, a series cap of 2.2pF, and a series inductor of 3.9nH. If the matching circuit is not installed properly or any of the components are missing, the extended antenna gain will be degraded by about 25dB and the retracted antenna gain will degrade by about 15dB.

- If corrosion is present or the pad is missing, replace the PWB and the mobile terminal.

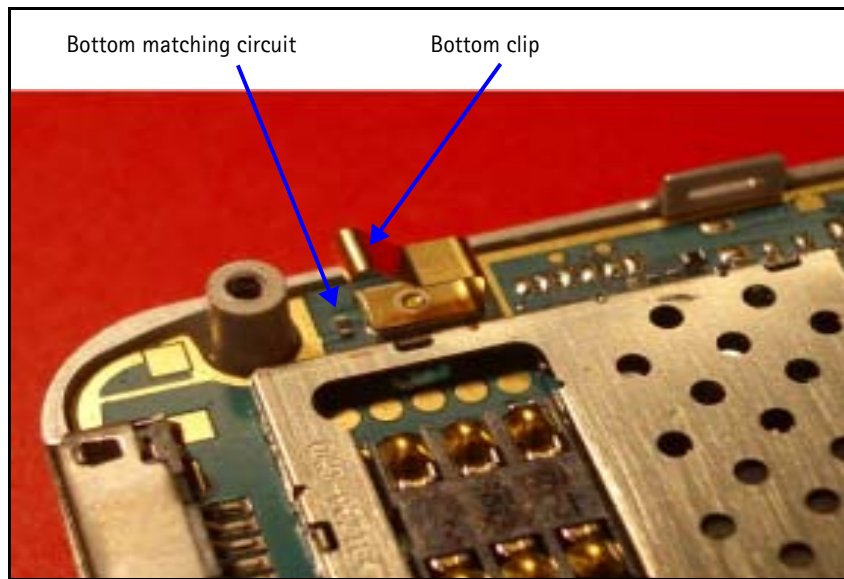
Figure 7: Bottom antenna clip

If the bottom antenna clip does not contact the whip stopper when the whip is fully retracted, the antenna gain will degrade by about 4-5dB at Cell band and 3-10dB at PCS band when the whip is retracted.

The bottom matching circuit is right next to the bottom antenna clip and consists of a series cap of 2.7pF. If the bottom matching circuit is not installed properly or the component is missing, then the retracted antenna gain will degrade by about 15dB.

- If the antenna clip is installed backwards, is damaged, or is missing, install a new bottom antenna clip in the correct position.

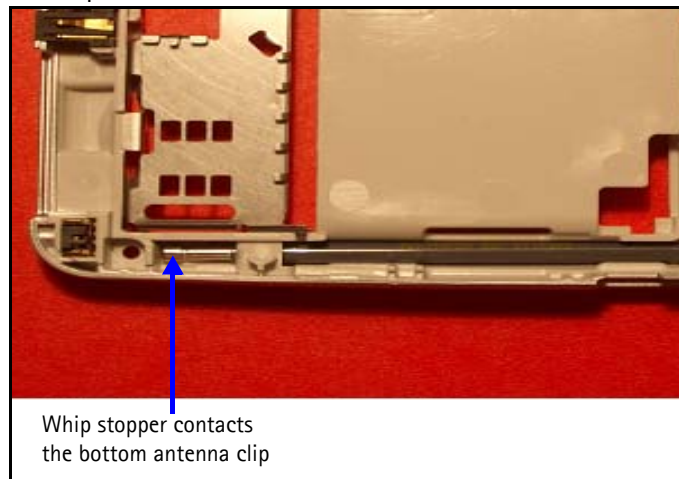
Figure 8: Whip stopper when the whip is fully retracted

If the whip stopper does not properly contact the bottom antenna clip, then the retracted antenna gain will degrade by about 4-5dB at Cell band and 3-10dB at PCS band when the whip is retracted.

- If the whip stopper is corroded or blocked by the whip straw, replace the whip assembly.
- If the whip stopper is obstructed or dirty, remove the obstruction and/or dirt.

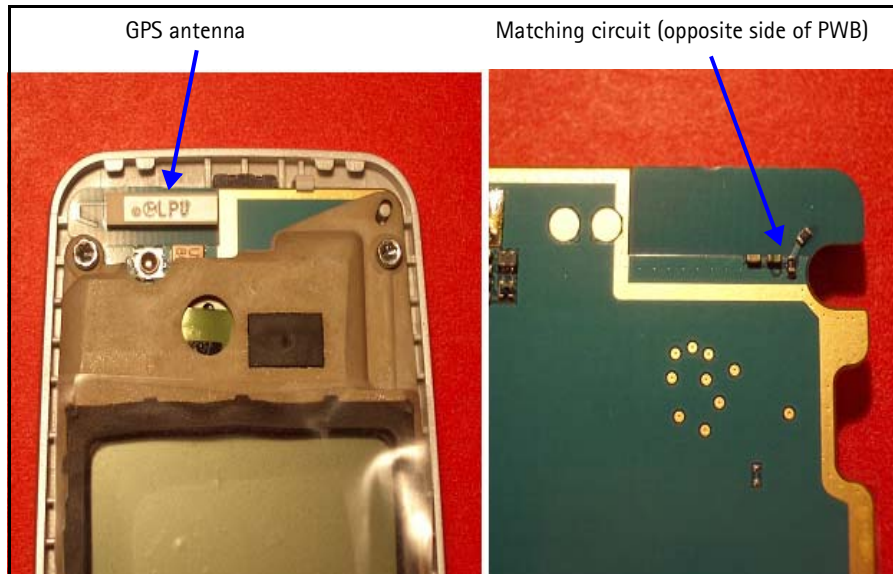
Figure 9: Position of the GPS antenna on the PWB

The GPS antenna is a ceramic chip soldered on the PWB. It has a matching circuit of series OR and a shunt inductor of 2.0nH.

- If the GPS antenna looks obviously damaged, replace it.
- If the GPS antenna is not present, install one (only for 3155i).
- If matching circuit is not properly installed or any of the two components are missing, install the proper matching circuit.

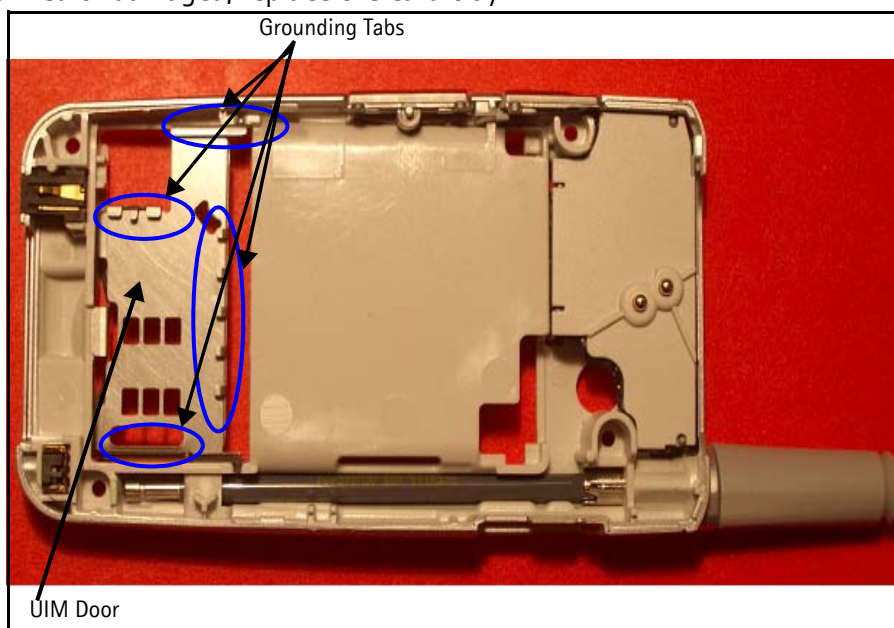
Figure 10: RUIM card holder assembled in D-cover

The card holder is grounded through grounding tabs. If the card holder is not properly grounded, the CDMA antenna performance can be degraded. If the grounding tabs are deformed or damaged, replace the card tray.
