CC Technical Documentation
RM-11 Series Transceivers

Troubleshooting - Antennas

This troubleshooting guide addresses potential failures that can affect the antenna performance of the RM-11 phone, and discusses methods for correction of these failures.

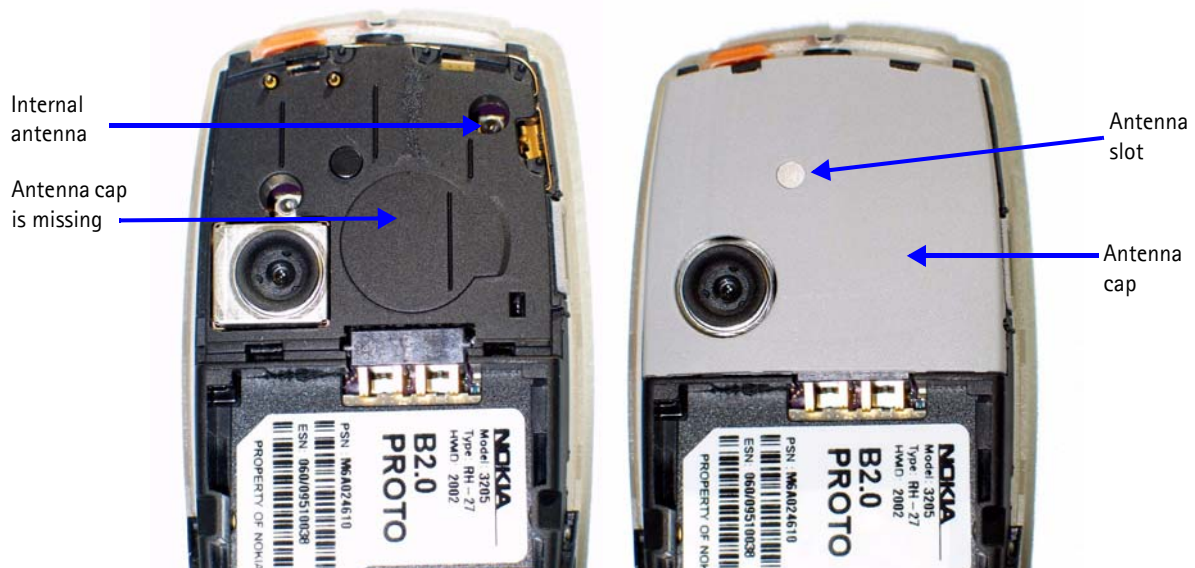
Figure 2: RM-11 phone with a missing internal antenna cap

If no antenna or no radiator is installed, the antenna gain will be degraded by more than 25 dB.

If the antenna cap is missing or if there is a cap without a radiator, install a new antenna cap with a radiator. If the radiator looks obviously damaged (i.e., dents or corrosion) or the slot in the radiator has a significantly different shape, then install a new antenna cap with the correct radiator.

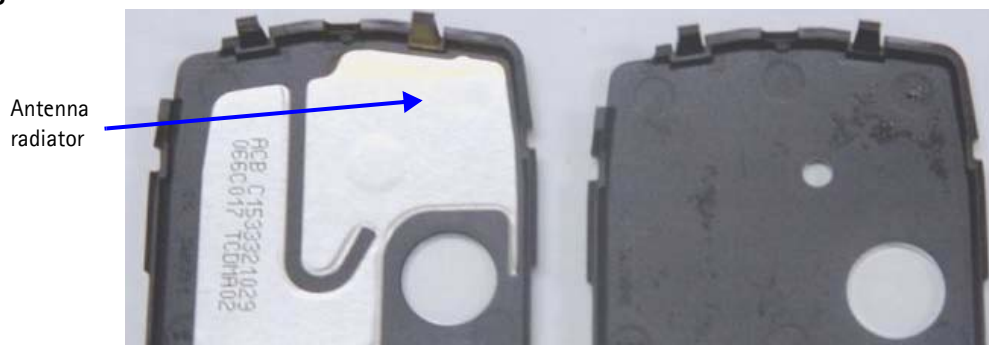
Figure 3: RM-11 phone with a missing antenna radiator

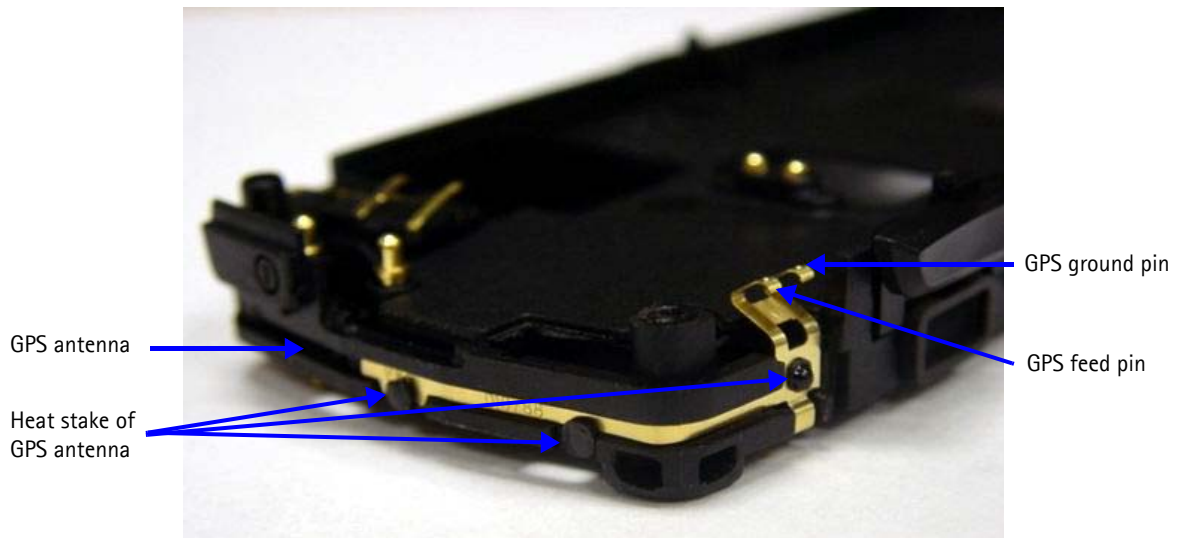
Figure 4: Back view of RM-11 (3205) C-cover with GPS antenna assembled

- GPS antenna is missing
- GPS antenna looks obviously damaged
- Any of the three heat stakes appears damaged; the GPS antenna will be loose
- Any of the three heat stakes are over-heated and the GPS antenna melts into the C-cover; the antenna will look distorted and bent
- Either the GPS antenna feed or the ground leg is broken or bent so that neither pin touches the PWB.

The RM-11 GPS antenna is heat-staked to the C-cover. If any of the following events occurs, replace the entire C-cover assembly:

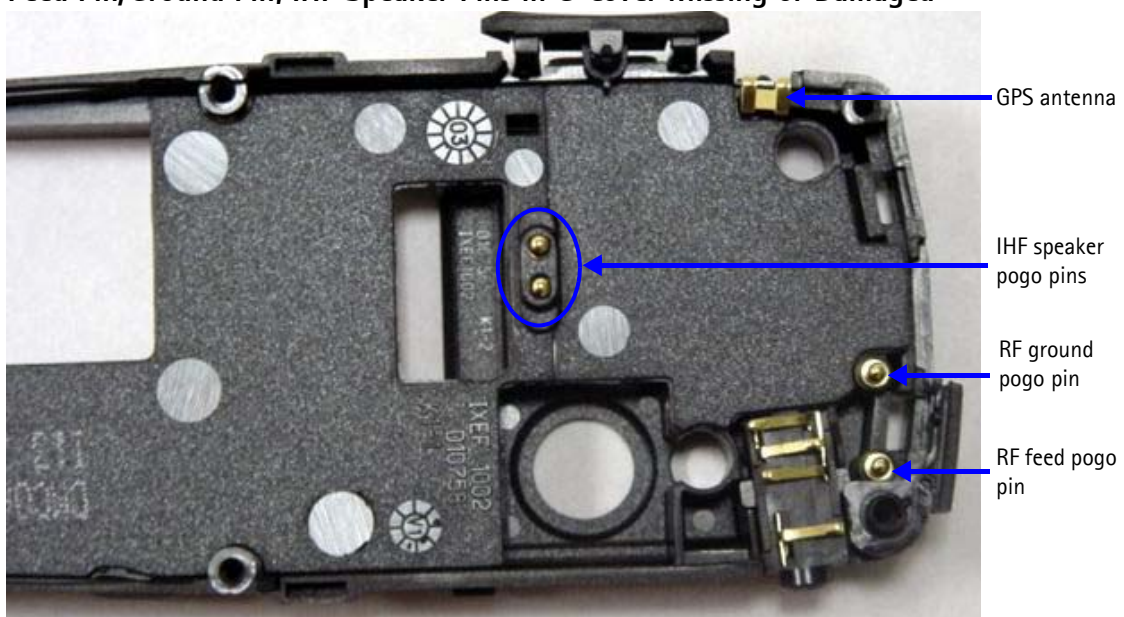
Figure 5: Inside view of the C-cover

Two pogo pins are inserted in the C-cover. One end of the pogo pin touches the antenna, the other end touches the pad on the PWB (see Figure 5). If either of the pogo pins is missing or obviously damaged (i.e., stuck in the C-cover plastic tube, loose the inside spring force), the antenna will lose the contact to the PWB. In this case, replace the C-cover assembly with a new one.

If the RF feed does not touch the PWB, then the antenna gain will degrade by more than 25 dB. If the ground pin does not touch the PWB, then the antenna gain may degrade about 5 to 10 dB.

If either of the IHF speaker pins is damaged or missing, the speaker will not connect to the PWB and the antenna PCS gain will drop 2 dB. If this happens, replace the C-cover.

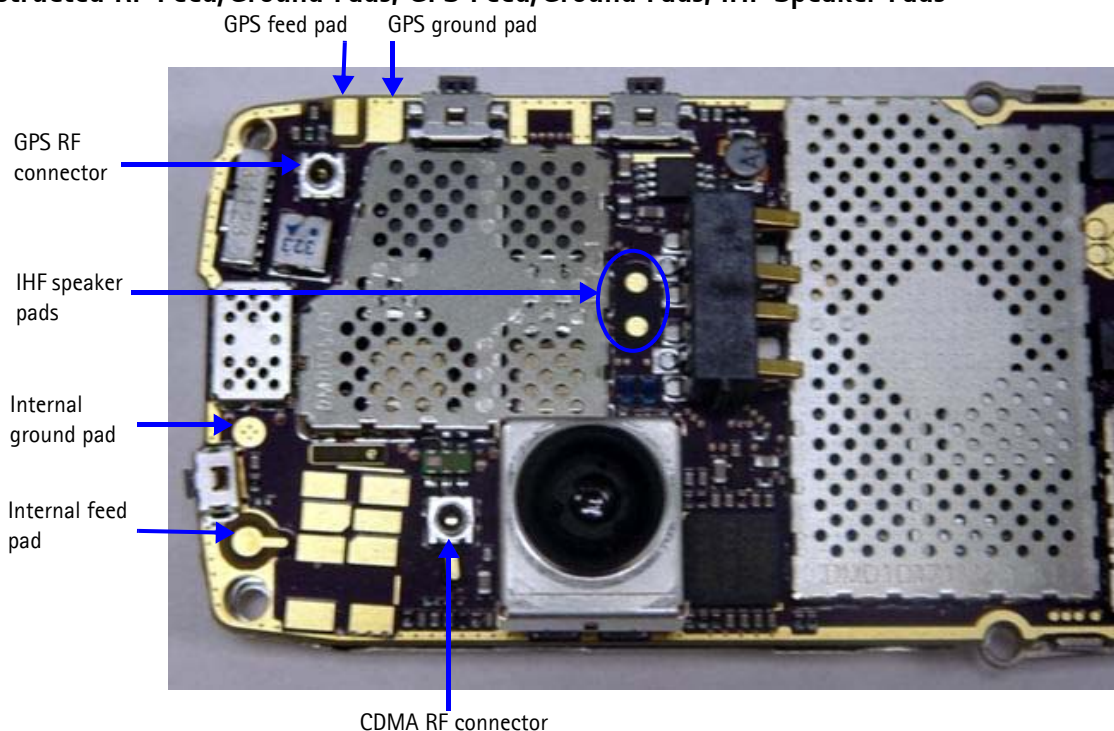
Figure 6: Obstructed RF feed and ground pads, GPS feed/ground pads, and IHF speaker pads

If the RF feed pad is obstructed, removed, or covered, then the internal antenna feed pogo pin will not touch the PWB and the antenna gain will degrade by more than 25 dB. If the ground pad is obstructed, removed, or covered, then the ground pogo pin will not touch the PWB and the antenna gain will degrade by more than 5 dB. If corrosion is present or the pad is missing, replace the PWB and phone. If either pad is obstructed or covered, then clear or clean the pad.

If the GPS feed pad is obstructed, removed, or covered, then the GPS antenna feed leg will not touch the PWB. If the ground pad is obstructed, removed, or covered, then the ground spring clip will not touch the PWB.

If the Internal Hands Free (IHF) speaker pads are obstructed, removed, or covered, then the IHF speaker will not produce sound. The antenna PCS gain will be degraded by about 2 dB. If corrosion is present or the pad is missing, replace the PWB and phone. If either pad is obstructed or covered, clear or clean the pad.

CDMA and GPS use the same type of RF connector. The RF connector could fail by not connecting the RF input to the RF output of the RF connector. If this happens to the CDMA RF connector, then the antenna gain will degrade by about 25 dB. If this happens to the GPS RF connector, the GPS antenna gain will degrade by about 20 dB. Test for DC conductivity between the RF input and RF output of the RF connector.

If the RF input is not connected properly to the RF output, replace the RF connector.

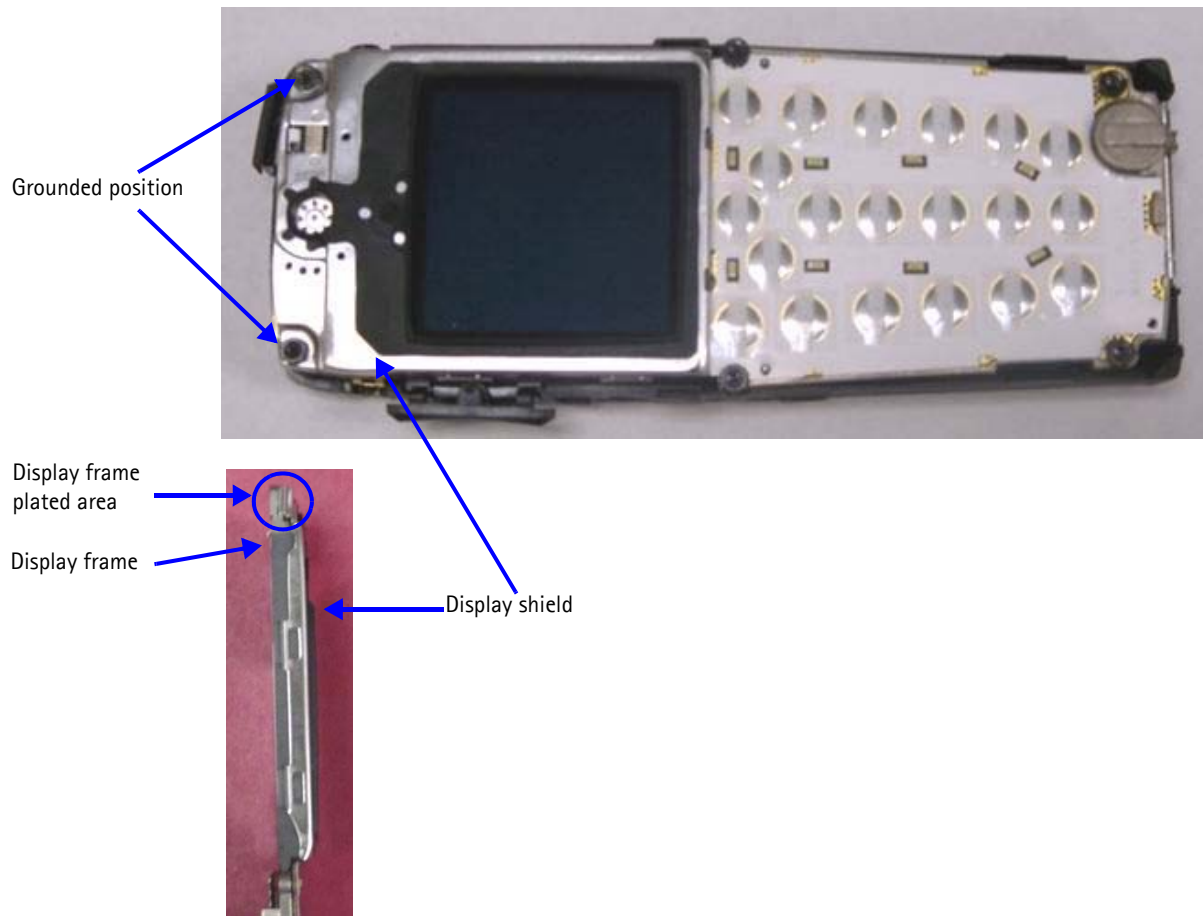
Figure 7: RM-11 display assembly (top) and side view (bottom)

First, the display shield is connected to the display frame plated area (screw boss area), and then to the PWB through the two top screws. The grounding of the display shield and frame impact the radiation performance of the phone. If the screws are loose, tighten them. If the screw bosses are stripped, replace the chassis. If the screws are missing, install new ones.

If the plated area of the display frame is cracked or the metal plating is peeled off, then the grounding of the display shield and frame will not be guaranteed. If this is the case, replace the frame.

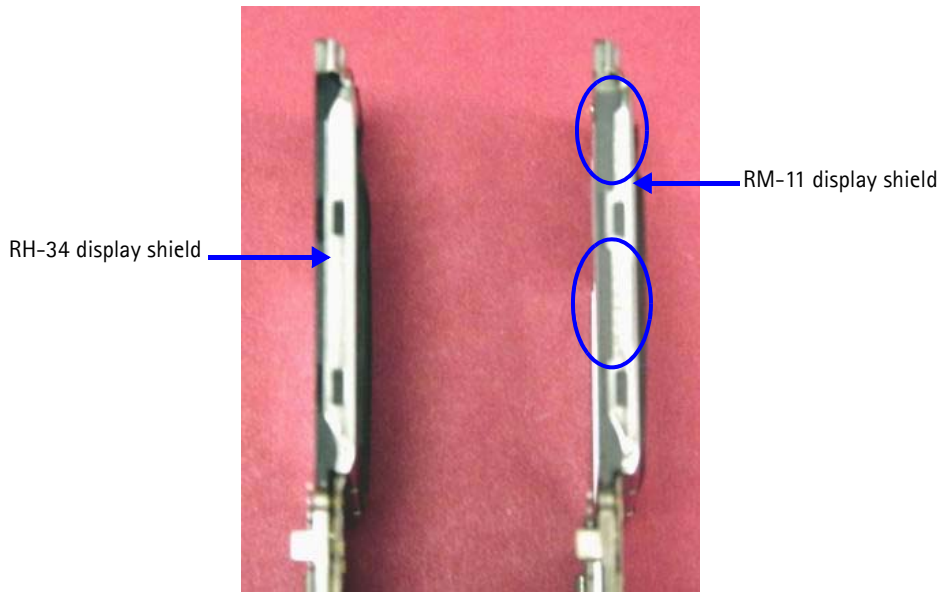
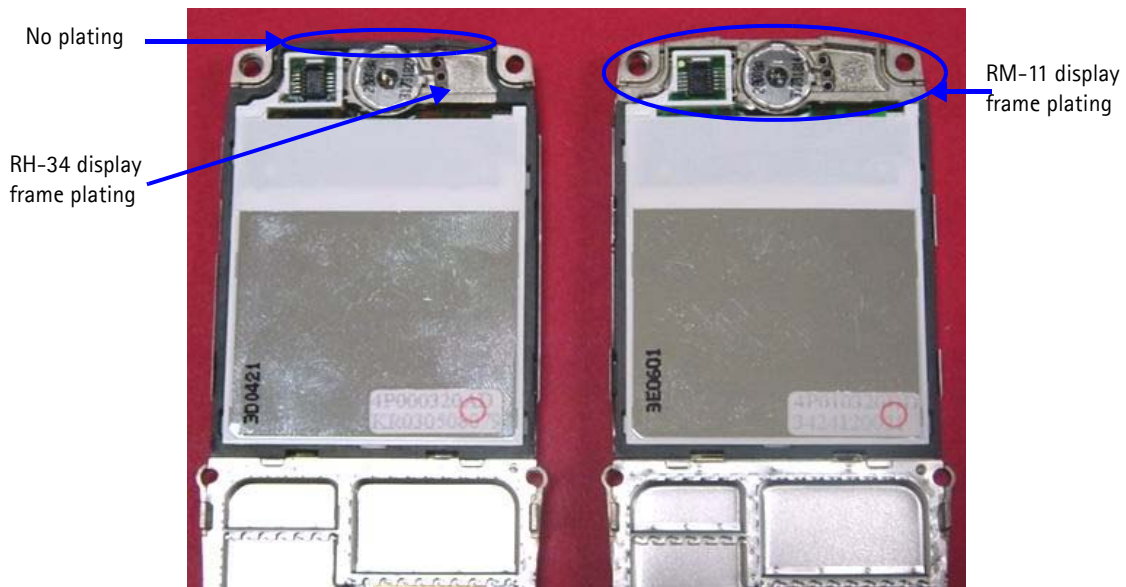
Figure 8: Side view of RH-34 and RM-11 display assembly

Figure 9: Back view of RH-34 and RM-11 display assembly

The RH-34 (6585) and RM-11 (3205) display assemblies are very similar. However, the side of the RM-11 display shield is different than the side of the RH-34 display shield (see Figure 8). In addition, the metal plating at the top area of the RM-11 frame is different from the top of the RH-34 frame (see Figure 9). For the RH-34 frame, the screw boss area is plated but isolated from the rest of the frame, and also there is no plating in the top area. For the RM-11 frame, the whole top area is fully plated.

If the wrong display shield or frame is installed, replace it with a correct one.

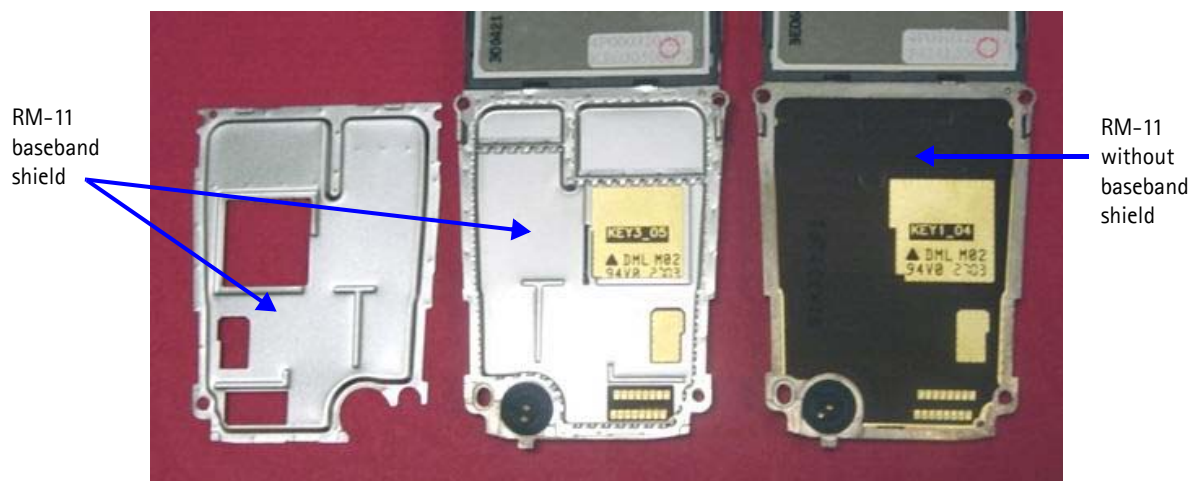
Figure 10: Baseband shield for the RM-11

The baseband shield is part of the display assembly. If the baseband shield is missing or is obviously damaged, the radiated phone performance will be impacted. Check the spring fingers on the baseband shield to ensure that they are raised up so that they make contact with the PWB when installed. If damaged, install a new baseband shield.
