# Repairhints

# 3310/3330

# NHM-5/6

The purpose of this document is to provide some further service information for NOKIA 3310 / 3330 phones.

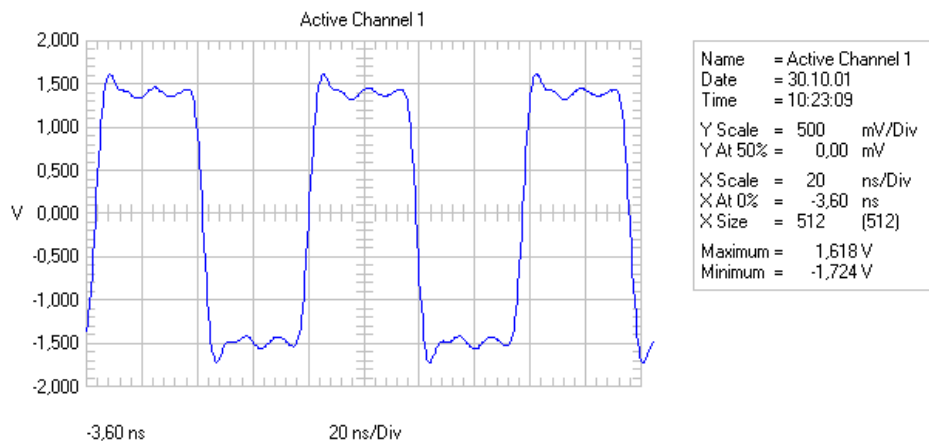
Figure 8-1

Probably COBBA N100 faulty or broken solderings under it – change COBBA and retune RX/TX-values.  
If fault remains after changing COBBA, MAD or PCB faulty.

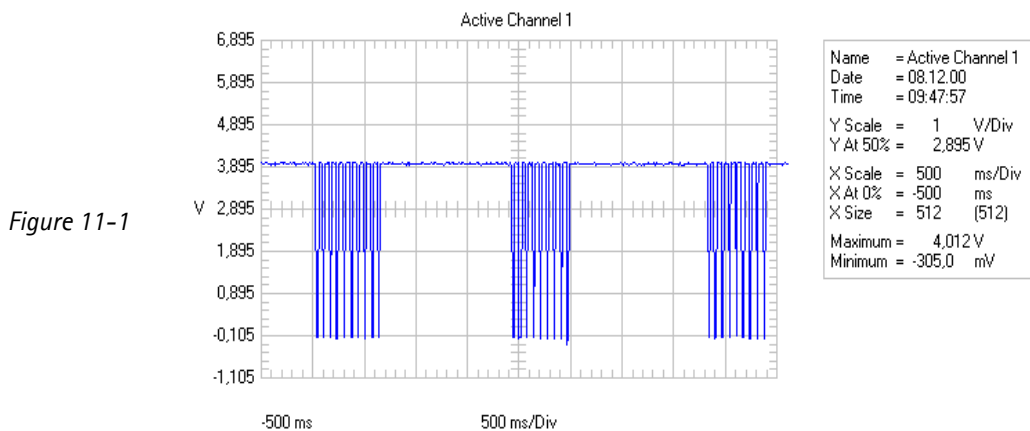
Figure 11-1

Check VB 3.6 VDC at pin 1 and VBB 2.8 VDC at pin 2 of N400.  
Check vibra\_cnt at pin 19 of N400. If signal is ok but vibra does not work, change N400, else there is a disconnection between D300 and N400 or MAD is faulty.

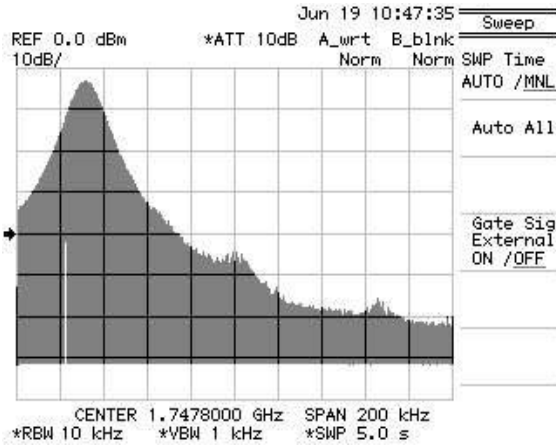
Figure 12-14

1) Normal spectrum

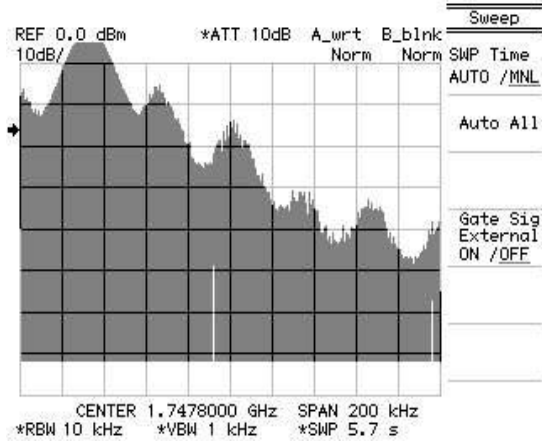
Figure 12-15

2) Spectrum with broken solderings under CCONT  
Spectrum turns to picture 1 if CCONT is pushed careful with some nonmetallic item.

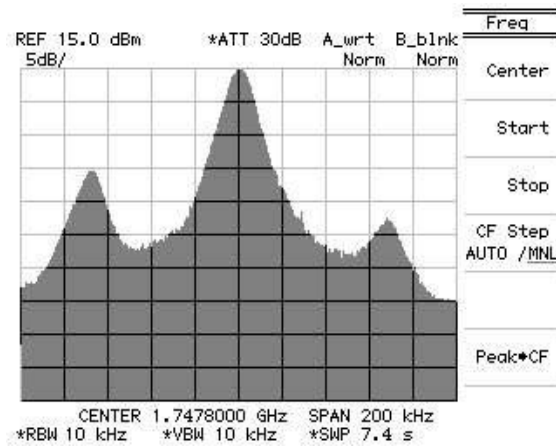
Figure 12-16

3) Spectrum of faulty COBBA

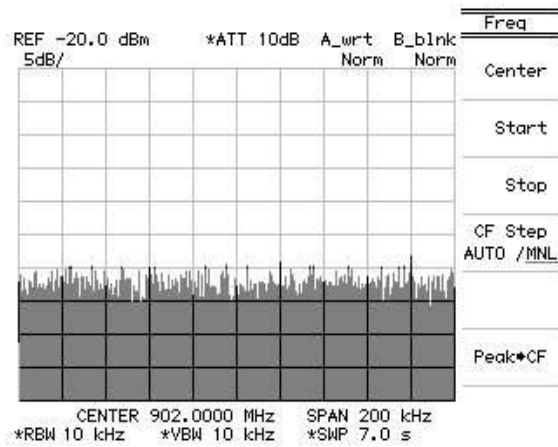
4) Spectrum of faulty oscillator G500

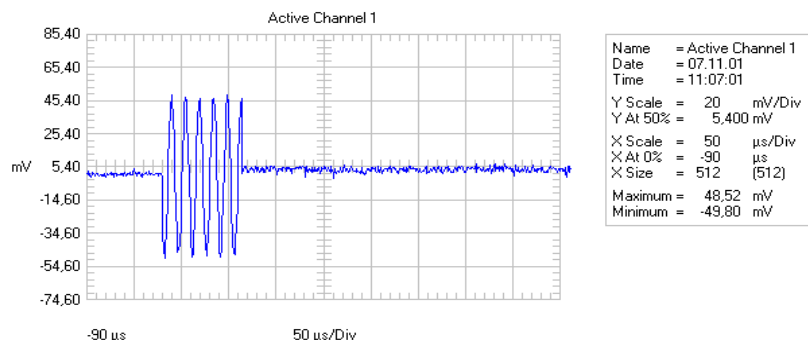
Figure 12-23

If signal is not ok, check C508 for shorts to ground, check resistance of R500 (4 x 100Ω) or change HAGAR N500.

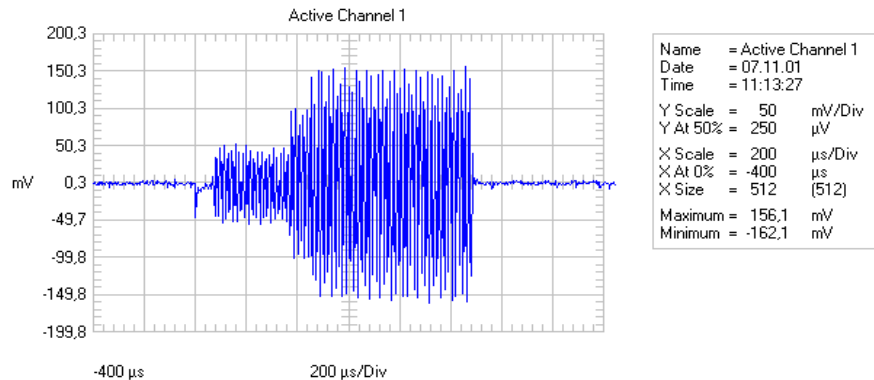
Figure 12-24

If signal at R504 is not measurable, check VREF\_2 1.35 VDC at C535/536 and RXREF 1.2 VDC at C529. Also check C514/526 if broken or cold soldered, change HAGAR N500 if necessary.
