CCS Technical Documentation

NPD-1 Series Transceivers

Troubleshooting – Antenna

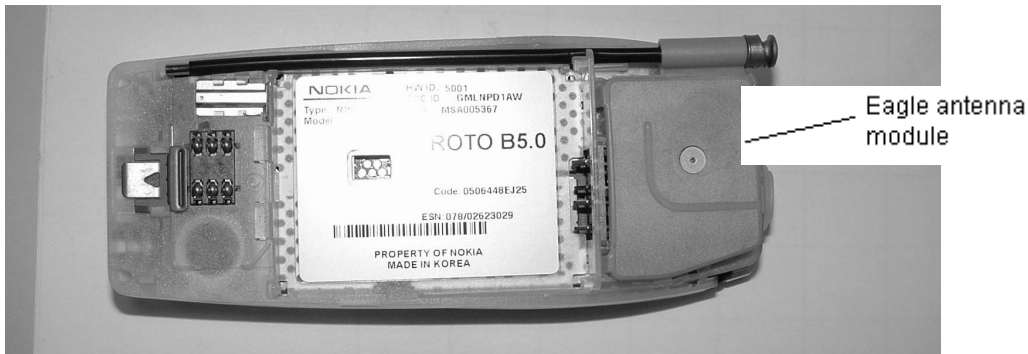
Figure 1: Eagle Antenna Module installed)

A properly installed and plated Eagle antenna module is shown in Figure 1.

If no internal antenna is installed, the antenna gain will be degraded by more than 25 dB.

If the Eagle antenna module is missing, install one. If an unplated internal antenna is installed, replace it with a properly plated internal antenna module.

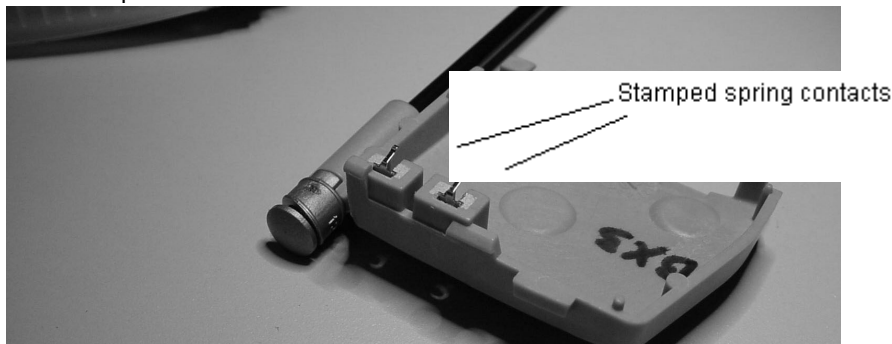
Figure 2: RF feed and ground stamped contact spring clips properly installed

Figure 2 shows the RF feed and ground stamped contact spring clips properly installed. Figure 3 shows both stamped contacts spring clips missing. If the either contact is missing or bent, replace antenna module with new antenna.

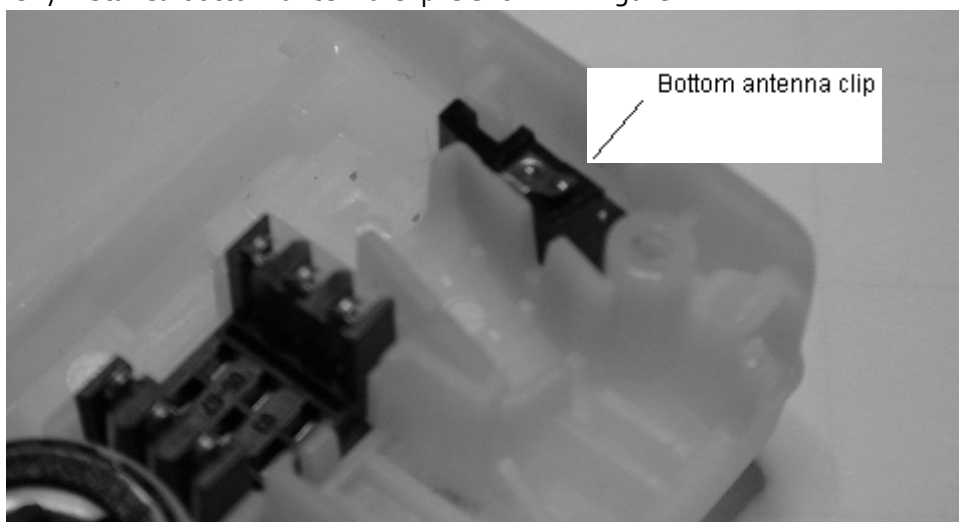
Figure 4: Properly installed bottom antenna clip

The bottom antenna clip is located near the bottom of the phone in the D-cover. A properly installed bottom antenna clip is shown in Figure 4.

The degradation in antenna performance is only about 2 to 4 dB in the receive portion of the CELL band when the whip is retracted. PCS band, retracted whip, degradation will be 10 to 15 db.

If the bottom antenna clip is bent or missing, then it should be carefully replaced with a new one.

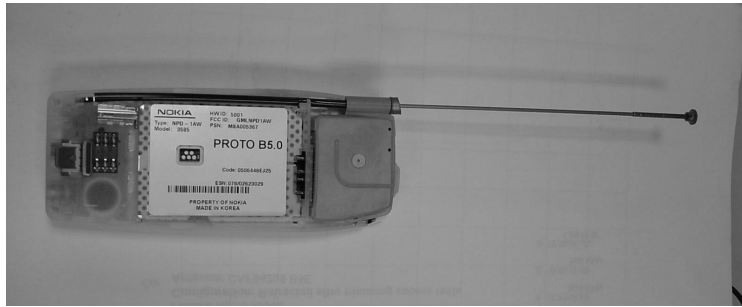
Figure 5: Properly installed whip antenna

The whip will perform 2 dB better than the internal antenna in free space. The whip will perform up to 3 dB better than the internal antenna in talk position.

If the whip is missing, then the Eagle antenna module should be replaced. Figure 5 shows a properly installed whip antenna.

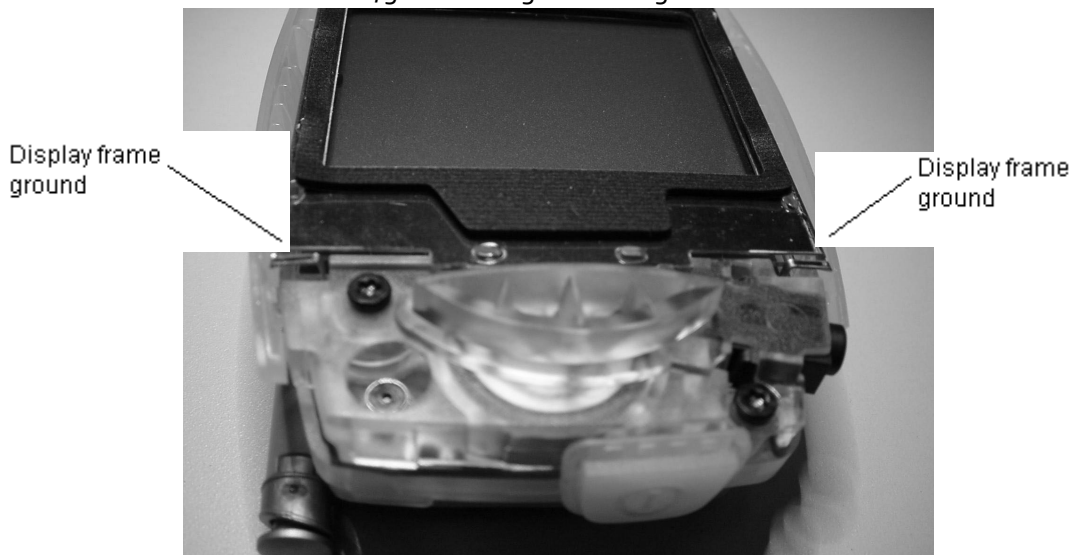
Figure 6: Display frame grounded by two spring clips

The display frame is normally grounded by two spring clips (Figures 6). The figure shows the display frame grounding locations. If clips are missing or bent, replace light guide with good one. SAR performance will degrade by .5 mW/g for one leg not grounding to the PWB to over 1.7mW/g if both legs are not grounded.

The D cover and light guide have snaps near the display frame ground positions. Make sure they are locked in position for ESD protection. These snap features help maintain display leg contact with the PWB.
