**Nokia Customer Care
RH-27 Series Transceivers**

Troubleshooting - Antennas

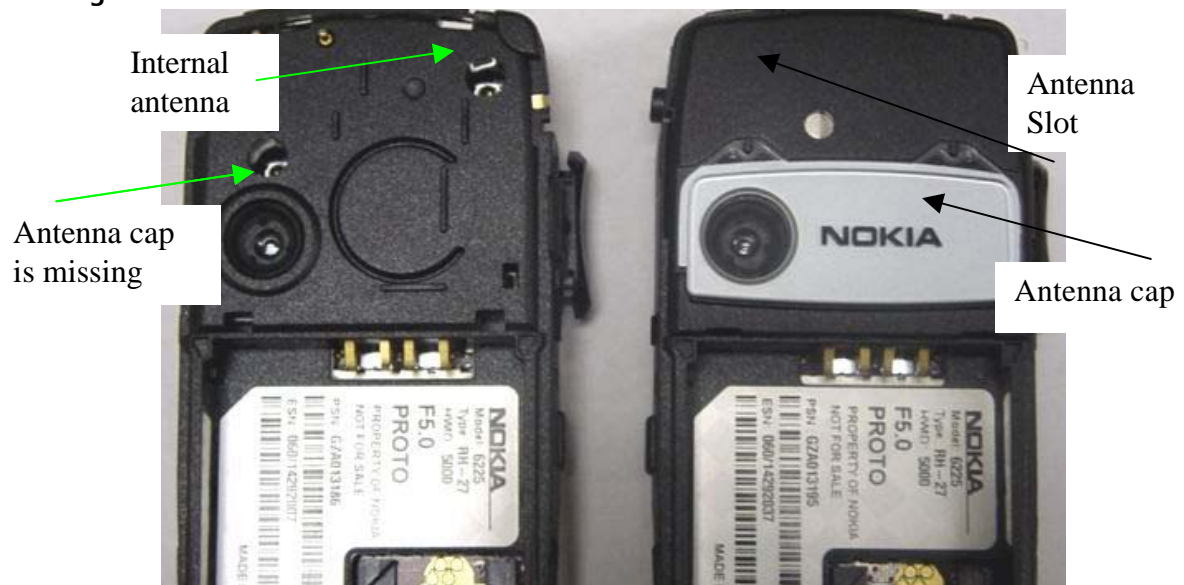
Figure 2: RH-27 (6225) phone with and without antenna cap

If no antenna or no radiator is installed, the antenna gain will be degraded by more than 25 dB.

If the antenna cap is missing or there is a cap but it has no radiator, install a new antenna cap with radiator. If the radiator looks obviously damaged (dents, corrosion) or the slot in the radiator has a significantly different shape, then install a new antenna cap with correct radiator.

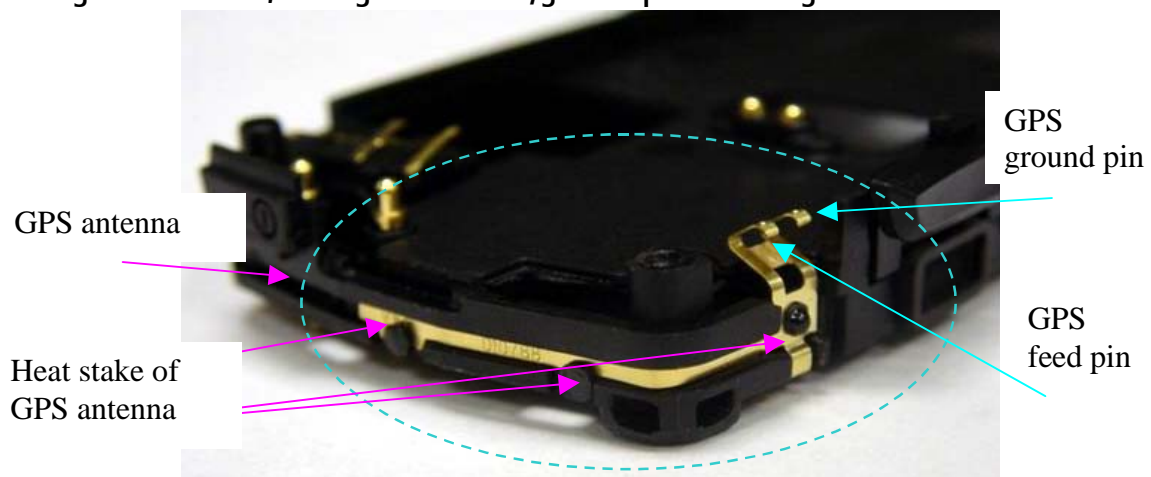
Figure 4: Back view of RH-27 (6225) C-cover with GPS antenna assembled

- 1 GPS antenna is missing
- 2 GPS antenna looks obviously damaged
- 3 Any of the three heat stakes appears damaged; the GPS antenna will be loose
- 4 Any of the three heat stakes are over-heated and GPS antenna melts into the C-cover; antenna will look distorted and bent
- 5 Either GPS antenna feed or ground leg is broken or bent so that either pin will not touch the PWB.

RH-27 GPS antenna is heat-staked to the C-cover. If any of the following events occurs, the entire C-cover assembly should be replaced with a new one:

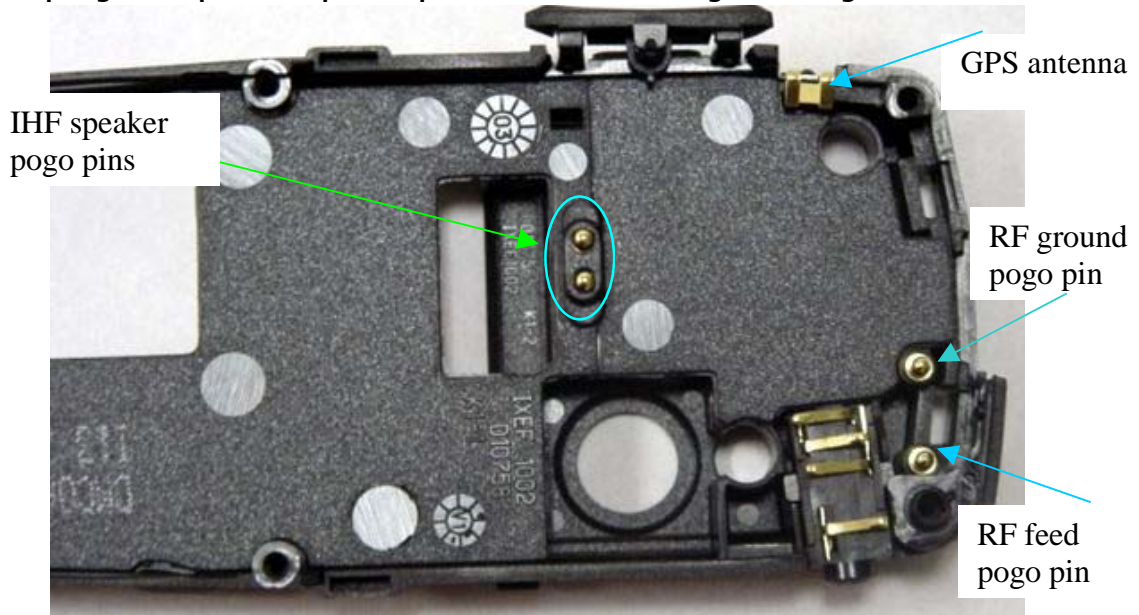
Figure 5: Inside view of the C-cover

Two pogo pins are inserted in the C-cover. One end of the pogo pin touches the antenna, the other end (in Figure 5) touches the pad on the PWB. If either of the pogo pins is missing, or either of the pogo pins is obviously damaged (stuck in the C-cover plastic tube, loose the inside spring force), the antenna will lose the contact to the PWB. Replace the whole C-cover assembly with a correct new one.

If the RF feed doesn't touch the PWB, then the antenna gain will degrade by more than 25 dB. If the ground pin doesn't touch the PWB, then the antenna gain may degrade about 5 to 10 dB.

If either of the IHF speaker pins is damaged or missing, the speaker will not connect to PWB. Antenna PCS gain will drop 2 dB. The C-cover assembly should be replaced.

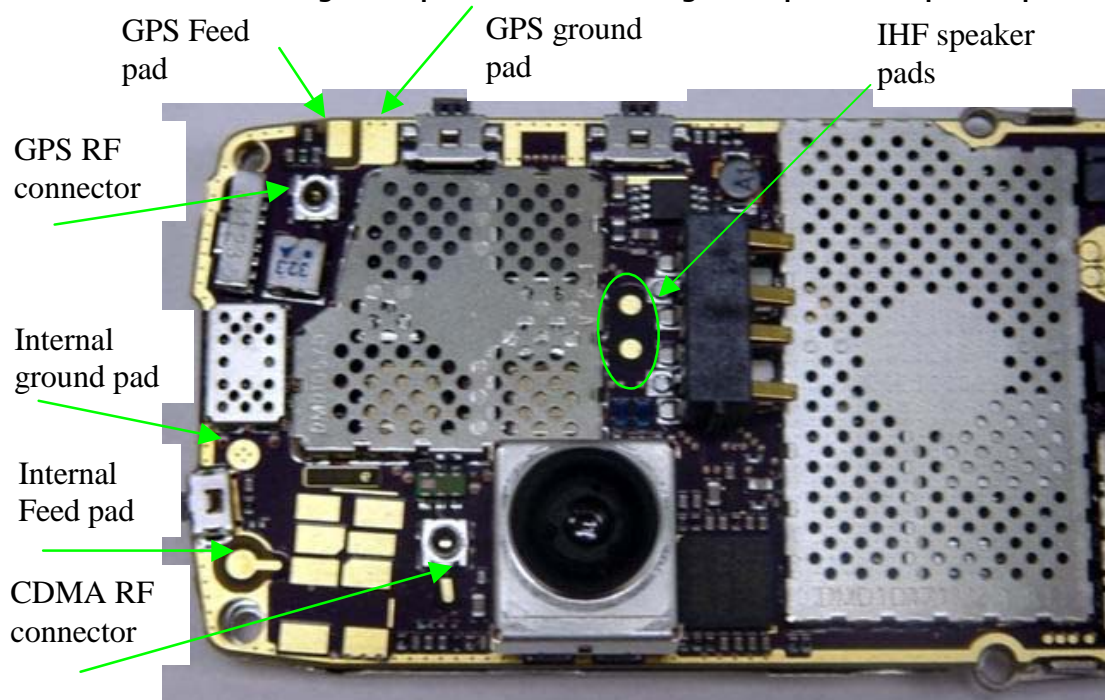
Figure 6: PWB layout of RF feed/ground pads, GPS feed/ground pads, and IHF speaker pads

If the RF feed pad is obstructed, removed, or covered, then the internal antenna feed pogo pin will not touch the PWB and the antenna gain will degrade by more than 25 dB. If the ground pad is obstructed, removed, or covered, then the ground pogo pin will not touch the PWB and the antenna gain will degrade by more than 5 dB. If corrosion is present or the pad is missing, then the PWB and phone most likely needs to be replaced. If either pad is obstructed or covered, the pad should be cleared and/or cleaned.

If the GPS feed pad is obstructed, removed, or covered, then the GPS antenna feed leg will not touch the PWB. If the ground pad is obstructed, removed, or covered, then the ground spring clip will not touch the PWB.

If the Internal Hands Free (IHF) speaker pads are obstructed, removed, or covered, then the IHF speaker will not produce sound. The antenna PCS gain will be degraded by about 2 dB. If corrosion is present or the pad is missing, then the PWB and phone most likely needs to be replaced. If either pad is obstructed or covered, the pad should be cleared and/or cleaned.

CDMA and GPS use the same type of RF connector. The RF connector could fail by not connecting the RF input to the RF output of the RF connector. If this happens to the CDMA RF connector, then the antenna gain will degrade by about 25 dB. If this happens to the GPS RF connector, the GPS antenna gain will degrade by about 20 dB. This can be checked by testing for DC conductivity between the RF input and RF output of the RF connector. Note the DC conductivity test must be done without any cable attached to the RF connector. Since the RF connector is also a switch, the RF output will be disconnected from the RF input when a cable is inserted into the RF connector. When a cable is not inserted, the RF input is connected to the RF connector. The locations of both RF

If the RF input is not connected properly to the RF output, then the RF connector must be replaced.

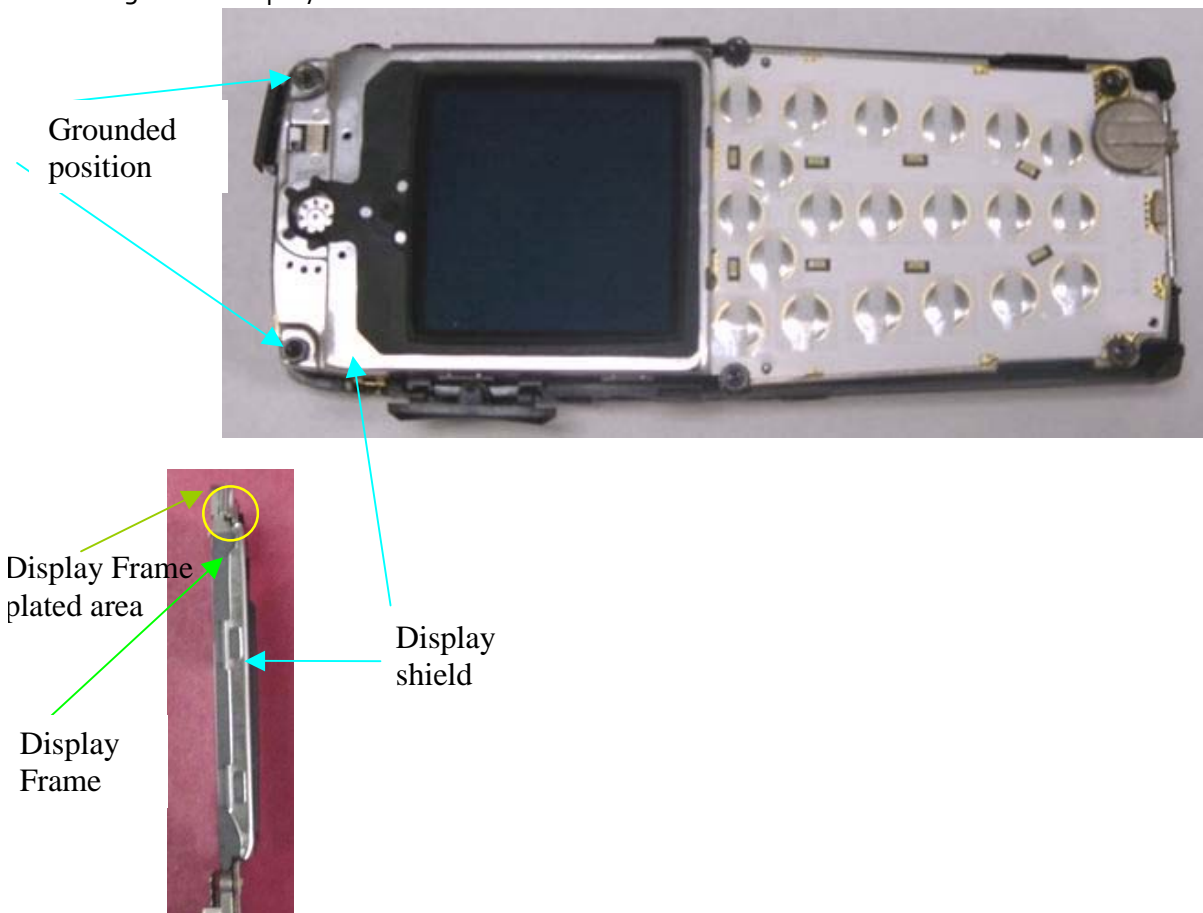
Figure 7: RH-27 display assembly (above, right) and side view of RH-27 display assembly (above, left)
The display shield is connected to the display frame plated area (screw boss area) and then the the PWB through the two top screws. The grounding of the display shield and frame will impact the radiation performance of the phone. If the screws are loose, tighten them. If the screw bosses are stripped, the chassis will need to be replaced. If the screws are missing, install new ones.

If the display frame plated area is cracked or the metal plating is peeled off, then the grounding of the display shield and frame will not be guaranteed. Replace the frame.

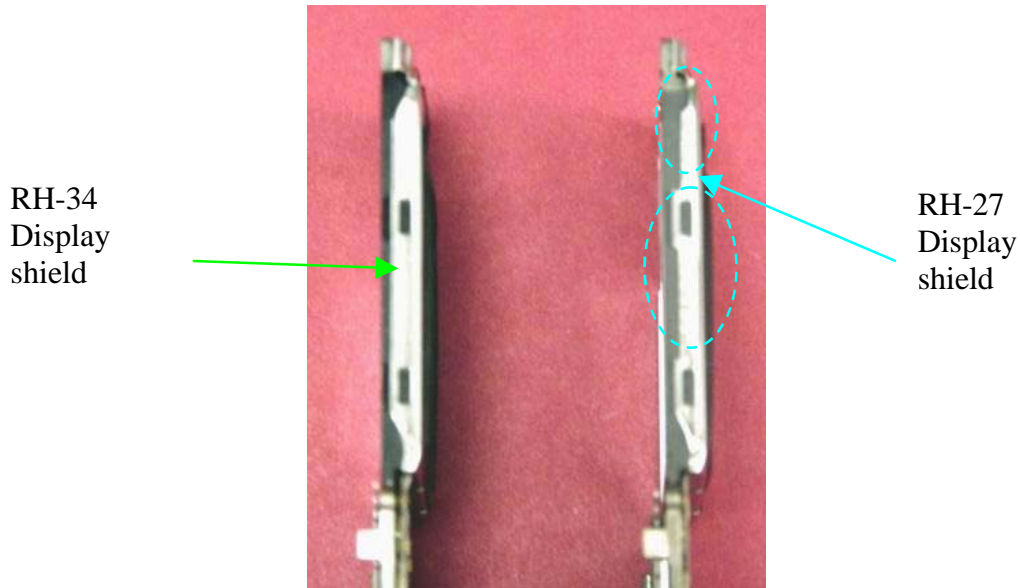
Figure 8: Side view of RH-34 and RH-27 display assembly

Display assemblies of RH-34 (6585) and RH-27 (6225) are very similar. However, the RH-27 display shield is different on the side from the RH-34 shield, as shown in Figure 9 inside the blue dashed line. Second, the metal plating at the top area of the RH-27 frame is different from the top of the RH-34 frame, as shown in Figure 9 inside the blue dashed line. For RH-34 frame, the screw boss area is plated but isolated from the rest of the frame, and also there is no plating in the area inside the green dashed line in Figure 9.

If the wrong display shield or frame is installed, replace it with a correct one.

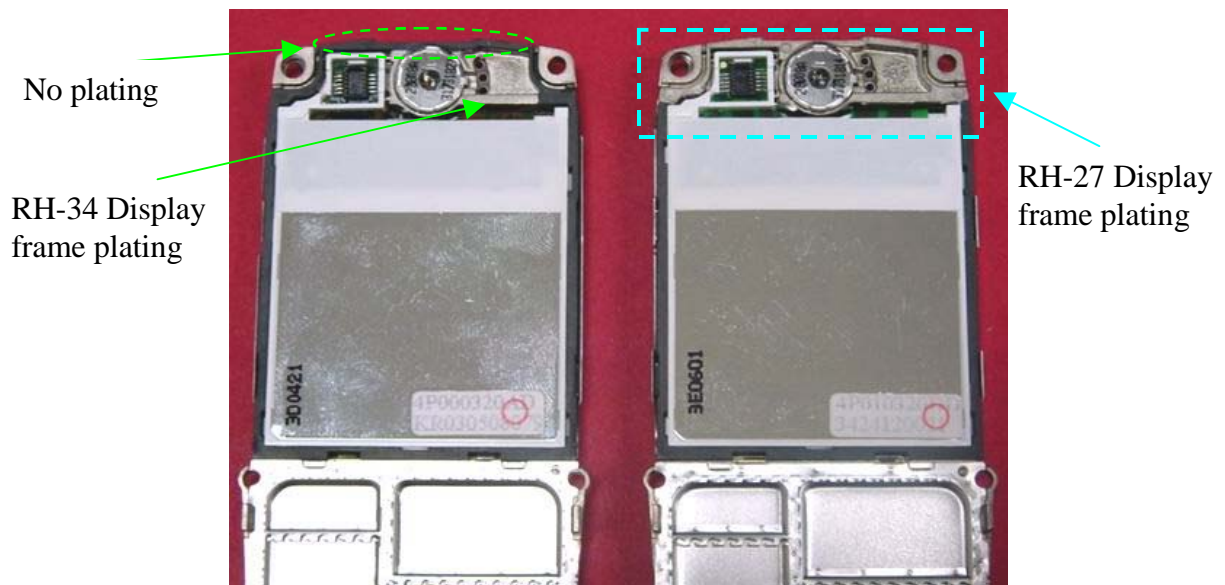
Figure 9: Back view of RH-34 and RH-27 display assembly

For the RH-27 frame, the whole top area is fully plated.

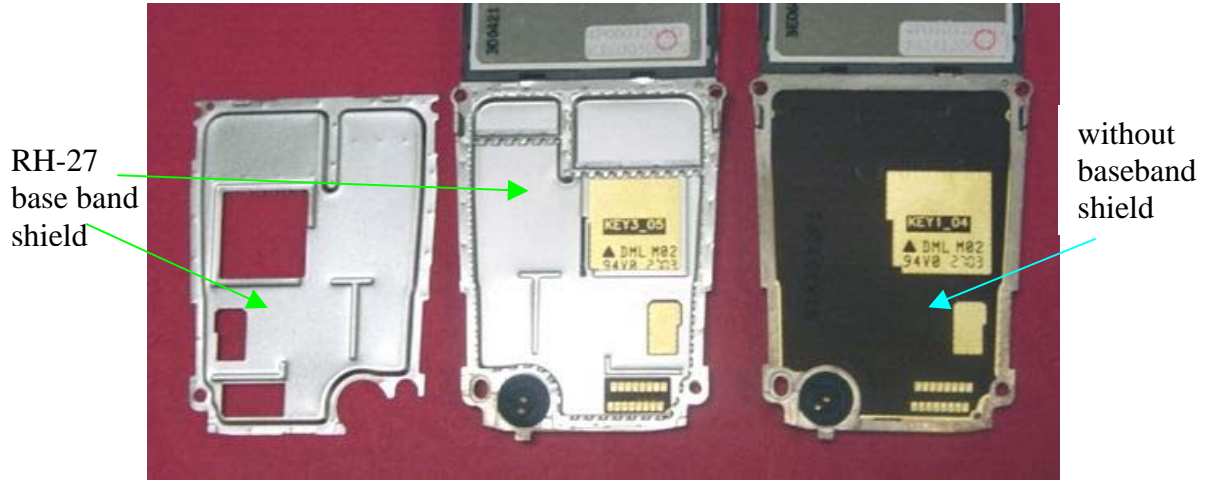
Figure 10: RH-27 baseband shield assembly

Baseband shield is part of the display assembly. If the baseband shield is missing or is obviously damaged, the radiated phone performance will be impacted. Check spring fingers on baseband shield to ensure that they are raised up so that when installed, they make contact with the PWB. If damaged, install a new baseband shield.
