CCS Technical Documentation
RH-34 Series Transceivers

Troubleshooting - Antennas

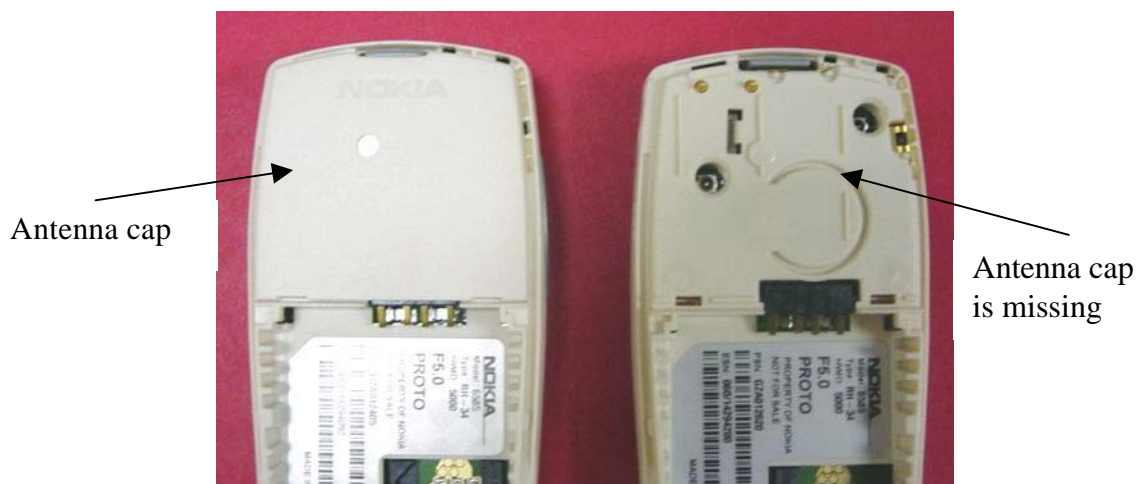
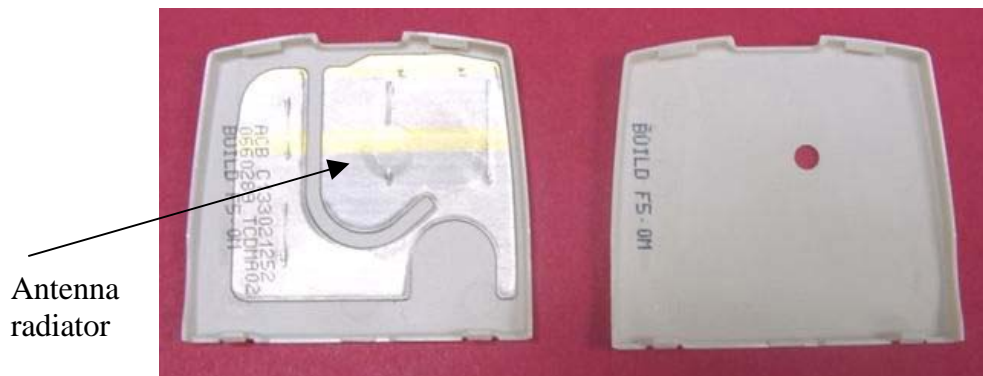
Figure 2: RH-34 (6585) phone with and without antenna cap

If no antenna or no radiator is installed, the antenna gain will be degraded by more than 25 dB.

If the antenna cap is missing or there is a cap but it has no radiator, install a new antenna cap with radiator. If the radiator looks obviously damaged (dents, corrosion) or the slot in the radiator has a significantly different shape, then install a new antenna cap with correct radiator.

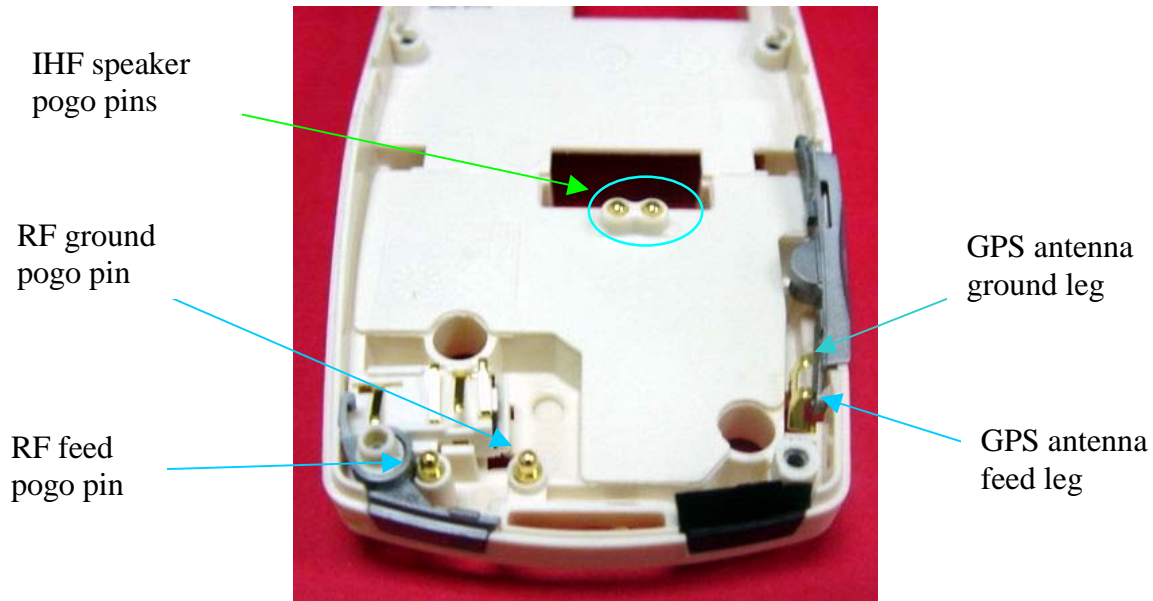
Figure 5: Inside view of the C-cover

Two pogo pins are inserted in the C-cover. One end of the pogo pin (in Figure 4) touches the antenna, the other end (in Figure 5) touches the pad on the PWB. If either of the pogo pins is missing, or either of the pogo pins is obviously damaged (stuck in the C-cover plastic tube, lose the inside spring force), the antenna will lose the contact to the PWB. Replace the whole C-cover assembly with a correct new one.

If the RF feed doesn't touch the PWB, then the antenna gain will degrade by more than 25 dB. If the ground pin doesn't touch the PWB then the antenna gain may degrade about 5 to 10 dB.

If either of the IHF speaker pins is damaged or missing, the speaker will not connect to PWB. Antenna PCS gain will drop 2 dB. The C-cover assembly should be replaced.

As shown in Figure 5, if either the GPS antenna feed or the ground leg is broken, or bent such that either pin will not touch the PWB, then the GPS antenna should be replaced with a new one.

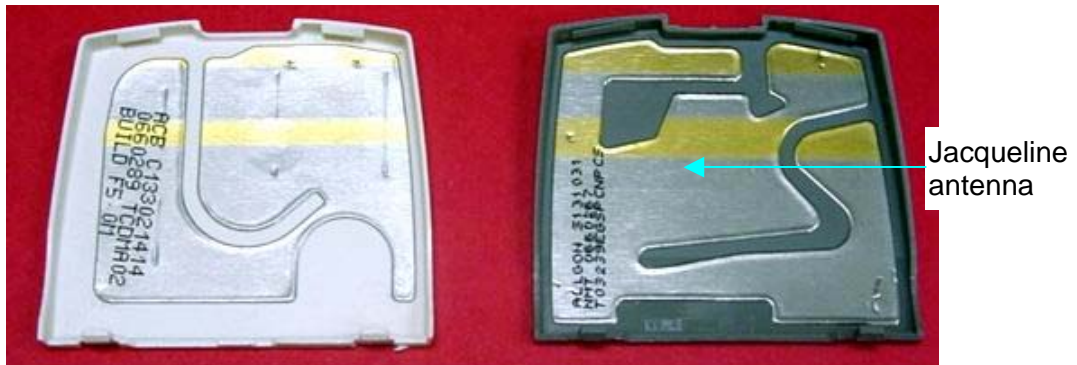
Figure 6: Top view of RH-34 (6585) antenna vs. Jacqueline antenna

The RH-34 (6585) antenna and the Jacqueline antenna caps are similar in appearance. The radiators are totally different.

If the wrong antenna is installed, install the correct one.

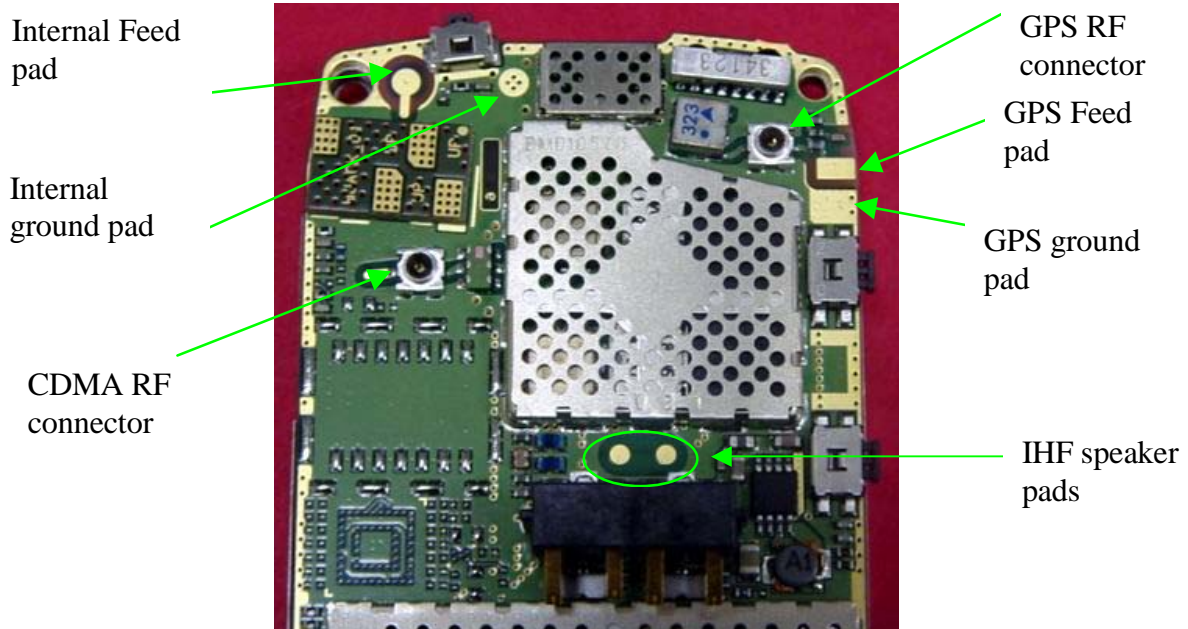
Figure 7: PWB layout of RF feed/ground pads, GPS feed/ground pads, and IHF speaker pads

If the RF feed pad is obstructed, removed, or covered, then the internal antenna feed pogo pin will not touch the PWB and then the antenna gain will degrade by more than 25 dB. If the ground pad is obstructed, removed, or covered, then the ground pogo pin will not touch the PWB and the antenna gain will degrade more than 5dB. If corrosion is present or the pad is missing, then most likely the PWB and phone needs to be replaced. If either pad is obstructed or covered, the pad should be cleared and/or cleaned.

If the GPS feed pad is obstructed, removed, or covered, then the GPS antenna feed leg will not touch the PWB. If the ground pad is obstructed, removed, or covered, then the ground spring clip will not touch the PWB.

If the Internal Hands Free (IHF) speaker pads are obstructed, removed, or covered, then the IHF speaker will not produce sound. The antenna PCS gain will be degraded by about 2 dB. If corrosion is present or the pad is missing, then most likely the PWB and phone needs to be replaced. If either pad is obstructed or covered, the pad should be cleared and/or cleaned.

CDMA and GPS use the same type of RF connector. The RF connector could fail by not connecting the RF input to the RF output of the RF connector. If this happens to the CDMA RF connector, then the antenna gain will degrade by about 25 dB. If this happens to GPS RF connector, the GPS antenna gain will degrade by about 20 dB. This can be checked by testing for DC conductivity between the RF input and RF output of the RF connector. Note the DC conductivity test must be done without any cable attached to

the RF connector. Since the RF connector is also a switch, the RF output will be disconnected from the RF input when a cable is inserted into the RF connector. When a cable is not inserted, the RF input is connected to the RF connector. The locations of both RF connectors are shown in Figure 7.

If the RF input is not connected properly to the RF output, then the RF connector must be replaced.

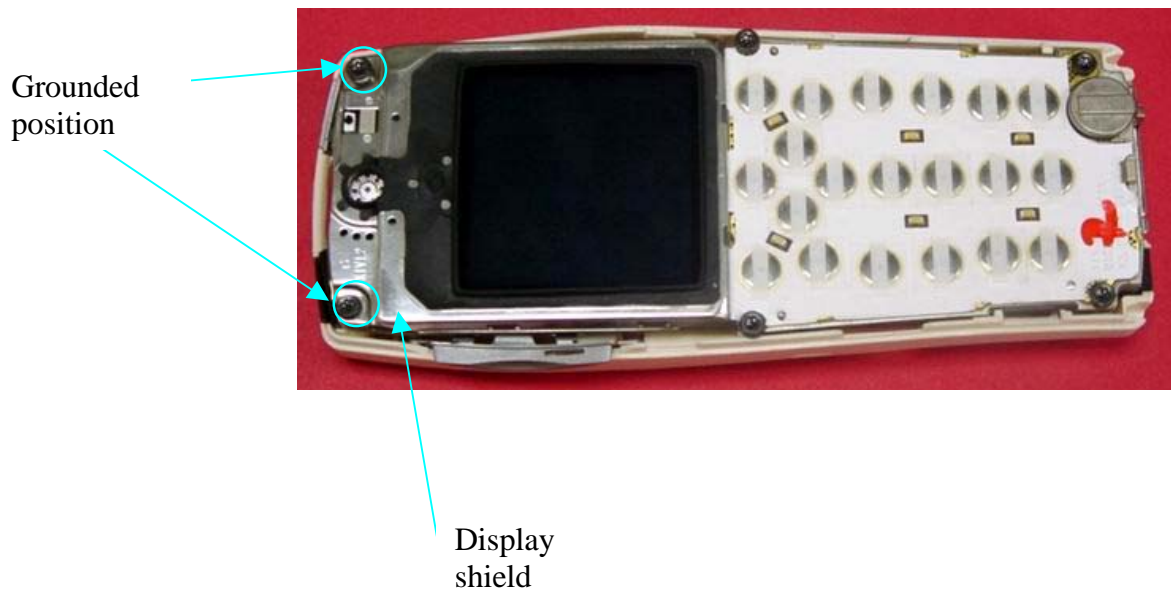
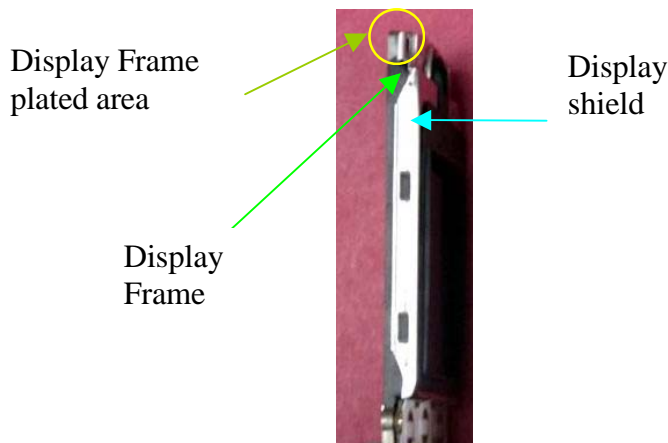
Figure 8: RH-34 phone display assembly

The display shield is connected to the display frame plated area (screw boss area) and then to the PWB through the two top screws. The grounding of the display shield and frame will impact the radiation performance of the phone. If the screws are loose, then tighten them. If the screw bosses are stripped, then the chassis will need to be replaced. If the screws are missing, install new ones.

If the display frame plated area is cracked or the metal plating has peeled off, then the grounding of the display shield and frame will not be guaranteed. Replace the frame.

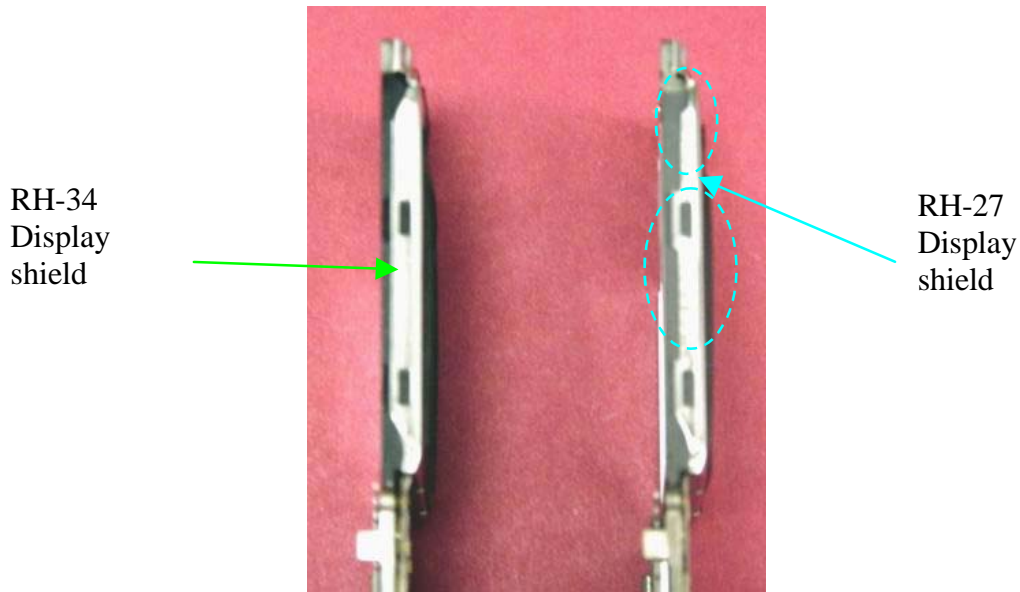
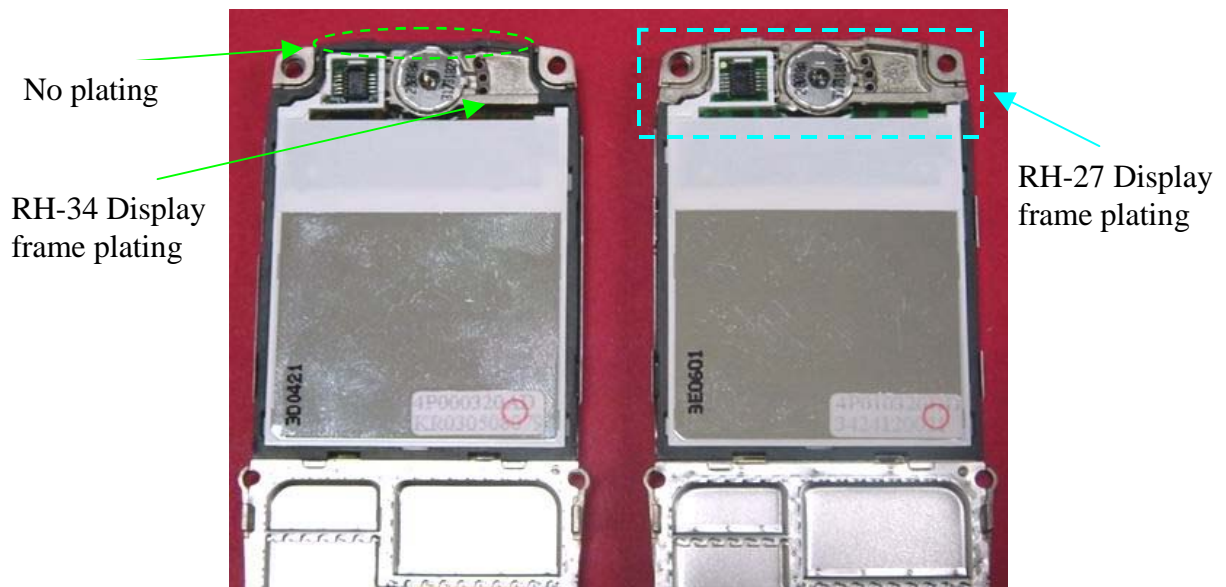
Figure 10: Side view of RH-34 and RH-27 display assembly

Display assemblies of RH-34 (6585) and RH-27 (6225) are very similar. However, the RH-27 display shield is different on the side from the RH-34 shield, as shown in Figure 10 inside the blue dashed line. Second, the metal plating at the top area of the RH-27 frame is different from the top of the RH-34 frame, as shown in Figure 11 inside the blue dashed line. For RH-34 frame, the screw boss area is plated but isolated from the rest of the frame, and also there is no plating in the area inside the green dashed line in Figure 11. For the RH-27 frame, the whole top area is fully plated.

If the wrong display shield or frame is installed, replace it with a correct one.

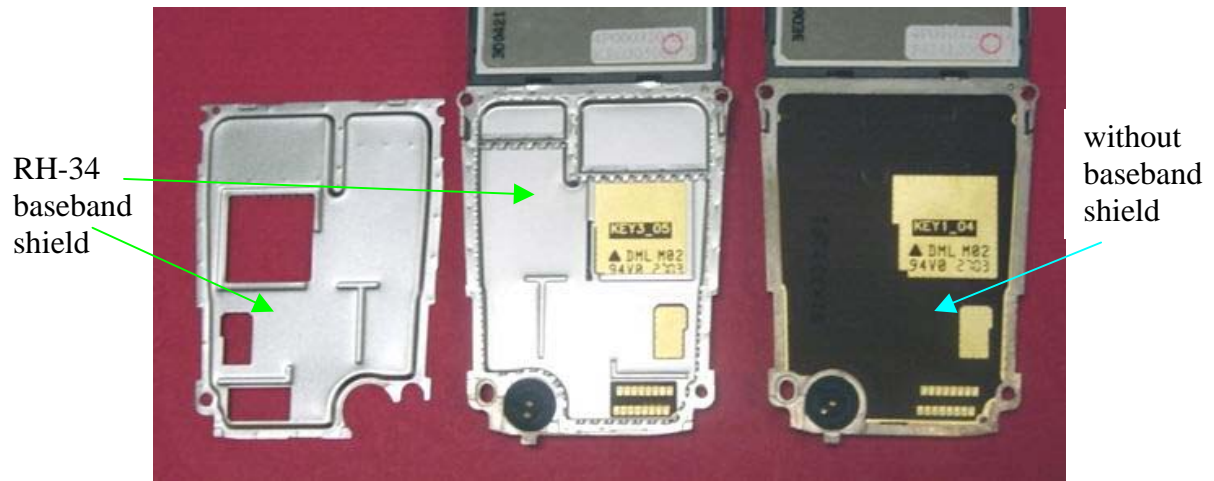
Figure 12: RH-34 baseband shield assembly

Baseband shield is part of the display assembly. If the baseband shield is missing or obviously damaged, the radiated phone performance will be impacted. Install a new baseband shield.
