CCS Technical Documentation

RH-10 Series Transceivers

Troubleshooting – Antenna

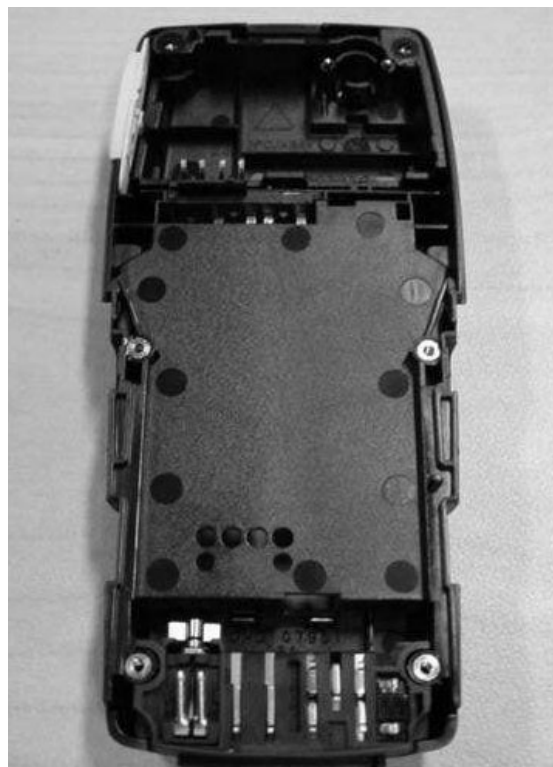
Figure 2: Internal antenna properly installed in D cover

If no internal antenna is installed, the antenna gain will be degraded by more than 25 dB.

If the internal antenna is missing, install one. If the radiator looks obviously damaged, then replace the internal antenna.

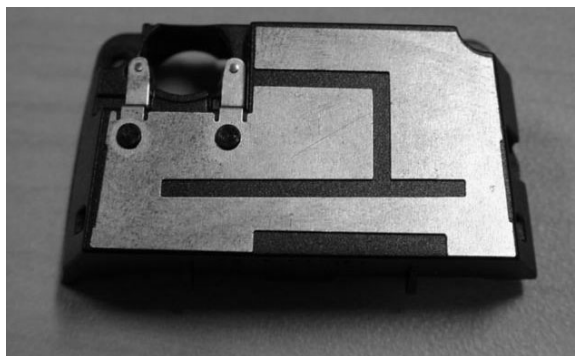
Figure 3: Giovanni internal antenna

The correct internal antenna can be determined by looking at the sheet metal radiator. The radiator on the Diva antenna (Figure 1) is different from the Giovanni antenna (Figure 3). Installing the incorrect antenna will only change the antenna gain by about 1 dB, but the phone will not be compliant with our FCC submission.

If the wrong antenna is installed, install the correct one.

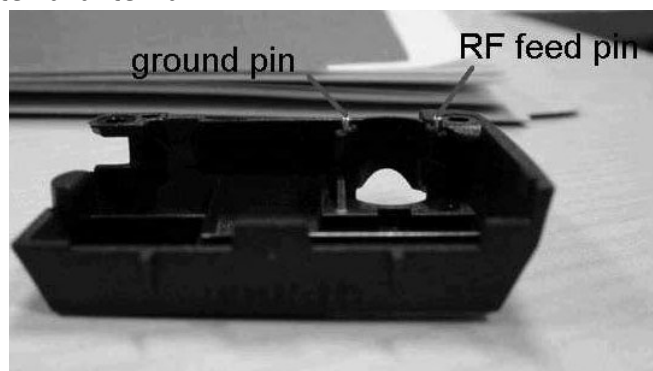
Figure 4: RF Pin and ground pin of Diva internal antenna

If either pin is pushed in, such that the pin is not clearly visible, as in Figure 4, then it is likely that the pins will not touch the PWB. If the springs are visibly bent upwards (as shown in Figure 5), then it is likely that the pins will not touch the PWB. If the pin gets stuck or has excessive friction in the plastic tube/guiding feature, then the spring will not work properly. In these situations, the antenna should be replaced.

If the RF feed doesn't touch the PWB then the antenna gain will degrade by more than 25 dB. If the ground pin doesn't touch the PWB, then the antenna gain may degrade about 5 to 10 dB.

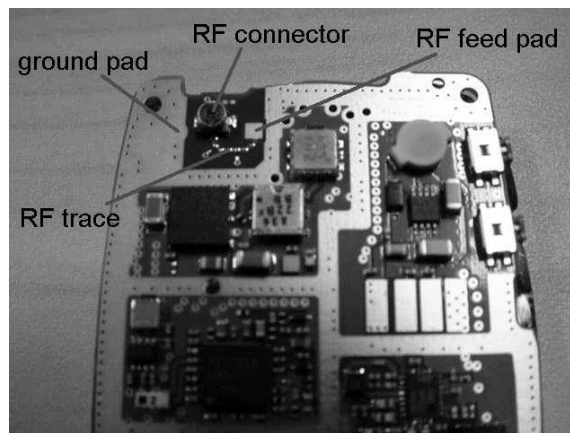
Figure 6: PWB layout of RF feed and ground pads

If the RF feed pad is obstructed, removed, or covered, then the RF feed pin will not touch the PWB and the antenna gain will degrade by more than 25 dB. If corrosion is present, then most likely the PWB and phone needs to be replaced. If the ground pad is obstructed, removed, or covered, the ground pin will not touch the PWB, and the antenna gain may degrade about 5 to 10 dB. In both of these cases, the pad should be cleared and/or cleaned.

If the RF connector is damaged or missing, then a new RF connector needs to be installed. A missing or broken RF connector breaks the RF path and will result in 25 dB or more degradation in the antenna performance.

If the RF trace is broken, then the PWB must be replaced. A broken RF trace will result in 25 dB or more degradation in the antenna performance.
