Repairhints

8310

NHM-7

The purpose of this document is to provide some further service information for NOKIA 8310 phones.

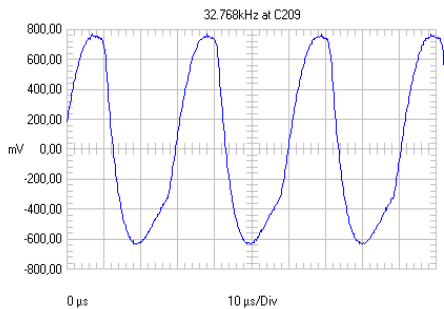
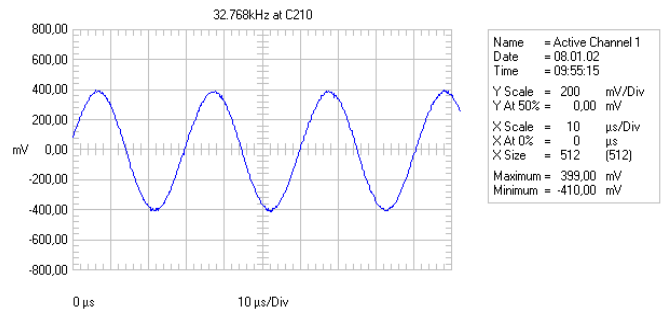
B200

- check DC-voltages at C209 and C210, normally 0.5VDC. If voltages are not ok check C209/210 for shorts to ground. It also is possible that UEM D200 is defect.
- if DC-voltages are ok but no 32.768kHz signal is measurable at C209/210 change the crystal B200.
Note that this signal must be always measurable if battery voltage is higher than 3.1VDC, even if phone is switched off! In this case amplitude of 32.768kHz is a bit lower (700mVpp at C209, 550mVpp at C210).

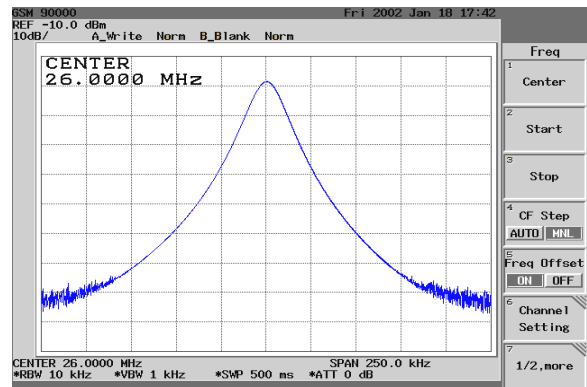
G660

- check voltage at C662, 2.8VDC
- check signal of 26MHz reference oscillator at C660:

With the voltage of 2.8VDC at C662 the oscillator must be able to work on a frequency around 26MHz, else you have to change G660.

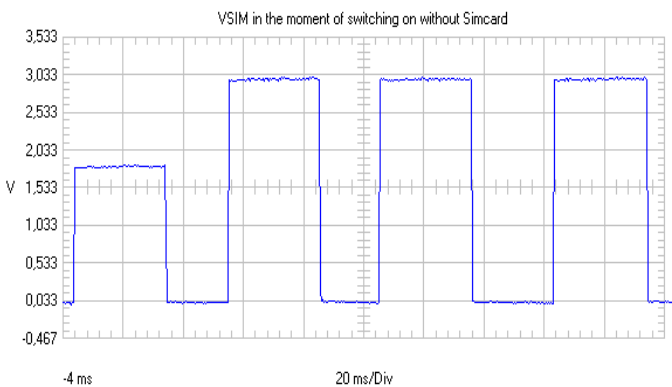
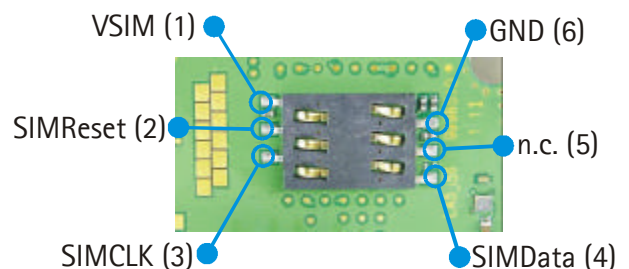
R388/D200/D400

If mechanical appearance of SIM reader seems to be ok but fault persists, check with an oscilloscope if SIM lines at SIM reader pin 1-4 are pulse to 1.8Vpp / 3Vpp as shown in the chart below. Signals are slightly different between pin 1-4 but the amplitude always is 1.8Vpp / 3Vpp.

In case that the above mentioned signal is not measurable at one or more simlines, check SIM lines for shorts to ground. Resistance of simdata- and VSIMline normally is > 200kΩ, resistance of SIM reset- and SIM clock line normally is ~ 4.5MΩ. If resistance of any line is not ok check parts the SIM lines consists of (R388, C203, C389).

In case that resistance of all lines is ok but fault persists, EMI-filter R388 may have internal interruption. Change part and retest the phone. It also is possible that UEM D200 or UPP D400 are responsible for this fault. Due to the missing possibility to rewrite phonedata after changing UEM D200 you should not change this part.

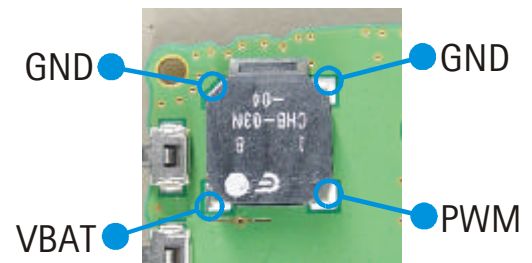
Buzzer faulty

- ensure that fault is no result of too old phonesoftware. SW-version should be 4.04 or newer.
- if SW-update does not solve the problem, activate buzzer with Phoenix in menu "Maintenance/Testing/Audio Test". Check VBAT 4VDC and PWM-signal coming from UEM at buzzer, change buzzer if necessary
- it also is possible that UEM D200 is defect, but since there is no possibility to rewrite phonedata after reworking UEM you should not change this part.

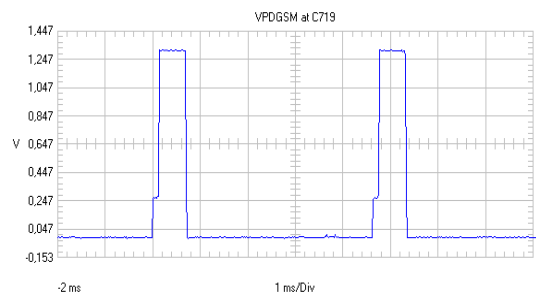
N700

- set phone with Phoenix to local mode and activate TX-burstmode Ch.37 (Ch.700 for GSM1800). Data in parenthesis are mentioned for GSM1800.
- check VBATTRF 3.9VDC on both sides of L703
- check incoming RF-signal of 897.4MHz at C731 (1747.8MHz at R705)
- check VTXBGSM 2.8Vpp at C720 (VTXBDCS 2.8Vpp at C714) and VPDGSM 1.3Vpp up to 2.5Vpp depending on TX-power-level at C719 (VPDDCS 1.2Vpp up to 2.1Vpp at C718):

If the above mentioned signals are ok but no or too low TX-power signal is measurable at L750 pin 1 (pin 3 in GSM1800), it is necessary to change the poweramplifier N700.

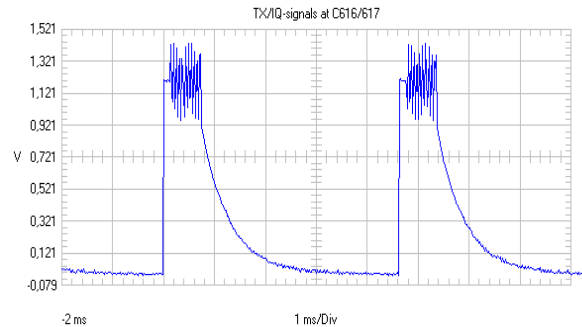
N600

- set phone with Phoenix to local mode and activate TX-burstmode Ch.37 (Ch.700 for GSM1800).
- check 26MHz reference clock at C660, refer to signal shown on page 14.
- check VR1A 4.75VDC at C600, VR2 2.8VDC at C723, VR3 2.8VDC at C662, VR4 2.8VDC at C601, VR5 2.8VDC at C603, VR6 2.8VDC at C605 and VR7 2.8VDC at C650
- check with an oscilloscope TXC at C615 (0.5Vpp – 2.1Vpp depending on TX-powerlevel), also check TX/IQ-signals at C616/617:

If these signals are ok but no TX-signal is measurable at C726 (C700 in GSM1800), you have to change Hagar N600. Unfortunately TXP and Hagar reset, which also are necessary for a working Hagar are not checkable because of missing testpoints. Change UPP D400 in case of doubt and retest the phone.

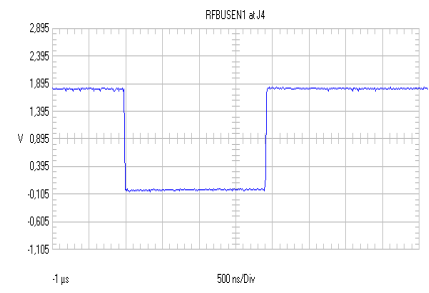
- check with an oscilloscope RFBUSDA at J2, RFBUSCLK at J3 and RFBUSEN1 at J4:

- it has been seen that in some cases UPP D400 was responsible for "No Service"-faults. Unfortunately it is not possible to check some important signals because of missing testpoints (e.g. TXP, Hagar reset). Nevertheless you can check with an oscilloscope for activity on the RFBUS (J2/3/4). If already here a signal is missing and there is no short circuit to ground on these lines, you should change D400.

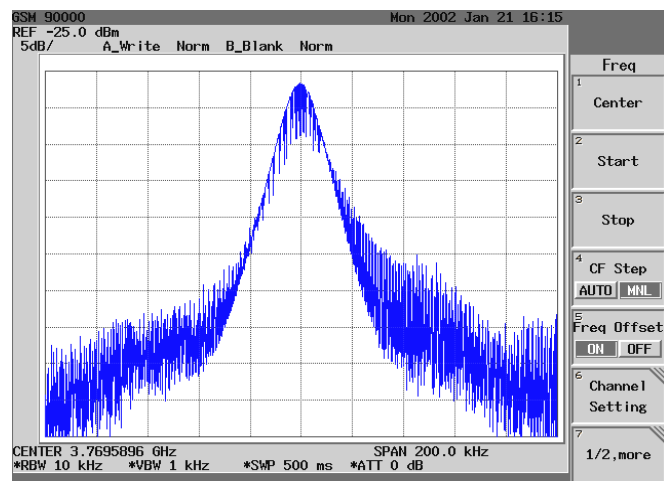
G650, C653

- to check if the SHF-oscillator G650 is working you have to activate RX-burstmode Ch.37. After that check signal (3769.6MHz) at T650 pin 3 and 4 as shown below:

If no signal is measurable at T650 check VR7 2.6VDC at C650. If OK, set span of your analyser to e.g. 250MHz to check if the oscillator works on any other frequency as on the supposed. In case of that check control voltage at C652 which normally is 3VDC on channel 37. Especially check C653 (tendency to leak) in case of noise on the control voltage. In case that the oscillator does not work at all, change G650 and retest the phone.
