Release Note

R&S[®] IQR20
R&S[®] IQR100

Firmware Version 1.04.006

Date: 2011-12-05

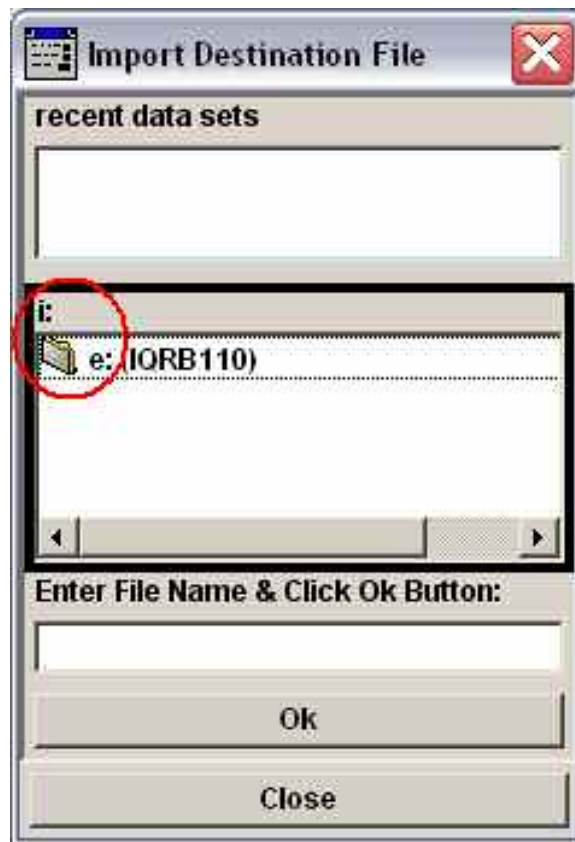
File selection : Take care on the drive letters. Occasionally, the initial drive letter is wrong in the file selection dialog box. You might see for example the following import destination file dialog.

If you would enter a file name now and confirm entry with ENTER key, the file would be written to drive i: instead of drive e:

Solution :

Tap the e: (IQRB110) to select drive e: The i: shall change to e:.. Then enter a file name in the line below, and press ENTER to confirm the file name.
