Release Note

R&S[®] IQR20
R&S[®] IQR100

Firmware Version 2.01.03

Date: 2012-05-11

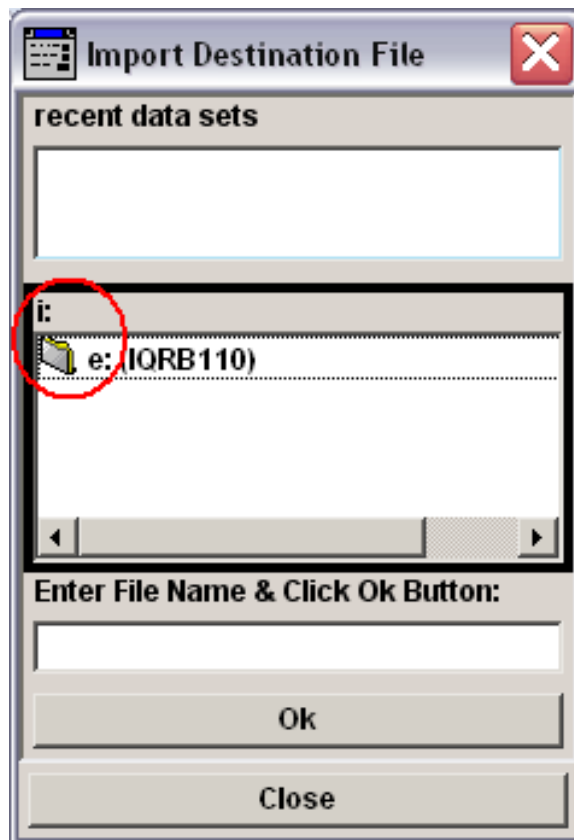
figure 2 : file select dialog

Take care on the drive letters. Occasionally, the initial drive letter is wrong in the file selection dialog box. You might see for example the following import destination file dialog.

If you would enter a file name now and confirm entry with ENTER key, the file would be written to drive i: instead of drive e:

Solution :

Double tap or double click the e: (IQRB110) to select drive e: The i: shall change to e:.. Then enter a file name in the line below, and press ENTER to confirm the file name.

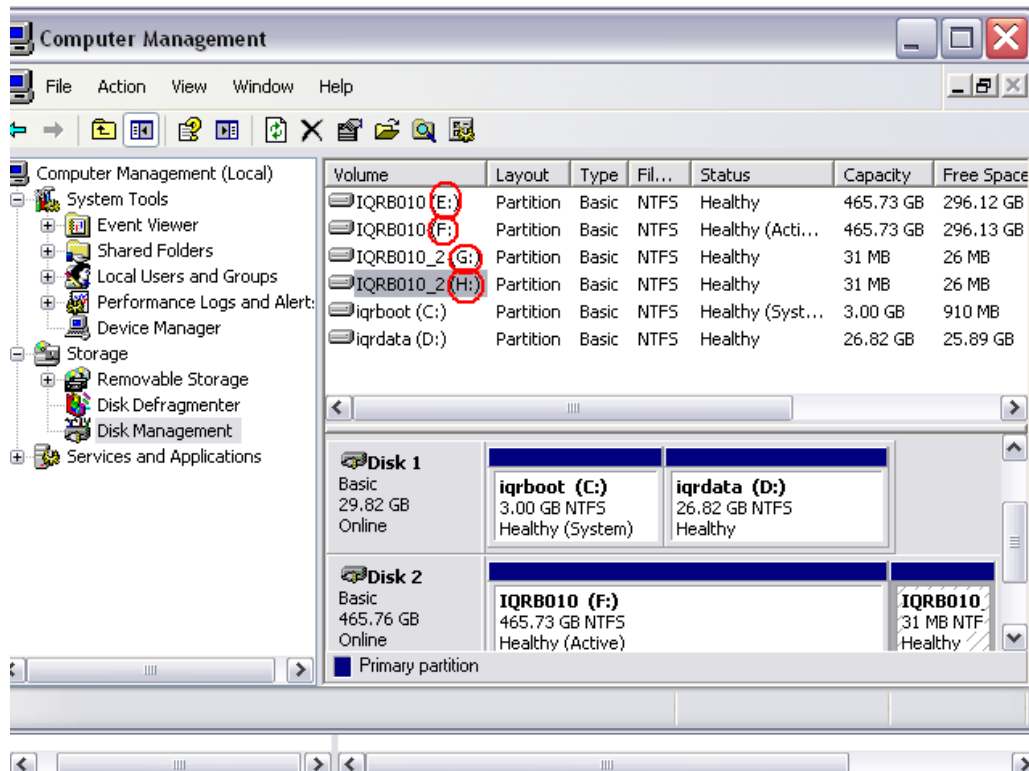
figure 2 : correct driver letter assignment

If a new disk option is installed in an IQR, it may happen that the drive letter assignment by Windows is not executed properly. The IQR then can't find the disk option correctly and the firmware can't load files.

Drive letters "E" and "G" must be on Disk 0, "F" and "H" must be on Disk 2.

To fix this error, use the windows disk management tools. Execute the following steps :

- connect USB keyboard and USB mouse
- terminate the IQR application (ALT-F4)
- open Windows explorer (Windows-key and E pressed simultaneously)
- right click on "instrument <deviceid>"
- select "Manage"
- click "Storage→Disk Management"
- right click the wrong drive letter
- select "Change drive letter and paths"
- select any unused drive letter (e.g. Z)
- confirm the windows warning message with "OK"
- repeat this step for the other wrong driver letters, using unused drive letters as preliminary letters

- finally assign the correct drive letters to the partitions
- exit the Computer Management tool.
- Power down the IQR
- Power on again.
