S/1 NEWS

OCT-75

INSTRUCTION FOR THE REPLACEMENT OF THE CX-7B POWER SUPPLY BOARD

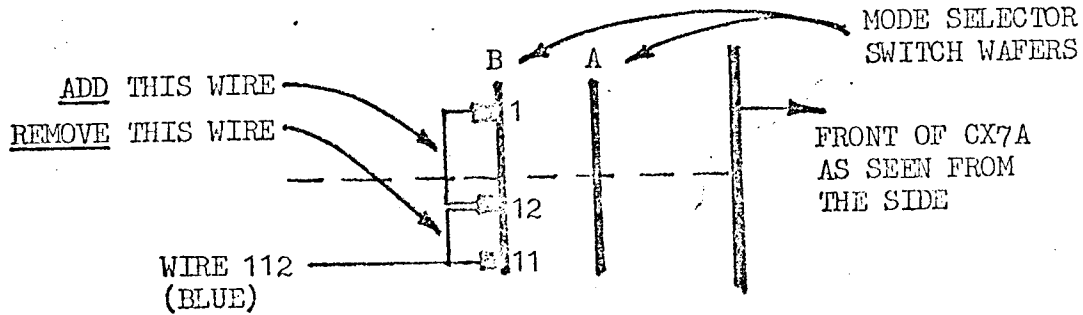
WA6NGM writes about his modifications for RTTY operation: He says that in any case, steps 1 and 2 described by W4FQM/1 are necessary as described in Volume I, No. 7 of S/1 NEWS. (600-ohm audio at J19 and FSK keyline cable from P6). He goes on to describe a simple modification to allow LSB mode for FSK:

Deck B of function switch S8 is modified as shown:

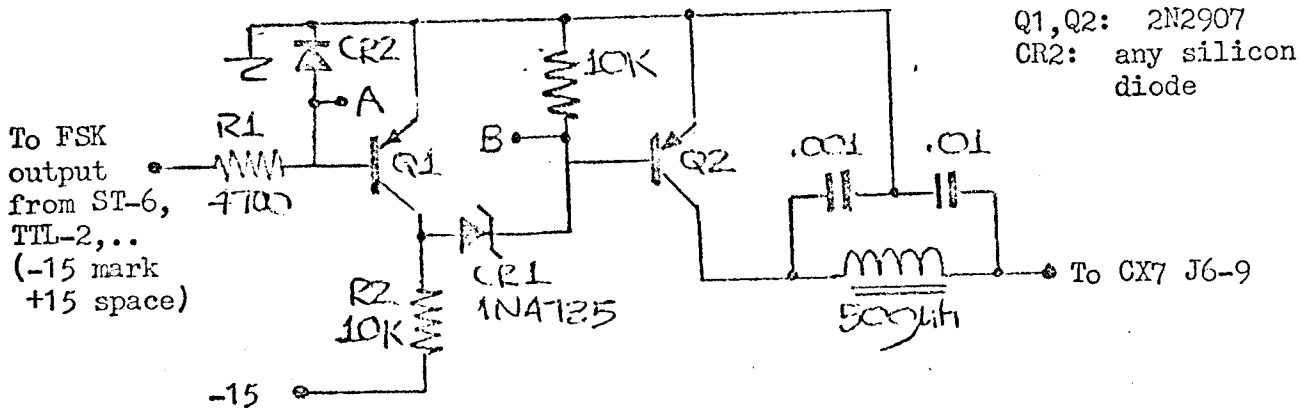
The following RTTY interface is via W2GRU. The circuit results in mark high for unmodified CX7A. If FSK operation has been modified to LSB (previously described), remove Q1, CR1, R2 and add a jumper from A to B.
