S/1 NEWS is published monthly by Bob Sullivan, WØYVA / N4RS, POB 6216, Arlington, Virginia, 22206.

CX7B LED COUNTER BOARD  
INSTALLATION INSTRUCTIONS

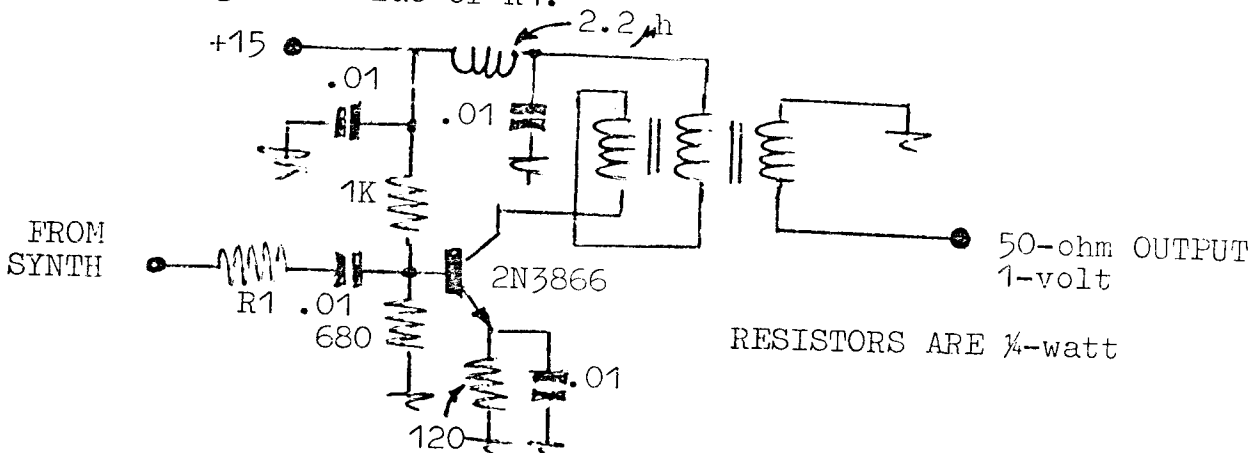
Harry's synthesizer requires a bit of amplification for best conversion gain. See circuit below for a solution. This will give 1-volt into 50-ohms. The output transformer consists of 12 tri-filar turns on a CF102-Q1 core. Each tri-filar conductor is three strands of #32, tightly twisted. Output is adjusted to 1-volt by selecting the value of R1.
