ORIGINS

This is a trial first issue for a monthly newsletter covering the SIGNAL/ONE transceivers. I have sent out quite a number of my "Trouble Guides" and many owners have returned comments concerning setting up some sort of SIGNAL/ONE club and net. I think the best way to build a club is with a monthly newsletter covering topics of interest to owners such as modifications, trouble shooting information, where to procure parts, and so forth.

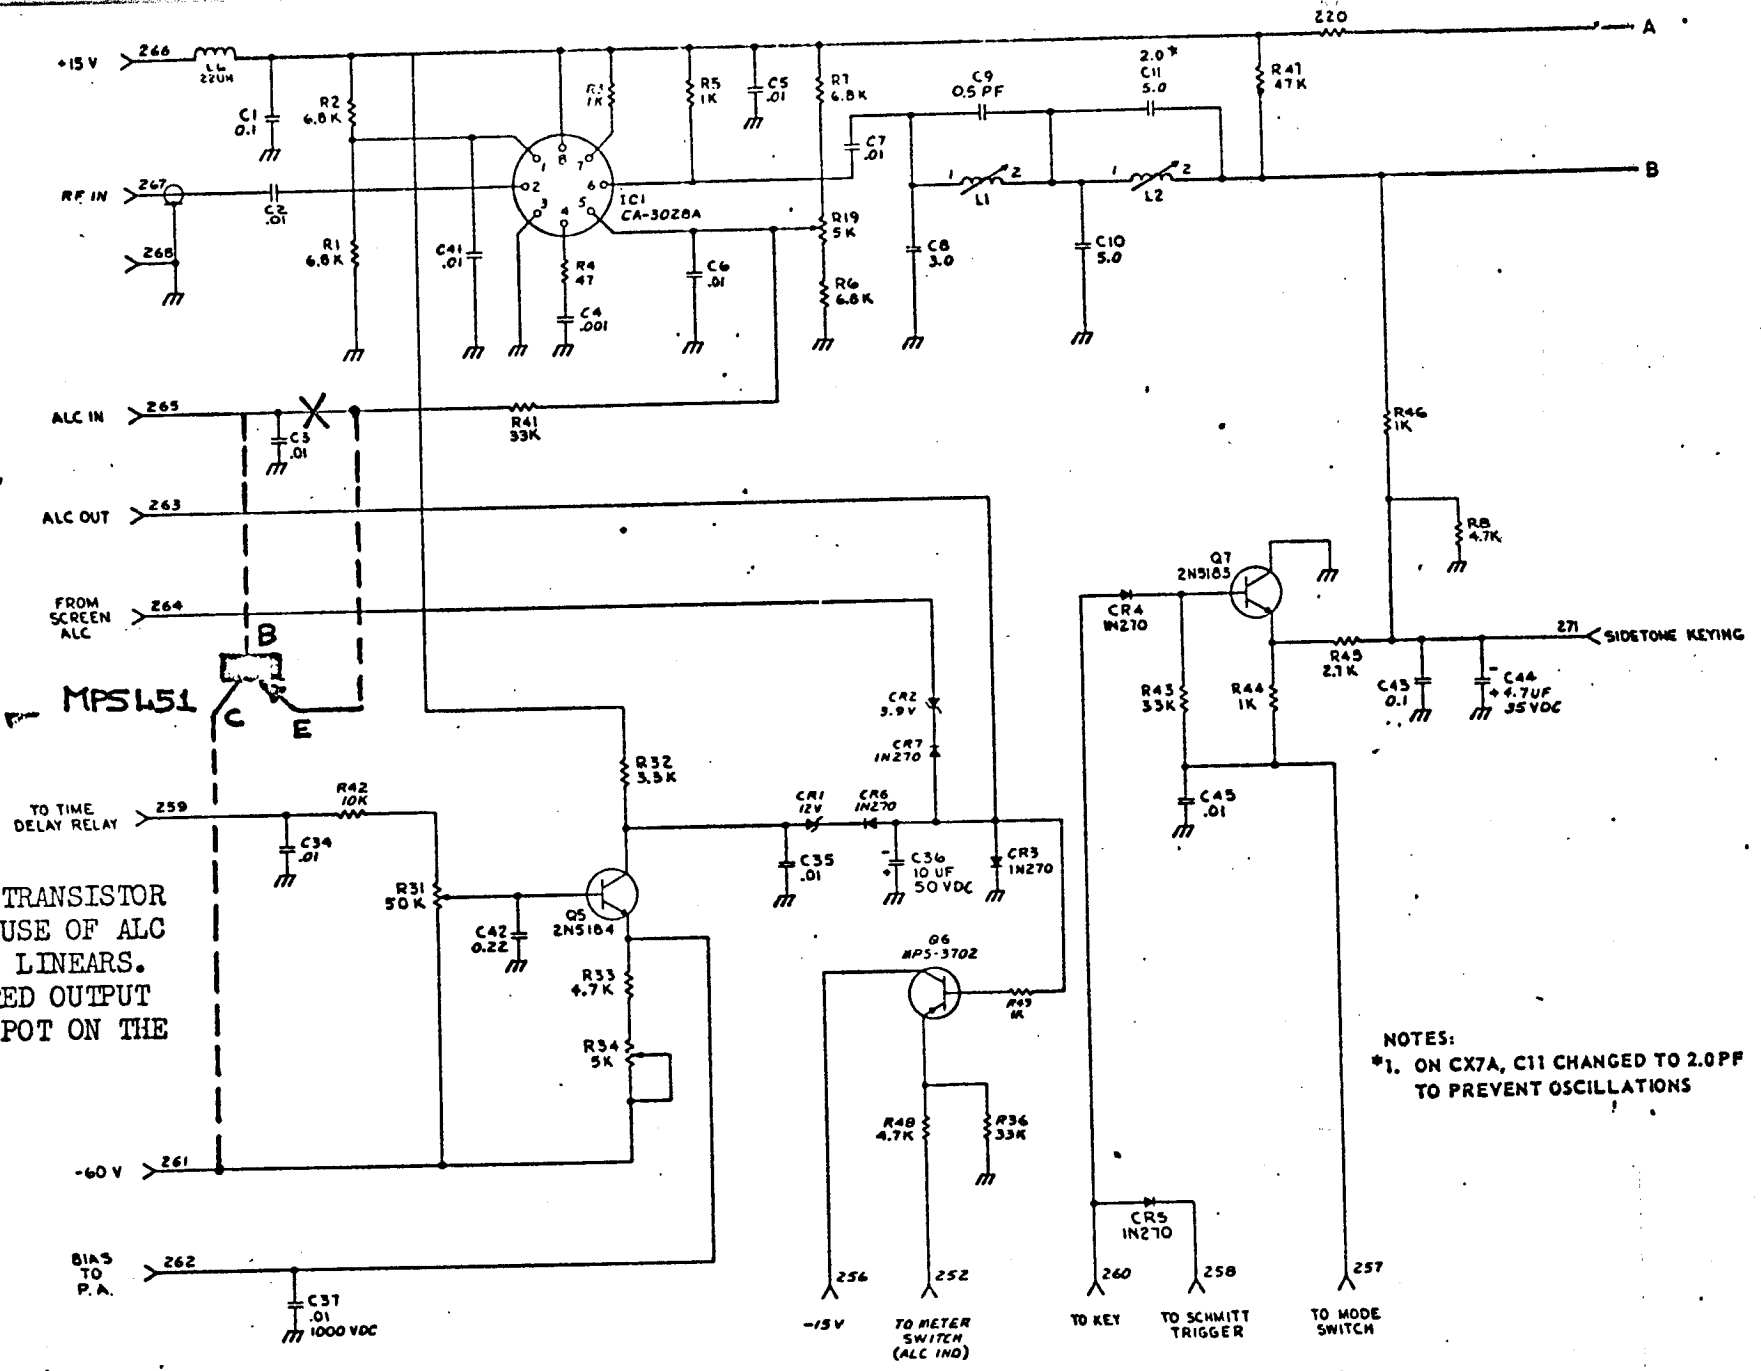
W2CR sent in an interesting modification of interest to all of us using the ALPHA 77 linears with Signal/Ones. The modification only consists of adding a single transistor which will allow use of the ALC circuits in the A77. According to W2CR, once a power level is set using the ALC pot on the A77, power will not exceed the set value no matter how hard you drive! See the attached schematic for the RF driver board, A5, which shows the added transistor in dotted lines. The recommended transistor is a MP5L51. This is a PNP unit with Vcb and Vce ratings of 100 volts and a gain of 20. A good substitute would be a 2N5400 for example. After the modification is installed connect A77 ALC to ALC jack on CX7 and set ALC pot on A77 for desired power level.

ADD THIS TRANSISTOR TO ALLOW USE OF ALC WITH A-77 LINEARS. SET DESIRED OUTPUT WITH ALC POT ON THE A-77.

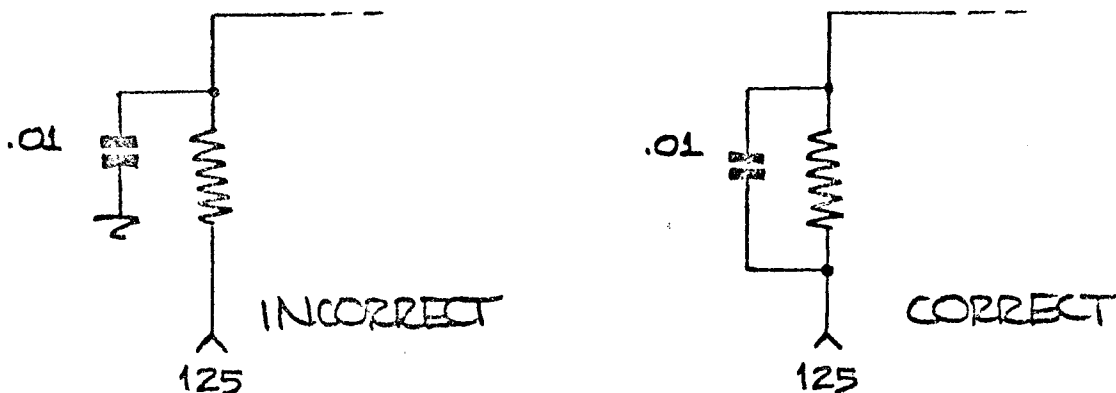
On "B" power supply boards using the Motorola Audio IC, there is an error on the board which effects high frequency response. At pin 125 (audio in) on power supply board immediately after a resistor there is a .01µf capacitor to ground. This capacitor should not return to ground but should be in parallel with the resistor. See drawings below:

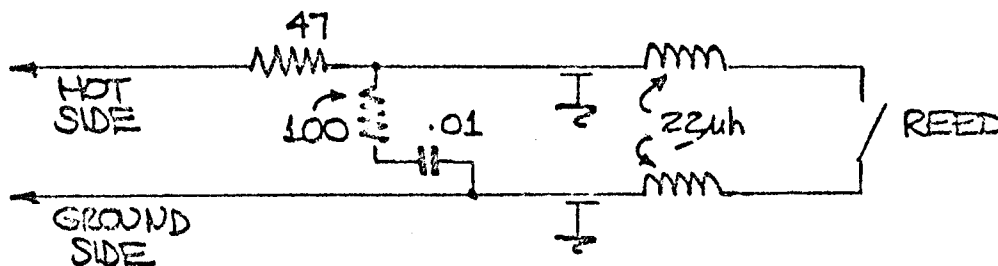
According to K2GI, Signal/One suggested the following circuit to prevent welding contacts together on the reed relay that are used for keying a linear amplifier

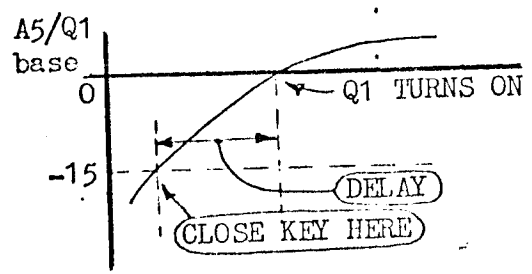
2. Soft keying looks easy to cure at first blush, until you find out the CBs (clever bastards) are using the same time constant to delay turn-on, giving relays a chance to close:
