Tektronix 49x/275x-Series Spectrum Analyzer Service Notes

John Miles, KE5FX
jmiles@pop.net

March 29, 2009

Errata and helpful notes on calibration/service procedures

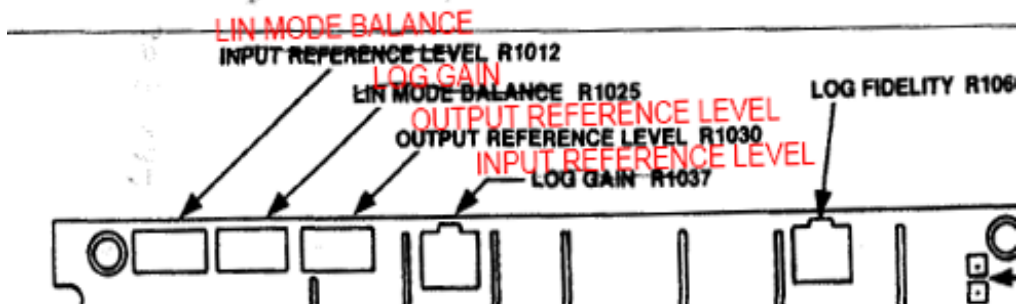
The catch is that at least two different layouts were used for the controls in figure 5-13. At some point, probably around the time Tek redesigned the board using surface-mount components in the late 1980s-early 1990s, the trimmer functions were reordered *while their physical locations were left alone*. In earlier logamp assemblies, the order is as specified (left-to-right on the component side):

INPUT REFERENCE LEVEL R1012
LIN MODE BALANCE R1025
OUTPUT REFERENCE LEVEL R1030
LOG GAIN R1037
LOG FIDELITY R1060

In later assemblies, the correct control order is:

LIN MODE BALANCE R1025
LOG GAIN R1037
OUTPUT REFERENCE LEVEL R1030
INPUT REFERENCE LEVEL R1012
LOG FIDELITY R1060

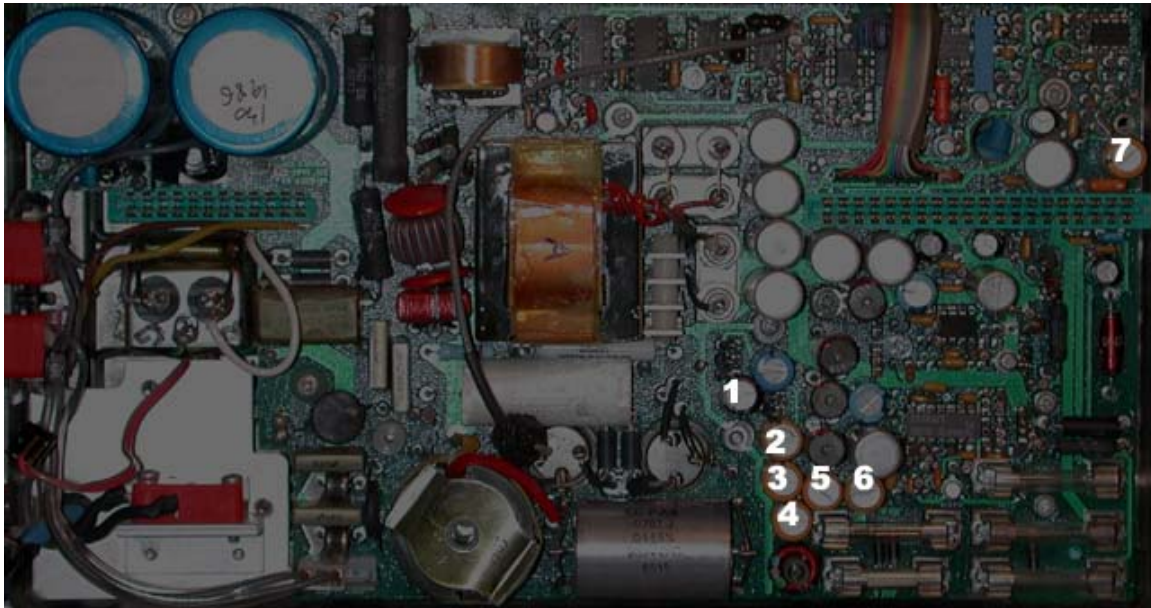
Regulation tolerances for the low-voltage supply buses are specified in service volume 1, and are not usually a problem. However, the +100V and +300V supplies are frequently below their specified values. If any 66-kHz ripple or sagging is observed, all of the miniature 2.2 μ F/200V axial-lead electrolytic capacitors in the power supply should be replaced. These are inexpensive high-failure-rate parts, so they should be replaced in any event if the power supply is otherwise disassembled for service.

High ESR in the filter capacitors on the lower-voltage rails (+17V, +5V) has been reported as a cause of excessive power-supply temperature, so when servicing the power supply, you should check ESR on *all* electrolytics as a matter of habit. Check heat-sink fasteners for tightness, and renew the heat-sink compound while you're at it. Avoid losing track of the mica washers and aluminum spacers that may fall out when you remove the PCB.

Use 105 degree C-rated electrolytics where possible, e.g., 3.3 μ F 350V 105C, [Digi-Key](#) part # 493-2046-ND. These can replace all of the high voltage capacitors on the power supply (6x 2.2 μ F/200V, 1x 1 μ F/350V).

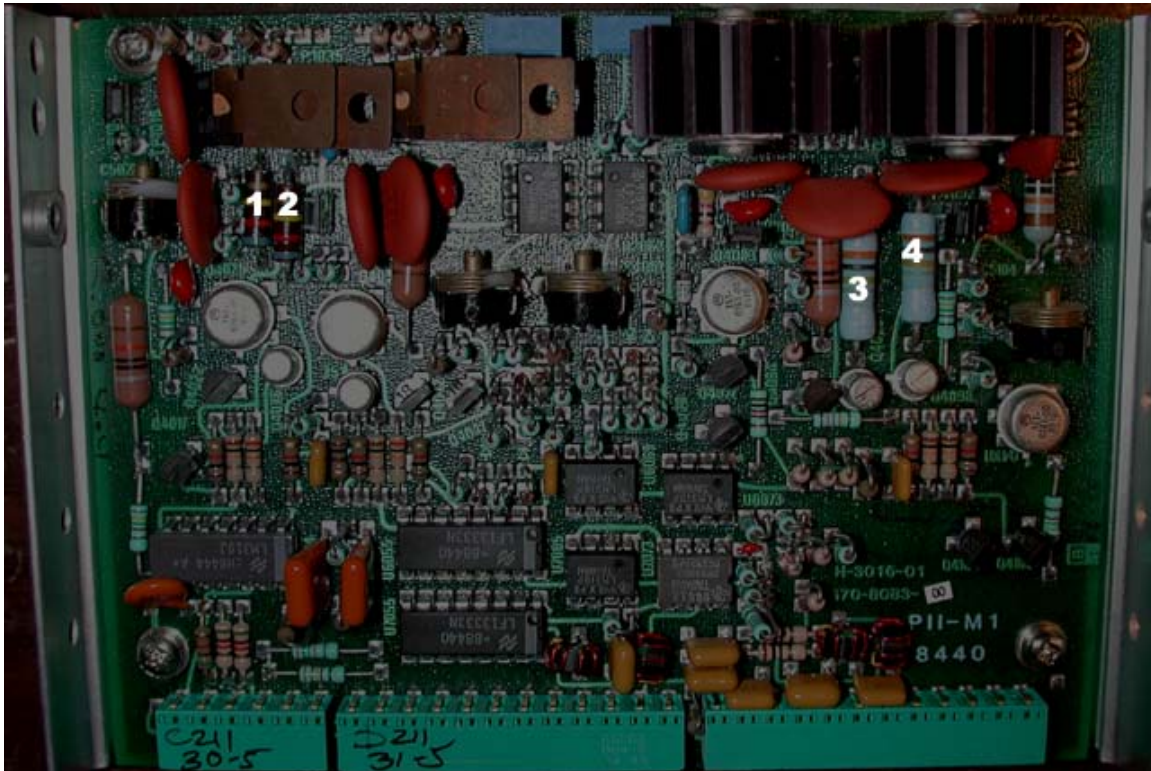
This particular board already had 300K metal film resistors (3,4) in place, so they were left alone. The 620K, 5% carbon-composition resistors (1,2) were measured at 580K and 980K, respectively.

When servicing instruments with the pre-1988 deflection amplifiers, it's a good idea to replace the 620K and 300K carbon-composition resistors in the negative-feedback paths. Many of these resistors have drifted upward over time, and/or become noisy. Typical replacement parts would be [Digi-Key](#) P620KBBCT-ND (two each) and BC300KW-2CT-ND (two each). Calibrate the deflection amplifier and digital storage subassemblies after replacing these resistors.

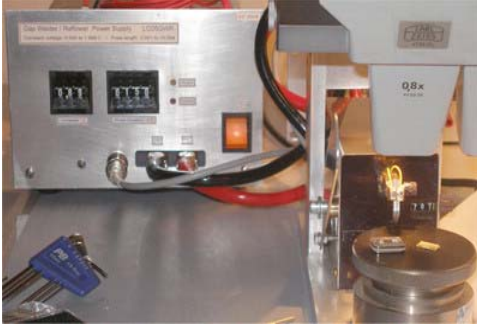
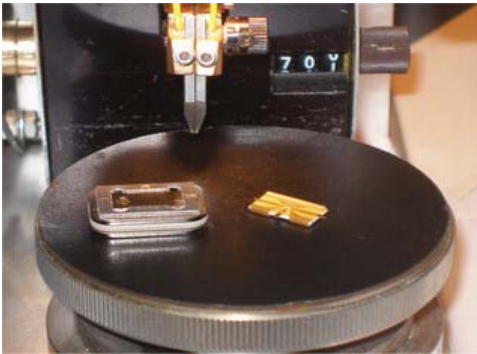
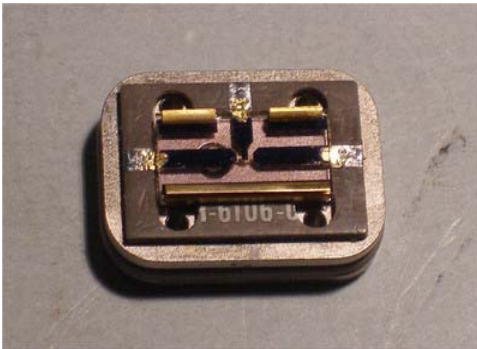
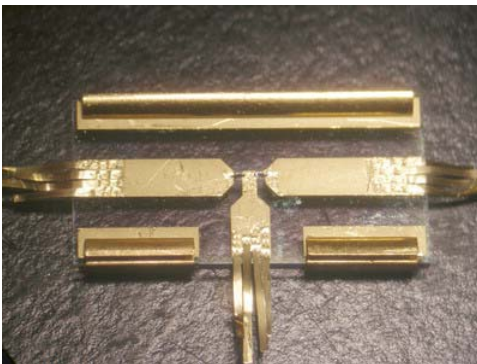
Photos courtesy Luis Cupido, CT1DMK, of the [chip-hybrids](#) group, showing the diode carrier from the 21 GHz first mixer with its substrate removed, undergoing diode replacement.

The mixer diodes themselves are almost too small to see, even in the magnified view at bottom. Actual width of the entire substrate is approximately 15 mm.

It's been reported by Luis Cupido, CT1DMK that the beam-lead diodes can be replaced with either BAT30 low-barrier parts from Infineon or MSKN709 medium-barrier diodes from Metelics. Low-barrier Metelics parts should also be usable, as may similar diodes from MA/COM. Luis has found that the better-known HCSC9101 diodes need more LO power than the analyzer has available.

Although the mixer and its diode carrier are easy to work with on the bench, replacing the diodes on the carrier is another matter. Gap-welding capabilities are required for the gold ribbon-to-substrate attachment, while gap reflowing is used to attach the ribbons to the diode holder (although the latter operation may be performed with a small soldering iron). It may be difficult to preserve the original gold ribbons during disassembly; be prepared to replace them with new ribbon stock.

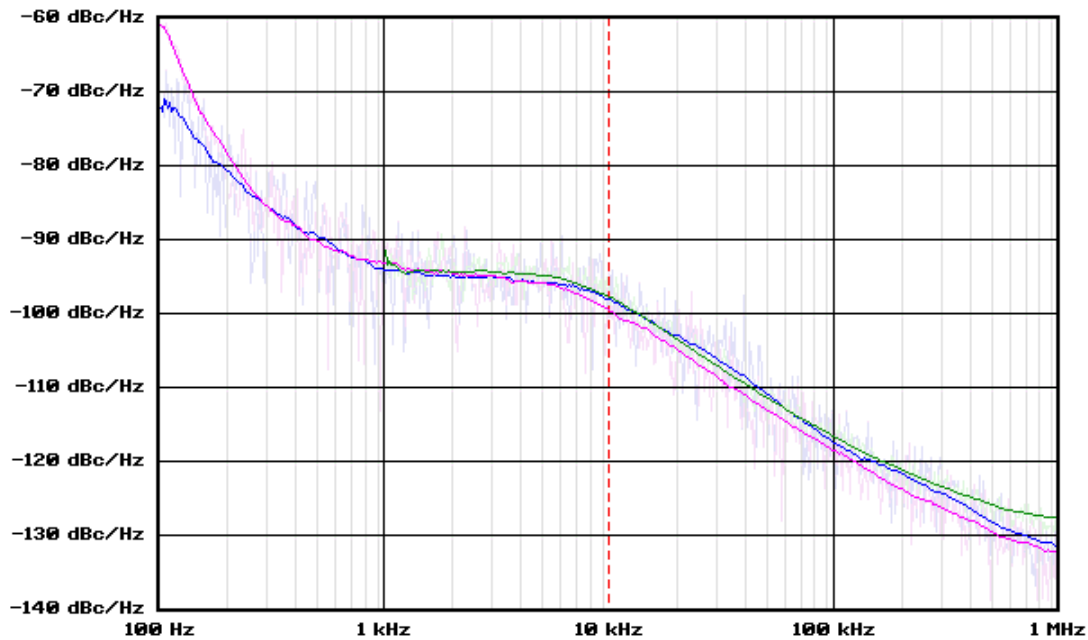
The traces below were acquired with PN.EXE from the GPIB Toolkit, measuring the output of a Wenzel crystal oscillator whose phase noise is substantially lower than the analyzers' own. Typical examples of the 494AP, 494P, and 492P spectrum analyzers were compared. Minimum RF attenuation was set to 0 dB in all three cases, and 20 dB of carrier clipping was used.

The 494P appears noisier close to the carrier, but this is actually a consequence of its broader 30-Hz RBW specification compared to the 494AP's 10-Hz minimum bandwidth. The 30-Hz filter skirt, and not the LO phase noise, is responsible for the observed performance at offsets below about 300 Hz.

At offsets of 10 kHz and beyond, all 49x/275x analyzers should generally perform within +/- 5 dB of these traces. All three analyzers meet Tektronix's rather-loose PN specifications easily.
