January 13, 2015

Loose Screw on Front Drive Unit HVIL Switch

Classification	Campaign Bulletin	Section/Group	44 - High Voltage System	Country/Region	United States, Canada□
Year	2014	Model	Model S	Version	P85D

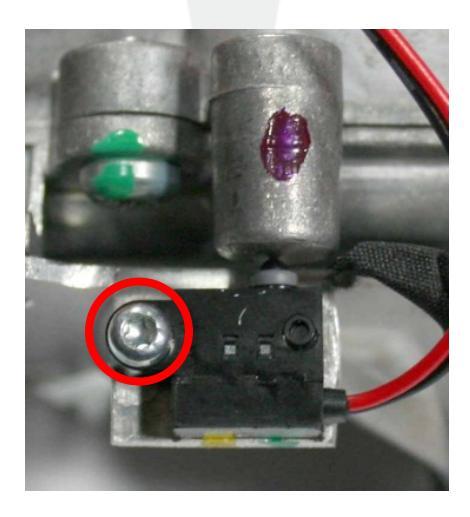
Figure 5

On some dual motor performance vehicles, the screw that secures the HVIL (High Voltage Interlock Loop) switch to the front drive unit fuse bracket might come loose. This might result in an HVIL fault.

5. Remove and discard the screw that secures the HVIL switch to the bracket (Figure 5).
