Tesla, Inc. Service Bulletin		c. ^{tin} Disable Rear Do	Disable Rear Door Cladding Sensors		
SB-21-12-005			-		
October 22, 2021					
Classification		Section/Group	Mobile Service		
Repair Bulletin		12 - Exterior Fittings	Can Perform (where permitted)		
Model Yea	ar Model	Country/Region	Version		
2015 - 2018	8 Model X	All	All		
The model(s) and applicability of th	d model year(s) listed a is bulletin for a particula	a general approximation of the affected VIN list. Re vehicle.	fer to the VIN/Bulletin Tracker or Customer/Vehicle profile to determine

Condition

For some Model X vehicles built before May 2018, should water seep into the printed circuit board of the rear door cladding sensor, an alert might be displayed on the touchscreen.

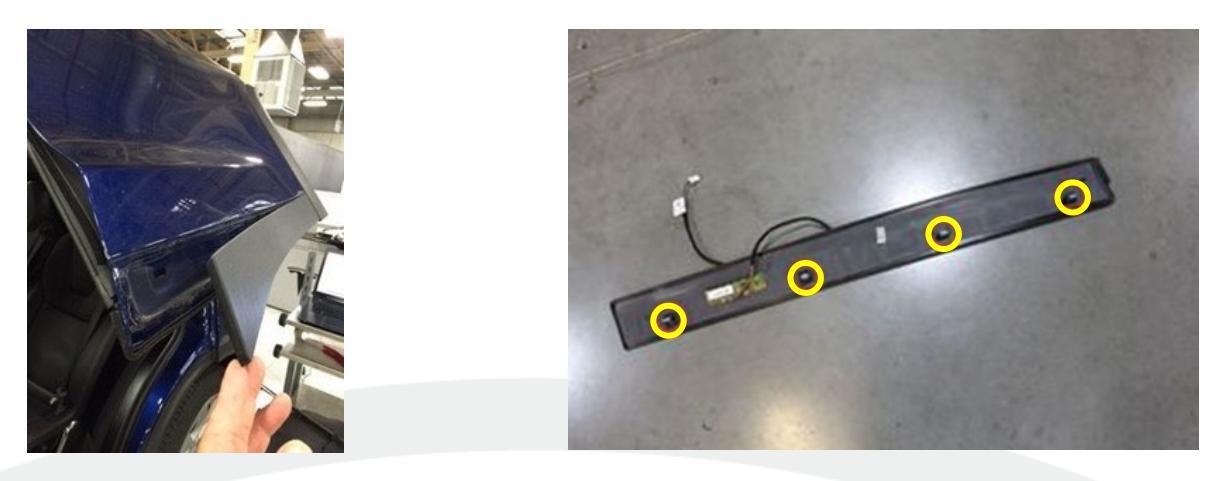
Figure 9

- If the cladding is in good condition, disable the cladding sensor. Skip to step 27.
- If the cladding is discolored, cracked, or damaged, replace the cladding sensor with a cosmetic-only cladding. Continue to the next step.

17. Release the clips (x4) that attach the LH rear door cladding sensor to the LH rear door, and then remove the cladding sensor from the door (Figures 8 and 9).
