AP 6040
PROFESSIONAL SERIES

MODEL TYPE: YS6040

SERVICE MANUAL

Re : AP6020 / AP6040 Internal Fuse Problem

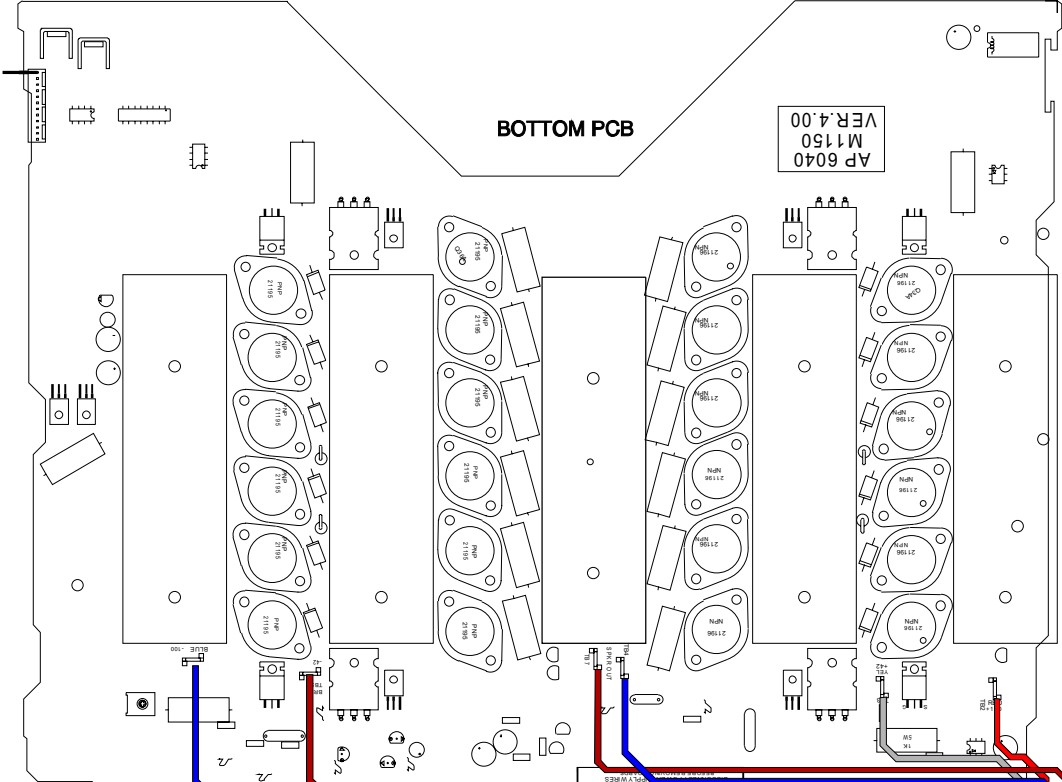
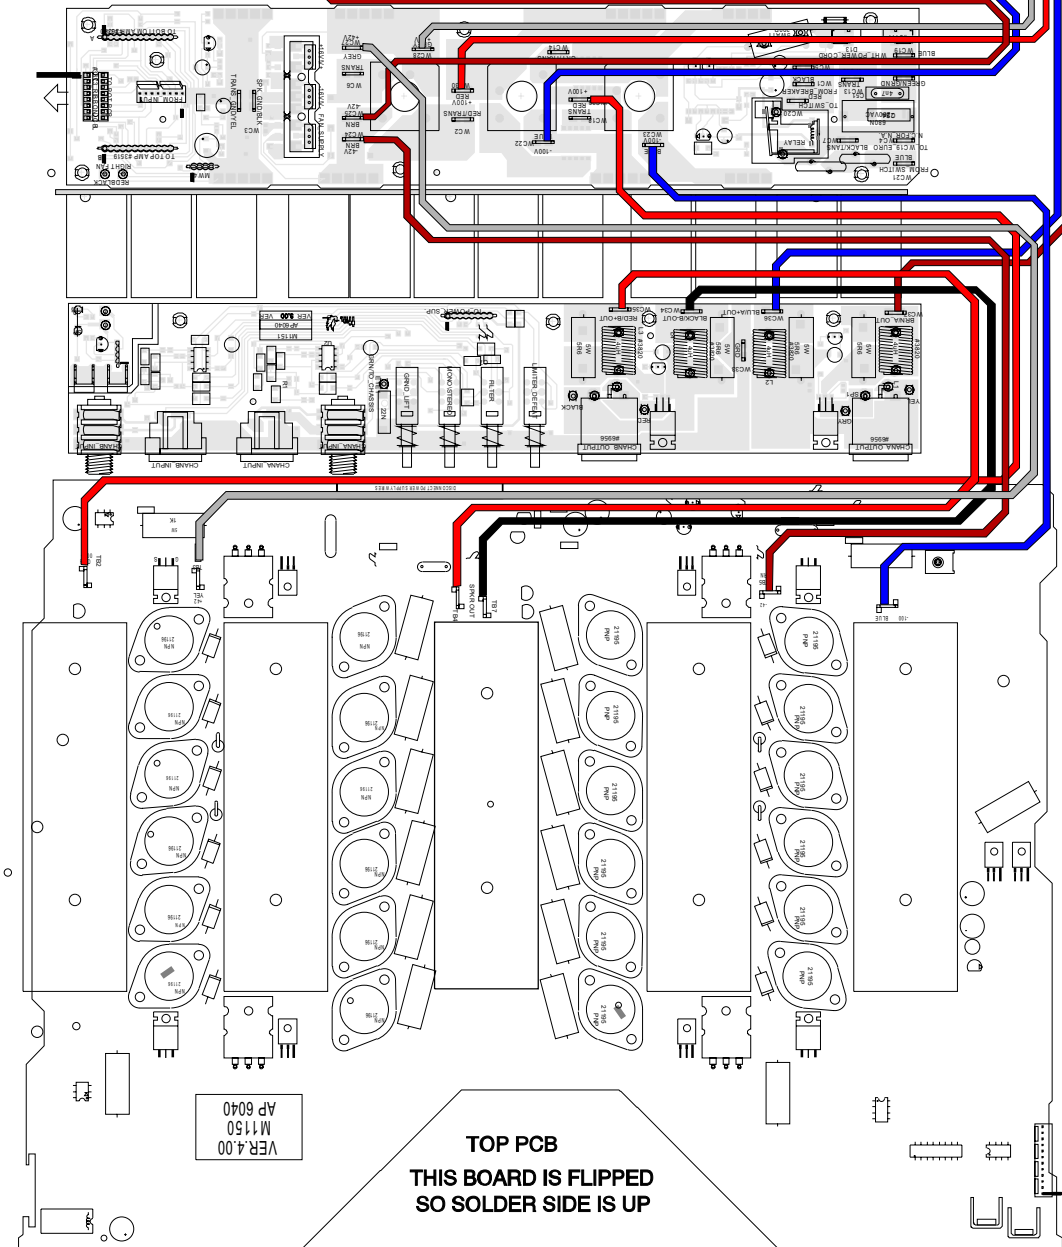
THIS CONNECTION
 MUST BE BROKEN HERE

BOTTOM PCB

TOP PCB
THIS BOARD IS FLIPPED
SO SOLDER SIDE IS UP

- Remove the lid from the unit and both power amp boards.
- Locate the small 0.1A fuse on lower power supply board (#M1151 - AP6040 or M1177 - AP6020). This is the only fuse in the unit.
- Replace this fuse with a 5W 390R resistor (YSL Part#4736).
- Dress all wires away from the two 5W 390R resistors.
- In order to be sure that no damage was done to the upper power amp boards when they were removed it is strongly advised that the technician carefully retouch the solder on the three legs of each of the following transistors: #Q32A, Q32B, Q33A and Q33B on each of the two power amp boards (AP6040 - M1176/M1176A, AP6020 - M1150/M1150A)
- Replace the upper boards and lid.
