SERVICE MANUAL

nx520p

TYPE:YS1002

Product NX520P		
NX520P	PCB# M1159-A	Sheet 3 of 4
Date: Wed Apr 23, 2003		Rev: VER.4.10
Filename: M1159-A-VER4.10.sch2001

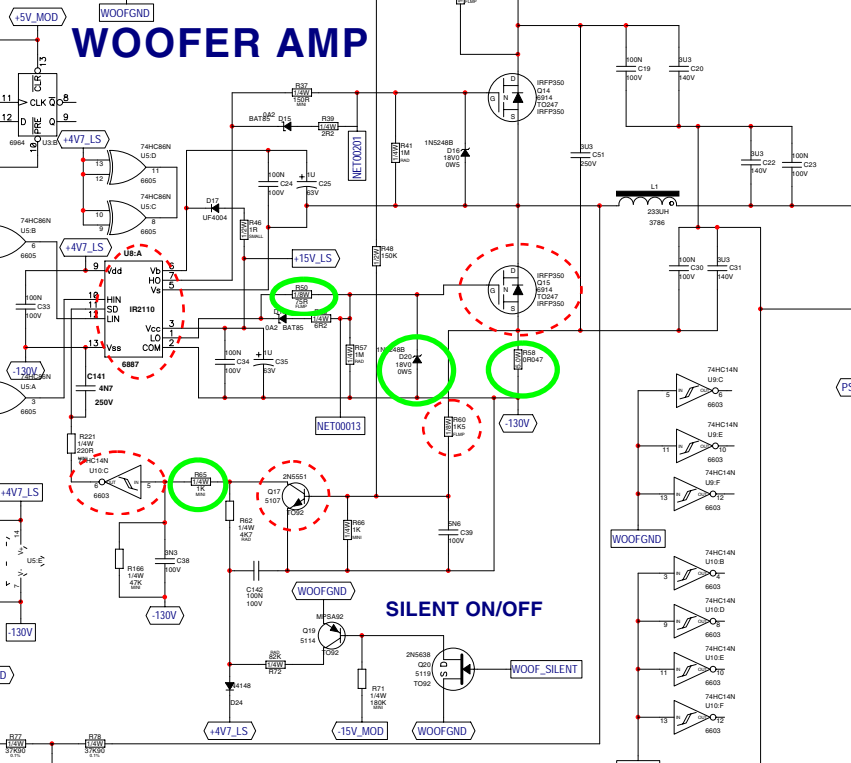
WOOFER AMP

We have experienced some failures with the short pilot runs of 520P and EF500P due to an incorrectly mounted resistor on the power board. There are only about a dozen of each of these in each of our market territories. These failures at first sight will seem somewhat intimidating due to the blackening soot which is produced when the resistor arcs out to the printed high voltage rails under the resistor designated R60. The damage looks far worse than it really is and is generally repairable by anyone with basic electronics and soldering skills.

The greatest difficulty with servicing class "D" amplifiers is that most service people have never serviced one before. And, like all things new, they don't like being in unfamiliar water. When you have done a couple of these kinds of amps, you will realize that they are probably easier to repair than their linear counterparts. But there are two dramatic differences to be observed in testing this class of amp. They are:

- 1) You cannot soft start this type of amplifier as it has an error amplifier, which will deny start up at low voltage.
- 2) You must have a load connected to the output upon startup. The amp sends a test pulse upon startup which must be registered in the feedback loop before it will activate the driver chip. If there is no load there is no current in the output, if there is no current, there is no voltage and consequently no feedback pulse.

The good news is that this class of amp will generally not cook off if you failed to repair it and then try to fire it up. It usually just sits there dumbfounded waiting for you to find the missing faulty bits.

The process for repair of units suffering from an R60 arc over is as follows.

- A) Remove the remains of R60 and clean the soot from the board. Please remember this is a double-sided circuit board with thru plated component holes. Do not use excess force to remove the component leads from their solder holes. They will come out easy enough when you have enough heat on the joint.
- B) Replace the following components : 1) Q15 , IRFP350 2) Q17 , 2N5551 3) U10 , 74HC14N 4) U8 , IR2110 And finally, R60 , 1K5 , which should be installed about ¼" above the board so as not to arc out to the high voltage traces again.
- C) Measure the following parts; just to be sure we don't have any stragglers. 1) R58, .47ohms 2) R50 , 75R 3) R65 , 1K and 4) D20 , 18 volt zener.
- D) Yorkville Part #'s (Q15 = 6914) (Q17 = 5107) (U10 = 6603) (U8 = 6887) (R60 = 2034)

When all the bits have been replaced and the other parts measured, you are ready to fire it up.

Do not forget the startup rules mentioned above and you should have a 95% chance of a first shot success on the job.
