Evaluation of Bonding Parameters on Random Fatigue Life of Bonded Aluminum Joints

H.F. Wolfe* and C.L. Rupert†

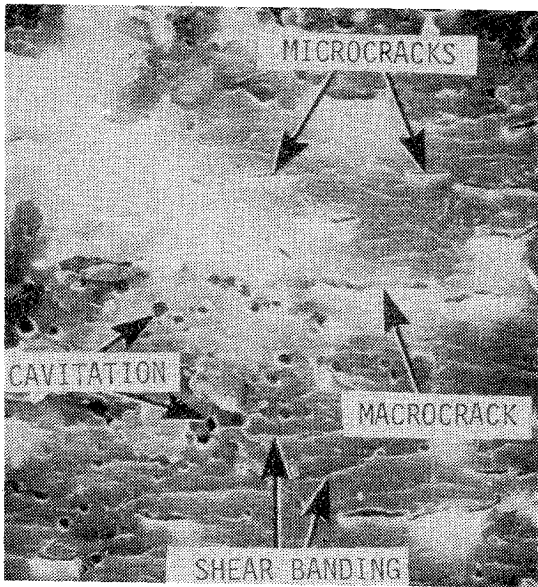
Fig. 7 Example photomicrograph of adhesive failure.

adhesive is a two-phase material, consisting of elastomeric particles (precipitated during the curing reaction) in an epoxy continuum. Background information on the morphological and fracture characteristics of these types of two phase elastomer modified epoxies is given in Ref. 3, 4, and 5. Under combined shear and tensile loading such as the adhesive was subjected to in the fatigue tests, the adhesive fractures by cavitation around the elastomeric particles and by "shear banding," which has the appearance of thin layers, displaced stepwise from each other. Under repetitive loading or increasing magnitude of load, cracks form around these cavities, the cracks coalesce together forming macrocracks, and then gross fracture occurs. An example of such "cohesive" fracture is shown in Fig. 7.

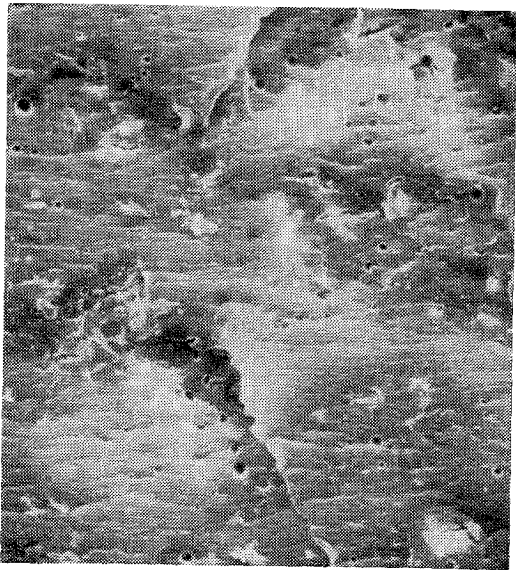
Fig. 10 Photomicrograph of "fresh" fracture surface (skin side), group A, specimen No. 1.

The fracture shown in Fig. 10 is immediately adjacent to a region which was intact (still bonded) when the fatigue test was terminated and, therefore represents a "freshly fractured" surface. The fracture surface in Fig. 11 is about $\frac{1}{8}$ in. (0.318 cm) further outboard (away from the tee) from that shown in Fig. 10. Here, fracture occurred earlier since it was subjected to greater dimensional excursion. This caused elongation of the cavities and subsequent microcracks connecting the cavities.

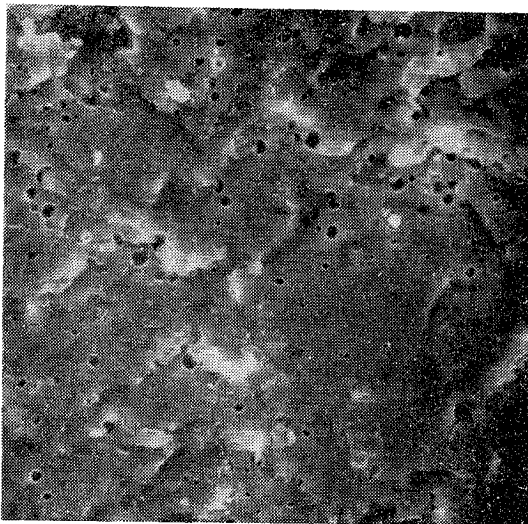
Fig. 12 Photomicrograph of fracture surface (tee side), group C, specimen No. 2.

cohesive within the adhesive, but there were also zones of interfacial failure, namely, adhesive-to-primer failure, and primer-to-oxide failure. The interfacial failures were on the skin side. This is illustrated by Fig. 12 for the tee and Fig. 13 for the skin, both showing fracture surfaces near the zone of fracture initiation. Figure 12 shows the classical cohesive failure for FM73, whereas Fig. 13 shows a combination of failure modes, both cohesive and interfacial.

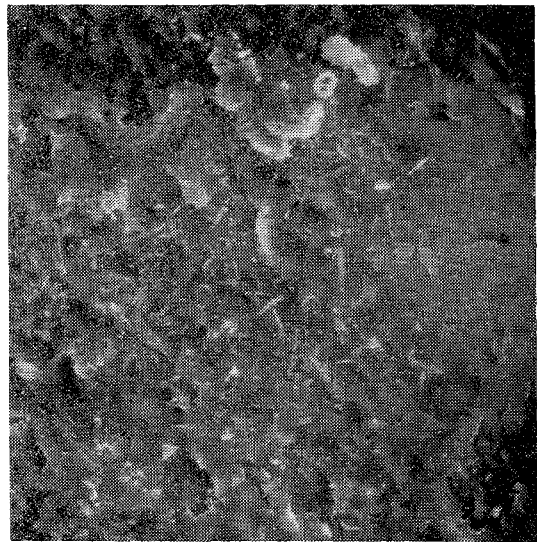
Fig. 13 Photomicrograph of fracture surface (skin side), group C, specimen No. 2.

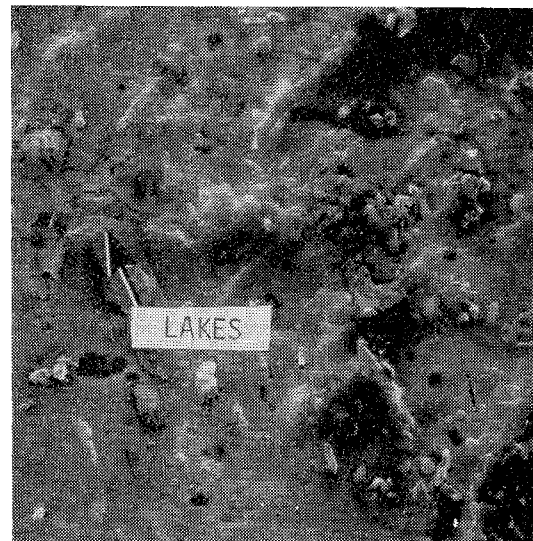
Fig. 14 Photomicrograph of fracture surface (skin side), group D, specimen No. 3, near initiation 500X.

For a representative specimen from group D (specimen No. 3, FM73 adhesive on phosphoric acid anodize without a primer), failure initiated cohesively but then propagated interfacially toward the skin. Figure 14 shows the fracture surface of the skin about $\frac{1}{8}$ in. (0.318 cm) from the point of initiation. This photomicrograph at 500X, shows a thin layer of polymer adhering to the oxide. The pits in the adherend surface are evident, indicating that the fracture is very close to the oxide surface. One interesting feature in this photomicrograph is the presence of "lakes" of a dispersed phase in the polymer layer, rather than spherical particles. The reason for the lakes is not known. However, it is speculated that they may have resulted from the high surface energy of the aluminum oxide causing sufficient spreading of the adjacent polymer layer to transform the elastomeric

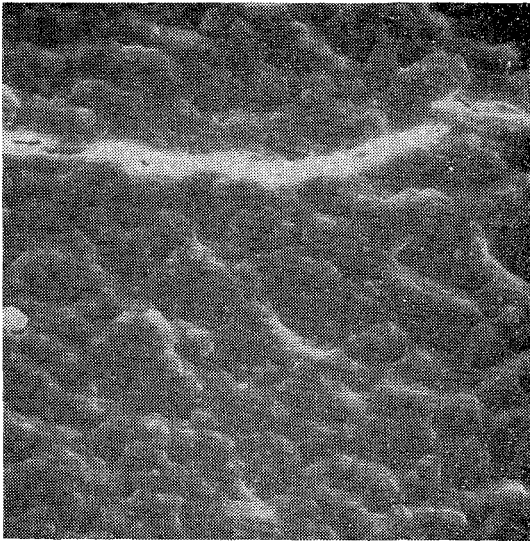
Fig. 15 Photomicrograph of fracture surface (skin side), group F, specimen No. 3.

Photomicrographs of the fracture surfaces of a specimen made with AF30 (group F, specimen No. 3), a nitrile rubber phenolic adhesive, indicated predominantly cohesive fracture, but with a morphology different from that of FM73 adhesive. Figure 15 of the fracture surface of the skin shows a continuous phase which appears to be elastomeric. The elastomeric nature is indicated by local regions of "necked-down" material and the undulating, highly deformed overlapping layers. Figure 16 is a photomicrograph of the flash area at the edge of the tee flange. The interesting features here are the fragmentation of the surface grains of the adherend and the separations at grain boundaries. This is presumed to have been caused by the very high energy input during the fatigue test.

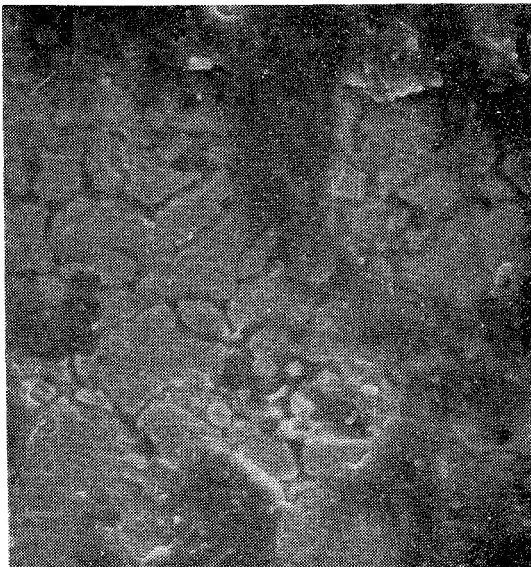
Fig. 16 Photomicrograph of flash area.
