Wear of artificial hip joint material

E.P.J. Watters^a, P.L. Spedding^{a,*}, J. Grimshaw^a, J.M. Duffy^a, R.L. Spedding^b

^a *Research Support Unit, The Queen's University of Belfast, Belfast BT9 5AG, UK*

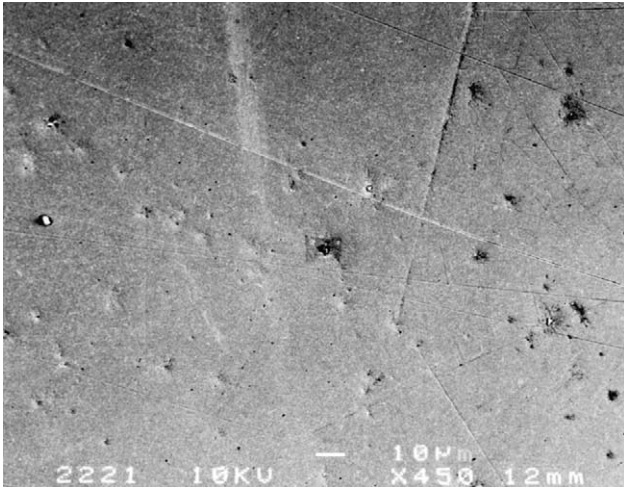
The unworn femoral head surface was examined and it was found that certain were of inferior quality. Fig. 2 shows a micrograph of one such head where, despite conforming to the required standard, the surface was criss-crossed with prominent polishing lines and possessed embedded carbide grains and holes. Fig. 3 highlights one of the holes which were formed either by the physical removal of protruding carbide grains or by outgassing during manufacture. Such surface imperfections will give increased polymer wear and provide some explanation for the wide variation in reported

Fig. 2. Micrograph of an unworn femoral head of inferior quality, showing polishing lines carbide grains and holes formed by grain removal and outgassing.

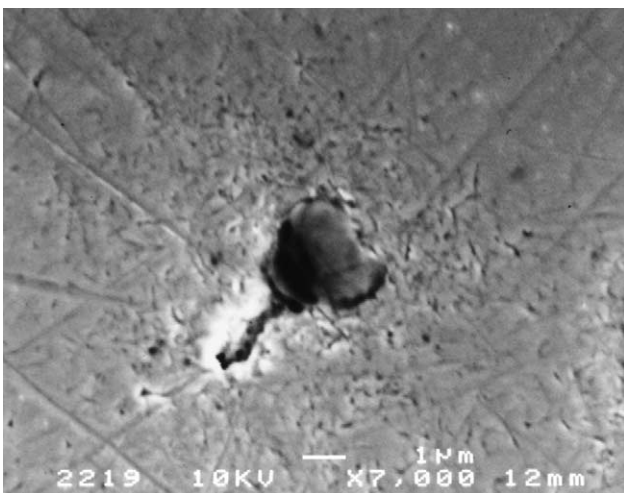
Fig. 3. A close-up on a grain removal hole in an unworn inferior quality femoral head.

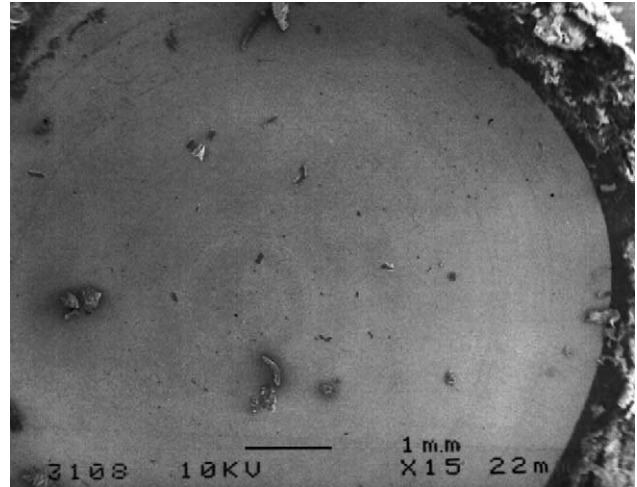
Fig. 4 shows a wide view of the worn femoral head with a considerable buildup of wear debris adhesion at the edge of the wear indent area. Fig. 5 is another wide view of the wear area on the femoral head. There is no sign of any abrasive wear of the metal surface but evidence of adhesive wear is

Fig. 4. Wide view of the femoral head wear area, with considerable debris at the edge of the wear region.

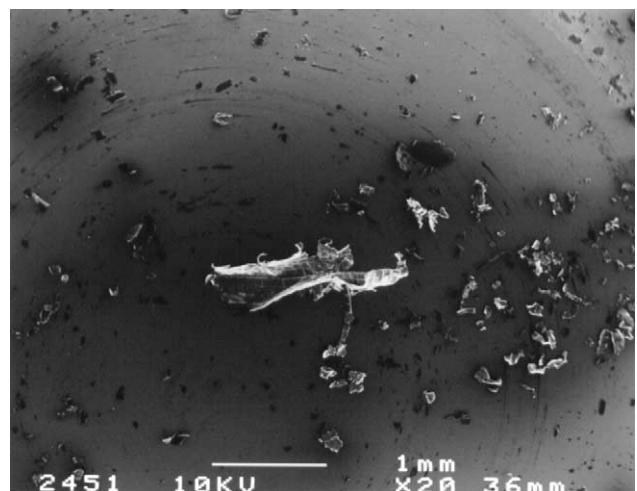
visible at B. The delaminated polymer wear strips at A attest to severe surface fatigue wear of the polymer having taken place. Such fatigue wear has been reported in revision prosthesis [17–19]. The morphology of the flaklet debris taken from periprosthetic tissue has been shown not to match that from simulator wear tests [19–21]. The micrograph in Fig. 6 of some of the typical adhered flaklet debris from this work by contrast exhibit a similar morphological form to that found in vivo. Such a match suggests that the methodology used in this work paralleled that in vivo. Further, it shows that wear in a prosthesis is largely without lubrication.

Fig. 5. Wide view of adhesive and fatigue wear on the femoral head.

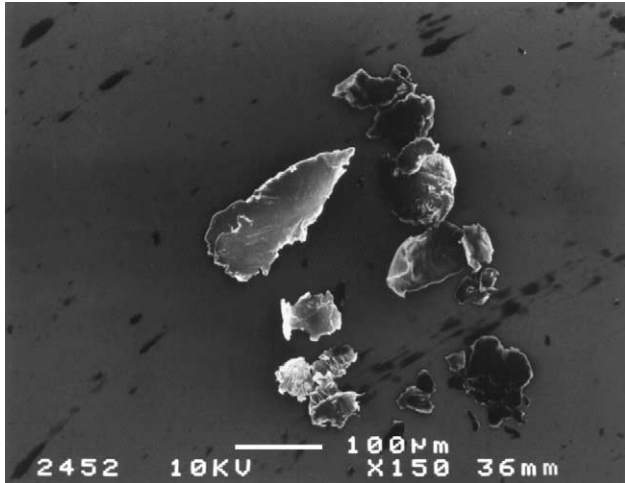
Fig. 6. Test debris on the femoral head similar to that observed in vivo.

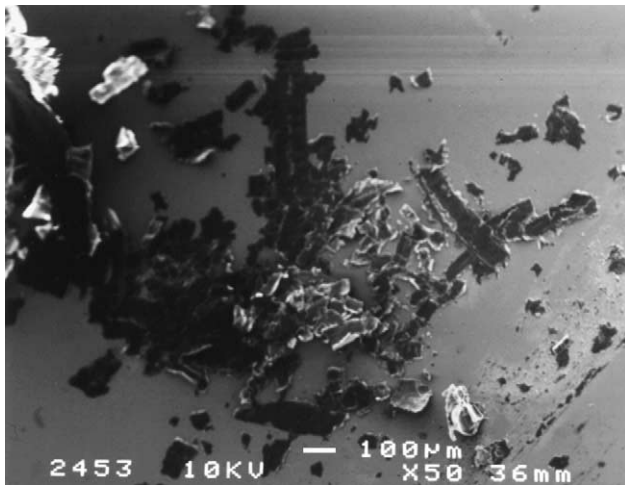
The outer edge of the wear area of the femoral head given in Fig. 7 has substantial amounts of surface fatigue fragments at A, and evidence of transfer film buildup at B. Closer examination of the transfer film region indicated that it was comprised of adhered fatigue flaklets and many micron and submicron scale polymer fibrils, e.g. Fig. 8. Some of the fibrils are being generated off the surface of the flaklet as illustrated

Fig. 7. Delaminated polymer strips and adhesive wear on the outer edge of the femoral head wear area.

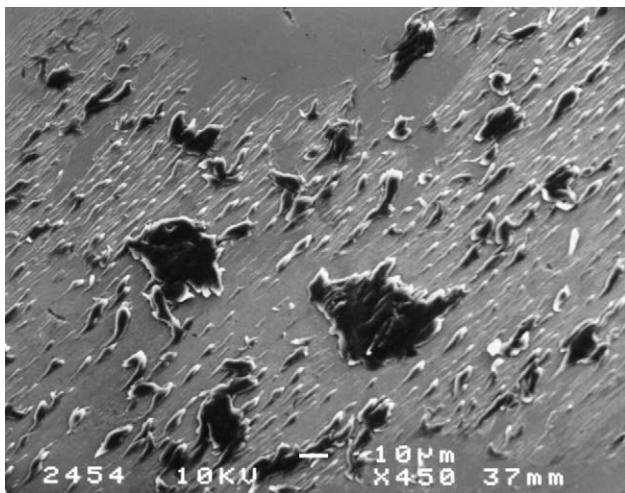
Fig. 8. Closeup on adhesive wear of flaklets adhered to the femoral head. Smeared polymer fibrils are visible.

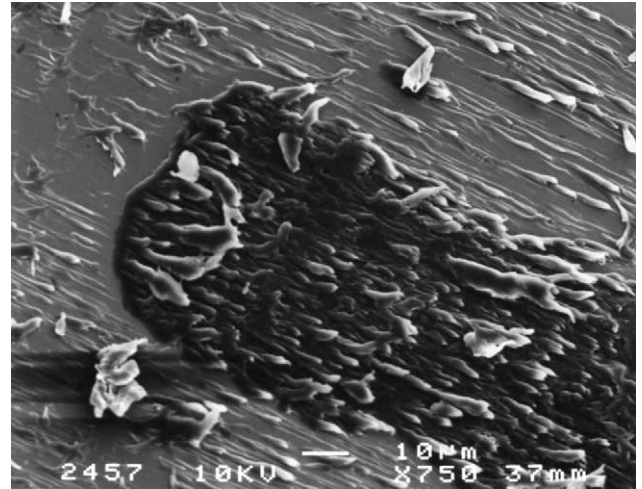
Fig. 9. Magnification of the fibril formation observed on an adhered polymer flaklet.

in Fig. 9 indicating their formation by adhesive wearing due to the passage over the polymer disc counterface. Thus the flaklet is adhered to the surface of the head and is progressively being worn down with the uni-directional orientation of the adhered polymer fibrils indicating the movement. Clear areas between the adhered fibrils show a faint granular nanostructure of grain size 0.2–1 μm. Granular submicron debris recovered from periprosthetic tissue falls within this range [22–24]. Also the nanostructure between the fibril indicates that a thin film of polymer is adhered to the surface of the femoral head. Fig. 10 confirms this and has a clear view of the covering film when it has suffered a brittle fracture due to crystalline formation and fatigue. The film also has polymeric adhesions blended into its structure at A with transfer film in evidence at B. At C there are features suggestive of the criss-crossing polishing lines existent on the underlying stainless steel. Fig. 11 focuses on the rim wear area of the femoral head. Fibrils and their associated transfer film are in

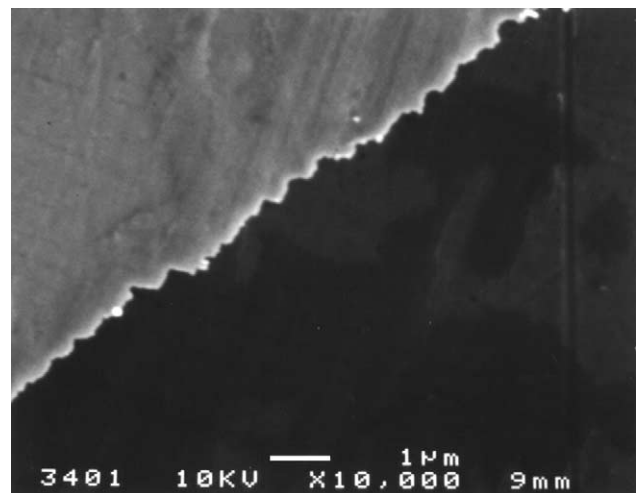
Fig. 10. Brittle fracture crack edge of the polymer film on the surface of the femoral head.

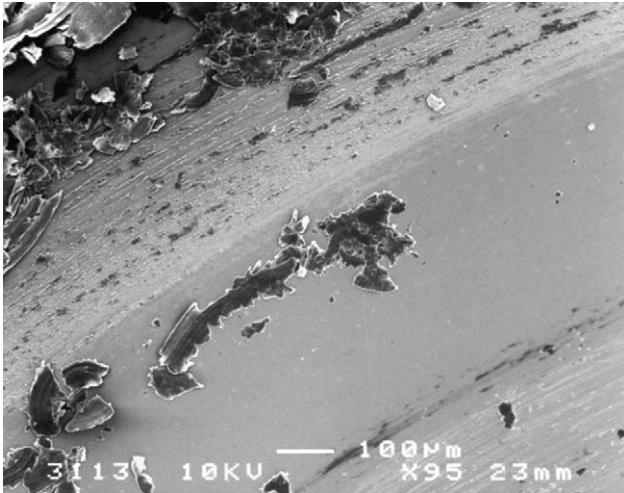
Fig. 11. Adhesive wear and delaminated debris at the edge of the femoral head wear area.

evidence at A and correspond to the fibril formation area on the disc. The delaminated strip B still retains the polishing marks indicating its origin from the original surface region of the disc.

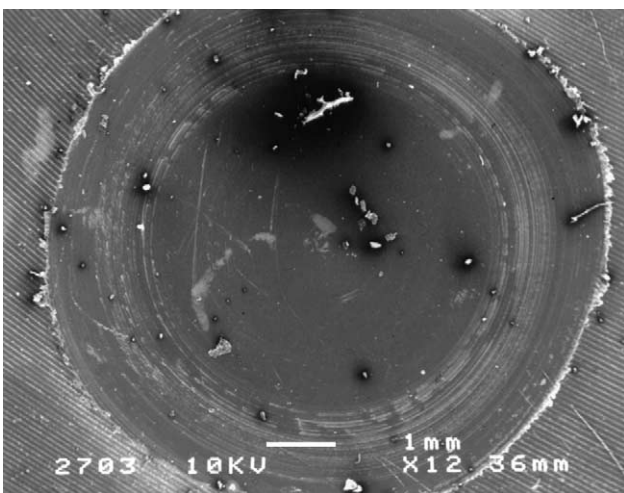
Fig. 12 is a wide view of the polymer disc indented wear area. There is evidence of polymer debris in the relatively smooth central area at A and buildup at the outer edge of the wear area. These features attest to severe fatigue wearing having taken place. The unworn disc surface beyond the worn indent exhibits machine polishing marks. The prominent striated transfer film at B on the approaches to the edge of the wear area of the indent slope exhibits polymer fibrils that correspond to the region B of Fig. 7. These fibrils are generated off the surface of material adhered to the corresponding counterface surface on the femoral head.

Fig. 12. Wide view of the polymer disc wear area with flaklet debris and adhesive wear fibrils on the outer wear slope.

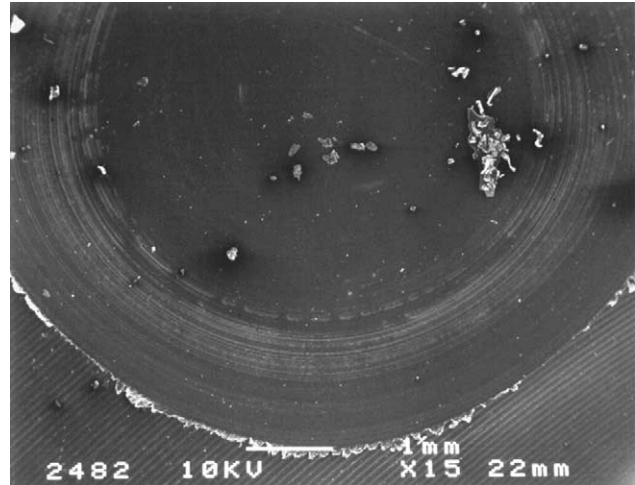
An enlargement of wear outer region in Fig. 13 shows the striated polymer fibrils to be fatigued (area A). Large flak-

Fig. 13. A closeup on the outer region of the polymer disc wear area showing fatigue flaklets, adhesive wear fibrils and debris buildup on the edge of the wear area.

lets similar to those retrieved in hip revision surgery [19] are present at B. The buildup of worn polymer debris at the edge of the disc worn area will continue to register in the final weighing of the disc even though its origins will have been from the worn indent polymer volume. Thus a sizable amount of wear material will still register in the final disc weighing, resulting in a bias and wide variation in the weight determination of the wear rate. In this work the typical variation in weight loss was in the order of $\pm 50\%$. Indeed in some cases registered weight loss was close to zero.

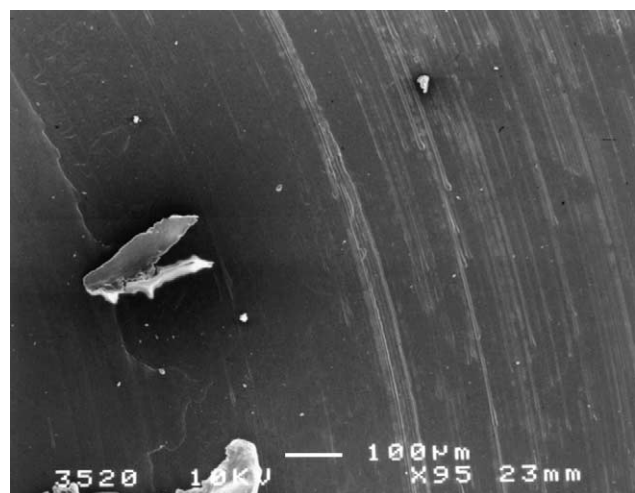
A close-up on the beginning of the outer wear tracks is given in Fig. 14 highlighting both the deposition and smoothing of transfer film at A and the drawing out of fine fibrils on the indent outer slope at B. Fig. 15 emphasizes the pronounced edge wear lines with intense fibril production in this region.

Fig. 14. A closeup on the beginning of the outer wear tracks with the edge of a transfer film and fibril formation evident.

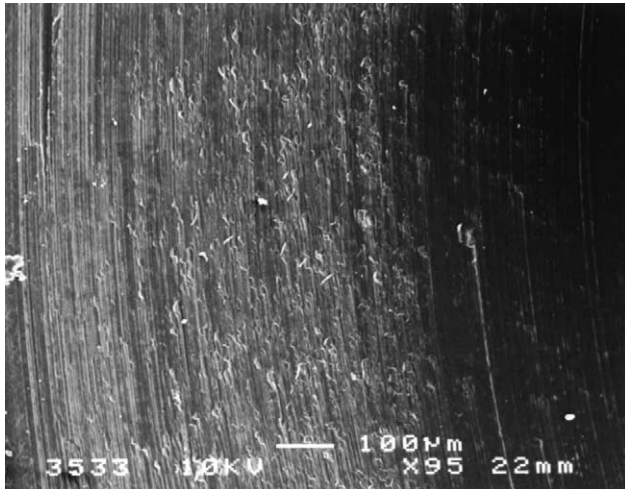
Fig. 15. Pronounced edge wear lives with intense fibril production at the lower edge of the wear area.

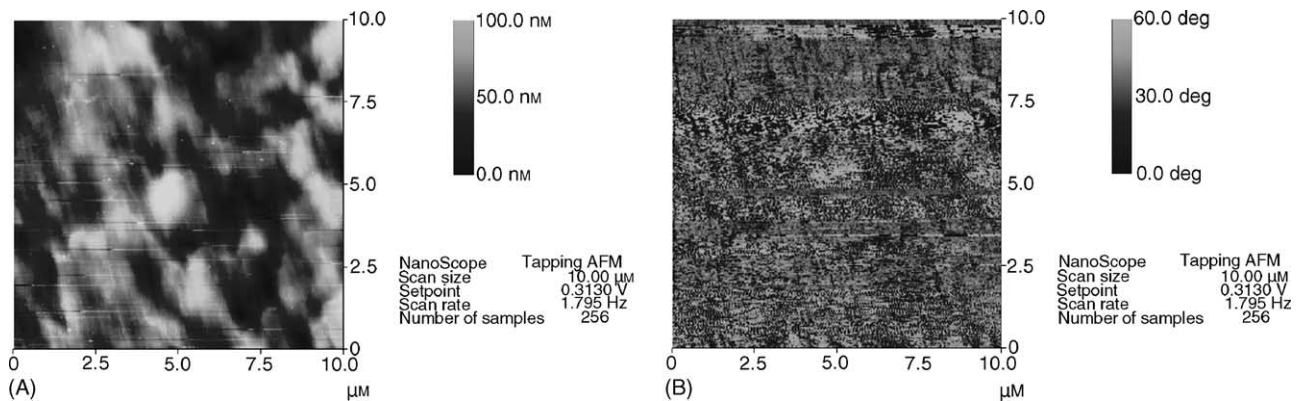
Fig. 16 is an AFM scan of the smooth central indented wear area of the disc. The normal view shows surface plastic flow highlighted as lighter regions. The phase view indicates that much of the area is covered with a crystalline subsurface

that developed in the polymer during prolonged rubbing contact. Any areas of delamination and the edges of plastic flow regions share a strong phase response indicating they are separate masses from the rest of the surface. The white centered scan lines show that there are some loose particles on the surface of the polymer. There are visible voids left in the surface where nanosized particles have been torn away. These particles form the basic fine polymer structure and are released as the final product of the wear process. Thus UHMWPE will by its very nature result in the production of fine particles that cause osteolysis [5]. Fig. 17 is a micrograph of the wear slope near the top edge of the wear indent. There is a lot of plastic flow present, the edges of which are clearly highlighted in the phase view. There is a little sign of the crystallinity observed in the central wear region and few voids. Some loose material is apparent as is some delamination at A. Details on the application of the AFM to worn UHMWPE are given elsewhere [25].

Fig. 16. (A) Topography near the centre of the polymer wear area showing graining plastic flow. (B) Phase view showing crystalline orientation void structure and fine granular overlay.

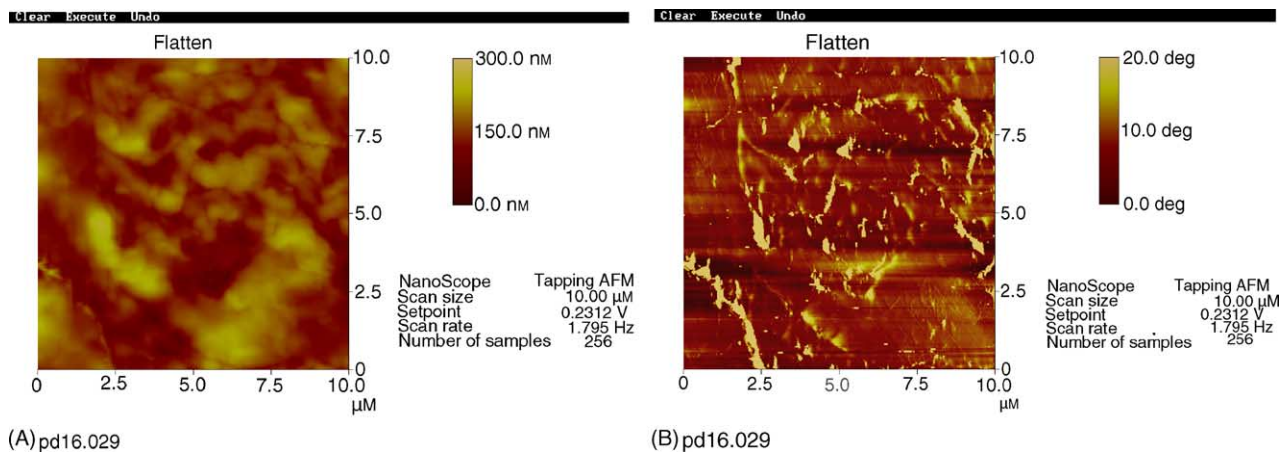
Fig. 17. (A) The top of the polymer wear slip with large plastic flow features and some delamination. (B) Phase view showing a high response from the delamination.

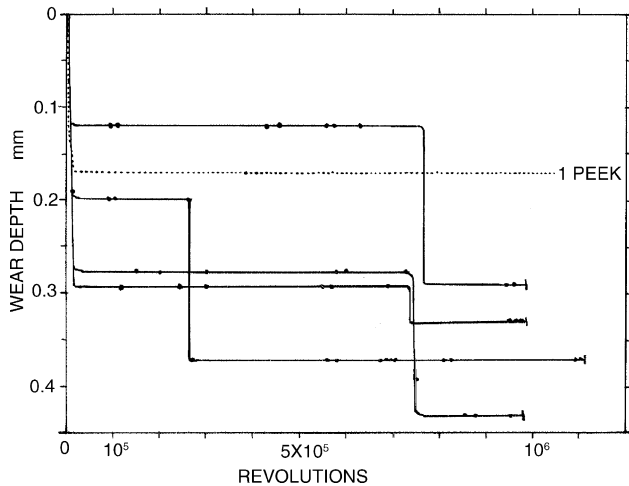
The stepped wear penetration profiles for four typical runs are presented in Fig. 18. There was an initial rapid indentation of the femoral head due to creep and fatigue wear. Some resulting debris became attached to the counter faces acting as a barrier to further penetration. The subse-

Fig. 18. Characteristic wear profiles for PEEK and UHMWPE under dust-free conditions.

quent plateau in the wear profile corresponds to the slow attrition of the entrapped interfacial debris. When all the polymer protruberances have been worn away, direct contact of the crown of the femoral head leads to thermal friction generated heating, crystallization and ultimately fatigue which causes polymer to be torn out from the central wear area. This results in a sudden penetration into the UHMWPE and a repeat of the debris interfacial attrition process. Early penetration depths recorded showed a wide variation but longer term the wear depth fell within a relatively narrow range. This suggested wear mechanism is different to other suggested models [26,27] and does provide some explanation as to the observed wide variation in wear rates.

In Fig. 18 there is a wide variation in the initial UHMWPE penetration since the depth achieved depended on the capture of sufficient debris between the counterfaces to keep them apart. This process was variable as shown by the data. However as the wear proceeded the variability in the wear depth decreased. For PEEK the penetration remained constant at a value to support the weight through the femoral head onto the polymer.
