## Development of a safe guidewire

Toshiyasu Suzuki, Kenji Ito, Junichi Nishiyama, Keiichiro Hasegawa, Masahiro Kanazawa, and Haruo Fukuyama

## Abstract

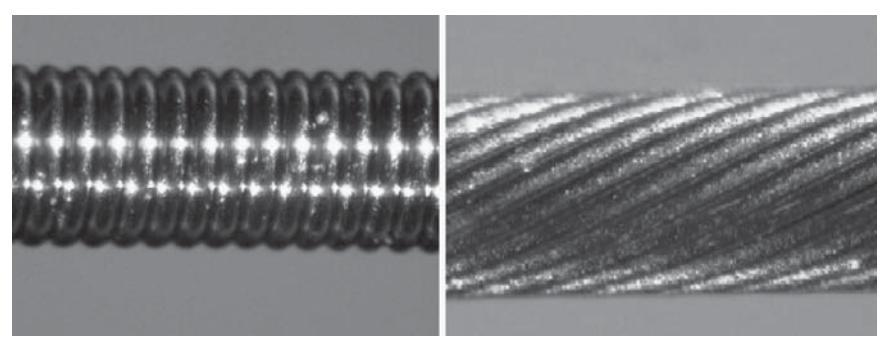
Figure 1 shows a conventional guide wire on the left and the improved guidewire on the right. The conventional guidewires consist of a stainless steel core wound lengthways by a spring made of the same material (hereafter wound lengthways). In the improved guidewire, thin wires of the same material are

**Fig. 1.** Structure of the guidewire. On the *left* is a conventional guidewire; on the *right* is an improved guidewire

plied in a straight line to form a single guidewire (hereafter multi-ply).

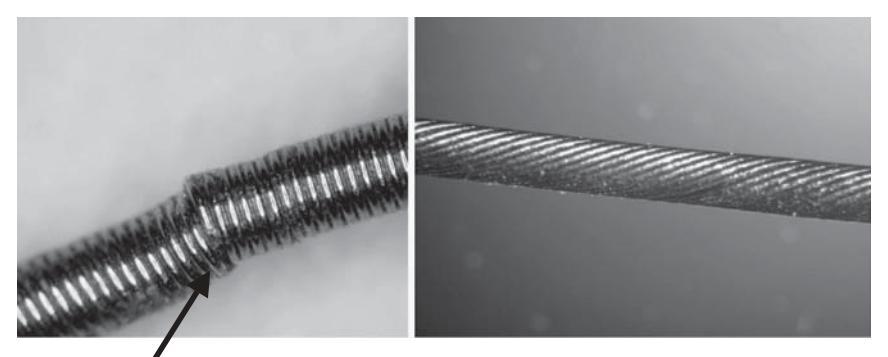
Figure 3 shows the relation between the morphological changes to the bent guidewire and the puncture needle. The top row illustrates the changes to the guidewire in both groups after they are bent at 90°. The bottom row illustrates the morphological changes when each of the guidewires is bent when joined to a puncture needle. In both rows, group A is on the left and group B on the right. The elastic limit of the group A guidewire is easily exceeded when the guidewire is bent 90°. It bends easily, and the gaps between the springs increase.

Deformation of coiled region No deformation of the coiled region 7/7 (100%) 0/7 (0%)

**Fig. 3.** Relation between the morphological changes in a bent guidewire and a puncture needle. The group A guidewire is easily bent, and the gaps between the springs increase. In contrast, the group B guidewire is difficult to bend, and the gap between the springs is small. The group A guidewire, with its expanded gaps between springs after being bent, can easily catch on the beveled portion of the puncture needle. Hence, there is a possibility that a spring may break

On the other hand, the group B guide wire does not bend easily, and it has a structure that makes it difficult for gaps to arise between the springs. As can be clearly seen in the photographs of the bottom row, the group A guidewire with enlarged gaps between springs after being bent can easily catch on the beveled part of the puncture needle and cause locking, which is thought to be the principal cause of guidewire trouble. According to the report by Domino et al. [9] there have been close to 20 reported cases of lawsuits stemming from guidewire mishaps.

Based on the results of our experiment, the main cause of locking was the affinity between the beveled surface of the metal needle and the guidewire. The most common guidewires contain a stainless steel core wound with a spring made of the same material and so have the flexibility characteristic of guidewires [10]. However, when they are bent to an extreme angle, the elastic limit of the metal is exceeded, enabling gaps to appear between the springs, which then catch on the beveled surface, causing locking.

To minimize the risk of locking, the improved device we are currently developing has a special structure that makes it difficult for gaps in the springs to develop, so it has an advantage that even in cases where it is difficult to insert the guidewire it is not necessary to remove the entire device. One must only retract the guidewire temporarily, and the guidewire can then be safely reinserted after finely adjusting the needle point.
