## A Microscopic Study of Fracture in Regenerated Cellulose Film\*

N. C. HILYARD, *Physics Department,  
University of Akron, Akron, Ohio*

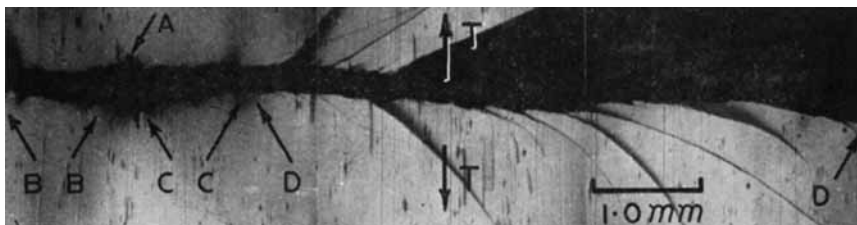
Fig. 1. Photomicrograph of the fracture edge in regenerated cellulose film: (A) site of initial failure; (BB and CC) slow-tear regions; (DD) fast-tear region. Direction of tensile load indicated by the arrow labeled T.

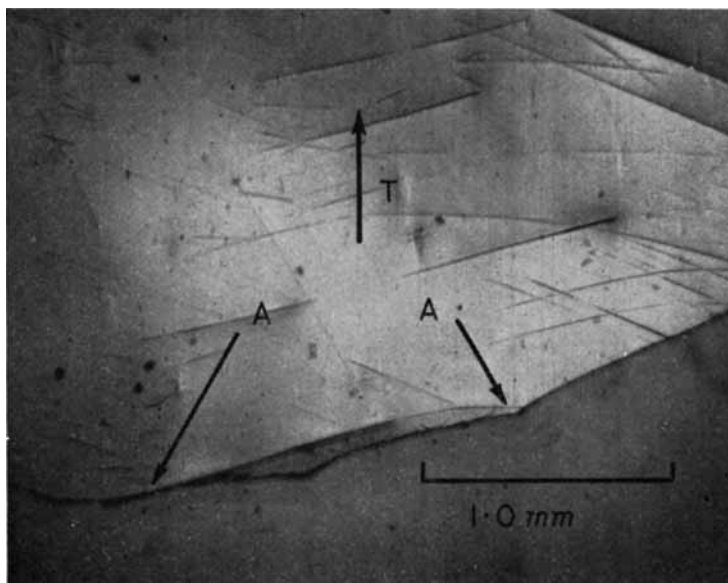
Fig. 2. Surface craze failure: (AA) region of initial failure.

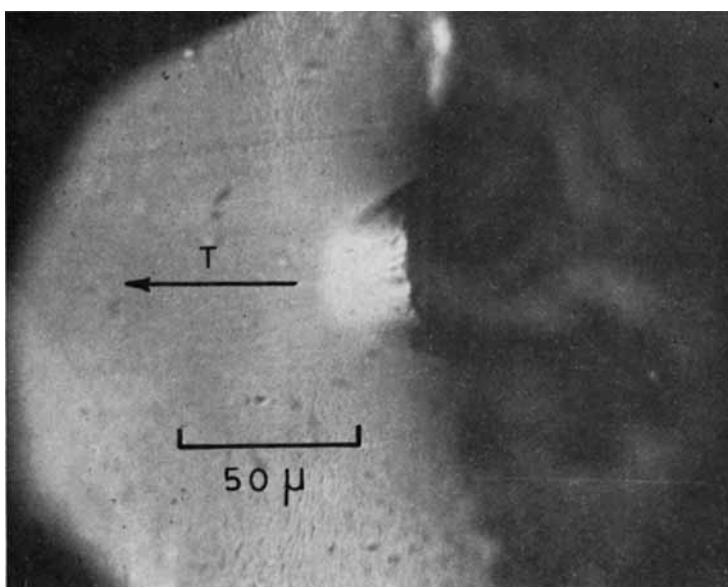
Fig. 3. Internal cavity failure.

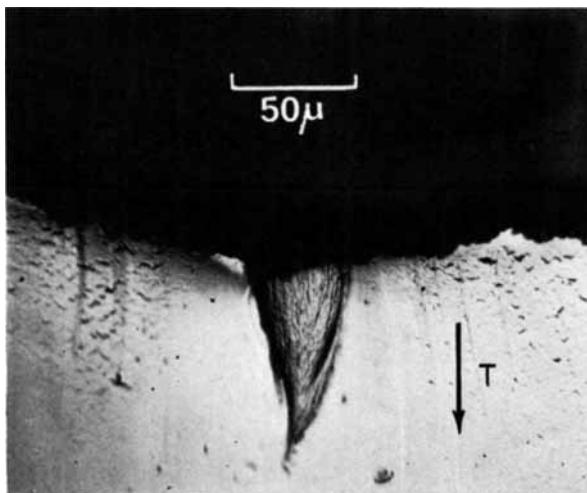
Fig. 4. Surface cavity failure.

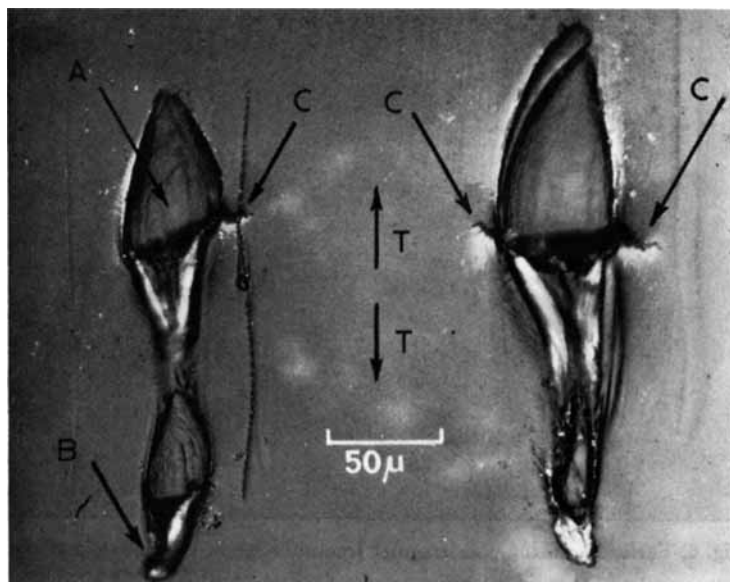
Fig. 5. Multiple-surface cavities: (A) cavity; (B) skin material; (C) transverse cracks.

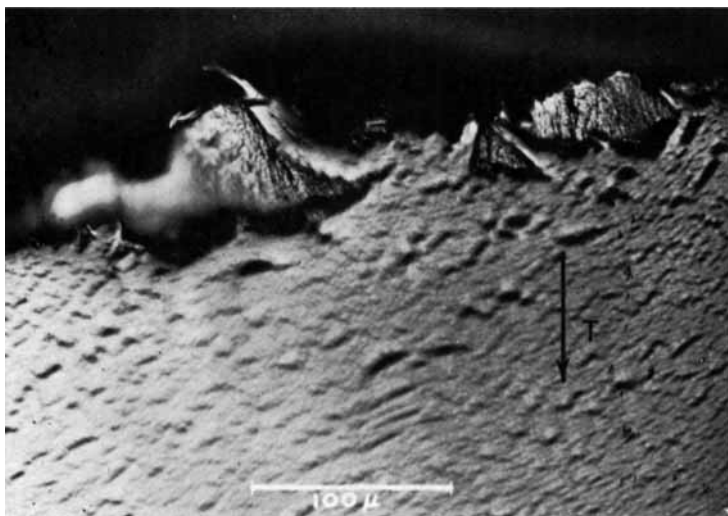
Fig. 6. Surface cracking and irregular fracture edge in the slow-tear region.

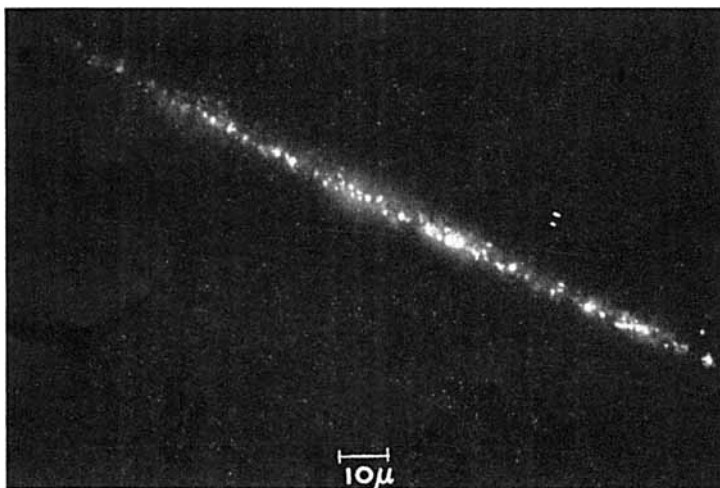
Fig. 7. Voids formed during the tearing process in the slow-tear region.

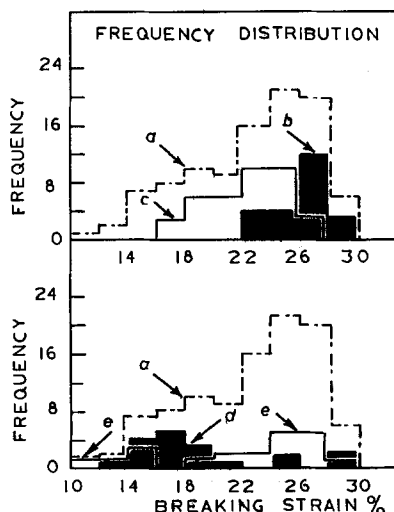
Fig. 8. A histogram showing the frequency distribution for breaking strain for an experimental cellulose film: (*a*) total distribution; (*b*) craze failures; (*c*) surface cavity failures; (*d*) internal cavity failures; (*e*), edge breaks.
