Environmental Stress Crack Growth in Medium-Density Polyethylene Pipe

EXPERIMENTAL

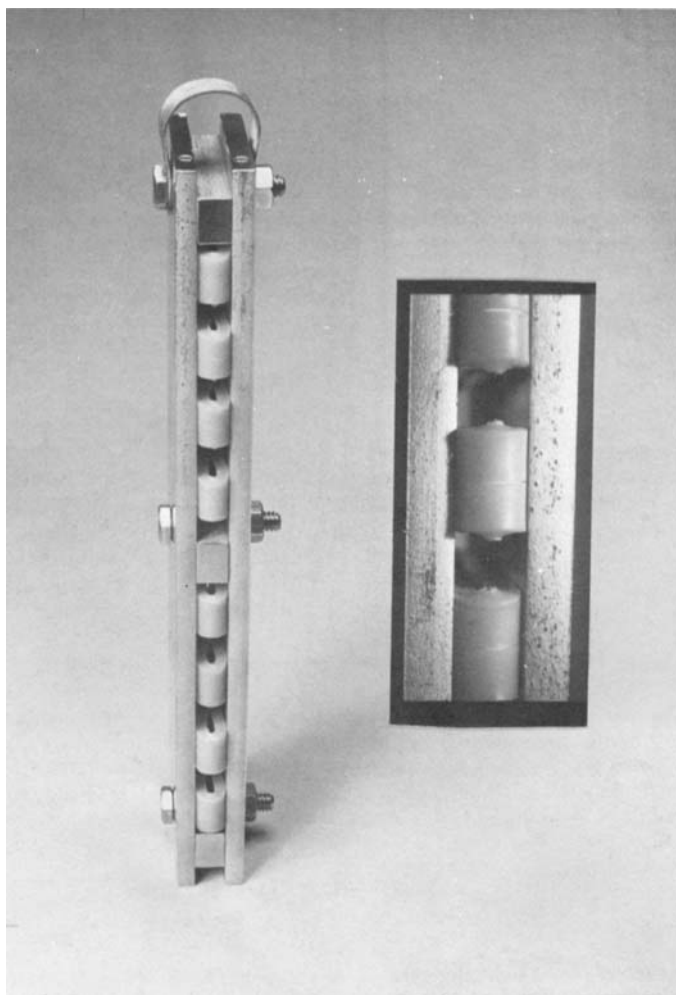
Fig. 1. Photograph of pipe specimens in the compressed-ring fixture prior to immersion in Igepal.

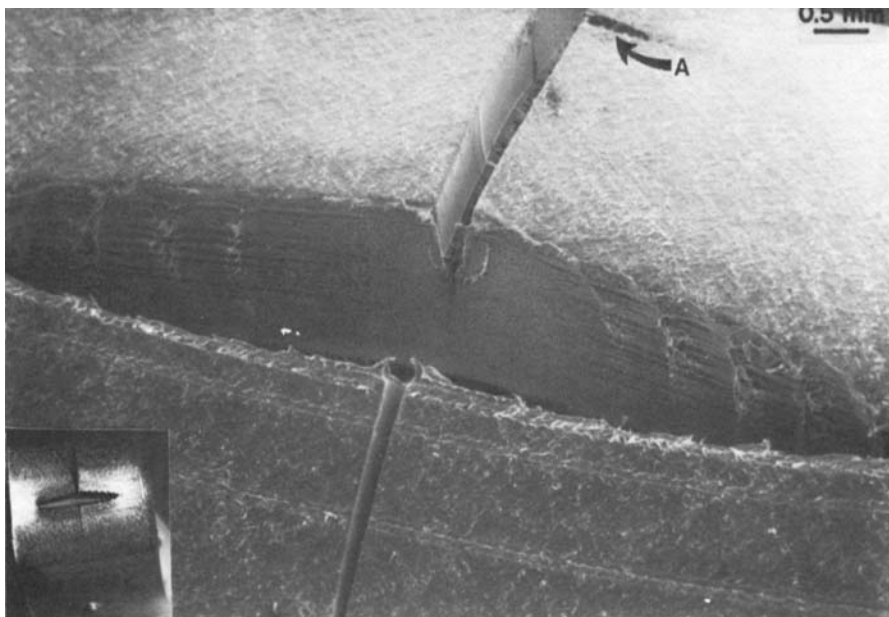
Fig. 2. SEM micrograph of notched portion of lot 1 compressed-ring specimen removed from the Igepal bath during crack formation (vertical groove is the razor notch.) A denotes small crack initiating at the notch. Insert: photograph of the same specimen.

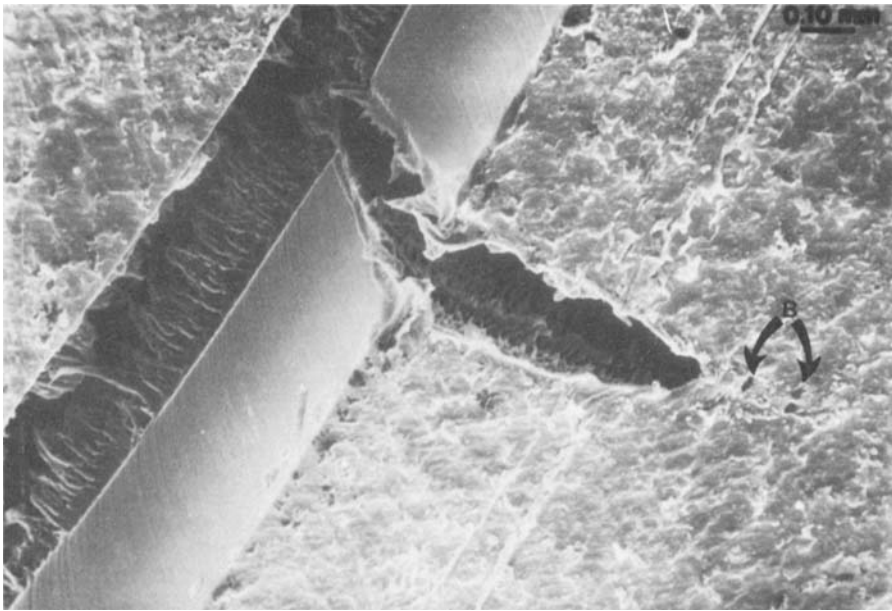
Fig. 3. SEM micrograph of notched portion of lot 1 compressed-ring specimen removed from the Igepal bath during crack formation. Area A in Fig. 1 shown at higher magnification. Crack propagation undercutting the specimen surface is shown at B.

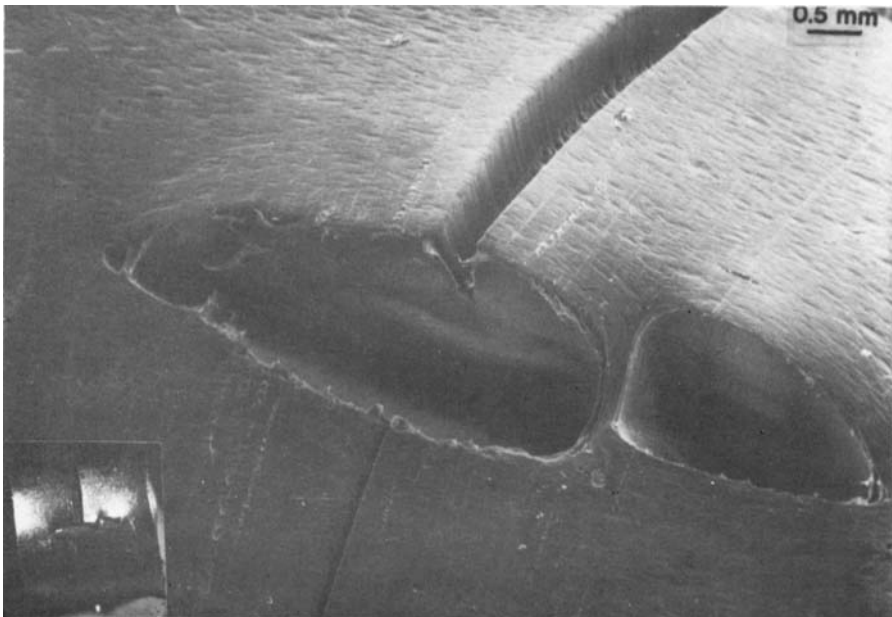
Fig. 4. SEM micrograph of notched portion of lot 2 compressed-ring specimen removed from the Igepal bath during crack formation. Insert: photograph of the same specimen.

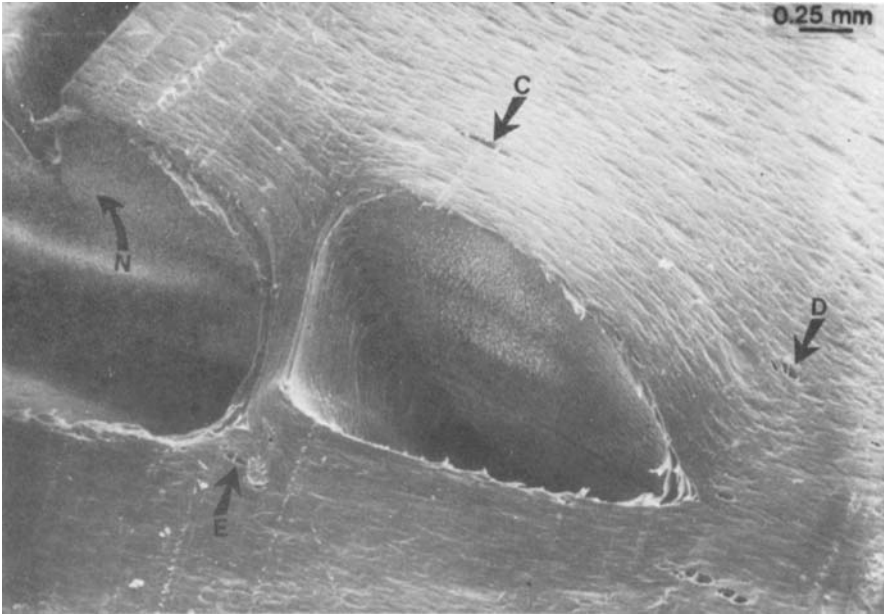
Fig. 5. SEM micrograph of notched portion of lot 2 compressed-ring specimen removed from the Igepal bath during crack formation. Right crack in Fig. 3 is shown at higher magnification. Superficial cracks are shown at C, D, and E.

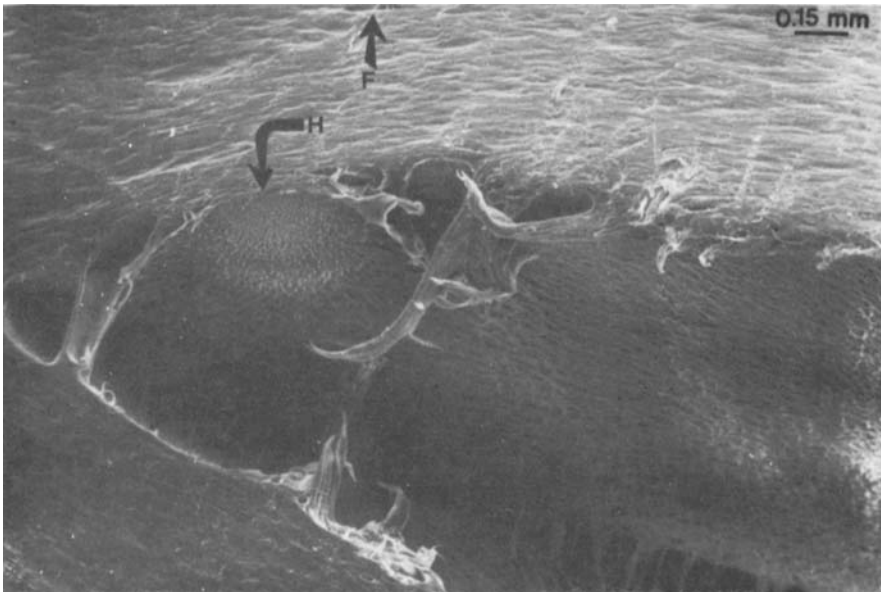
Fig. 6. SEM micrograph of notched portion of lot 2 compressed-ring specimen removed from the Igepal bath during crack formation. Left portion of crack in Fig. 3 shown at higher magnification. Superficial cracks are shown at F and G. Evidence of surface initiation is shown at H.

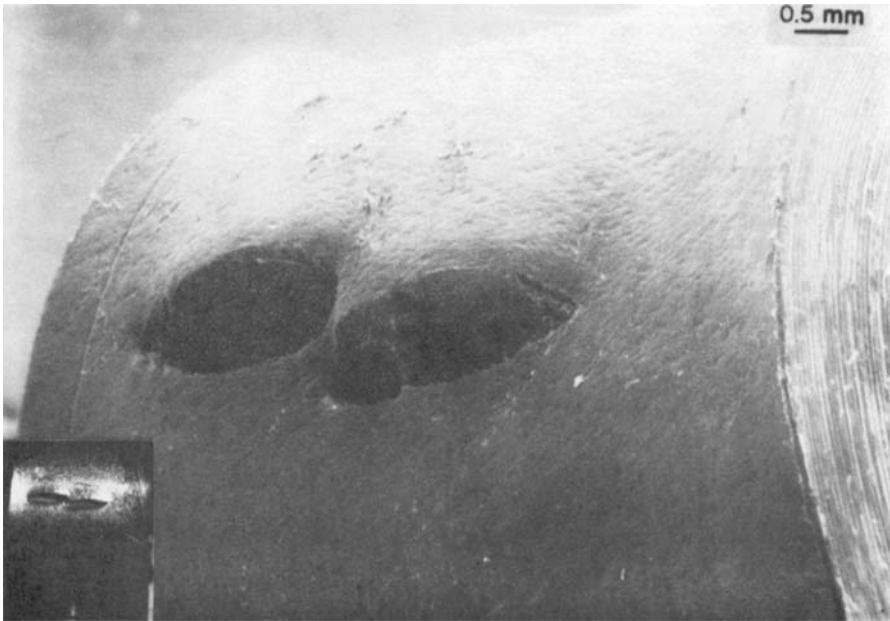
Fig. 7. SEM micrograph of unnotched portion of lot 2 compressed-ring specimen removed from the Igepal bath during crack formation. Insert: photograph of the same specimen.

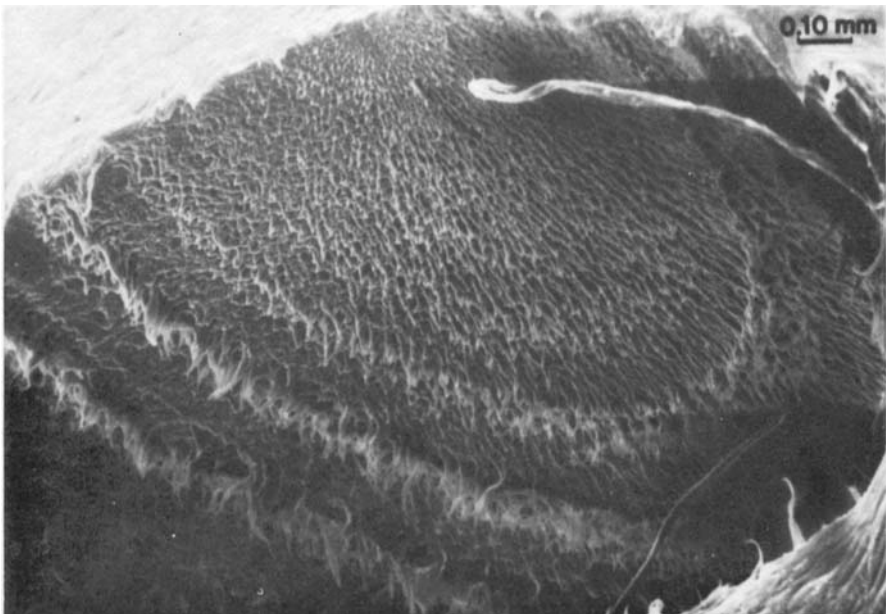
Fig. 8. SEM micrograph of unnotched portion of lot 2 compressed-ring specimen removed from the Igepal bath during crack formation. Left crack in Fig. 7 is shown at higher magnification.

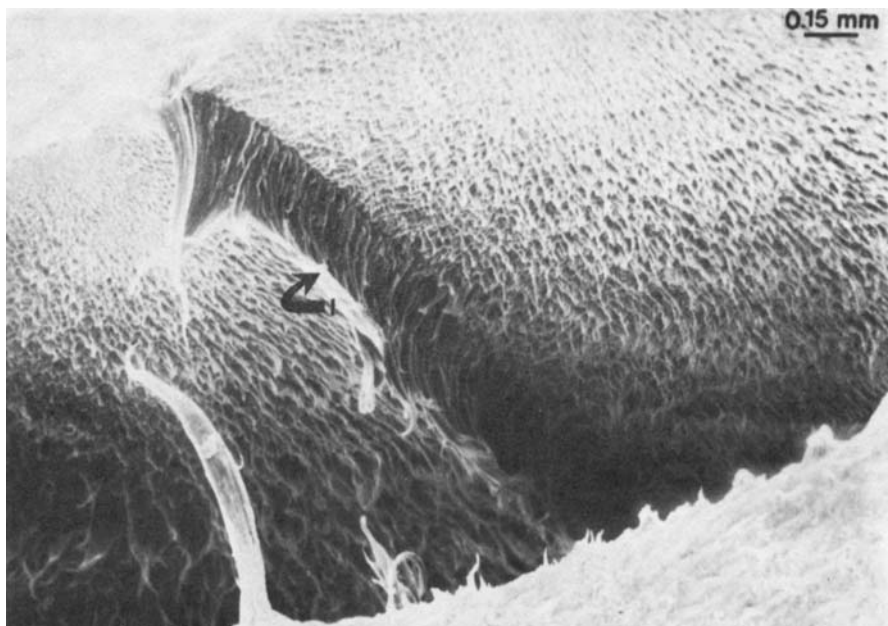
Fig. 9. SEM micrograph of unnotched portion of lot 2 compressed-ring specimen removed from the Igepal bath during crack formation. Right crack in Fig. 7 is shown at higher magnification.

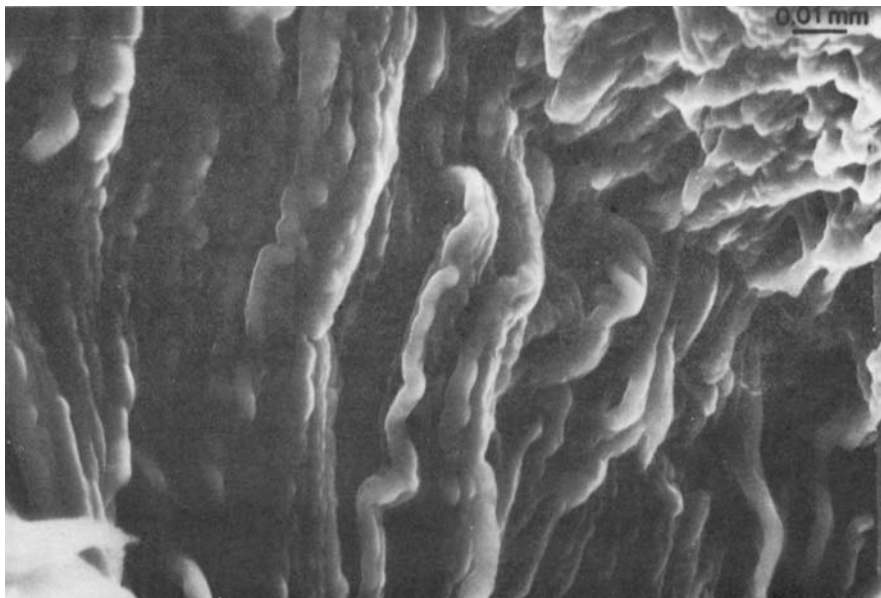
Fig. 10. SEM micrograph of unnotched portion of lot 2 compressed-ring specimen removed from the Igepal bath during crack formation. I region of Fig. 9 is shown in higher magnification.
