Gas Chromatography Problem Solving and Troubleshooting

Question:

The amount of baseline noise in my chromatogram suddenly increased. The GC parameters were not changed, and the sample is the same as before. What caused the sudden increase in the baseline noise?

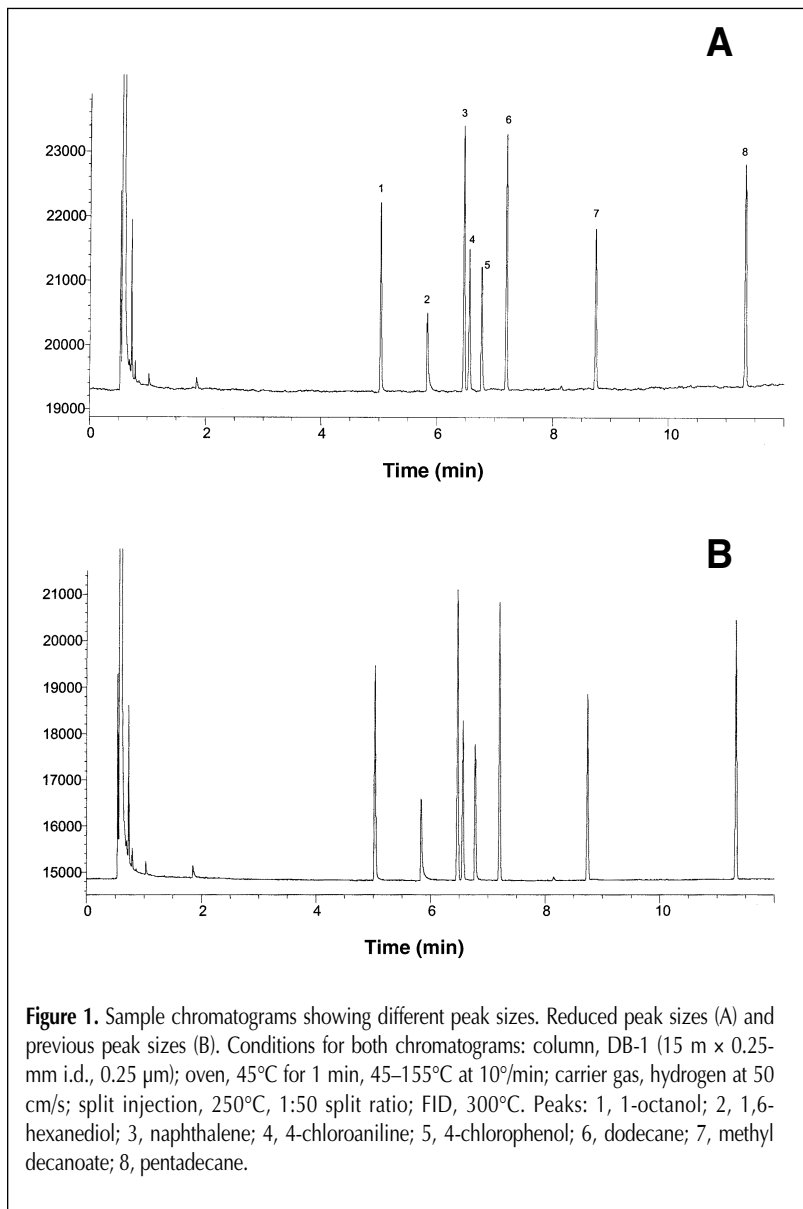
Sometimes, the problem that presents itself can be misleading. In this case, an increase in baseline noise is an example of this type of situation. Careful examination and comparison of the problem chromatogram to a previously acceptable one reveals that the actual problem is more of a decrease in peak height and less of an increase in baseline noise (Figures 1A and 1B). The data system scaled the chromatogram height relative to the tallest peak (note the difference in the scale of the y-axis in Figures 1A and 1B). Because the peaks are smaller, the baseline is magnified, thus the apparent increase in baseline noise. Comparing peak heights or areas shows that the peaks have decreased in size. Simply visually comparing the two chromatograms easily leads to the erroneous conclusion that only the baseline noise increased. The actual problem is a significant decrease in peak size and only a small increase in baseline noise. While there is a small increase in baseline noise, all of the peaks are approximately 35% smaller in the problem chromatogram (Figure 1A) compared with the acceptable chromatogram (Figure 1B). Also, all of the peak sizes decreased by the same amount and not by variable amounts. By identifying the actual problem, finding the source becomes easier.

Figure 1. Sample chromatograms showing different peak sizes. Reduced peak sizes (A) and previous peak sizes (B). Conditions for both chromatograms: column, DB-1 (15 m × 0.25-mm i.d., 0.25 μm); oven, 45°C for 1 min, 45–155°C at 10°/min; carrier gas, hydrogen at 50 cm/s; split injection, 250°C, 1:50 split ratio; FID, 300°C. Peaks: 1, 1-octanol; 2, 1,6-hexanediol; 3, naphthalene; 4, 4-chloroaniline; 5, 4-chlorophenol; 6, dodecane; 7, methyl decanoate; 8, pentadecane.

If a column becomes active and adsorptive, active compounds (i.e., usually hydroxyl or amine-containing compounds) may be adsorbed, thus reducing peak size. Nonactive active compounds such as hydrocarbons are not susceptible to adsorption problems, and their peak sizes are unaffected by an active column. The sample being analyzed contains active and nonactive compounds. Because all of the peaks decreased by the same amount, column activity can be safely ruled out. If the column was active, only the active compounds should have been affected. (peaks 1, 2, 4, and 5 in Figure 1A).

The pressure gauges for the GC in this case were reporting the correct pressures, thus it was assumed that the detector gas flow rates were correct. After eliminating the previously mentioned possible causes and with the lack of other possibilities, a more detailed investigation was performed. One of the procedures was to measure the detector gas flow rates using a flowmeter instead of relying on the pressure gauges. It was discovered that at the recommended and previously used pressure settings, the air flow to the detector was approximately 40% lower than recommended. Upon increasing the pressure to obtain the proper air flow rate (400 mL/min compared with 250 mL/min), the peak sizes and baseline noise returned to the previously obtained values (Figure 1B). The pressure gauge then reported a pressure approximately 50% higher than the one previously used to obtain the same air flow rate. A partial blockage of the gas line in the GC or a faulty gauge or regulator is probably responsible for the reduced air flow rate at the recommended pressure setting.

By making an assumption and faithfully relying on a gauge reading, your initial assessment of the situation was incorrect. It was assumed that the detector air flow rates were correct because the pressure reading was correct. By taking the 15–20 min necessary to check all of the easy and obvious areas, your assumption error would have been quickly revealed and the problem quickly found.
