## CASE REPORT

# An Unusual Case of Death by Lightning

**REFERENCE:** Blanco-Pampín JM, Suárez-Peñaranda JM, Rico-Boquete R, Concheiro-Carro L. An unusual case of death by lightning. *J Forensic Sci* 1997;42(5):942-944.

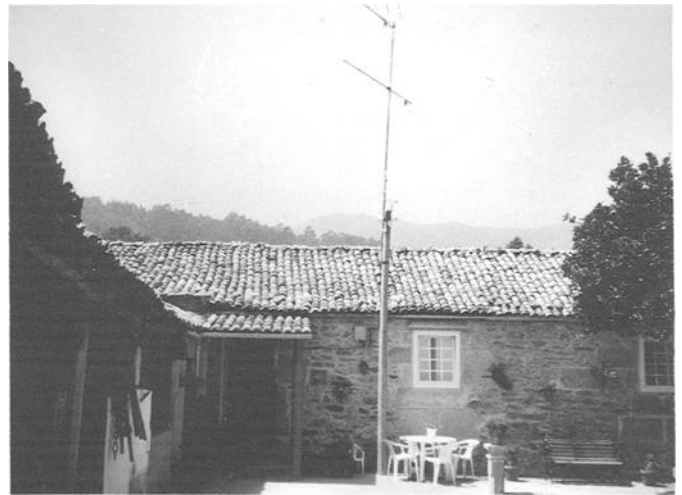
The body was found in an isolated house in a country area which was located upon a wolfram mine (mineral deposit). It had already been struck by lightning two years ago. There was a TV aerial, 8-m high, upon the roof (Fig. 1).

FIG. 1—General view of the house with the TV aerial located in the front yard.

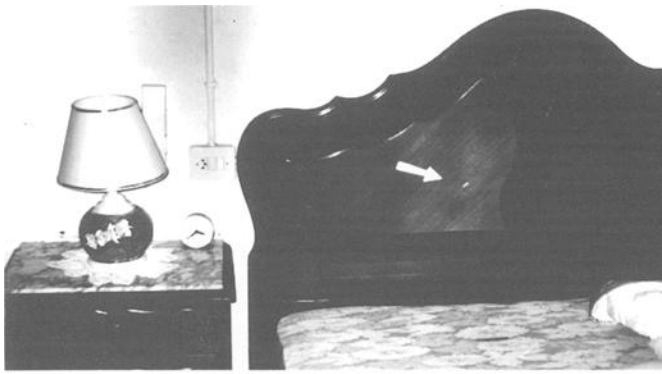
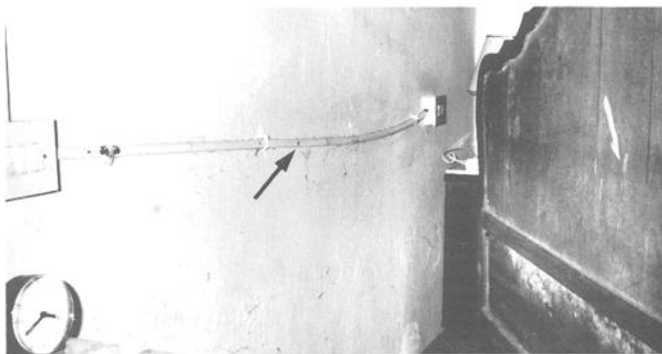
The corpse was lying in a bed in a tidy room. The bed-head was 10 cm away from a wall which had an electric wire, near the surface of the wall but with plastic insulation (Fig. 2).

The wooden bed-head was 2 cm thick and it had an irregular orifice traversing it completely, level with the wire. Some burns were found on the pillow, sheets and mattress (Fig. 3).

FIG. 2—Above: white arrow pointing to the orifice in front of the bed-head. Below: This was perforated and the orifice in the back (white arrow) was related to a defect in the plastic insulation (black arrow).

Carefully examination of the bed-head showed a perforation of about 1 cm in diameter at the level of the electric wire in the wall. This was interpreted as being caused by the lightning penetrating through the wooden bed-head. We had to hypothesize the formation of a "voltaic arc" from the electric wire to the shoulder through the bed-head, burning the pillow and the mattress.

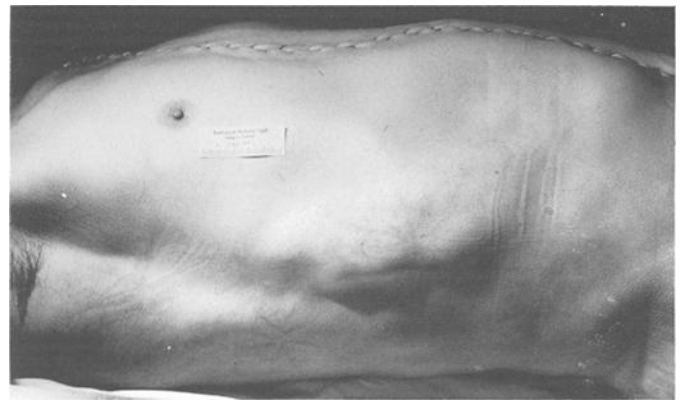
External examination showed a superficial injury (abrasion) in the right shoulder, 1 cm in its largest dimension. "Fern-like" cutaneous marks were found in the upper chest wall and, more intensely around the injury on the right shoulder (Fig. 4). When we examined the corpse, rigor mortis had not been established, but the muscles of both arms were vigorously contracted. Internal examination only revealed visceral congestion, but no other relevant findings were found, including evidence of recent or past cardiac disease. Toxicological investigation was negative.

FIG. 4—"Fern-like" marks in the skin of the right chest wall.

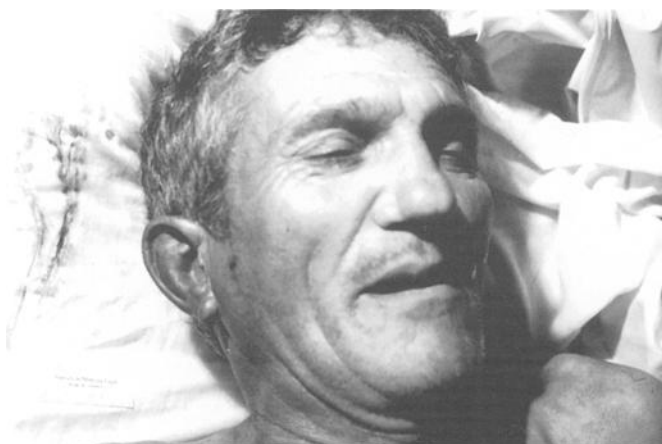
Because the right shoulder was in the line drawn by the burns on the bed, we think that the injury was caused by the discharge and thus should be considered the point of current entry. Under normal conditions, as in over the desert or the sea, electrical current when rising from ground level, increases in the order of 100 V/m. In extreme conditions such as electrical storms, conditions modify enormously causing a dramatic increase in electrical potential. This potential can sometimes reach electrical break (ray) producing highly elevated currents (in the order of 10,000 or more amps) (9). This situation, which matches a pattern of transitory discharge (10) is very dangerous for any person caught under the influence of such highly charged fields, because currents which exceed the threshold permissible for a human being may be induced into the body. Thus, with regard to the subject in question: He became a "floating" potential in the isolated bed, which in itself implies an increase in the existing electrical field (by a factor of 3 or more). Also, the close proximity of the subject to the earth potential (conducting cables which pass behind the headboard of the bed) allowed the induction of an electrical "break" between the individual and the earth potential (spark) as seen in the photographs, hence, a transitory current capable of reaching considerable intensity was produced. This would have been sufficient to cause death in any case.

FIG. 3—Burns in the pillow, at the right of the head, were aligned with the hole in the bed-head and the lesion in the shoulder.
