Fatal Fall of an Aircraft Stowaway: A Demonstration of the Importance of Death Scene Investigation

REFERENCE: Thogmartin JR. Fatal fall of an aircraft stowaway: a demonstration of the importance of death scene investigation. *J Forensic Sci* 2000;45(1):211–214.

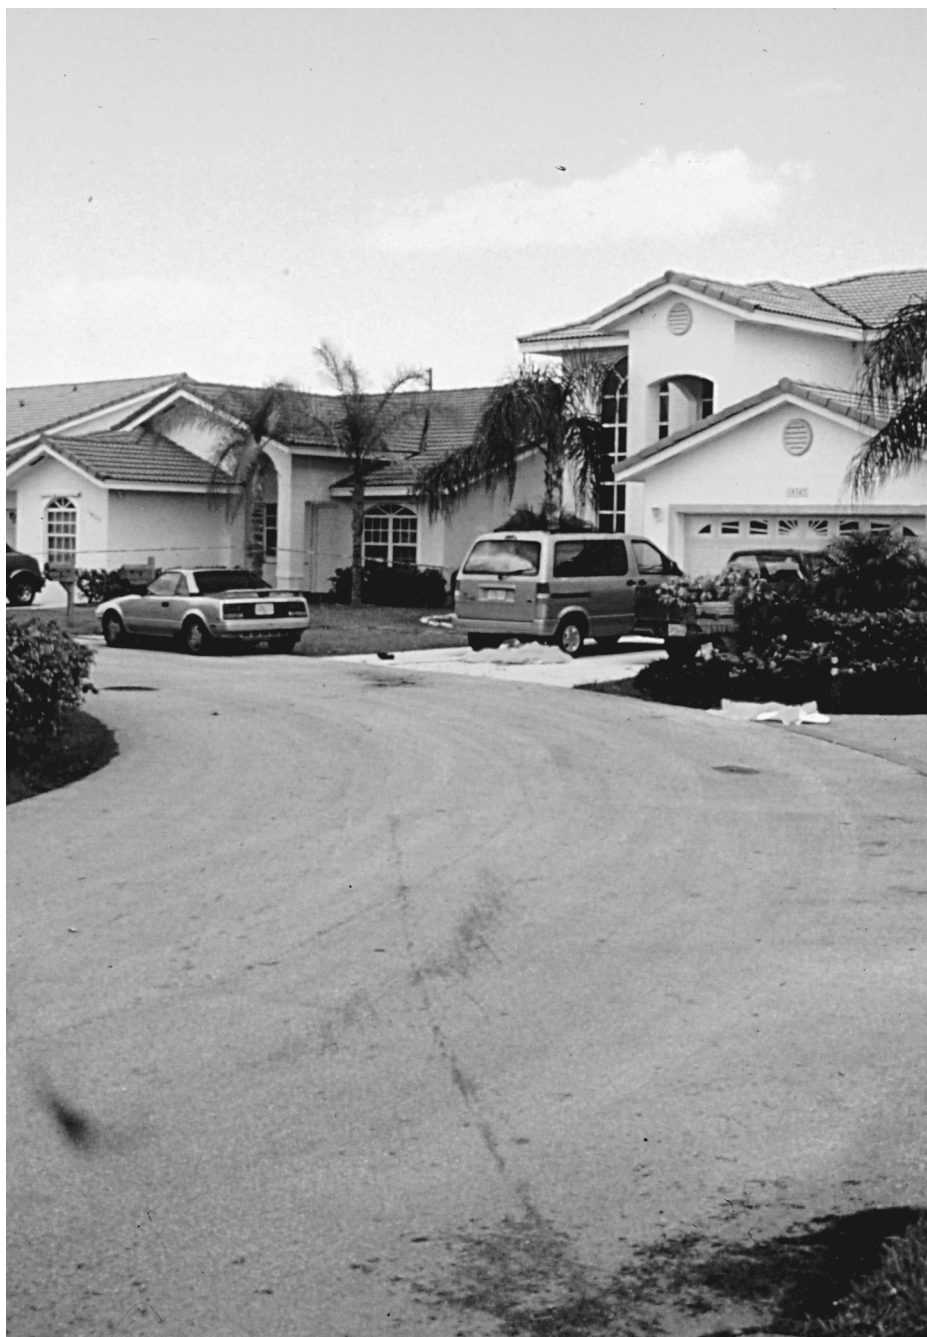
FIG. 1—Scene of the incident with point of impact and body under sheet.

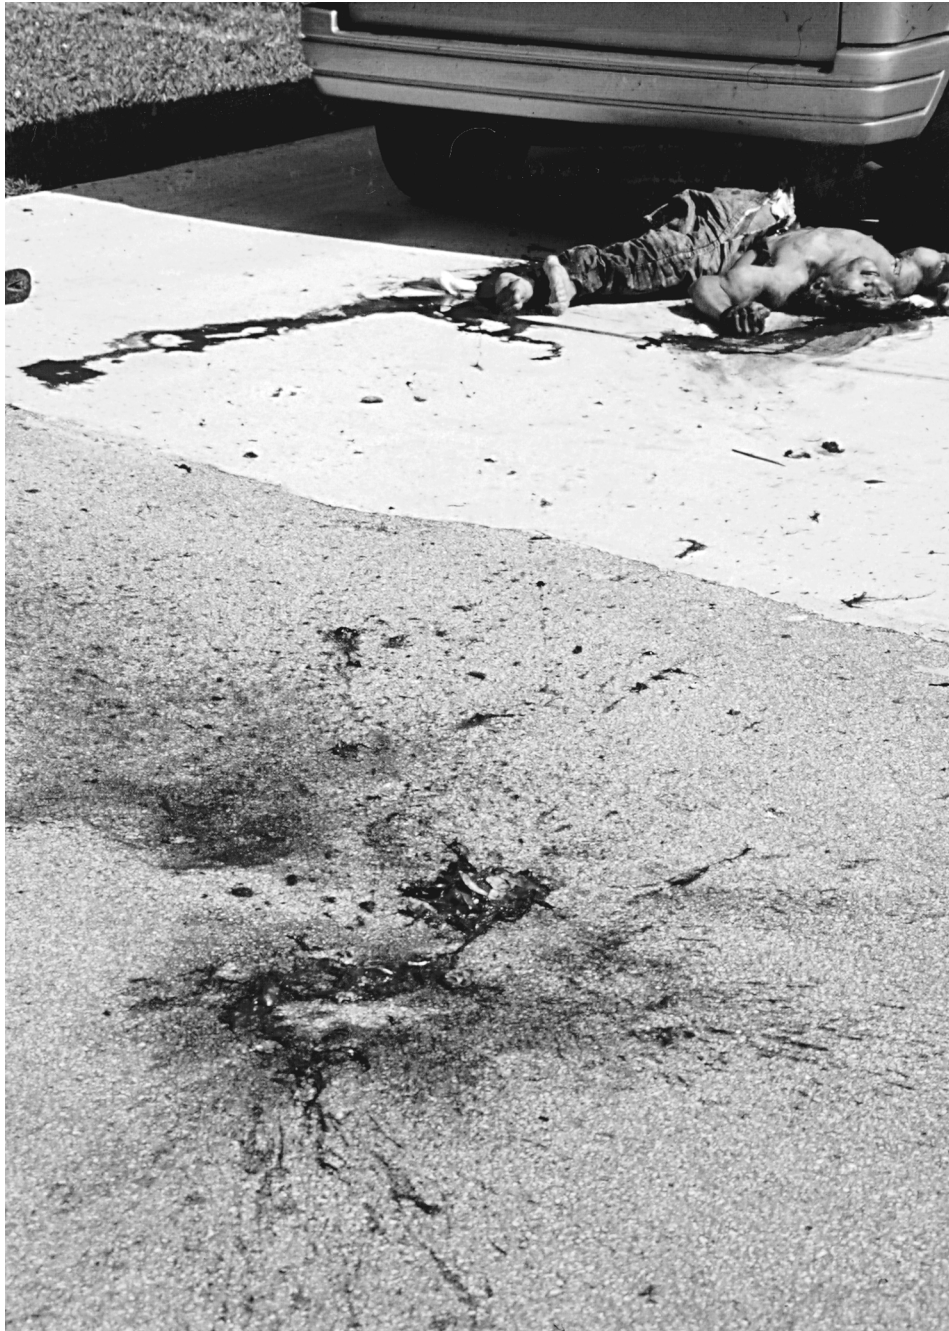
Prior to the arrival of the medical examiner, steps were taken to conceal the body from nearby onlookers and the media by covering it with a sheet. The decedent lay under the sheet on a cement driveway on the north side of an asphalt west to eastbound residential street. Just to the east of the decedent's location, the street made a 90-deg turn to the right. Two automobiles were parked in the driveway in which the decedent lay. Just to the west of the body was a compact car facing west on the right side of the street (see Fig. 1). The automobiles were not involved in the incident. On the north side of the street, approximately 10 ft (3 m) to the east and south of the body, was a collection of blood and tissue, in essence, an unmistakable point of impact (see Fig. 2). Between this point of impact and the body were minimal tissue traces.

FIG. 2—Point of impact with nearby body.

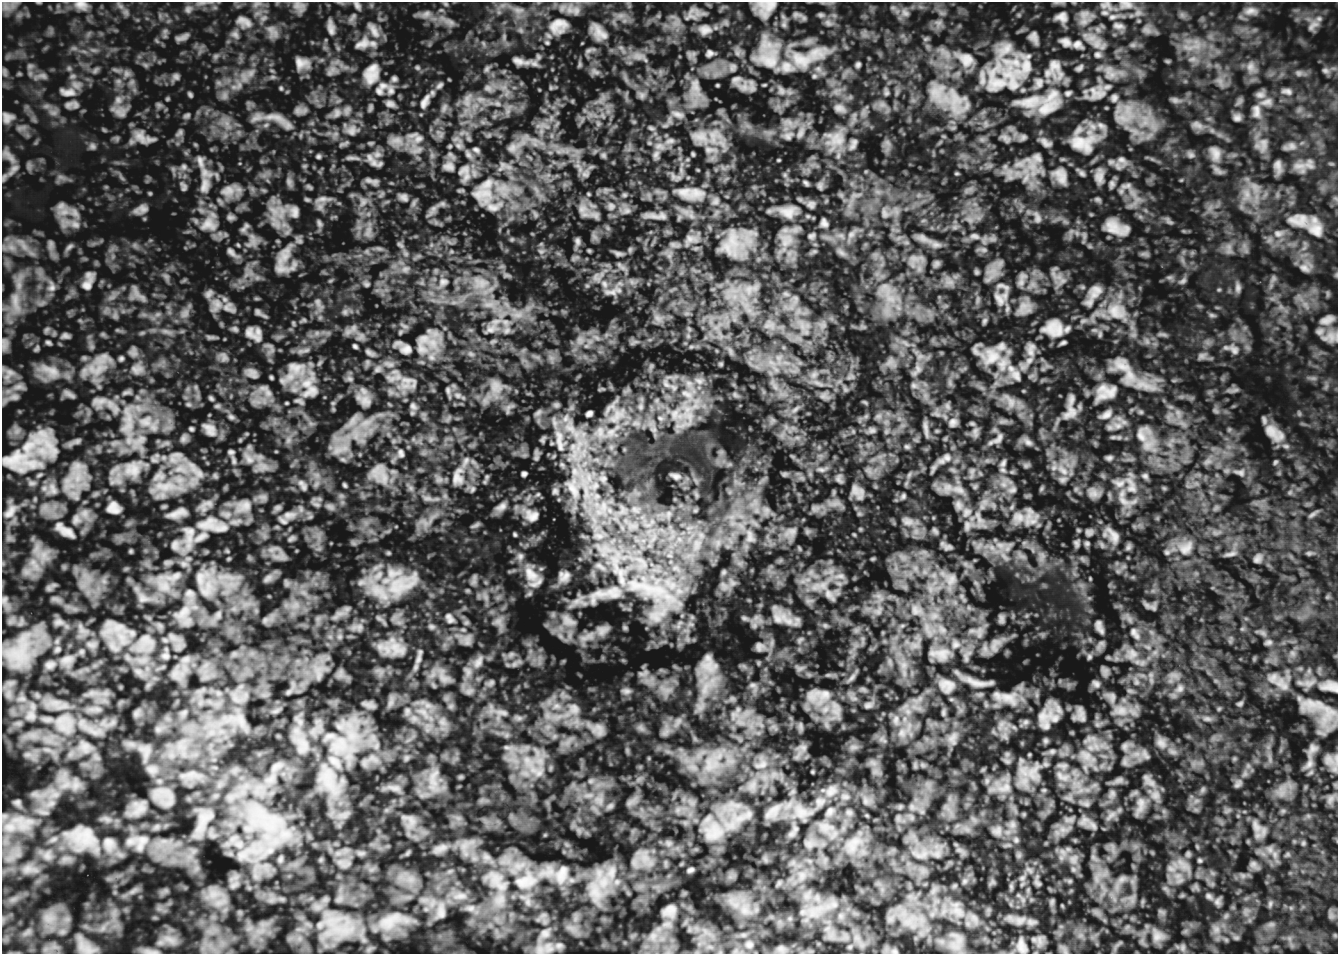
FIG. 3—Close-up of impact site with crater devoid of blood staining (liquid in crater is rainwater).

the gouge marks themselves were free of blood. It was theorized that the gouge marks were produced by bony portions of the body hitting the pavement at the same instant that the body, particularly the head, hit the ground and partially disintegrated (Fig. 3). The minimal blood traces between the site of impact and the body is inconsistent with a traffic incident and more consistent with a fall and subsequent "bounce."

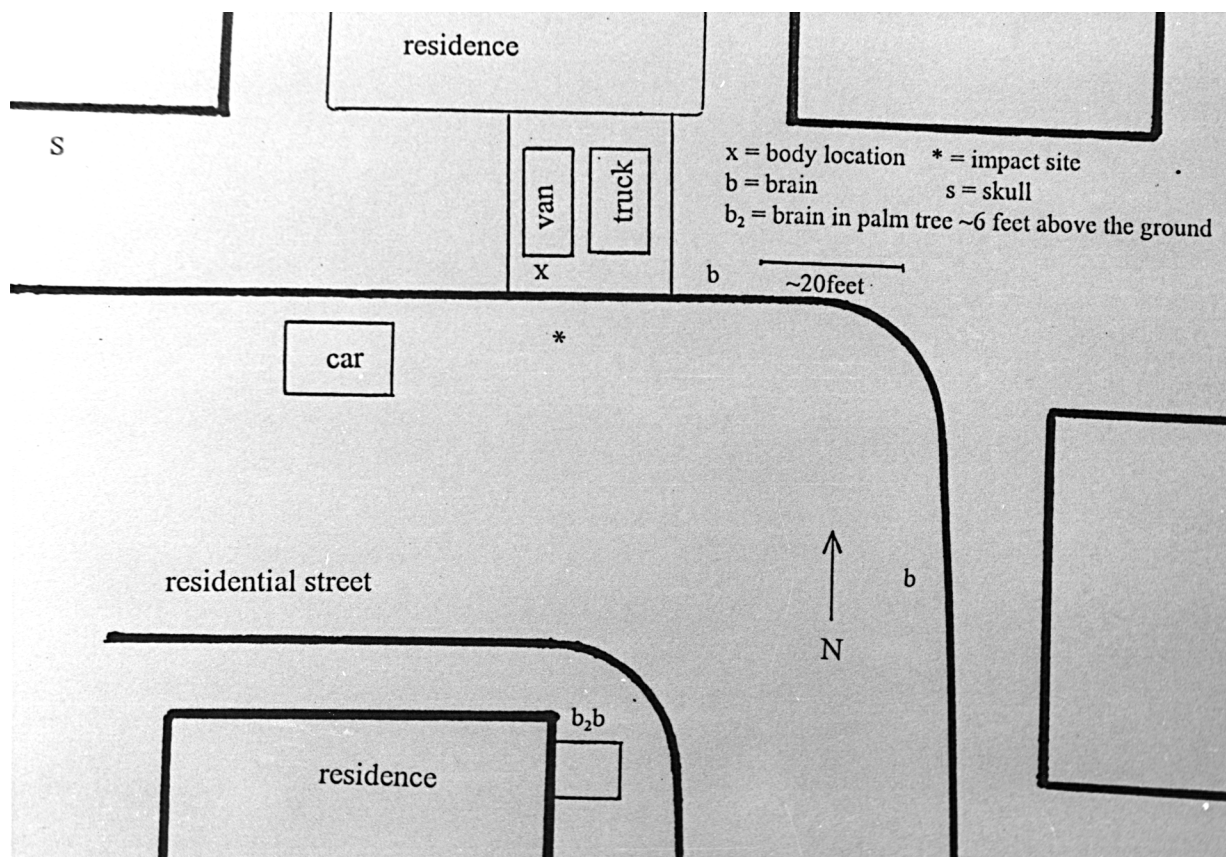
A skull fragment was found on a front porch of a house located approximately 70 ft (21 m) from the body. Brain matter was found 6 ft (1.8 m) off the ground in a palm tree across the street from the body (40 ft (12 m) away). Other pieces of brain matter were found 60 ft (18 m) down the street (clearly coming from the impact site) and on a nearby mailbox (3 ft (0.9 m) off the ground). A piece of muscle with attached tendon was found on the driver's side mirror of one of the adjacent driveway automobiles and a piece of dura mater was found in the back of another nearby automobile (a pickup truck). Minute fragments of brain matter were found on nearby vegetation. These bone and tissue fragments were dispersed in all directions originating at the point of impact (see Fig. 4).

FIG. 4—Schematic diagram of street, surrounding structures, point of impact, and body location (scale approximate).
