Comparison of Corrosion-Fatigue Properties of 6013 Bare, Alclad 2024, and 2024 Bare Aluminum Alloy Sheet Materials

J. Chaudhuri, Y.M. Tan, K. Patni, and A. Eftekhari

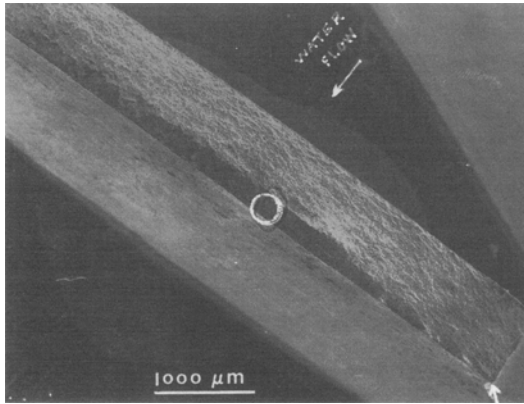
The Alclad 2024 specimen exhibited a relatively smooth fracture surface and had only one primary crack origin site at the notch. No corrosion damage was observed adjacent to the crack

origin site (Fig. 5 through 7). The soft Alclad layer was primarily responsible for the fatigue initiation.

Fig. 5 Scanning electron micrograph of the Alclad 2024 fracture specimen indicating uniform fracture surface features and the crack origin site as marked by the arrow. See Fig. 6 for the enlarged view of the crack origin area and Fig. 7 for the enlarged view of the circled area. Magnification 20 \times .

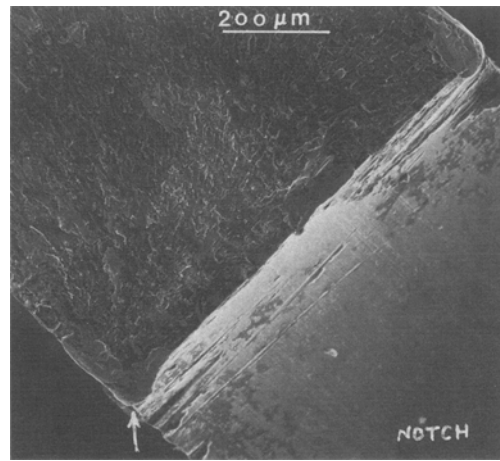
Fig. 6 Enlarged view of the crack origin area identified in Fig. 5 showing no indication of corrosion pitting (Alclad 2024). Magnification 100 \times .

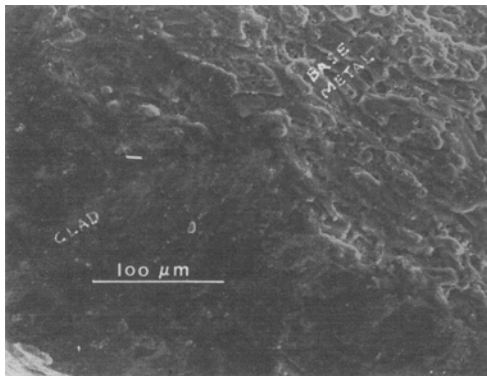
Fig. 7 Magnified view of the region inside the circle in Fig. 5. The base metal fracture surface did not show any evidence of damage by corrosion (Alclad 2024). Magnification 300 \times .

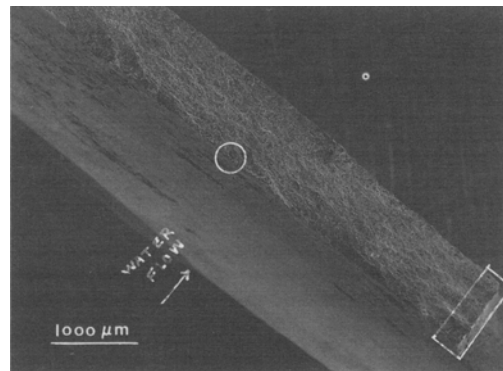
The 2024 bare specimen fracture surface had a rougher surface when compared to that of the Alclad 2024 and had multiple crack origin sites at the notch as well as at the specimen surface. It did not exhibit distinct steps. Corrosion pits were observed at the notch as well as on the specimen surface. Fatigue initiation was found to occur from these corrosion sites (Fig. 8 through 10).

Fig. 8 Scanning electron micrograph of the 2024 bare fracture surface indicating multiple origin sites at the notch and on the specimen surface. Some crack origin sites were present at the opposite side of the notch also. See Fig. 9 for the enlarged view of the notch and the fracture surface adjacent to it marked by the rectangle. Also, see Fig. 10 for the enlarged view of the circled area. Magnification 20 \times .

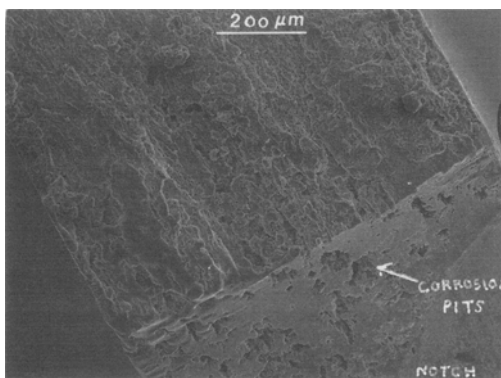
Fig. 9 Enlarged view of the region inside the rectangle shown in Fig. 8, indicating corrosion damage at the notch and on the fracture surface adjacent to the notch (2024 bare). Magnification 100 \times .

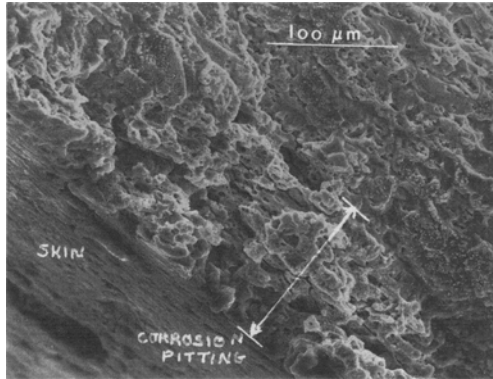
Fig. 10 Scanning electron micrograph of the region inside the circle in Fig. 8 showing corrosion pitting at the specimen surface (2024 bare). Magnification 300x.

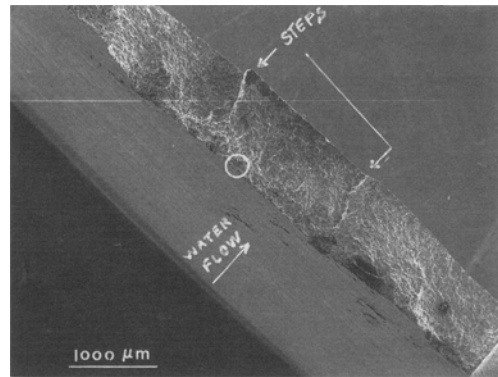
The 6013 specimen fracture surface had three distinct steps resulting from the initiation and propagation of multiple cracks.

The corrosion damage occurred mainly on the water inlet side almost along the whole width of the specimen. High magnification examination showed that the corrosion was intergranular. Figures 11 through 13 show the fracture surface features of the 6013 specimen.

Fig. 11 Scanning electron micrograph of the 6013 bare fracture surface. The fracture surface exhibits steps, which indicate that the fracture occurred by the coalescence of the cracks initiated from multiple crack origin sites. See Fig. 12 for the enlarged view of the notch and Fig. 13 for the enlarged view of the circled area. Magnification 20x.

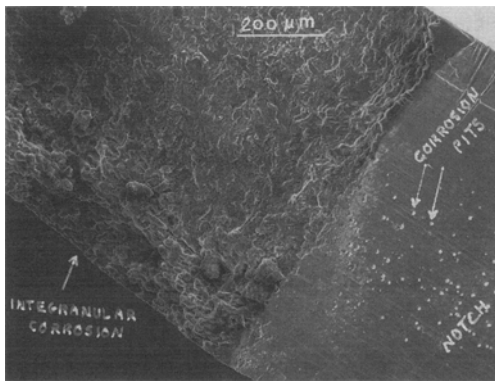
Fig. 12 Scanning electron micrograph of the fracture surface near the notch of the 6013 bare alloy showing corrosion pits at the notch. Magnification 100x.

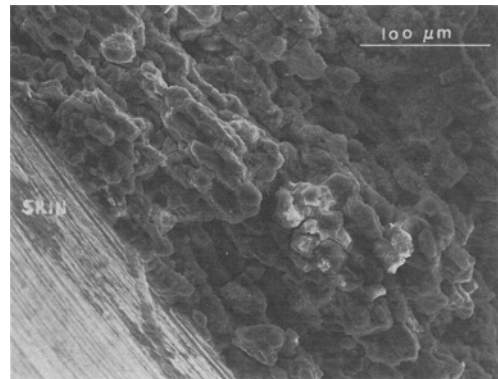
Fig. 13 Scanning electron micrograph of the region inside the circle in Fig. 11 showing intergranular corrosion adjacent to the specimen surface in the 6013 bare alloy.

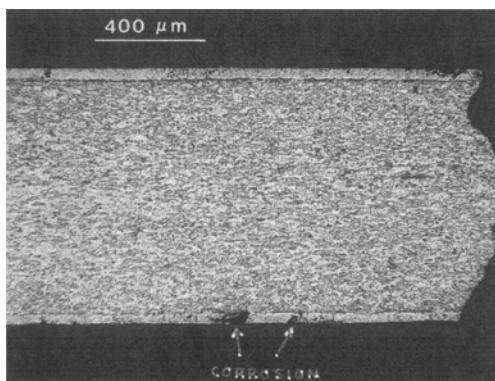
examination. The specimens were cross-sectioned at the location of maximum corrosion damage and metallurgical mounts were prepared. The microstructural examination showed that the corrosion did not penetrate completely through the cladding in the Alclad 2024 sample (Fig. 14). The 2024 bare sample had a number of transgranular corrosion pits on either side of the specimen thickness (Fig. 15). The depth of most severe corrosion pit in this sample was 0.007 in. The 6013 bare sample showed heavy intergranular corrosion damage to a depth of about 0.014 in. (Fig. 16). The heavy corrosion damage had occurred at the water inlet side of the specimen.

Fig. 14 Optical micrograph of the Alclad 2024 microsection showing no significant corrosion damage to the base metal. The microstructure also showed the grain size of the material finer than typically observed. Magnification 62.5x.

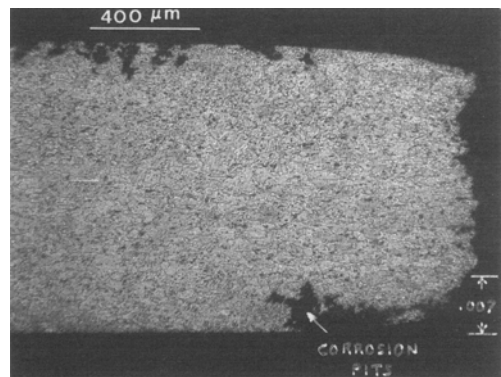
Fig. 15 Optical micrograph of the 2024 bare microsection showing large corrosion pits on both sides. It also showed the grain size of the material finer than typically observed. Magnification 62.5x.

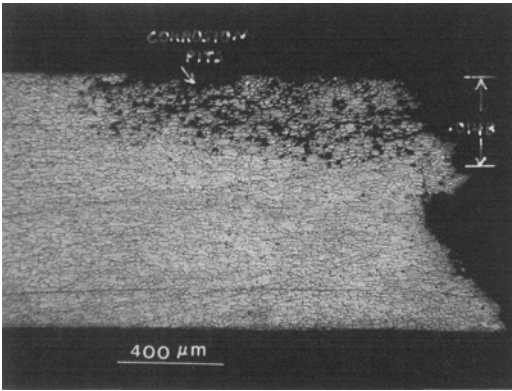
Fig. 16 Optical micrograph of the 6013 bare microsection showing corrosion pits and intergranular corrosion, which has penetrated about 30% of the specimen thickness. Magnification 62.5 \times .
