# Fracture Surface Analysis in HDPE Pipe Material Fatigued at Different Temperatures and Loading Frequencies

Zafarullah Khan

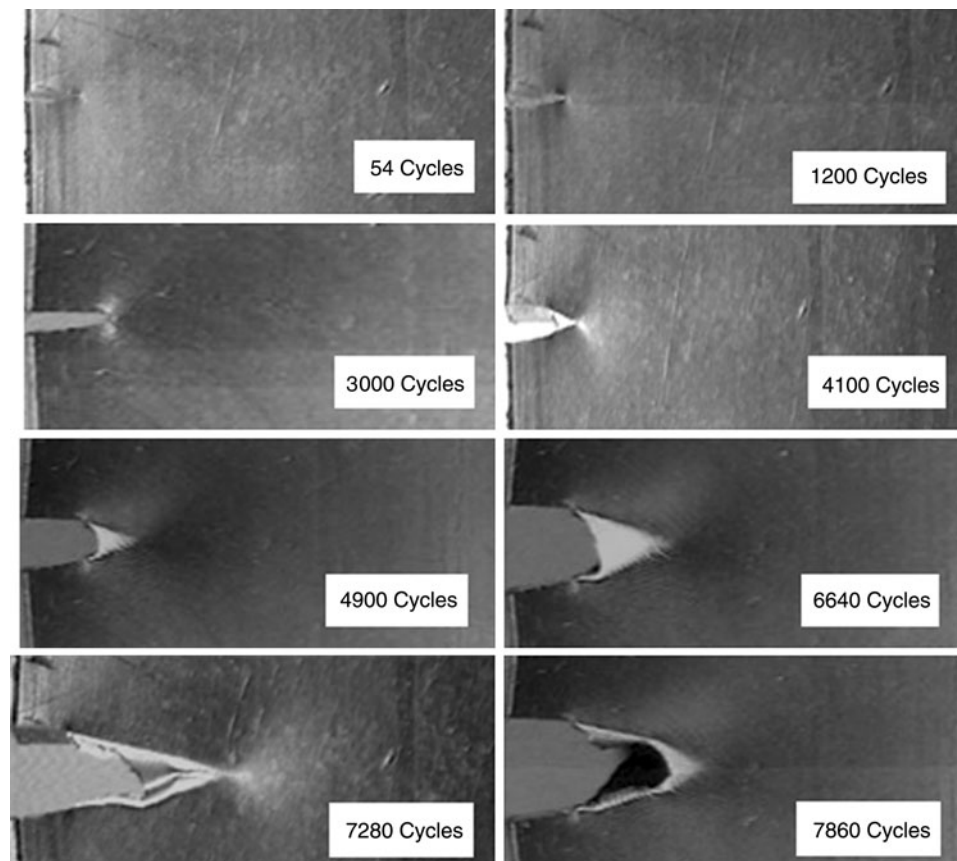
**Fig. 1** Macroscopic views of the development of craze zone and craze zone membrane in HDPE sample fatigued at  $23$  °C and at test frequency of 1 Hz

Similar to many other polymers, the progress of fatigue fracture in HDPE also takes place with the formation and rupture through initial shear yielding and subsequent crazing process. The series of optical photographs captured during the fatigue testing (see Fig. 1) provides evidence of such a fracture process in a HDPE sample fatigued at a temperature of 23 °C and a test frequency of 1 Hz. The first fully developed craze zone appears at around 3000 cycles. A thick membrane, which consists of highly stretched fibrils, can be seen developing at the crack tip. This membrane keeps the two fracture surfaces connected until the craze zone fractures develop to complete the crack-growth step. As it is evident from examination of Fig. 1, the crack growth occurs by formation of craze zone and craze zone rupture through dismemberment of the stretched fibrils of the stretched craze zone membrane.

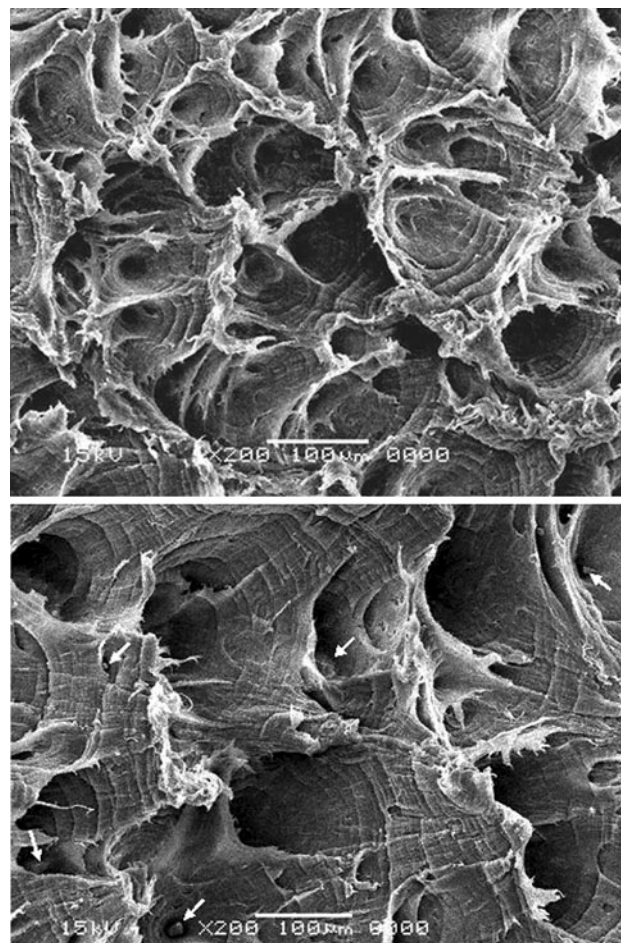
The SEM fractographs in Fig. 2(a) and (b) show the fracture surface morphology of a HDPE specimen fatigued at 23 °C at a test frequency of 1 Hz. These fractographs were taken at different positions along the crack path.

The fractograph shown in Fig. 2(a) displays an area of approximately 4 mm from the starter notch, with the fracture surface providing clear evidence of a crazing process originating from multiple sites. The fracture surface examination suggests that the crazing process proceeds with crack arrests during the intermittent craze zone fibril formation and fracture. The fractograph (Fig. 2b) which is taken at a distance of approximately 8 mm from the machined notch shows small filler material particles at the bottom of the micro-voids

**Fig. 2** SEM fractograph showing the fatigue fracture process in HDPE sample fatigued at 23 °C and at a frequency of 1 Hz: (a) 4 mm from the notch, and (b) 8 mm from the notch. The arrows in (b) point at the filler material particles

suggesting that these may have in fact acted as hard and brittle stress raiser particles within a ductile matrix and promoted micro-void formation. The filler materials (such as CaCO<sub>3</sub>) are commonly added to HDPE pipe material to enhance physico-chemical properties by improving crosslinking and inhibit swelling (Ref 29, 30). The role of such filler material particles in the fracture have also been reported by other researchers (Ref 21). Figure 2(b) also show crack-arrest markings on the fracture surface, which indicate that the crack growth at this stage occurs through a fully developed crazing process.

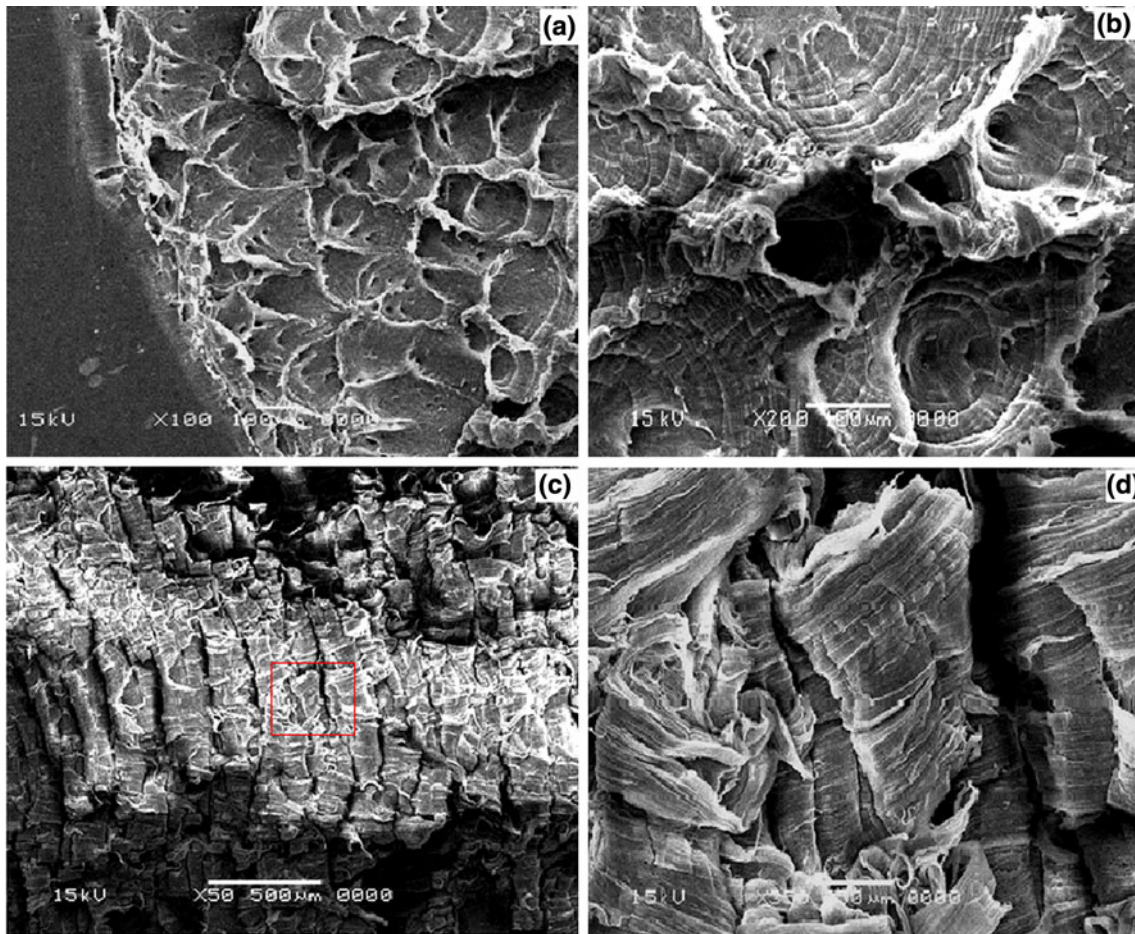
A change in the test frequency from 1 to 50 Hz at the temperature of 23 °C resulted generally in similar two stages in the crack-growth process. The region immediately adjacent to machined notch exhibited a shear yielding damage marked by cellular structure and matted down shear regions (Fig. 3a). However, at this frequency, it appears that more material has been drawn into the plastic zone ahead of the crack tip than that occurs at 1 Hz. At 2 mm from the machined notch, the fracture surface shows clear crack-arrest markings indicating an early onset of the fracture process through micro-void formation, multiple crazings, and fibril scission (Fig. 3b). The fracture surface, however, shows some areas especially at the edges of the micro-voids, where the drawn material may have experienced excessive temperature rise, which may have resulted in localized melting of the fibrils.

**Fig. 3** Series of SEM fractographs showing the fracture surfaces in HDPE sample fatigued at 23 °C and 50 Hz: (a) Shear yielding at the notch, (b) at 2 mm, (c) at 5 mm, and (d) higher magnification view of the boxed area of (c)

Such melting has also been reported for the HDPE by Brough et al. (Ref 31) in their study of fast fracture of HDPE under impact loading. Melting of the fibril material is a result of the elevation of the temperature due to crack-tip hysteresis heating expected at high-frequency cyclic loading. At a distance of approximately 5 mm from the notch (Fig. 3c), the fracture surface shows a craze deformation zone where crack arrest seems to have resulted in secondary cracking. It is expected that thermal softening of the material would result in highly deformed material in the damaged zone and would be unable to transfer the load from one deformation zone to the next, which would lead to concentration of the stress locally at the previous crack-arrest zone and cause the discontinuity to form. A clear evidence of thermal softening and melting of the polymer fibrils could be seen in the higher magnification fractograph (Fig. 3d) of the boxed area of Fig. 3(c). The figure shows several areas where heavily drawn fibrils have fused together as a result of such thermal softening and melting.

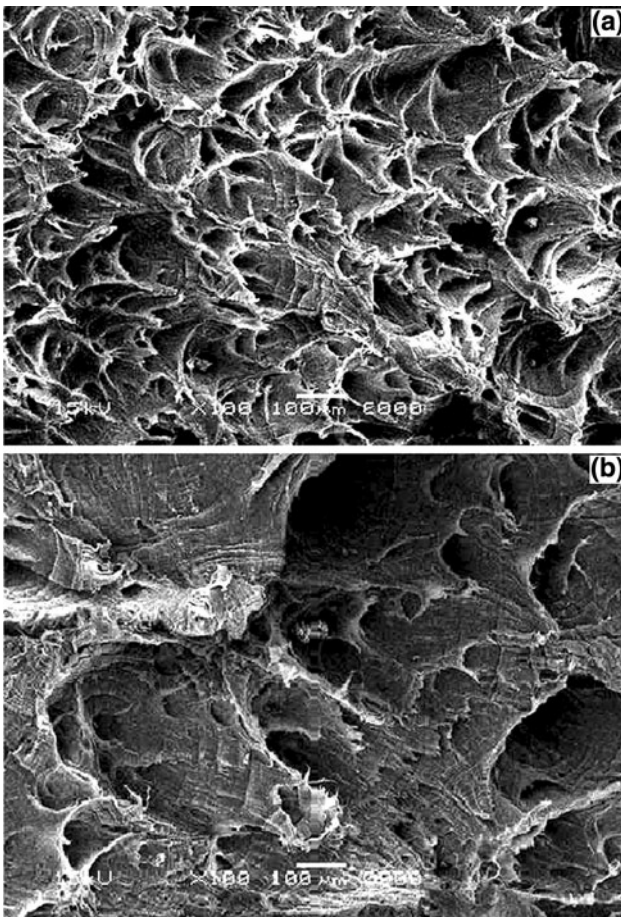
When the test frequency is changed to 0.1 Hz, the fracture surface appears somewhat different than what was observed at the other two frequencies of 1 and 50 Hz. A comparatively flatter surface spans most of the fatigue fracture zone (Fig. 4a). The crack growth appears to have involved a mixed shear and crazing process. The heavily drawn material seen on the fracture surface and less pronounced cavitation

suggests that the crack growth at the frequency of 0.1 Hz may have progressed predominantly by a shear yielding process rather than by crazing (Fig. 4b). This observation is supported by the absence of extensive crack-arrest markings on the surface as were observed at the other two frequencies of 1 and 50 Hz.

**Fig. 4** SEM fractographs showing the fatigue fracture process in HDPE sample fatigued at 23 °C and a test frequency of 0.1 Hz: (a) Shear yielding and crazing at the notch and (b) 8 mm from the starter notch

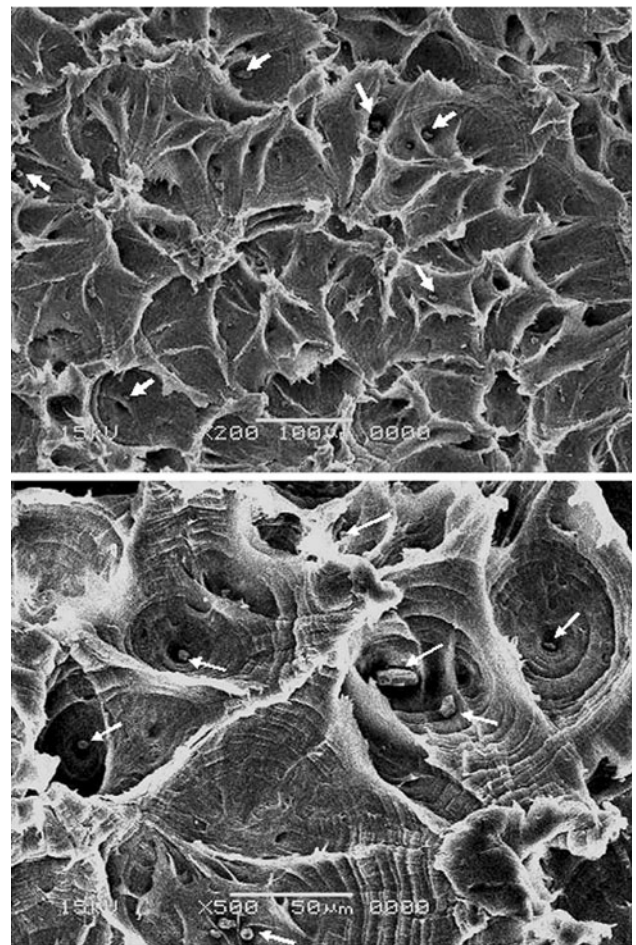
At 0 °C and a test frequency of 1 Hz the fracture surface has features representing a much less ductile fracture than observed at 23 °C. Figure 5(a) represents an area approximately 4 mm from the notch. A rather flat-faceted fracture surface morphology points at the fact that the material assumes a somewhat brittle character at the lower temperature of 0 °C.

The crack growth at 0 °C, however, still occurs by a mixed-mode shear yielding and crazing process as evidenced from extensive cavitation and crack-arrest markings on the fracture surface seen in Fig. 5(b). The role of the second-phase additive brittle particle in providing the stress concentration sites for micro-void formation can also be clearly seen in this figure.

**Fig. 5** SEM fractographs showing the fatigue fracture process in HDPE sample fatigued at 0 °C and a test frequency of 1 Hz: (a) 4 mm from the notch, and (b) cavitation and crack arrest at 8 mm. The arrows point at the filler material particles

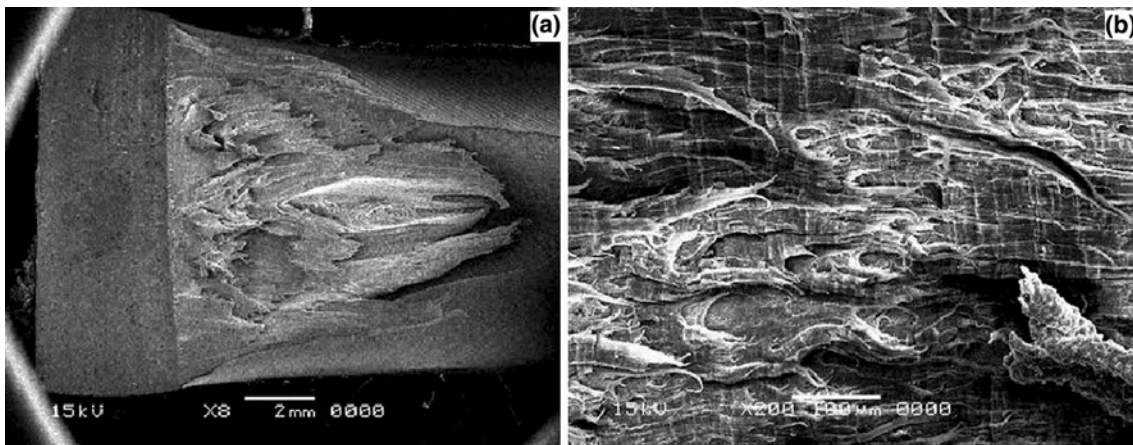
The samples tested at 40 °C and a test frequency of 1 Hz exhibit rather gross yielding of the bulk material as shown in Fig. 6. The test sample has experienced extensive necking at a test temperature of 40 °C. The fracture surface is rather flat and featureless, and provides no evidence that the fracture process has involved the typical shear yielding or crazing. A magnified view of the region adjacent to the machined notch reveals a

**Fig. 6** SEM fractographs showing the HDPE sample fatigued at 40 °C and a frequency of 1 Hz: (a) Gross yielding and (b) magnified view of the fracture surface near machined notch

very rapid crack-growth process with a fewer localized crack arrests during the growth process.

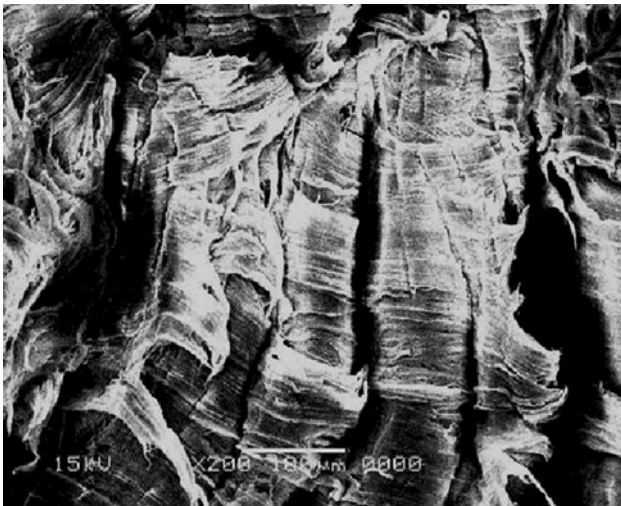
At higher frequency of 50 Hz, the fracture surface of a specimen fatigued at 40 °C provides clear evidence that the

crack growth predominantly involves a crazing process (Fig. 7). It is also interesting to notice that, at this high-frequency hysteresis, crack tip heating has caused localized fibril softening and melting as evident from Fig. 7.

**Fig. 7** SEM fractograph showing the HDPE sample fatigued at 40 °C and a frequency of 50 Hz
