Stress corrosion cracking of GRP pultruded rods in acid environments

B.NOBLE^{*}, S. J. HARRIS^{*}, M. J. OWEN[†]

*Department of Metallurgy and Materials Science and [†]Department of Mechanical Engineering, University of Nottingham, Nottingham, UK

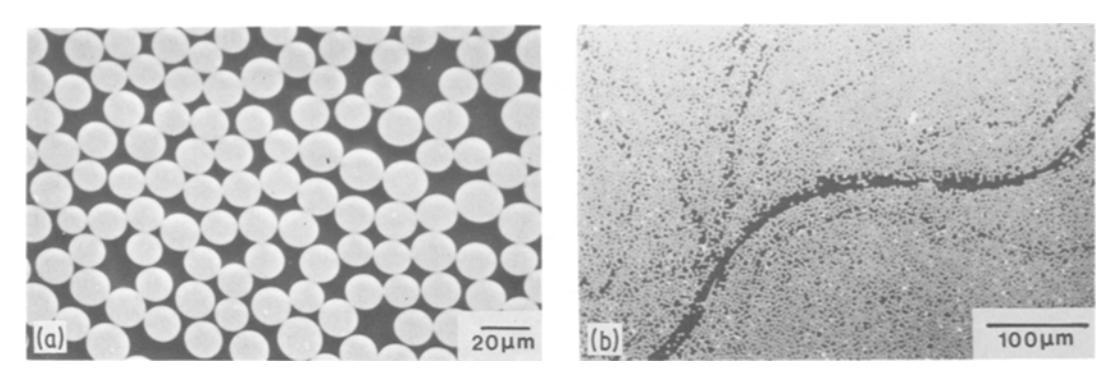
Figure 1 (a) Microstructure of the pultruded rod showing high volume fraction of glass fibre, and (b) resin-rich areas in the pultruded rod.

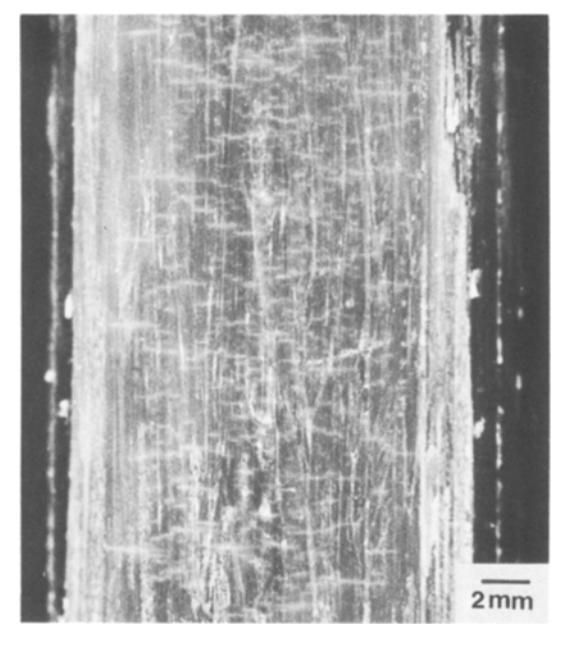
Figure 3 Transverse cracking on the surface of a GRP pultruded rod subjected to a stress of 207 MN m⁻² in an environment of 0.01 N hydrochloric acid for a time of 64 h. Magnification \times 3.

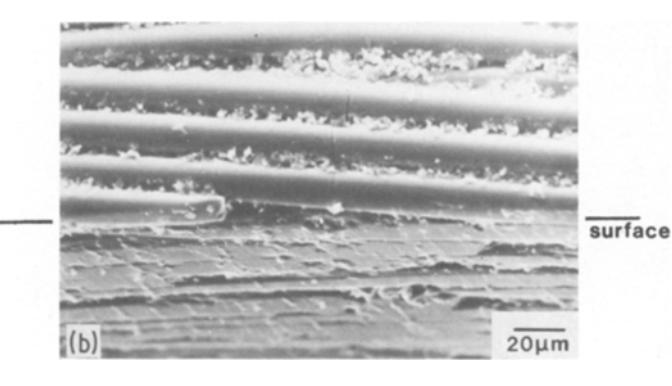
Figure 4 (a) Cracking of surface fibres after bend testing at a stress of 207 MN m^{-2} in 0.01 N hydrochloric acid for 16 h, and (b) axial section of specimen shown in (a) showing that surface cracks are restricted to a single fibre depth.

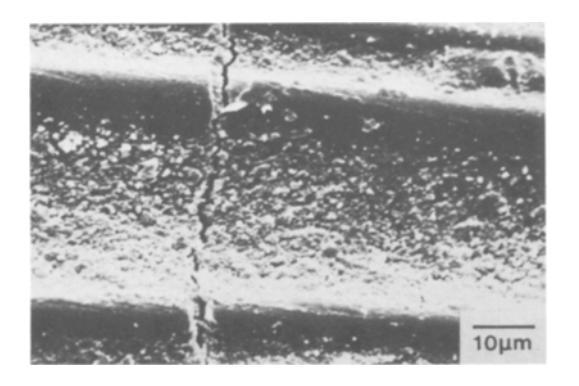
In the case of the 64 h specimen the transverse cracks are well developed. On the surface their apparent length is similar to the diameter of individual rovings and at this stage of testing cracking can now be observed in the resin as well as the glass fibres (Fig. 5). Axial sections of the rod reveal crack penetration for distances up to 150 fibre diameters (3 mm), as shown in Fig. 6a. It was noted that where misalignment occurred between adjacent rovings, the crack was sometimes deflected from its planar path (e.g. at a depth of 10 fibres in Fig. 6a). Where fibres were well aligned or in close proximity to one another the crack propagated in a very planar manner (Fig. 6b). Examination of the crack-tip region showed the crack opening to be small and that cracks had only partially propagated through fibres (Fig. 6c). There was also evidence that fibres may have cracked before failure of the resin occurred.

Figure 5 Transverse crack running through fibre and resin in a rod bend-tested for 64 h at a stress of 207 MN m^{-2} in 0.01 N hydrochloric acid.

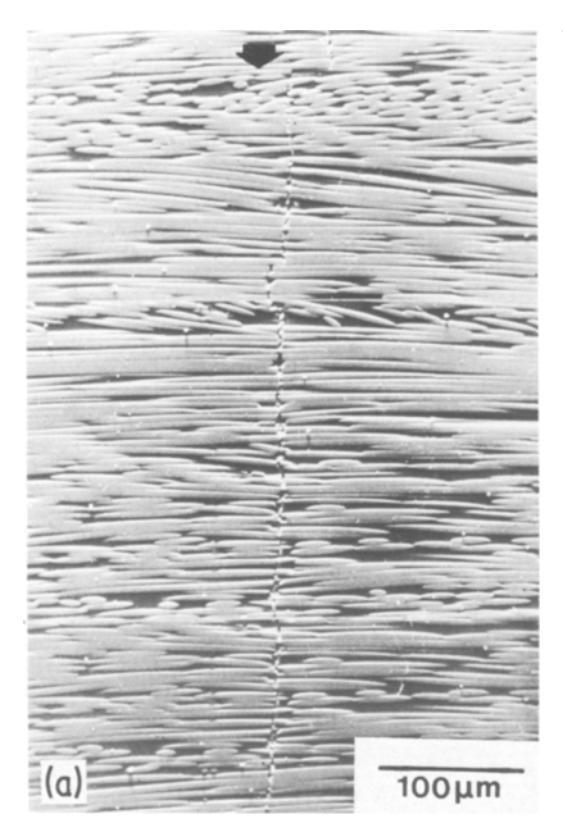
Figure 6 (a) Axial section of a rod bend-tested for 64 h at a stress of 207 MN m⁻² in 0.01 N hydrochloric acid. The transverse cracks extend up to 150 fibre diameters into the rod. (b) High magnification micrograph of axial section of a rod bend-tested in 0.01 N hydrochloric acid, showing the very planar nature of the fracture as the crack propagates from fibre to fibre. (c) Crack tip of the fracture shown in (b) showing cracking of fibres ahead of resin failure.

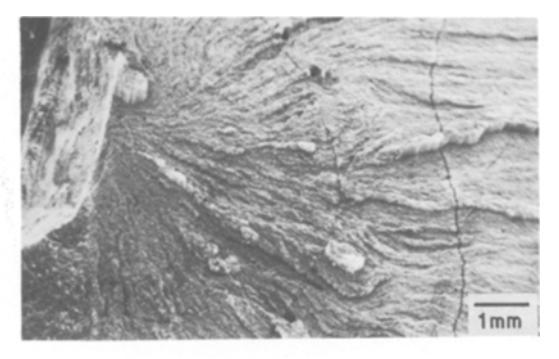
Figure 9 Detail of river markings on the fracture surfaces.

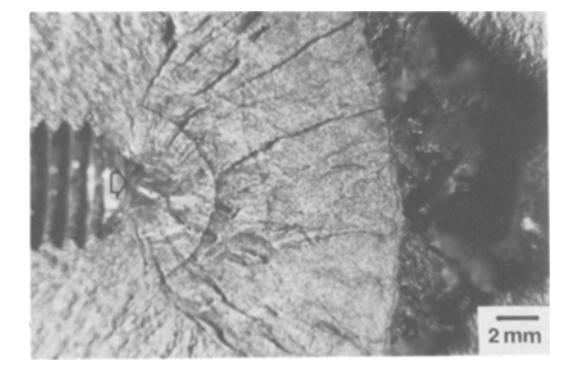
Samples that were encapsulated to produce acid attack at a localized region resulted in a fracture face that was very flat, the crack having propagated in a plane perpendicular to the rod axis. River markings are present on the fracture surface and these run towards the origin of fracture (Fig. 8).

Figure 8 Fracture surface of rod that has been tensiontested to complete failure (5 N HCl). The sample has been encapsulated with cycloaliphatic resin to restrict acid contact to one localized area (arrowed). Magnification \times 2.5.

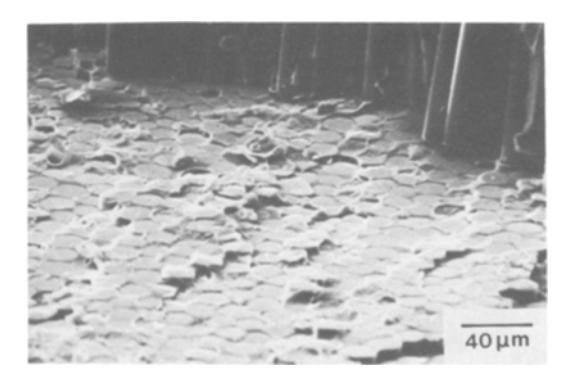
Figure 10 Undercutting of the glass fibres at the base of the river steps.

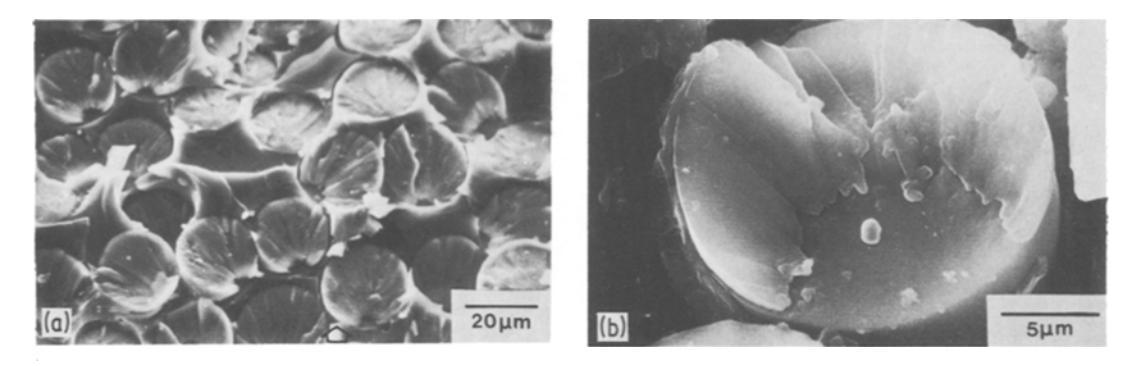
Evidence from the fracture surface of the pultruded rod indicates that the fracture of individual glass fibres is a two stage process. The initial propagation of the crack through the fibre is slow and this produces the mirror regions shown in Fig. 11. The mirror regions tend to be more pronounced in fibres close to the crack initiating point at the rod surface. After about 25% of the fibre has fractured the crack growth rate increases

Figure 11 (a) Characteristic glass wedges that are present on many of the fractured fibres. Direction of crack propagation arrowed. (b) High magnification micrograph of the glass wedge on a fractured glass fibre.

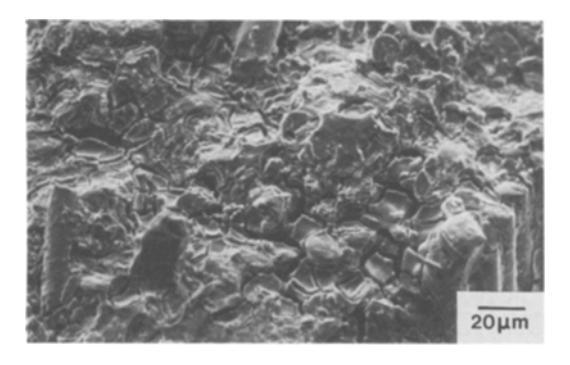
Parts of the fracture face of the rod near the point of crack initiation were frequently covered by a surface film that almost obscured the individual fibres (Fig. 12). X-ray analysis of the film showed it to consist mainly of aluminium, calcium and chlorine (probably $AlCl_3$ and $CaCl_2$) thus confirming the preferential leaching of aluminium and calcium from the fibres.

Figure 12 Surface film on fracture surface of sample that has been tension-tested to complete failure. Film is probably a mixture of $AlCl_3$ and $CaCl_2$.

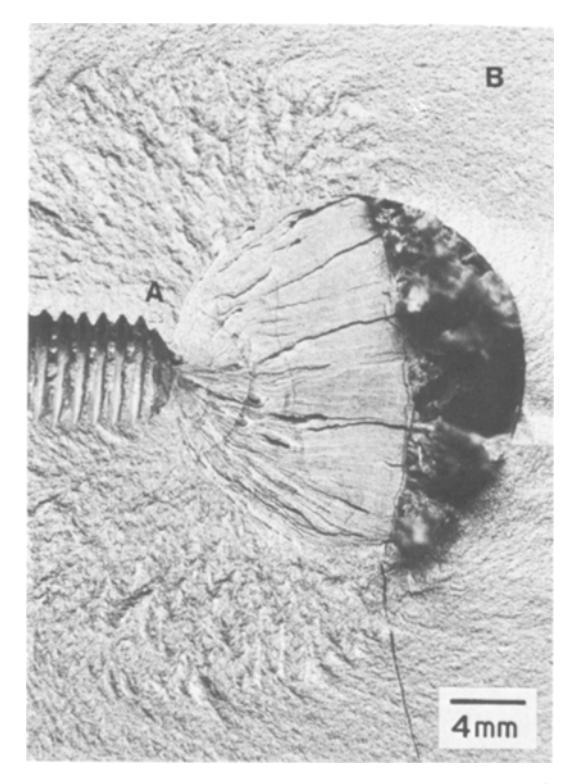
An interesting feature was noted on the fracture of the tension sample that had been encapsulated with the silica-filled cycloaliphatic resin. Examination at low magnification (Fig. 14) shows a variation in the texture of the fracture

Figure 14 Detail of the fractured cycloaliphatic resin showing rough and smooth textured areas.

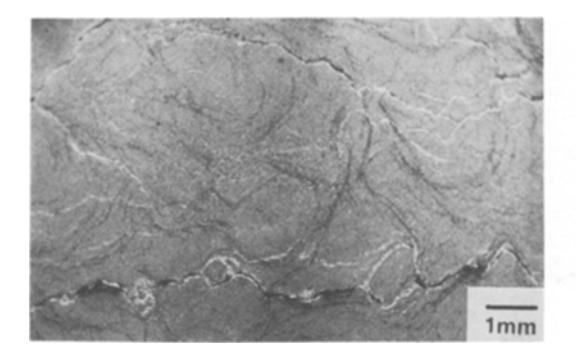
Longitudinal debonding between fibres and resin was apparent in many of the fracture faces, and transverse sections of the rod some 50 mm away from the fracture face showed that debonding occurred over considerable distances (Fig. 13).

Figure 13 Transverse section from sample shown in Fig. 8 that has been taken 50 mm from the fracture surface. Appreciable longitudinal splitting present.

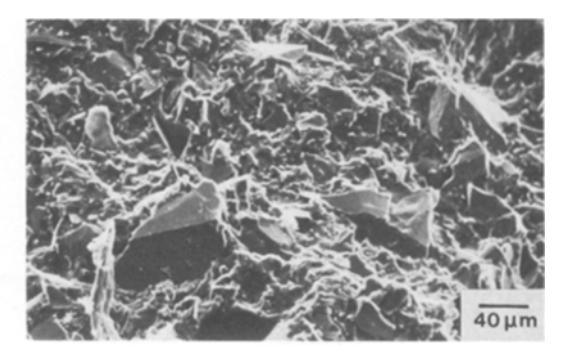
surface of the encapsulating resin. Near the origin of the fracture in the GRP rod a slow crack propagated in the encapsulating resin and examination at high magnification shows the crack to have followed the SiO₂ filler/resin boundaries, i.e. an intergranular type of fracture (Fig. 15). Away from the origin of fracture in the GRP rod the fracture has been more rapid in the encapsulating resin, and in this case the fracture path is through the SiO₂ particles, i.e. a transgranular type of fracture (Fig. 16).

Figure 15 High magnification micrograph of cycloaliphatic resin taken from near the fracture origin (Mark A in Fig. 14).

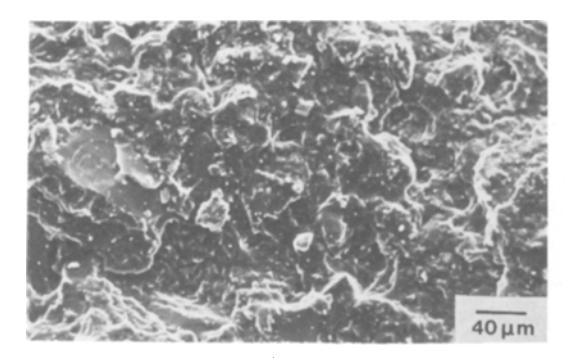
Figure 16 High magnification micrograph of cycloaliphatic resin taken from region B away from the fracture origin.

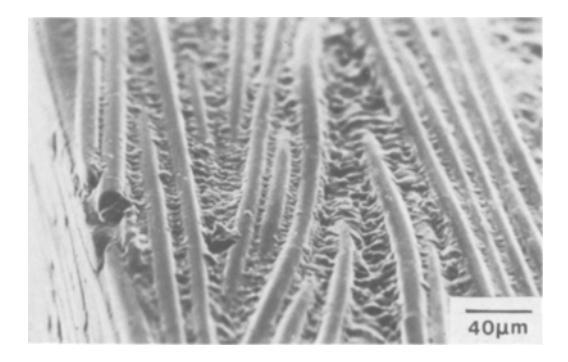
Figure 17 Glass fibres at the surface of the as-pultruded rod.

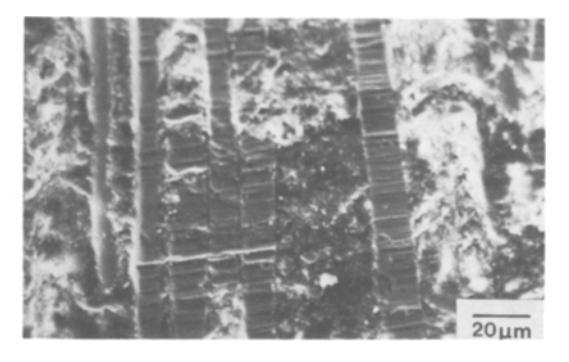
rods showed them to fail in a shorter time than similar pultruded rods in the "as-manufactured" condition. This is principally due to a shortening of the crack initiation stage in the abraded glass fibres.

Figure 18 Abraded glass fibres at the surface of a pultruded rod that has a ground finish.

A number of tests were carried out on the pultruded rod which had been surface ground prior to testing in the acid environment. Such treatment will obviously remove the resin surface layer and introduce severe damage to the surface fibres (Fig. 18). The resulting stress concentrations in combination with the acid environment will promote very rapid cracking leading to early failure.
