Hydrogen-induced cracking in two linepipe steels

K. K. CHAWLA*, J. M. RIGSBEE

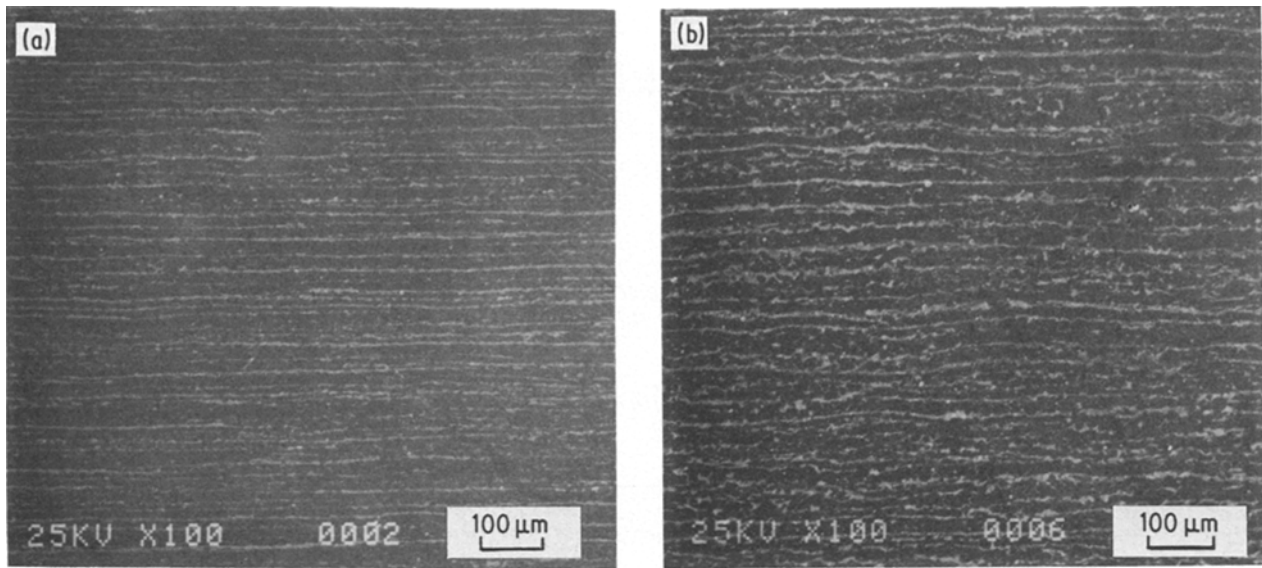
Figure 1 Banded microstructure of (a) Steel B, (b) Steel C. The degree of banding is higher in Steel B than in Steel C.

A detailed description of the initial microstructure has been given elsewhere [6]. Both steels, B and C, showed a high banded microstructure consisting of alternate layers of polygonal ferrite and non-ferritic constituents (pearlite, bainite and/or martensite-austenite). Fig. 1 shows the banded structure of the two steels. Notice that the degree of banding is higher in Steel B than in Steel C. Inclusions, equiaxed or elongated, in such severely rolled steels tend to lodge themselves in the non-ferritic bands, as shown for Steel C in Fig. 2. Many inclusions in Steel B consisted of elongated stringers of MnS (Fig. 3). It would appear that Steel B was neither calcium-treated to obtain a low sulphur content nor treated with rare-earth elements for inclusion shape control. The microstructure as observed in TEM at higher magnifications was essentially the same in the two steels. Fig. 4a and b show the pinning of dislocations by small niobium and vanadium carbonitrides in Steels B and C, respectively. Thus, the essential microstructural differences between the two steels were (i) a higher degree of banding in Steel B than in Steel C, and (ii) more elongated inclusions in Steel B than in Steel C.

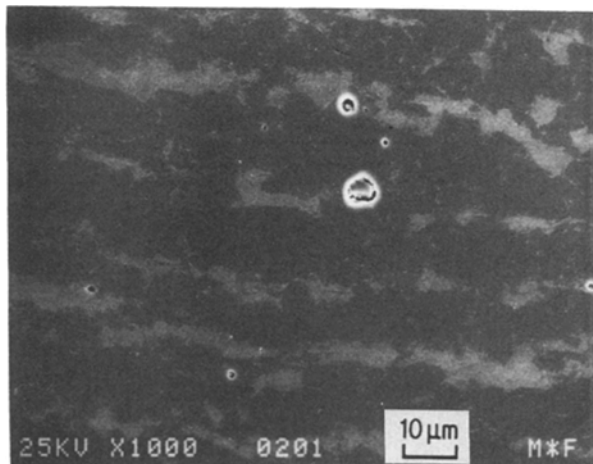
Figure 2 Inclusion (equiaxed) lodged preferentially in the non-ferritic band. Steel B. Etchant: picral.

It is well recognized that inclusions are one of the favoured types of site for microstructural damage due to hydrogen in such steels [1–3]. As pointed out above, the inclusions, whether elongated or not, tended to lodge in the non-ferritic band. This perhaps accentuated the effect of the banded structure. In any case, the initial effect of charging for low times was to produce damage consisting of voids at inclusions, generally located in or near the non-ferritic constituents. Fig. 5 shows this for Steel C charged for 1 h at 100 mA cm^{-2} . After 24 h of charging these microvoids, initiated at inclusions or at ferrite/non-ferritic interfaces, grew along the non-ferritic constituents or along the interface between ferrite and non-ferritic constituent, forming the so-called stepwise cracking. Fig. 6 shows this in an unetched condition. Notice the stepwise nature of cracking. Fig. 7 shows vividly the preferential alignment of these cracks along the non-ferritic band.

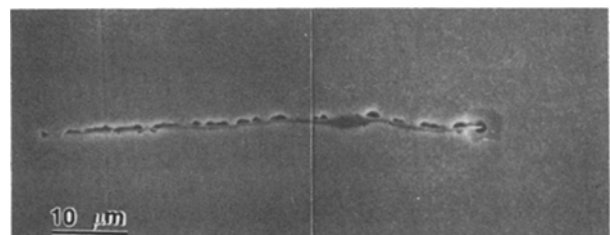
Figure 3 Elongated MnS inclusion in Steel B.

segregation of manganese and the practice of low-temperature finishing [1, 5]. Thus, reducing the amount of manganese to a minimum, coupled with a high-temperature finishing, would yield steels more resistant to HIC. Low sulphur content and/or inclusion shape control would also be beneficial.

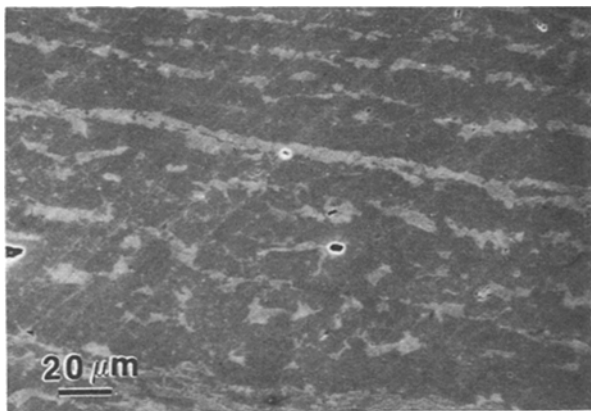
Figure 5 Microvoids at inclusions located in or near the non-ferritic band after 1 h charging. Steel C.

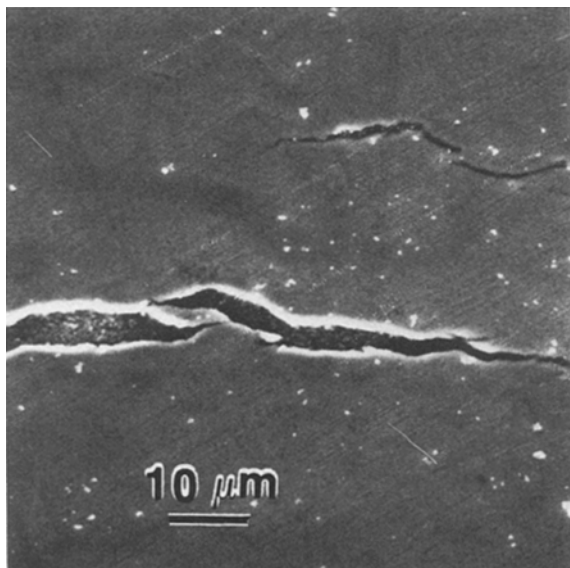
Figure 6 Stepwise cracking in Steel C after 24 h charging. Unetched.

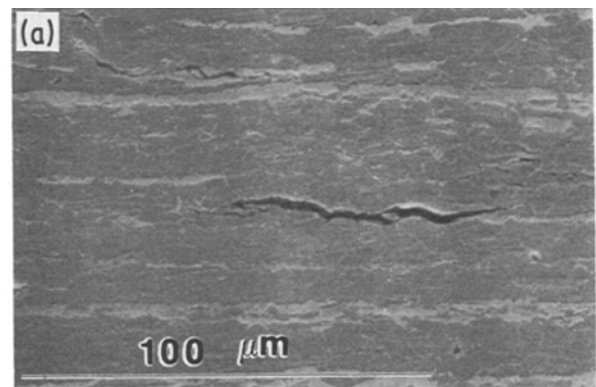
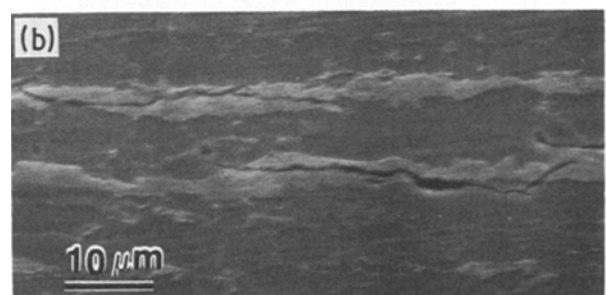
Figure 7 (a, b) Two different areas of Steel C, showing preferential alignment of cracks along the non-ferritic layers after 24 h charging. Etchant: picral.

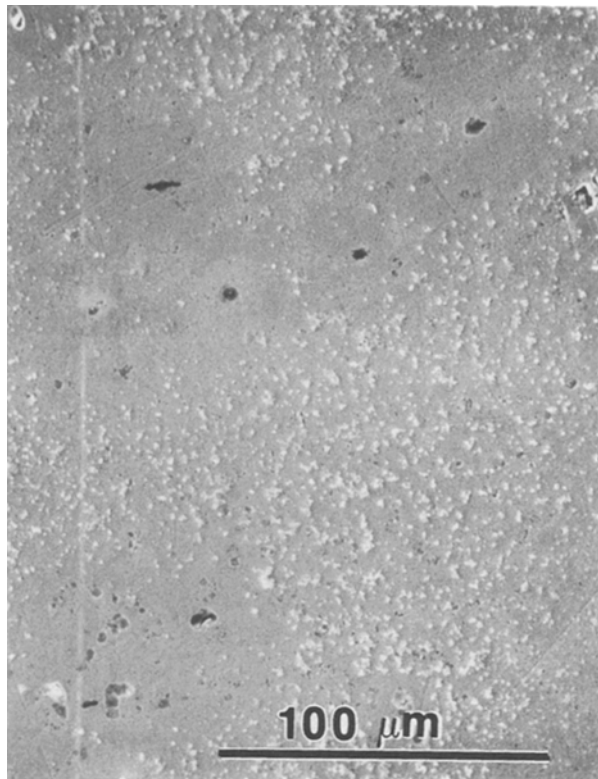
Steel B also showed initiation of voids at inclusions and/or at the non-ferritic constituent after a charging of 1 h at 100 mA cm^{-2} (Fig. 8). An aluminium-based inclusion lodged in a void in the same steel is shown together with AlK α mapping in Fig. 9. After 24 h of charging these voids grew into rather extensive stepwise cracks, as shown in the unetched condition in Figs. 10 and b. The cracks run parallel to the bands (not visible in this micrograph). Notice the greater amount of microstructural damage in Steel B (Fig. 10) than in Steel C (Fig. 6). The alignment of these hydrogen-induced cracks along the band existing in the structure is seen in Fig. 11, which shows the situation after etching.

Figure 8 Microvoids at inclusions and/or at non-ferritic bands. 1 h charging. Steel B. Unetched.

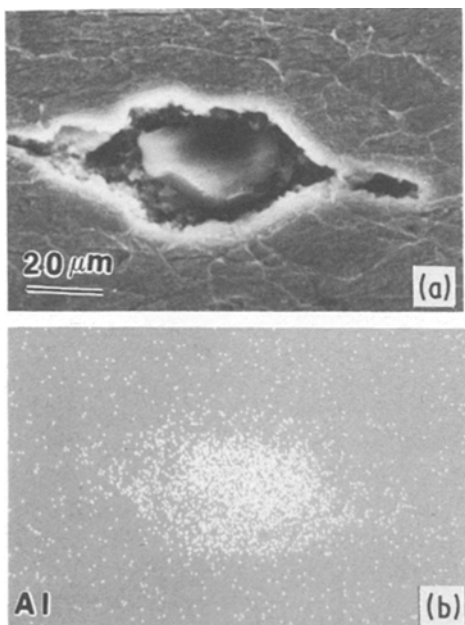
Figure 9 (a) An aluminium-based inclusion in the interior of a void; (b) AlK α mapping. Steel B, 1 h charging.

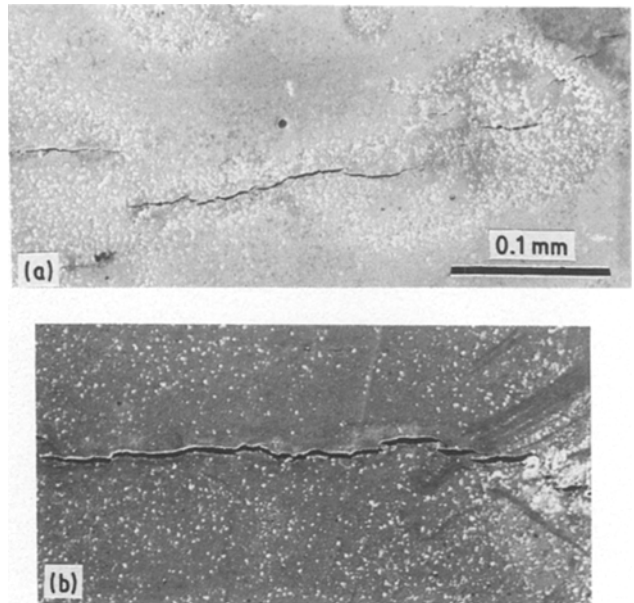
Figure 10 (a, b) Extensive stepwise cracking in Steel B after 24 h charging.

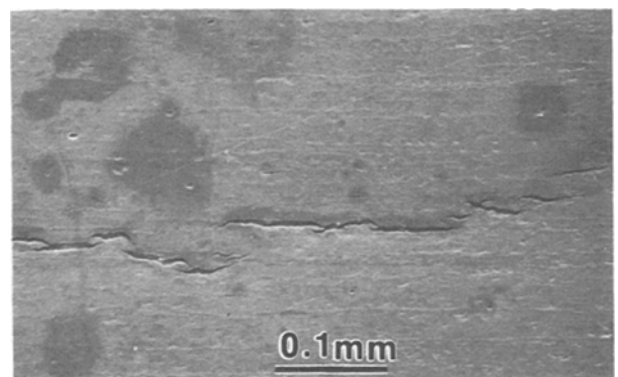
Figure 11 Alignment of cracks in steel with the bands in Steel B, seen after light etching with picral.

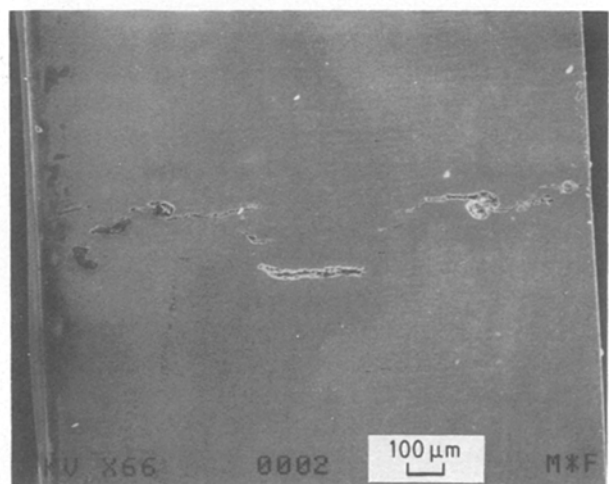
In order to assess and compare the extent of microstructural damage in the two steels, we examined through-thickness sections. Fig. 12 shows that in Steel B after 24 h charging the damage extended completely through the thickness. This was not the case in Steel C. The preferential growth of cracks along the bands in Steel B is clearly seen in Fig. 13. Steel C, which showed a lesser degree of banding and less elongated inclusions than Steel B, suffered a markedly less through-thickness damage. The situation existing at about the mid-thickness position (~ 1 mm from the surface) after 24 h charging is shown in Fig. 14. In all

Figure 12 Through-thickness section of Steel B, showing damage due to HIC after 24 h charging.

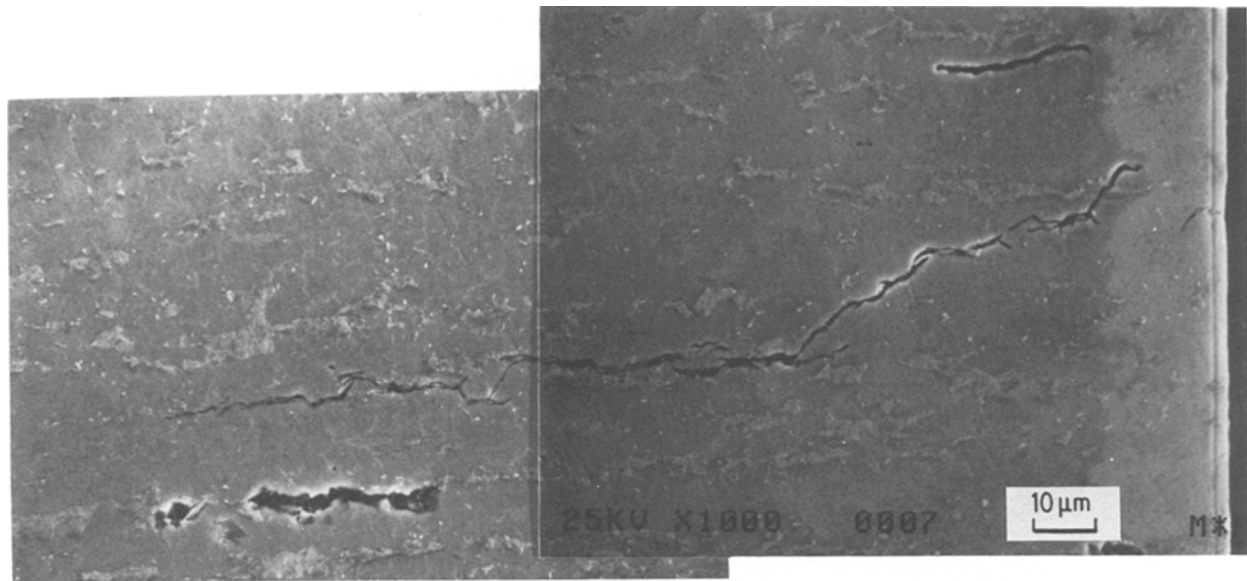
Figure 13 Alignment of cracks along the non-ferritic bands in the thickness direction of Steel B after 24 h charging.

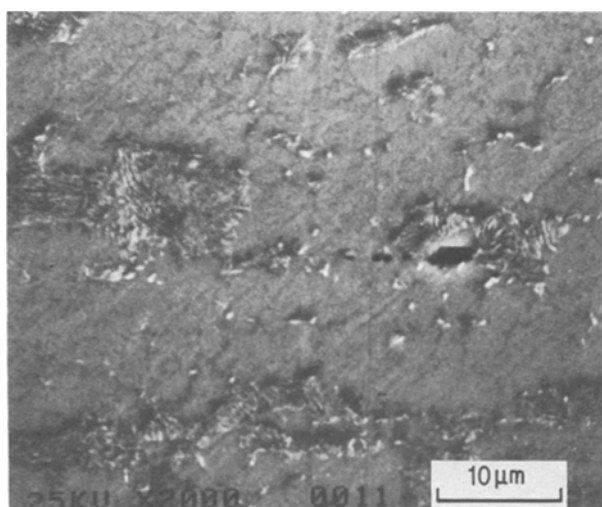
probability, the void initiated at some inclusion and grew some distance along the band.

Figure 14 Damage in Steel C at about mid-thickness (~1 mm from the surface).
