Fatigue crack growth of DSX40M alloy at ambient and elevated temperatures

Radiation Damage Group, Nuclear Physics Division, Pakistan Institute of Nuclear Science and Technology, P.O. Nilore Islamabad, Pakistan

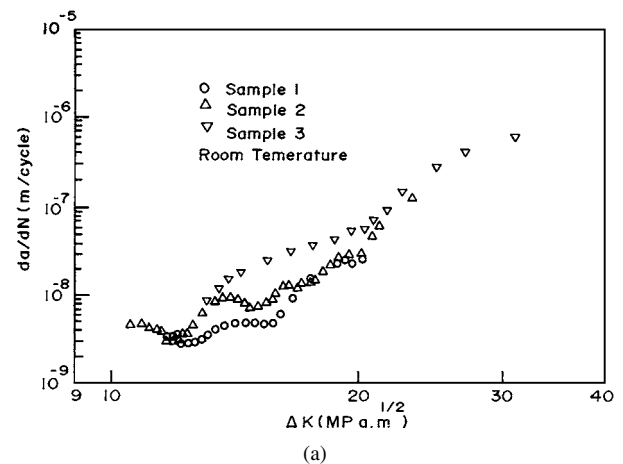
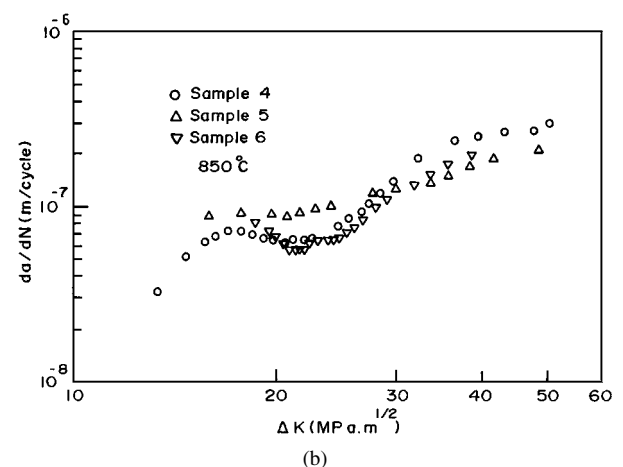
Figure 2 (a) Fatigue crack growth rate as a function of ΔK in air at room temperature. (b) Fatigue crack growth rate as a function of ΔK at 850°C.

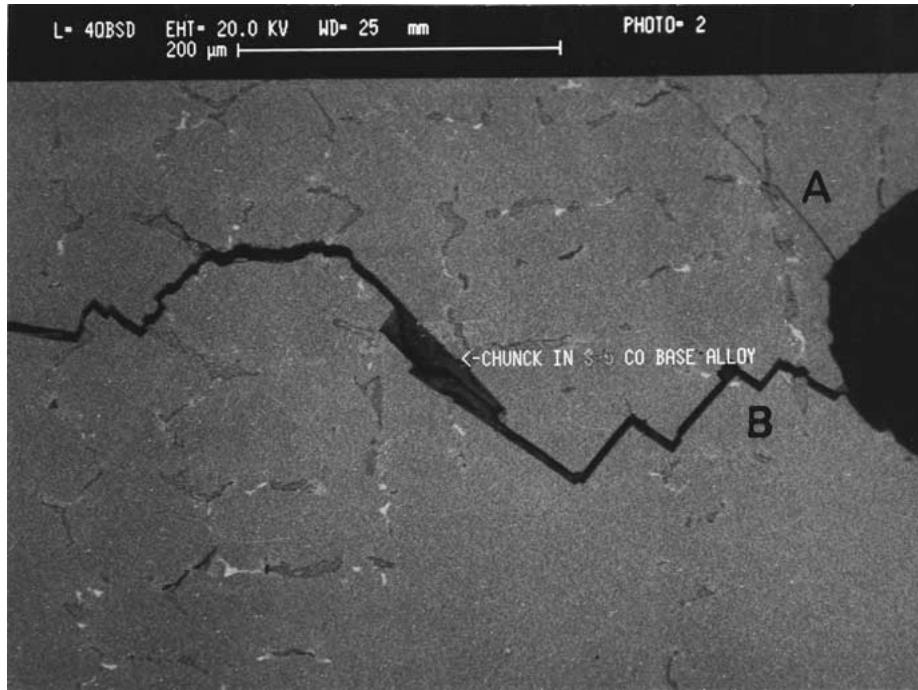
tion, referred to as stage I. With the increase in crack length, the stress intensity will increase, which promote the slip on the other system and the crack begins to propagate normal to the loading axis, i.e. in stage II by definition. However, as shown in Fig. 3b stage II cracking at a higher magnification, the crack growth is actually characterized by stage I on the microscopic scale. The crack propagates alternately activating on two slip systems. It is clear that two sets of slip traces that are inclined to each other by about 90° are visible near the fatal crack Fig. 3c. It can be explained on the basis of the alternating shear model proposed by Neumann [11] who suggested that when the crack is

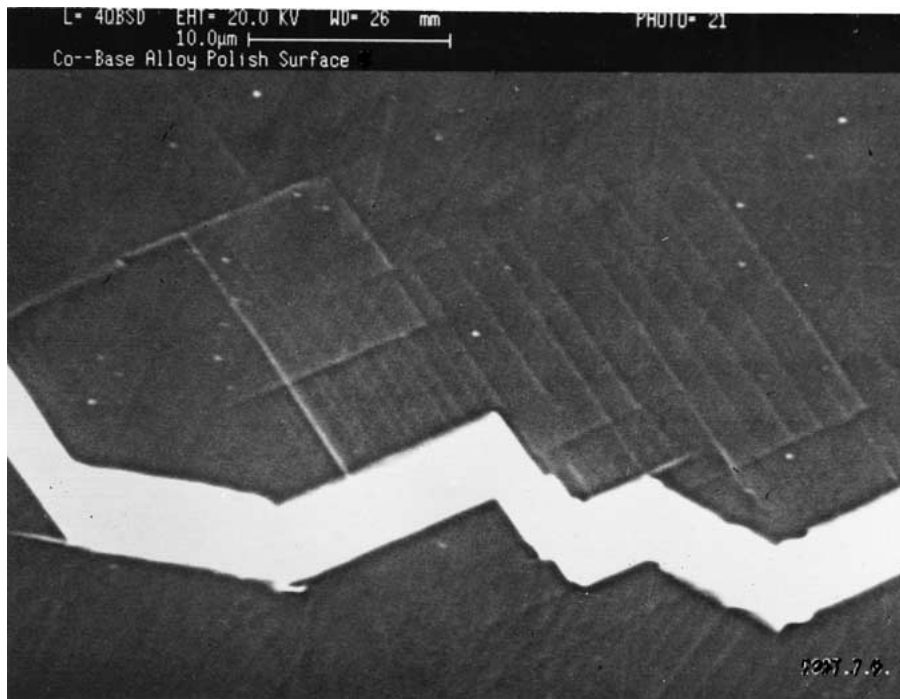
Figure 3 (a) SEM micrograph showing: (i) the deflection and branching (ii) nucleation of cracks A & B and propagation of the B crack. (b) High magnification micrograph of mode II cracking. (c) SEM micrograph showing the slip band at right angle to each other. (Continued.)

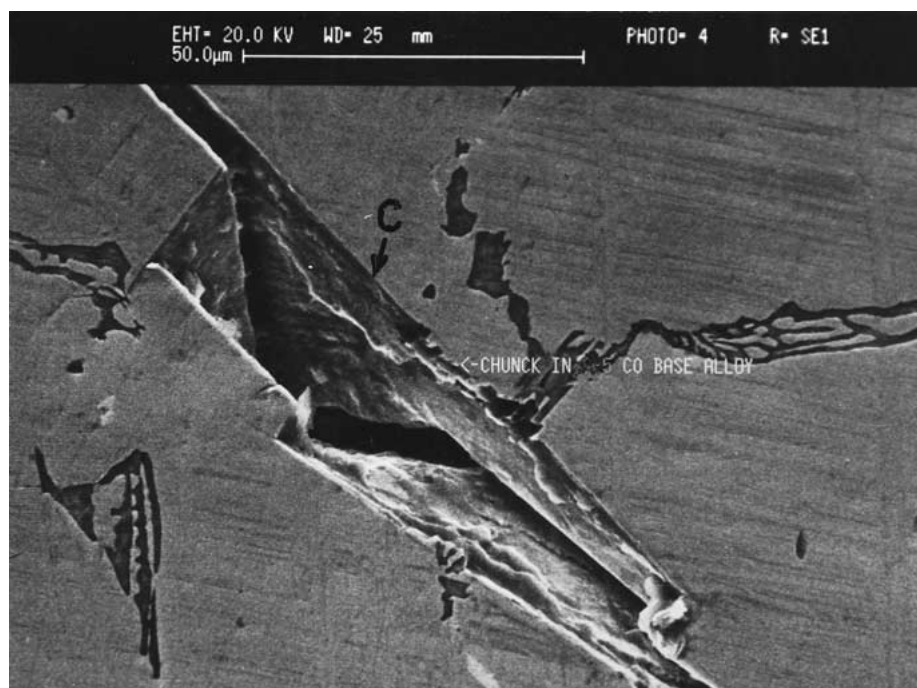
Figure 4 A chunk (indicated by letter 'C') of materials fell out from the specimen surface.

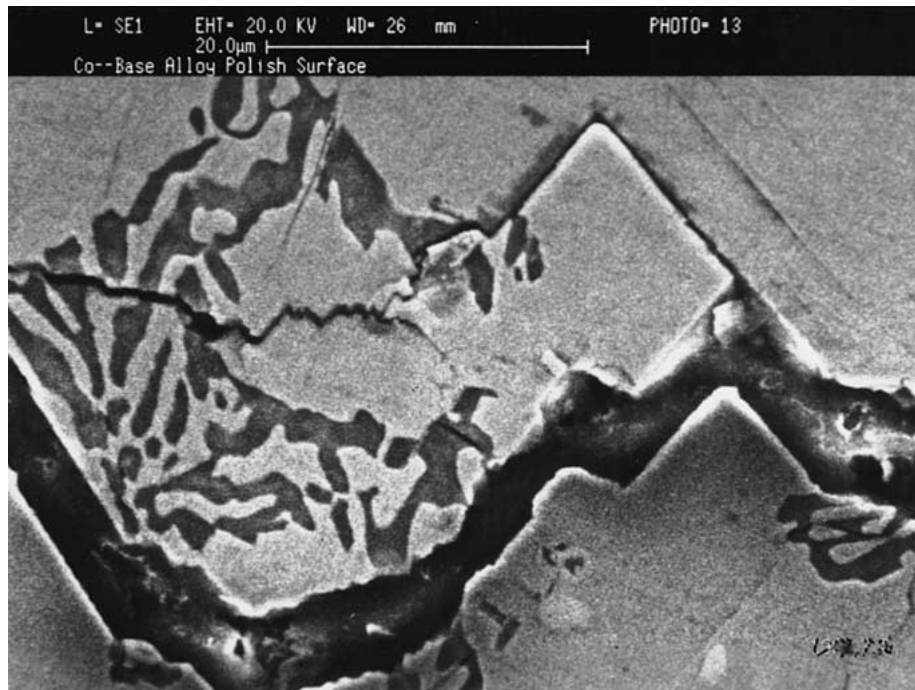
planes and was also observed in a Mar-M200 single crystal subjected to far field cyclic compression [12] and in $\text{Ni}_3\text{Al}(\text{Cr},\text{B})$ [13] single crystal fatigue tested at room temperature in air under stress controlled condition. It is shown in Fig. 5a, that crack deflected near the grain boundaries and changed its path. It is well documented [14] that for fatigue crack growth in underaged microstructure of precipitation hardened materials, such deflected crack path gives rise to significant amount of roughness-induced crack closure. The black debris was also observed and is shown in Fig. 5b. It is believed that black debris is formed as a result of rubbing of fracture surface during the fatigue cycle. The

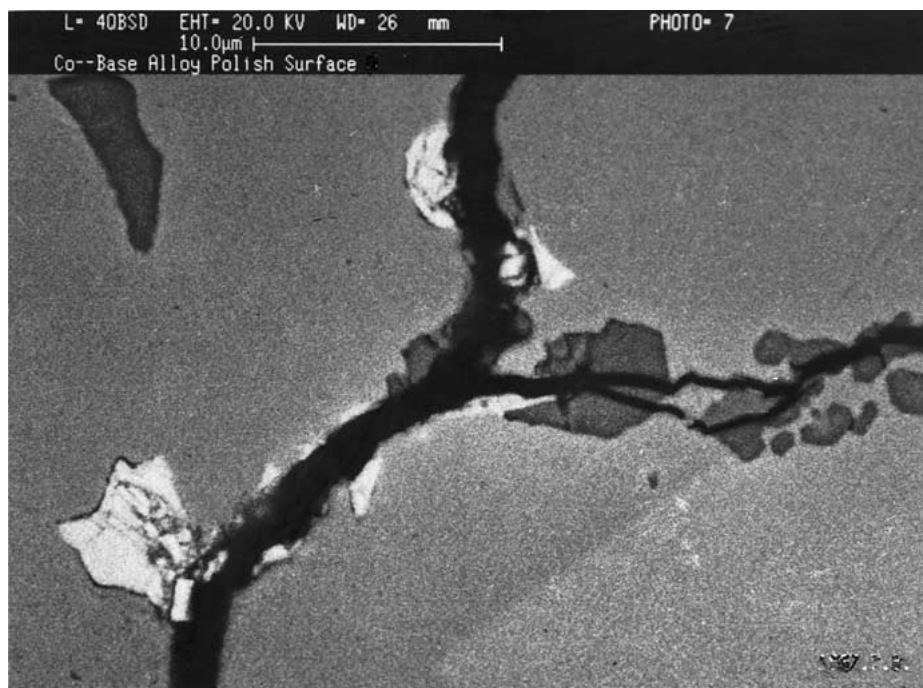
Figure 6 SEM micrograph of the DSX40M alloy surface failed by fatigue showing the microcracks at carbides/eutectic.

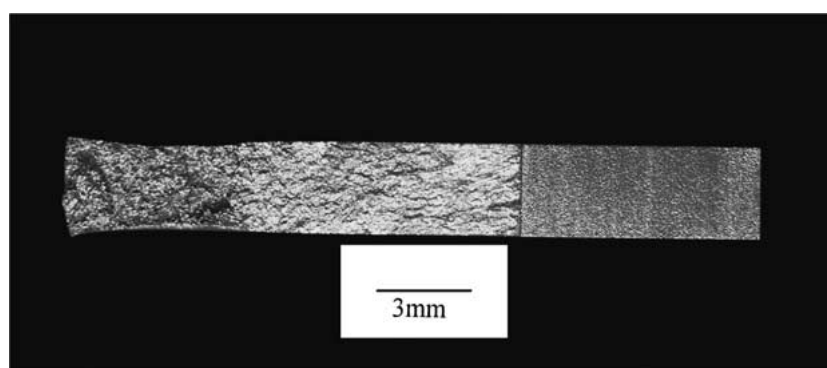
Figure 7 Macroscopic feature of the fractured surface.

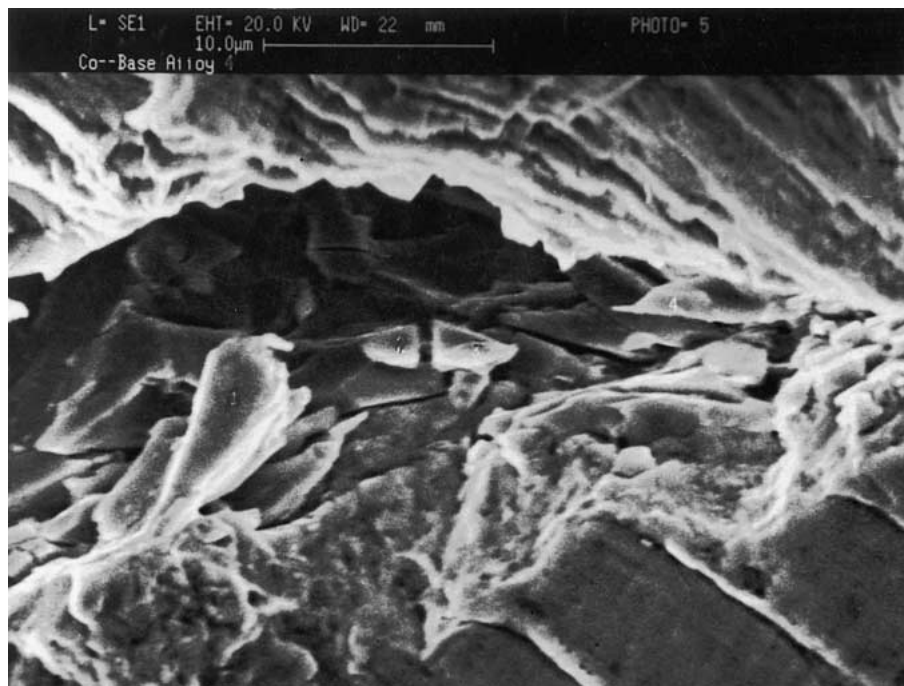
Figure 9 SEM micrographs showing cleavage fracture with ridges on the fracture surface.

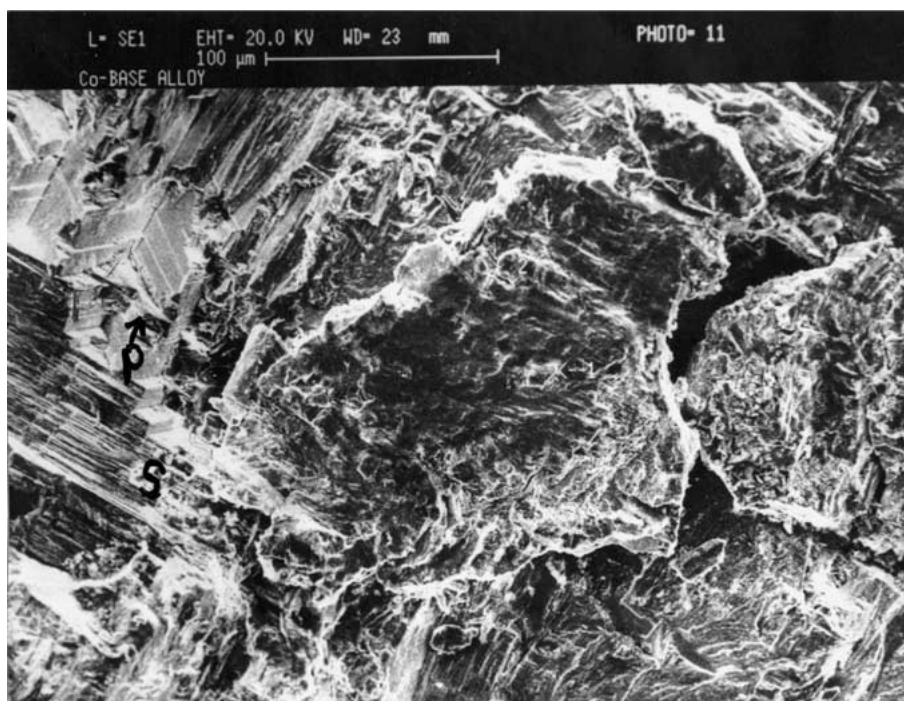
Figure 10 SEM micrograph showing the stair like step (indicated by letter “S”) and pyramid like feature (indicated by letter “P”).

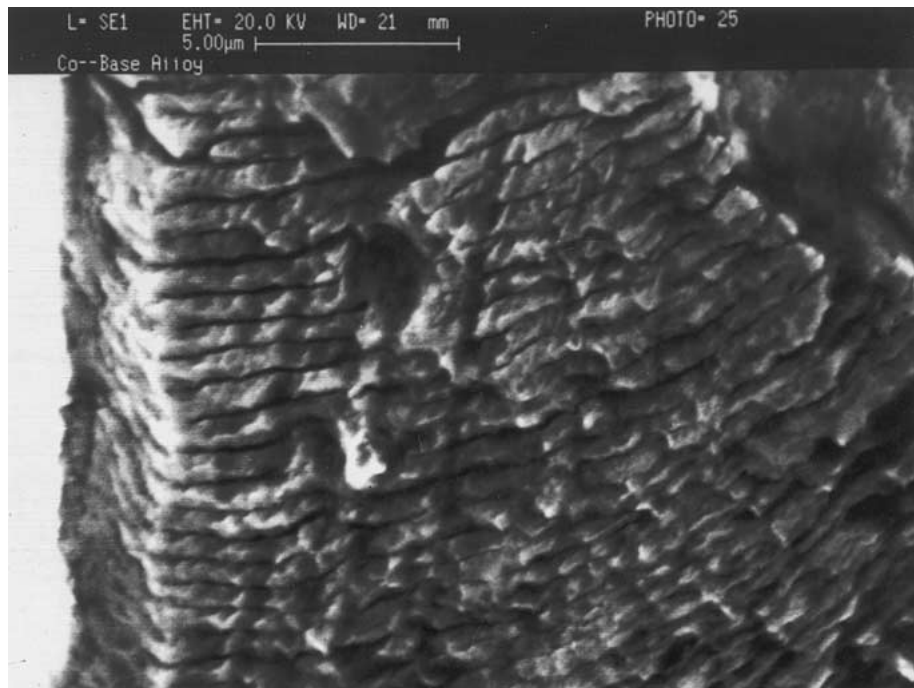
At 850°C the crack is propagating mainly in mode II. The fractured surfaces were oxidized during the test at 850°C. The cleavage fracture was observed. At

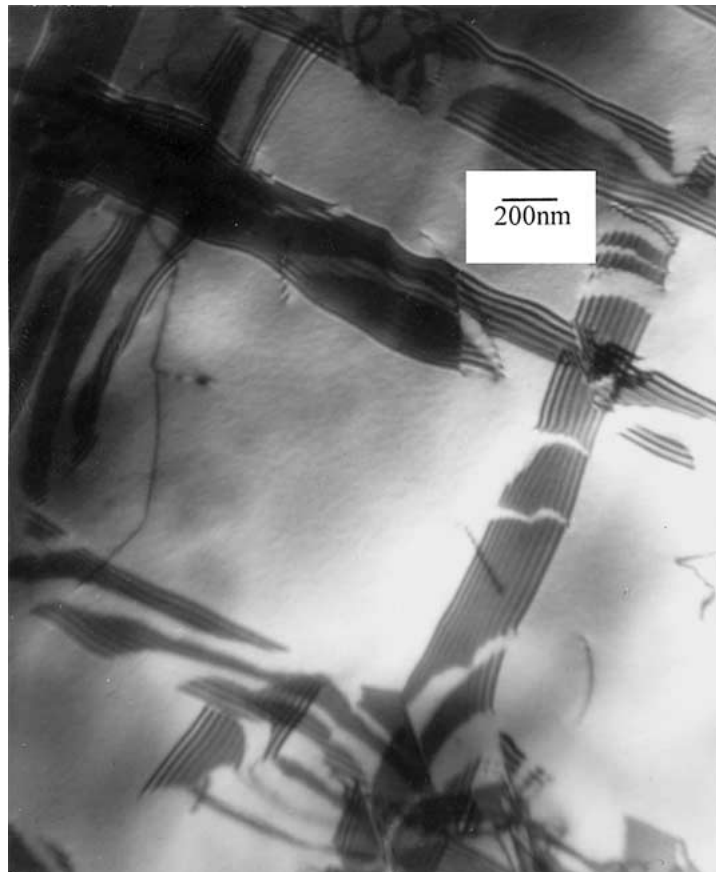
The density of the dislocations is higher at higher ΔK compared to low ΔK . The micrographs represent dislocations dipoles at higher ΔK as shown in Fig. 12d. Fatigue softening was also observed at RT test. The modification of the dislocations results in the fatigue softening. The network formation of the dislocations

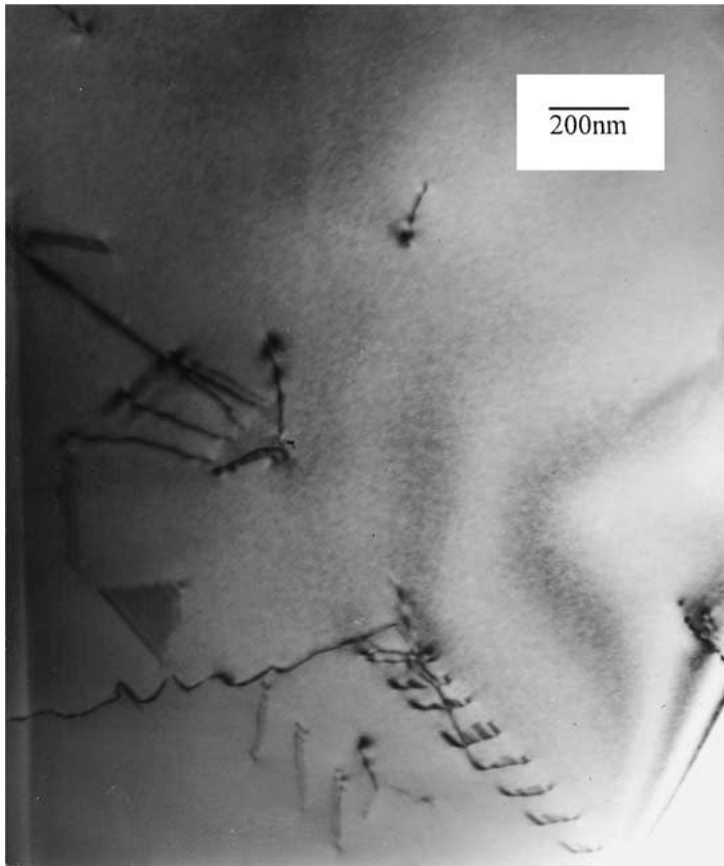
Figure 12 Transmission electron micrographs represent the (a) stacking faults and dislocation in the notch area. (b) Dislocation pile up in the crack propagation area. (c) The planar slip dislocation. (d) Dislocation dipoles at higher ΔK . (e) The dislocation forming network like structure in the final broken area. (Continued.)

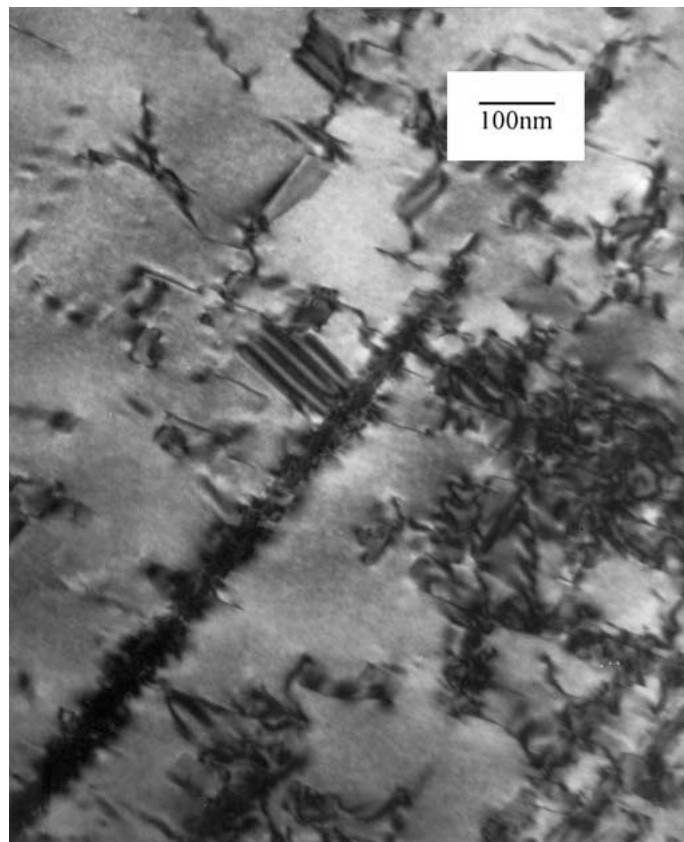
Figure 12 (Continued.)

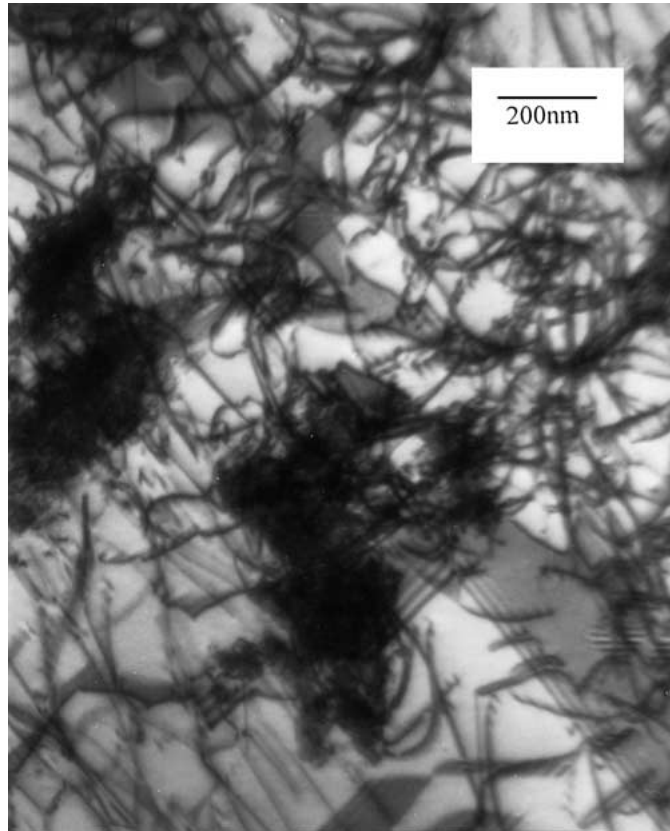
Figure 13 Transmission electron micrographs show that: (a) dislocations and dislocation dipole pile up in the crack propagation area at low ΔK , (b) dispersing of dislocations and forming a network like structure in the crack propagation area at higher ΔK , (c) dislocations forming a complete network like structure. (Continued.)
