Unusual Indelible Enamel Staining Following Fixed Appliance Treatment

Abstract. *Two cases are described of indelible enamel staining following fixed appliance therapy. The acquired pigmentation occurred in patients with an identifiable enamel defect prior to treatment. The interaction of factors to cause the staining is discussed and its prevention in future cases highlighted. Subsequent restoration of the affected teeth is shown.*

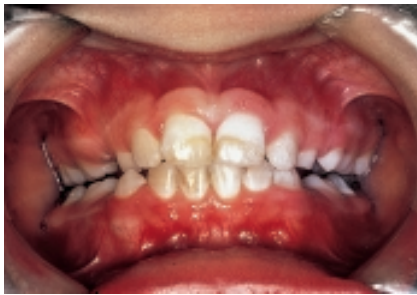
malocclusion. The lips were incompetent at rest with the upper incisors lying outside lower lip control. The patient was in the mixed dentition, with generalized brownish white enamel mottling of the permanent teeth, suggestive of fluorosis or hypomature amelogenesis imperfecta (Figure 1). Upper and lower arches were mildly crowded. In occlusion the overjet was increased to 11 mm, the overbite was average and incomplete, and the molar relationship was Class II bilaterally. The panoramic radiograph confirmed the presence of all permanent teeth with the exception of upper second premolars and all third molars. A lateral cephalogram confirmed the moderate Class II skeletal pattern and reduced vertical proportions.

FIG. 1 Case 1: anterior view showing pretreatment enamel mottling.

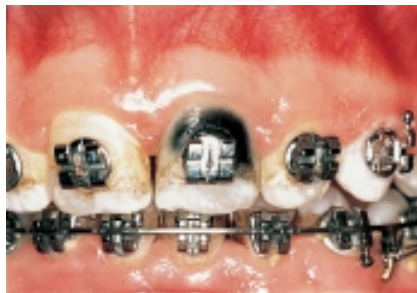
Lower second premolars and retained upper deciduous second molars were extracted, and upper and lower pre-adjusted edgewise fixed appliances were placed together with a transpalatal arch for anchorage support. The teeth were etched with 30 per cent phosphoric acid for 1 minute and ConciseTM (3M Unitek, Bradford, U.K.) composite, a chemically-cured composite, was used to attach stainless steel brackets (Dentaurum, Ispringen, Germany). Repeated bond failures of the upper incisor brackets occurred as a result of the hypomineralization and the same standard process of bracket placement was followed each time. Shortly prior to debond, green-black staining became evident on the upper left central incisor, extending from the apical aspect of the bracket base to the gingival margin

(Figures 2 and 3). No extrinsic factors could be identified which may have caused the tooth discolouration and the staining could not be removed by polishing. The tooth was vital to pulp testing and a peri-apical radiograph revealed no obvious pathology.

FIG. 2 Case 1: green-black staining evident around bracket base.

nickel phosphate. The greenish-black discolouration seen in Case 1 is likely to be due to a combination of these compounds. In contrast, the reddish-brown stain of Case 2 is typical of iron oxide and may have been due to a localized loss of the luting cement underneath the band as well as crevice corrosion.

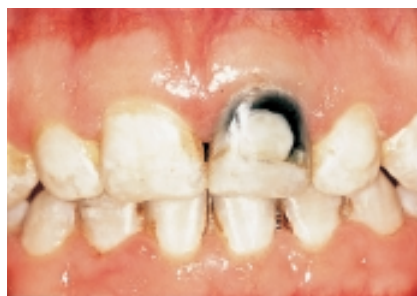
FIG. 3 Case 1: green-black staining after bonding.

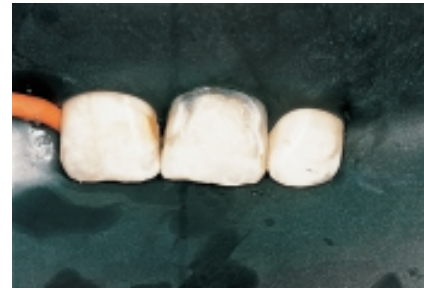
As an initial measure the stained enamel was removed while retaining as much of the underlying enamel as possible to optimise bonding. Dark striations were observed through the thickness of the affected enamel rather than uniform discoloration (Figure 4). A composite resin veneer was placed, but an acceptable shade match was not achieved due to the very high value of the patient's natural tooth shade. In addition, the mottling of the other incisors was still a cause for concern to the patient (Figure 5). It was decided to carry out micro-abrasion to 21|2 and to place a porcelain veneer 1|1. Micro-abrasion using 18 per cent hydrochloric acid-pumice slurry was performed, as well as external bleaching using Opalescence® (Optident Dental

FIG. 4 Case 1: appearance of 1|1 following initial removal of the most darkly stained enamel under rubber dam. Some stain remains at the cervical margin.

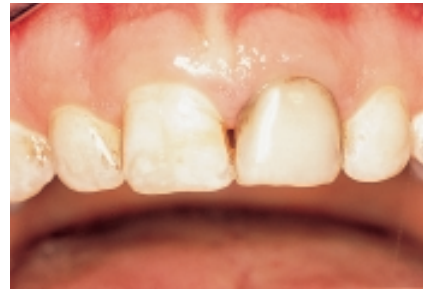
FIG. 5 Case 1: initial composite resin restoration 1|1.

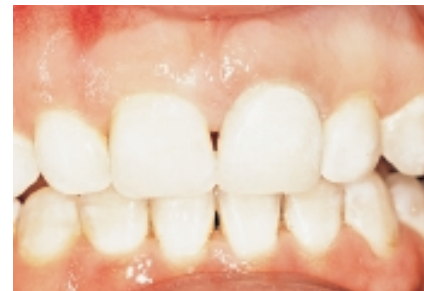
FIG. 6 Case 1: finished result showing porcelain veneer 1|1 and microabrasion 21|2.

Solutions, Skipton, U.K.), applied nightly over the course of 3 weeks, in order to further improve the mottling and to lighten the remaining stained cervical margin of 1|1. It was important to retain this marginal enamel in order to achieve an optimal seal with the resin luting cement. The definitive restoration achieved a satisfactory aesthetic result (Figure 6).

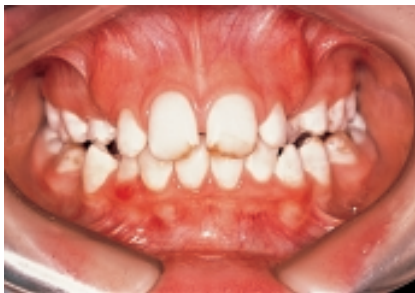
LH was referred by her general dental practitioner for orthodontic treatment. She presented at age 12 years with a Class II division 1 malocclusion in the late mixed dentition. The enamel of all permanent teeth was noted to be hypomineralized with hypoplastic areas affecting the incisal edges of the permanent first molars and maxillary central incisors, and occlusal tooth surface loss on the permanent first molars (Figure 7). A diagnosis of hypomature amelogenesis imperfecta was made. The upper and lower arches

FIG. 7 Case 2: anterior view showing pretreatment enamel mottling.

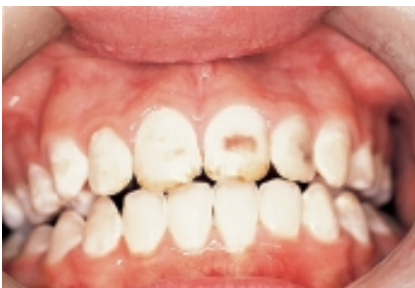
FIG. 8 Case 2: red-brown staining visible after debond.

Bands were in place between 15 and 24 months, and treatment was completed after 26 months. At debond, a red-brown staining of the central portion of the anterior teeth was evident. This was unusual in being confined to the area under the brackets or bands and was noticeably worse on 12 (Figure 8). Interestingly, the bands on these teeth had been in place for a shorter time than those on the contralateral teeth which were less severely affected.

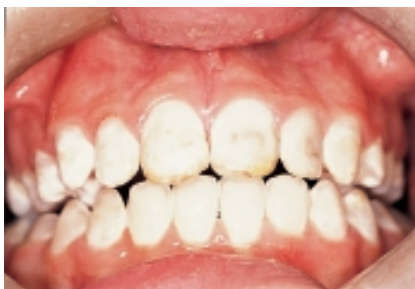
FIG. 9 Case 2: reduction in staining intensity after micro-abrasion.

Microabrasion was carried out using 18 per cent hydrochloric acid-pumice slurry which reduced the staining in intensity, but did not eradicate it completely (Figure 9). 3211123 were then prepared for porcelain veneers and it was noted that the stain was less intense again after the enamel surface was removed (Figure 10). Porcelain veneers were placed 3211123 and a satisfactory aesthetic result obtained (Figures 11 and 12).

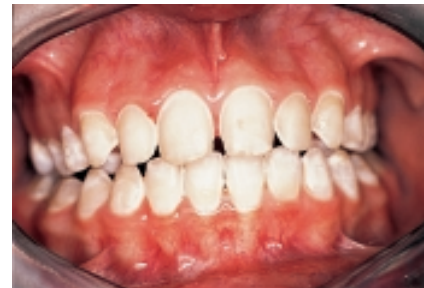
FIG. 10 Case 1: 3211123 prepared for porcelain veneers.

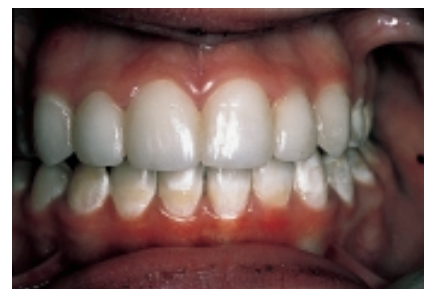
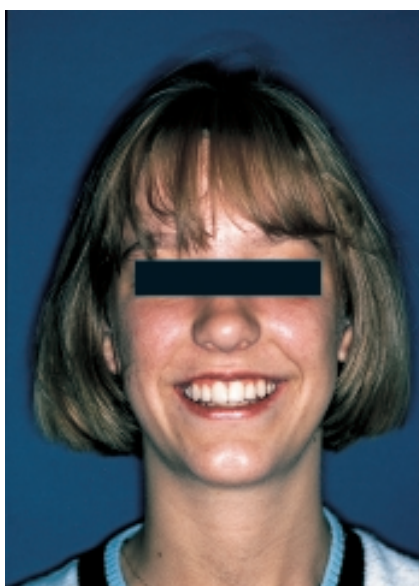
FIG. 11 Case 2: anterior view showing porcelain veneers 3211123.

FIG. 12 Case 2: facial view showing porcelain veneers 321|123.
