# Troubleshooting the Herbst Appliance

MICHAEL B. ROGERS, DDS

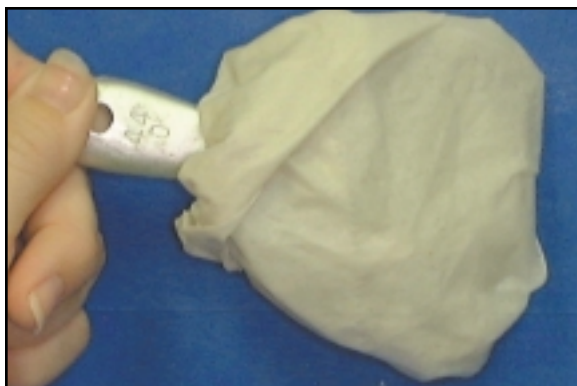
### 1. Distortion of models.

Fig. 1 Alginate impression wrapped in wet towel while waiting to be poured.

Solution: Take accurate impressions; pour alginate impressions immediately, or pour polyvinyl siloxane impressions after 30 minutes. Tip: Wrap an alginate impression in a wet towel while it is waiting to be poured (Fig. 1).

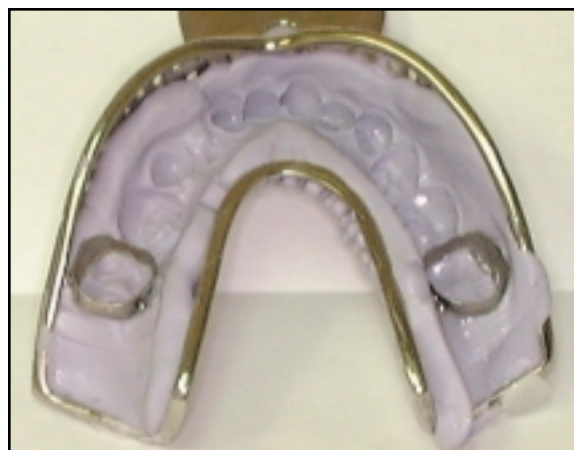
### 2. Improper placement of bands or crowns in impressions.

Fig. 2 Bands super-glued in position in polyvinyl siloxane impression.

Solution: If the direct method is being used, the orthodontist (not an assistant) should super-glue the bands or crowns into the impression for accuracy (Fig. 2). This can be done at the chair before the appliance is disinfected. After the glue has dried, vibrate the impression on low while pouring so that the super-glue bond will not be broken. Tip: A catalyst such as Zip Kicker\*\* or Zap\*\* (available in hobby stores) can be sprayed on the glue to set it up instantly.

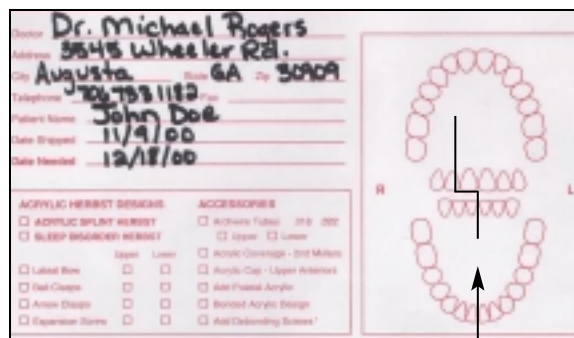
Fig. 3 Midline deviation marked on laboratory prescription.

### 3. Midline, overjet, and overbite errors.

Solution: Obtain an accurate wax bite registration, and mark the laboratory prescription carefully to note the amount of advancement and any midline deviations (Fig. 3). This will reduce chairtime at appliance delivery because the rods and tubes will be cut to the proper length in the lab. If the midline is off at appliance delivery, advancement shims (extenders) can be added to

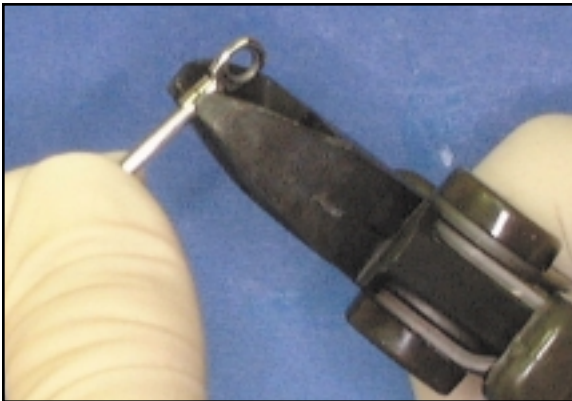
Fig. 4 Shim crimped in place with heavy wire cutter.

correct the deviation. The upper tubes may also be replaced to correct the midline as necessary. Tip: The shims should be crimped with a heavy wire cutter\*\*\* to prevent them from coming off and possibly being swallowed if the appliance disengages (Fig. 4).

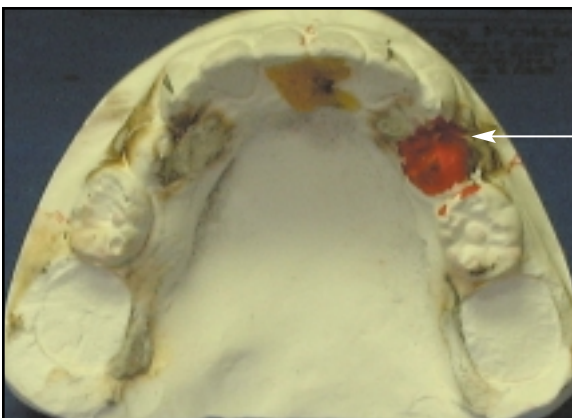
Fig. 5 This bicuspid will erupt slightly while Herbst is being fabricated.

### 4. Eruption of mandibular bicuspid during appliance fabrication.

Solution: Note on the laboratory prescription if a bicuspid will erupt while the Herbst is being fabricated. The lab technician can then allow for the  $\frac{1}{4}$ - $\frac{1}{2}$ mm of eruption by adjusting the rest or crossover wire occlusally (Fig. 5). If this is not done, the Herbst will not seat fully.

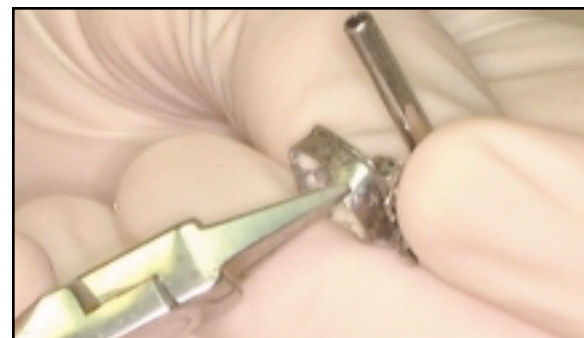
### 5. Loose bands.

Fig. 6 Band tightened by crimping gingival margin with birdbeak plier.

Solution: Microetch crowns or bands to increase surface area and retention. (This is usually done by the lab.) Microetching will also help the cement adhere to the band instead of the enamel on removal. Tip: A band or crown that is too large or that becomes stretched when loose can be tightened by crimping the gingival margin with a birdbeak plier (Fig. 6).

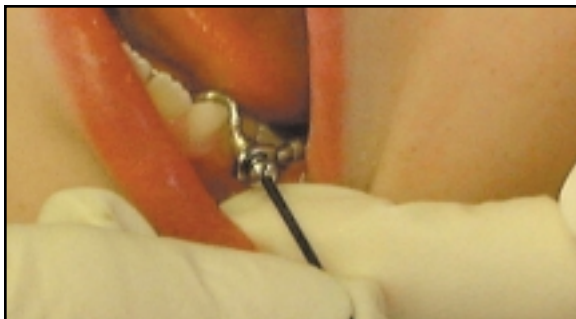
**Fig. 7** Ceka Bond applied to screw to keep it from unseating.

### 7. Loose screws.

Solution: Apply Ceka Bond† to all screws to prevent them from unscrewing in the mouth (Fig. 7).

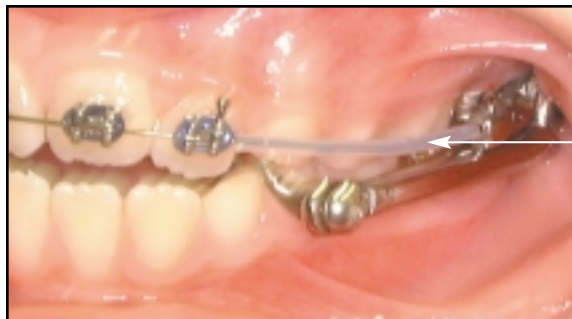
**Fig. 9** Archwire covered with plastic tubing to avoid sore spots.

### 9. Archwire impinging on the oral mucosa.

Solution: Cover the archwire with plastic tubing (Fig. 9) or closed-coil springs to avoid sore spots. If possible, use at least an .018" stainless steel archwire to prevent breakage.

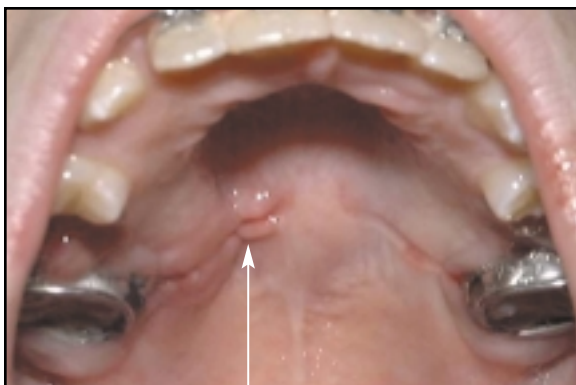
**Fig. 8** Sore spots from transpalatal arch.

### 8. Inadequate maxillary molar control.

which can cause sore spots (Fig. 8), facilitate the development of crossbites, and hinder maxillary arch expansion and molar rotation. Without a transpalatal arch, the molars are free to be expanded, moved distally, or rotated as needed for Class II correction.

Solution: Do not use a transpalatal arch,

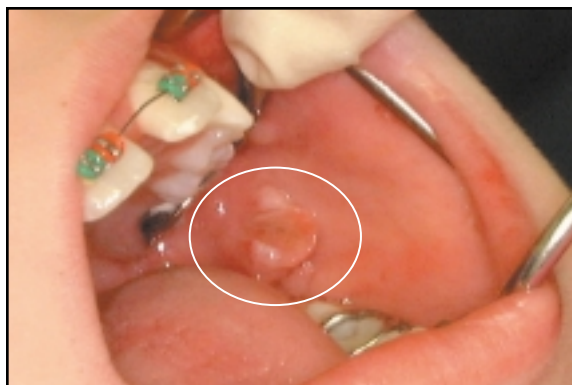
**Fig. 10** Sore spot from pivot impingement.

### 10. Impingement on the ascending rami.

Solution: Do not overadvance the mandible to the point that the Herbst pivots impinge on the ascending rami (Fig. 10). In severe cases, it may not be feasible to advance to an edge-to-edge bite at first, and a gradual advancement with shims

(extenders) may be preferable. Tip: Placing the Herbst screw casing in the center or to the mesial of the molar will prevent the screw casing from impinging on the rami.

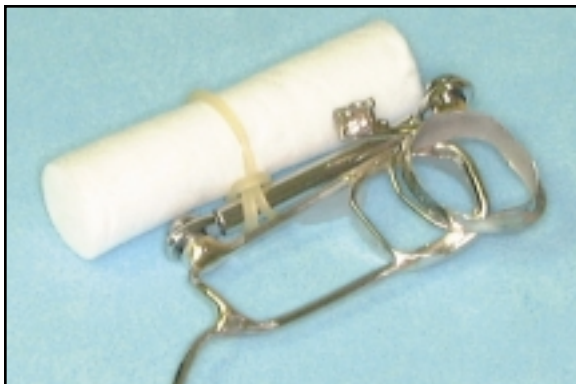
Fig. 11 Cotton roll attached to appliance with elastic to hold cheek away from pivot.

*11. Pivot screw impinging on the cheek.*

Solution: To hold the cheek away from the pivot, a cotton roll can be attached to the appliance with an elastic tied in a slipknot (Fig. 11). If sore spots develop, the screws can be covered with Comfort Caps<sup>‡</sup> (Fig. 12). Since these stay in place for only a few days, it is not advisable to use them on every Herbst case. Mushroom

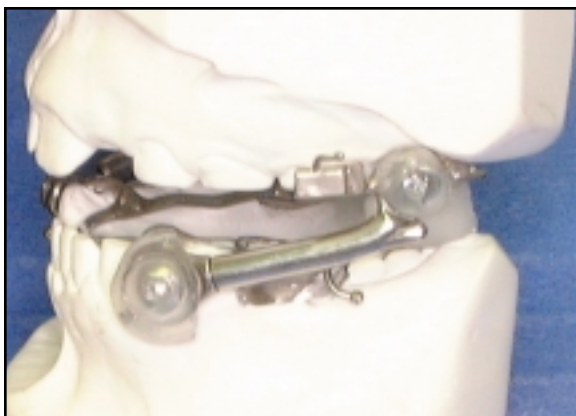
Fig. 12 Screws covered with Comfort Caps.

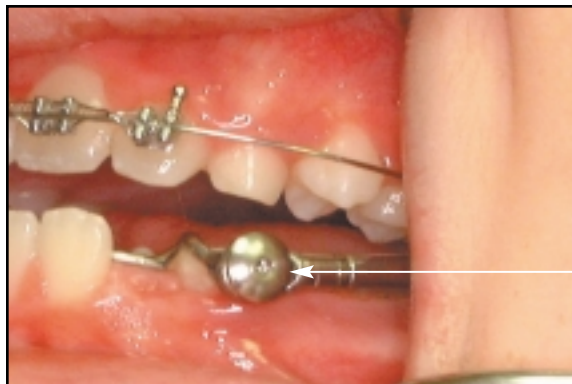
Fig. 13 Larger mushroom screw can be used in any quadrant if sore spot develops.

screws,<sup>††</sup> which have a 2mm greater diameter than regular Herbst screws, can also be used to help sore spots heal (Fig. 13). These screws should not be used routinely, however, because the larger heads tend to bind on the rods in lateral movements and thus to break off more often.

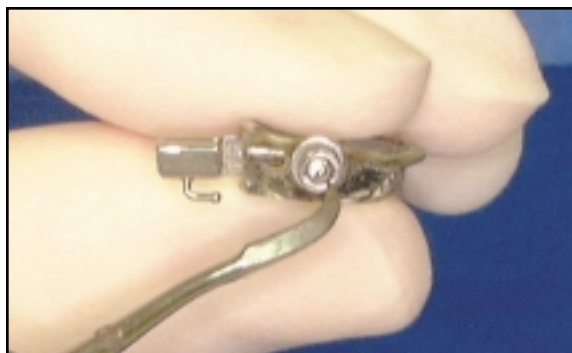
Fig. 14 Broken upper screw head grooved with bur and unscrewed with scaler.

*12. Broken screw heads.*

Solution: For a broken upper screw head, remove the band or crown, groove the screw stem with an S.S. White RA-35 slow-speed bur,<sup>‡‡</sup> and remove the screw with a scaler or a small jeweler's screwdriver (Fig. 14). A broken

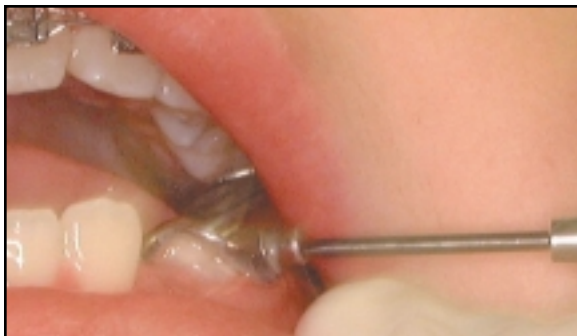
**Fig. 15** Broken lower screw head removed with screwdriver.

lower screw head can sometimes be unscrewed in the mouth without removing the appliance (Fig. 15). Another option: A wire can be spot-welded to the broken stem and then unscrewed (Fig. 16).

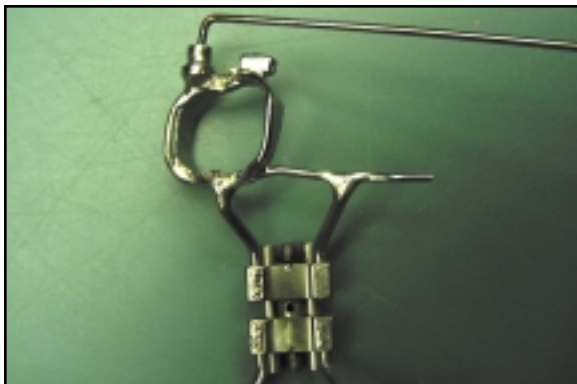
**Fig. 16** Wire spot-welded to broken screw stem.

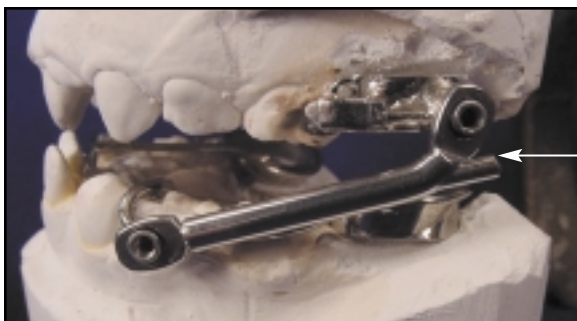
**Fig. 17** Rod cut to correct length.

### *13. Rods coming out of the tubes.*

**Solution:** Ensure that the rods and tubes are long enough to prevent the appliance from disengaging in the mouth (Fig. 17). To save chairtime, the laboratory can cut and polish rods to the correct length.

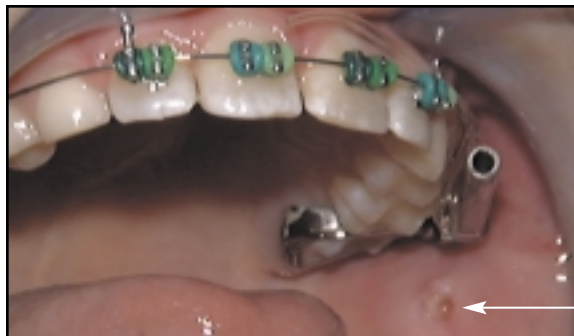
**Fig. 18** Sore spot caused by long rod.

### *14. Rod impinging on the oral mucosa.*

**Solution:** Make sure the rod is not too long. If the rod is causing a sore spot (Fig. 18), it must be shortened even if the appliance comes apart.

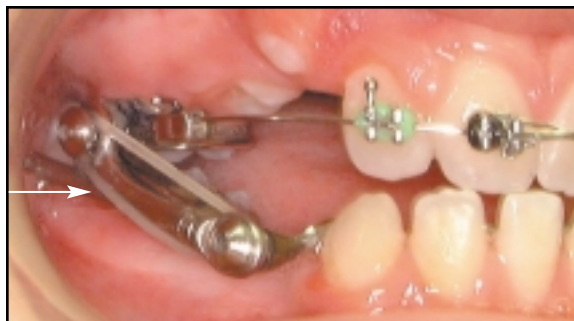
**Fig. 19** Elastic placed distal to upper pivot and mesial to lower pivot to hold appliance together when patient opens wide.

### *15. Bent rods and split tubes.*

The Herbst will normally come apart occasionally, but rods bend and tubes split when the appliance comes apart frequently. If this occurs, the patient should be seen as soon as possible, because routine disengagement is the primary cause of loose and broken appliances.

Solution: Make the rods and tubes longer. If the rods cannot be lengthened because they would impinge on the cheeks and the tubes cannot be lengthened because the appliance would be overadvanced, an elastic can be used to help keep the appliance together (Fig. 19).

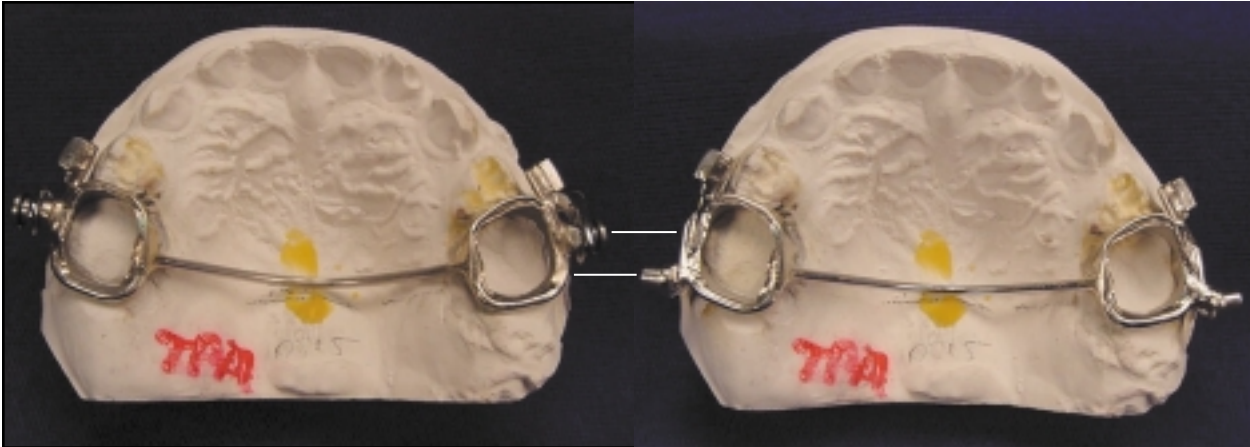
**Fig. 20** When upper primary second molars are used for anchorage, pivots should be moved about 2mm distally to prevent frequent disengagement.

*16. Frequent disengagement when upper primary second molars are used for anchorage.*

If the upper first permanent molars have not erupted sufficiently for banding, the primary second molars must sometimes be used. Solution: Move the pivots about 2mm distally on the bands or crowns (Fig. 20). Moving the pivots distally

allows for longer tubes, which will keep the appliance from coming apart every time the patient opens.

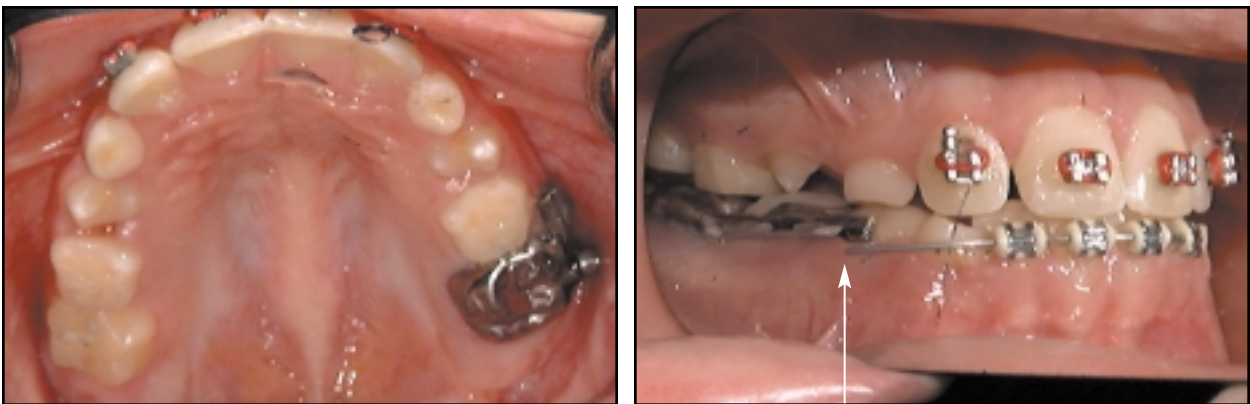
**Fig. 21** Broken wire and pivot and missing crown. Patient destroyed both crown and banded Herbst appliances.

*17. Chronic and excessive appliance breakage.*

Solution: Do not use the Herbst in autistic children, patients with severe bruxism, or extremely uncooperative children (Fig. 21). The Herbst, like all other appliances, requires proper patient selection.
