High-temperature hydrogen attack of carbon steel

D. ELIEZER

Materials Engineering Department, Ben Gurion University of the Negev, Beer Sheva, Israel

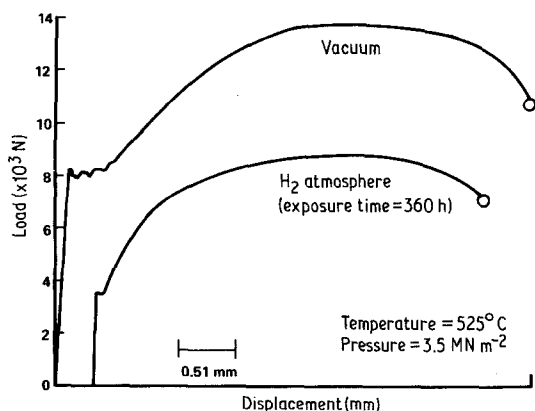
A high-purity hydrogen environment at 525° C was found to significantly degrade the tensile properties of SAE 1020 steel after as little as 120 h of exposure, the shortest exposure time of this study. Fig. 1 is a summary of the tensile curves observed at room temperature for a specimen exposed at 525° C to a vacuum environment and a specimen exposed at 525° C to a hydrogen environment for 360 h. As shown in Fig. 1, yield strength, ultimate tensile strength, and elongation-at-fracture are all reduced as a result of exposure to the high-pressure hydrogen environment. As can be seen, exposure to hydrogen for 360 h results in a 58% reduction in the yield strength a

Figure 1 A summary of tensile curves observed at room temperature for 1020 steel for a sample exposed to a vacuum environment at 525° C and a sample exposed to a hydrogen environment for 360 h at 525° C.

40% reduction in the ultimate tensile strength and elongation-at-fracture is reduced to less than 2%.

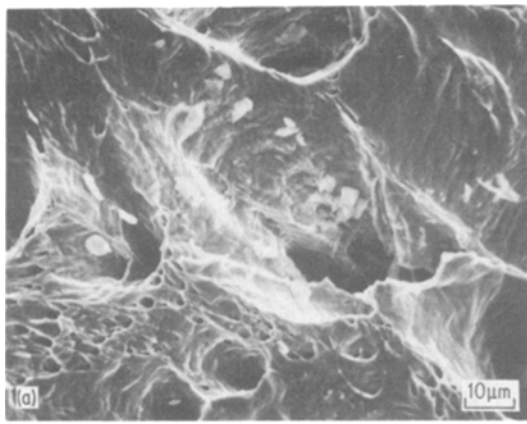
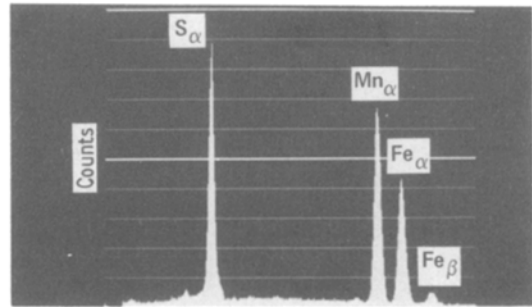
Examination of the fracture surfaces of the specimens exposed to the hydrogen environment indicates massive regions of microvoid coalescence producing ductile rupture (Fig. 2). The formation of microvoids was often associated with particles which were identified as manganese sulphide particles with some indication of aluminium and silicon [9]. Void formation during hydrogen attack around manganese particles has been previously observed [10, 11]. Pisko *et al.* [12] found that hydrogen attack started with the nucleation and growth of myriad small bubbles on a minority of the ferrite-pearlite or ferrite-ferrite boundaries.

Figure 2 Scanning electron microscopy (SEM) fractograph of fracture surfaces showing (a) massive regions of microvoid coalescence producing ductile rupture, (b) electron dispersive X-ray (EDAX) analysis showing manganese sulphide particles.

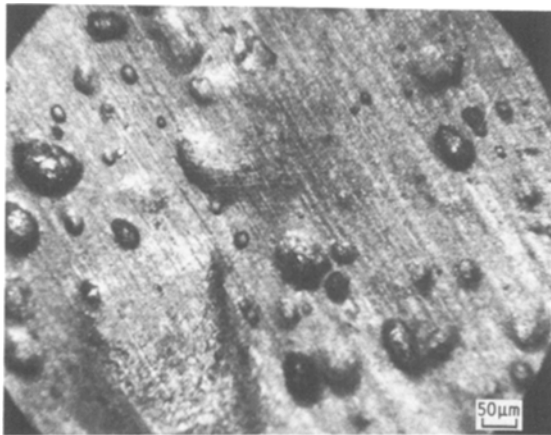
Figure 3 A typical surface of a specimen exposed to gaseous hydrogen at a pressure of 3.5 MN m^{-2} and at a temperature of 525° C for 240 h.

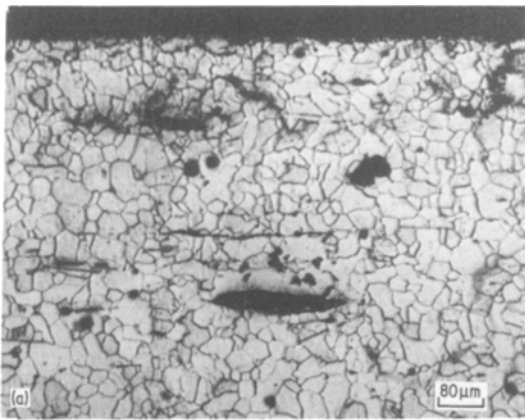
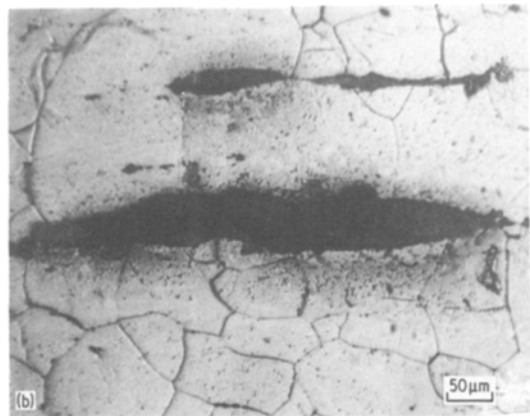
Sorell and Humphries [15] report the close relationship and resemblance between blisters and fissuring in a damaged carbon steel. Once fissures begin to interconnect it becomes easier for the steel surface to bulge out and for progressive damage along the plane of the blisters. Such blistering is inevitably accompanied by extensive decarburization. A tear observed in the interior of the specimen is shown in Fig. 4. These tears are extensive at the gauge length, relatively few at the shoulder, and are not observed in the WOL specimen. It can be seen (Fig. 4) that the region close to the tear has very coarse ferrite grain structure. The preferential recrystallization and grain

Figure 4 Tears observed in a completely decarburized specimen.

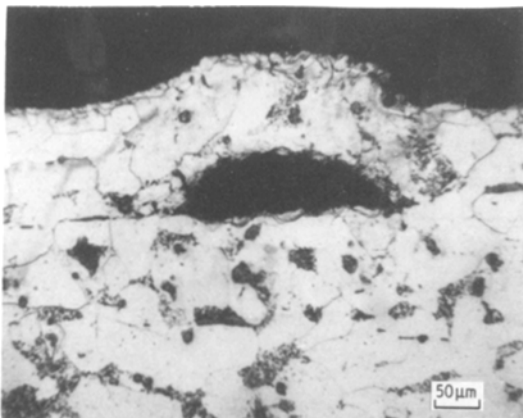
coarsening confirms that substantial internal pressure exists inside the tear. A typical blister observed in a partially hydrogen-attacked specimen is shown in Fig. 5. When a tear is located close to the specimen surface it bulges and produces blisters. It is proposed that during hydrogen attack of a commercial 1020 steel, tears form and undergo crack growth as a result of the formation and accumulation of methane under high pressure at the weak interfaces such as at the inclusion–matrix or the ferrite–pearlite bands. The internal pressure of methane within the tear is maintained due to the continued hydrogen attack and the tear runs along the length of the specimen leading to delamination. It should be mentioned that all the attacked specimens showed methane bubbles (of size about $2 \mu\text{m}$) along grain boundaries similar to those observed by others [11]. As exposure time increases these bubbles begin to coalesce into fissures. In the more advanced stages of hydrogen attack some of the fissures form into large tears (of about size $60 \mu\text{m}$) along the inclusion in the rolling direction. If a large tear is located close to the surface, it bulges to form a blister. The tears grow and the blisters bulge rapidly, compared to the growth of the bubbles, leading to fissuring and delamination. Therefore, tearing and blistering may lead to accelerated failure by hydrogen attack.

Figure 5 Tear bulges into a blister in a partially decarburized specimen.
