The origin of the "crack tip" mode of failure in boron filaments

F. E. WAWNER, J. W. McCOY University of Virginia, Charlottesville, Virginia 22901, USA

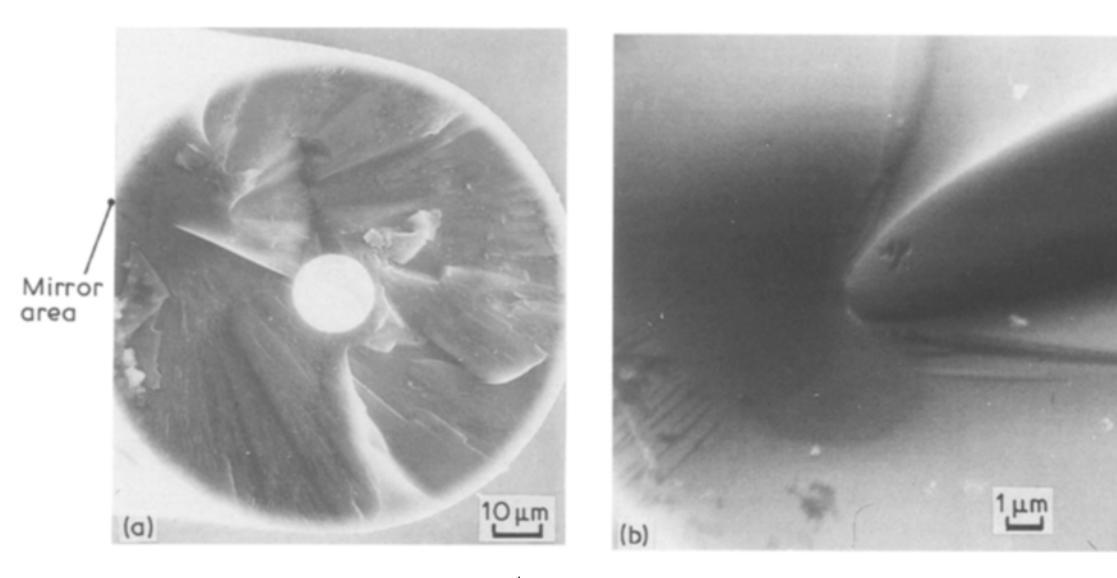
The tensile tests revealed that while sections of the filament had fracture stresses of $4.3 \,\text{GN}\,\text{m}^{-2}$, most of the samples failed at approximately $1.7 \,\text{GN}\,\text{m}^{-2}$ or less. Fig. 3a depicts a typical fracture surface for the

low-strength filament showing the "crack tip" mode of failure. The high-strength filaments failed at the core-sheath interface. In the micrograph of the "crack tip" failure one can observe that the mirror area (denoting slow crack growth) surrounds the tip of the radial crack. Regions of this type normally surround the fracture nucleation site in brittle, glassy materials. Fig. 3b shows the extreme tip of a radial crack incorporating the fracture nucleation site. One can see that there is a step associated with the radial crack and at its tip is a differently appearing region (darker) approximately $5 \mu m$ in diameter. There is, however, no indication of an actual flaw in this region. The transverse slow crack has propagated at different levels from the tip of the crack inward and there are surface steps on the mirror area at the tip of the radial crack, oriented in the direction of the propagating transverse crack. Also obvious are some surface steps outside the dark fracture nucleation area [5].

Figure 3 (a, b) Fracture surface showing "crack tip" mode of failure.

Upon loading, the radial crack is initiated at some stress level lower than the ultimate axial fracture stress and propagates to the neutral zone with internal stress as the driving force. Transverse crack formation is then initiated at the voids along the neutral axis (which coincides with the tip of the radial crack) and slowly grows with increasing applied stress during the tensile test. The fact that the transverse slow growth crack propagates at different levels on opposite sides of the crack (Fig. 3b) suggests that the radial crack is present before the transverse crack is initiated.

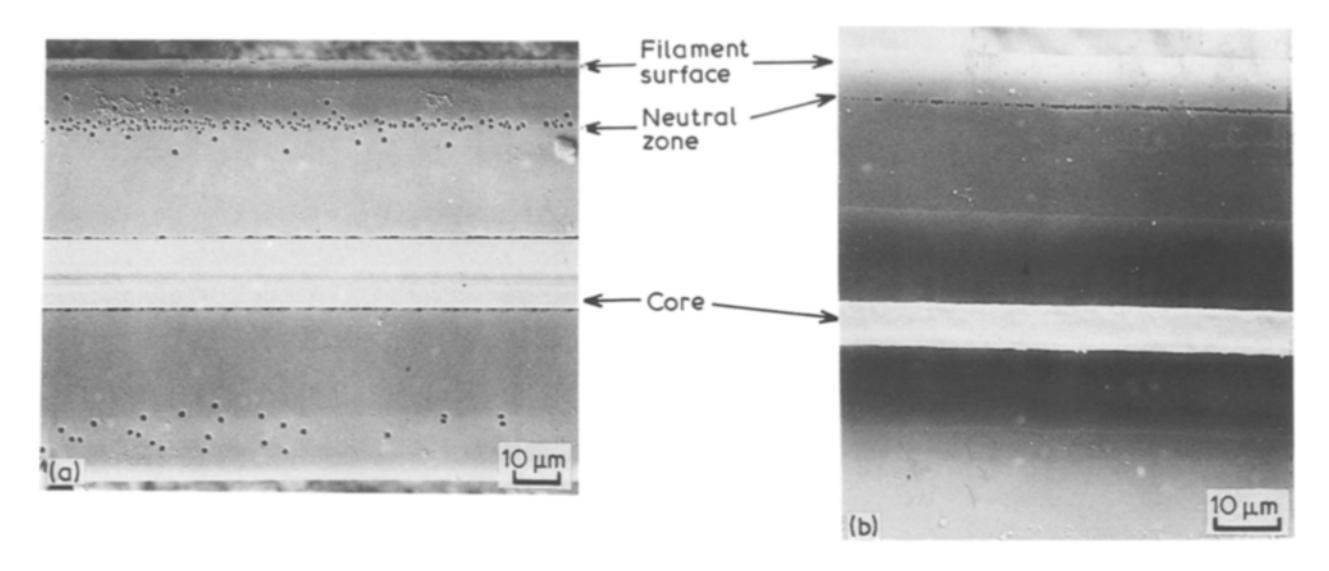
Figure 4 (a, b) Split filament showing voids, enhanced by etching, aligned along neutral stress zone.

radial crack is the actual fracture nucleation site or whether the fracture first nucleated at some flaw in the bulk boron and the radial crack initiated at a proximate void [6] and propagated to this region as a result of stored elastic energy in the highly strained filament (Krukonis' concept [7]). In an attempt to generate information, etched split filament was examined in the SEM. Figs 4a and b show two representative micrographs. Holes or pits that have been enhanced by the etching can be seen in the bulk boron. Whereas on occasion the holes were randomly distributed, in the majority they were aligned in a row parallel to the fibre axis and located in the region corresponding to the neutral axis between tensile and compressive residual stress regions in the filament. All split and etched filament exhibited a similar phenomenon.

It is proposed that as the rate of deposition in CVD boron filament is increased due to forcing the temperature profile, greater amounts of reactant gases are trapped within the bulk boron. These gases migrate to voids formed by the coalescence of vacancies which subsequently grow to bubbles due to stress-induced mechanisms described by Stiegler *et al.* [14]. The bubbles then migrate to a region of lower stress in the manner suggested by Martin [16]. This region of lower stress coincides with the neutral zone between tensile and compressive residual stresses in the boron deposit. The bubbles align themselves along this region and link up to form stable crack nuclei [14]. Scanning electron micrographs shown in Figs 4a and b demonstrate that this does occur.
