The origin of striations on the surface of iron-zinc coated steel sheet produced by hot-dip galvannealing

VIJAY JAGANNATHAN*

Homer Research Laboratories, Bethlehem Steel Corporation, Bethlehem, PA, USA

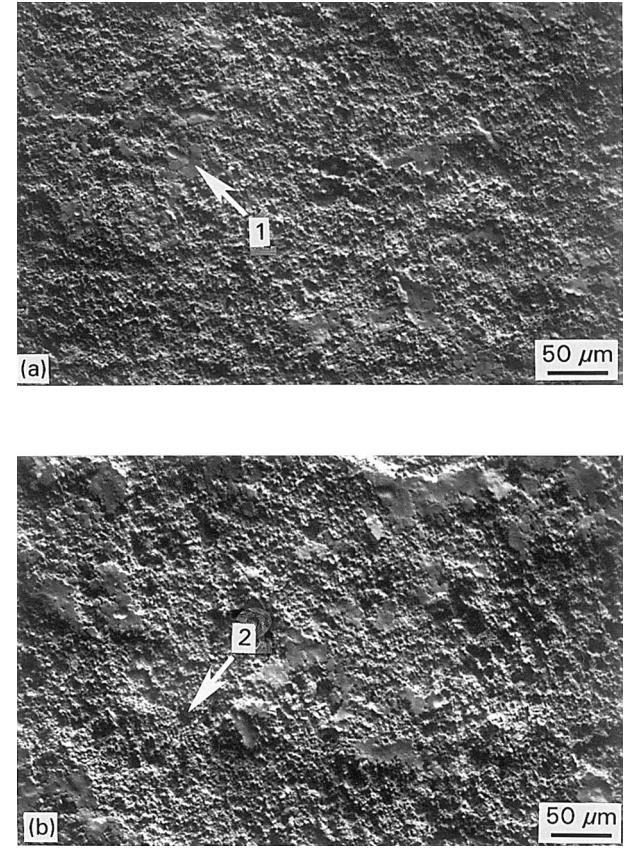
Figure 3 SEM micrograph of (a) Surface of a light area on the sheet surface, (b) surface of a dark striation on the sheet surface. Note burnish marks (1) and craters (2).

SEM micrographs of the light and dark areas that constitute the striations on the surface of the coating are shown in Fig. 3 (a and b) respectively. A combination of backscattered and secondary electron signals were used for imaging in the SEM to present a better view of the topography of the coating in the dark and light areas. The inherent roughness of the surface of galvanneal coatings is evident in both the light and dark areas. Areas of the surface also appear to be burnished, which is also a typical feature of such coatings that have been through a galvanneling line and have undergone skin-pass or temper rolling. The difference between the two surfaces as shown in Fig. 3 (a and b) visually appears to be an increased roughness in the dark area when compared with the light area. This increased roughness in the dark area is the result of numerous small craters or pits that have been identified in Fig. 3 (a and b). On observation at higher magnifications, shown in Fig. 4 (a and b), the crystals of the iron–zinc δ phase intermetallic [4] are clearly seen in both areas, with a crater, or pit in the dark area shown more clearly in Fig. 4b. It is therefore evident that the darker areas on the sheet surface appear so because of the greater roughness of the coating. The larger number of surface pits would reduce the amount of reflected light, to cause those regions to visually appear darker than the adjacent coating regions and therefore give rise to the striated appearance. Optical metallography of the cross-sections of the coatings also confirmed the rougher nature of the dark areas of the coating.

Thus, the striations on the surface of the commercial galvanneal samples can be explained on the basis of the differential formation of the iron-aluminium barrier layer at the steel-bath interface during galvanizing. The contact of the sink roll with the steel sheet causes variations in the iron-aluminium barrier layer at the interface, with a more coherent layer formed in the areas where there is no contact i.e., the areas of the grooves on the sink roll. As a result, when the sheet is galvannealed to form iron-zinc intermetallics, the coating in the groove regions develops under a local environment of higher aluminium concentration than the adjacent areas. This growth of the iron-zinc coating under a higher local aluminium concentration leads to a greater pitted surface appearance in those areas, as shown in Figs 3b and 4b, and results in the formation of dark striations on the surface of the coated sheet.

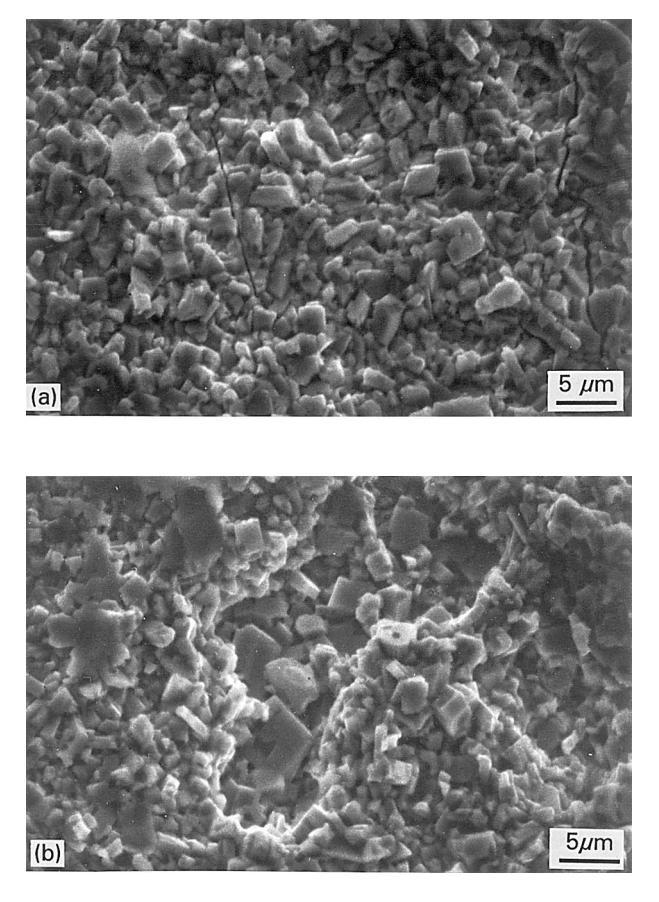
Figure 4 SEM micrograph of (a) a higher magnification view of the surfaces of (a) light area and (b) dark striation on the sheet surface.

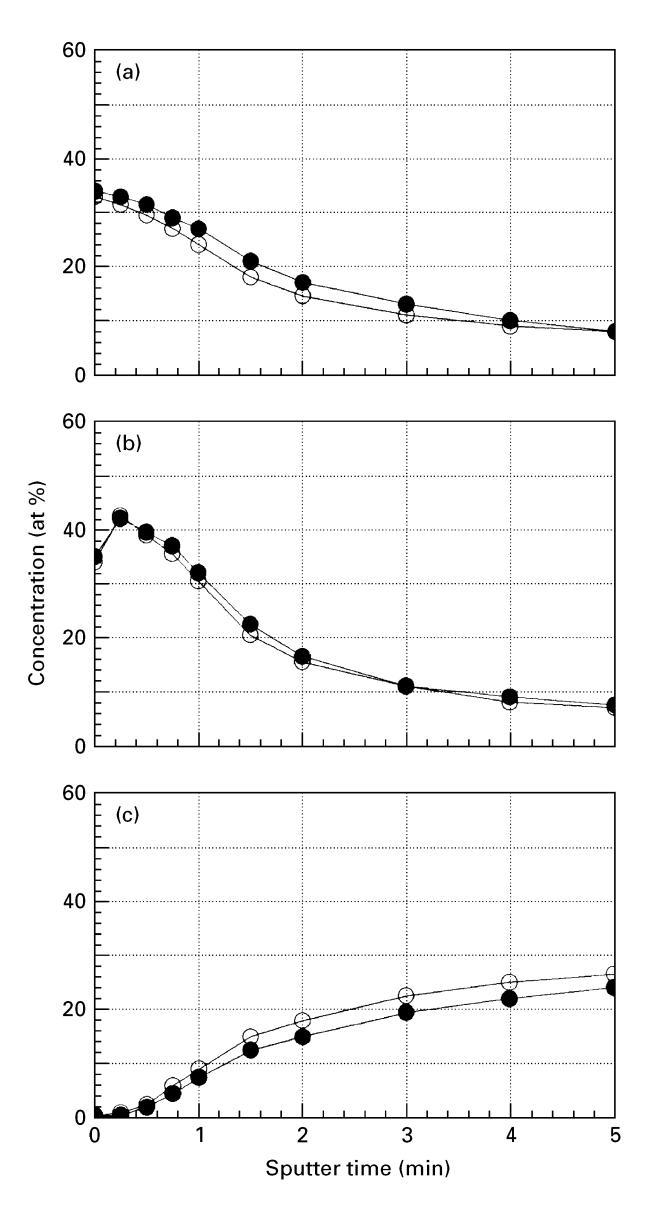
AES elemental depth profiles for aluminium, oxygen and iron are shown in Fig. 5(a-c). These are representative profiles from analyses carried out on duplicate samples of each of the light and dark areas. The results of the analyses indicate that the dark areas have a greater concentration of aluminium and oxygen at the surface, and less iron, especially with increasing depth profiling, when compared to the light areas. The differences observed are slight, but consistent enough to be noted.

Figure 5 Elemental depth profiles of the surface of the sheet determined by AES (a) aluminium, (b) oxygen and (c) iron in all cases data taken from a dark area is denoted by the symbol (\bigcirc) and data from a light area is denoted by the symbol (\bigcirc).

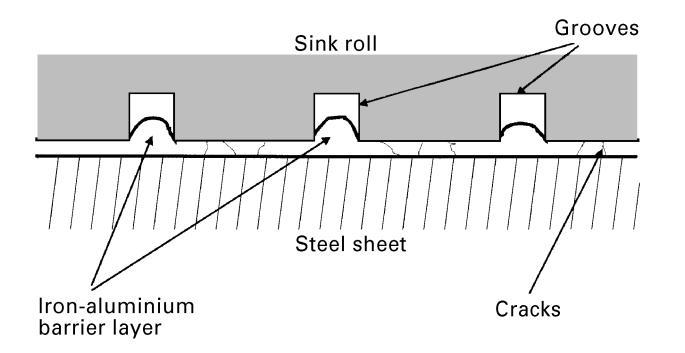
The contact of the grooved sink roll with the steel sheet in the zinc bath selectively suppresses the formation of the iron-aluminium barrier layer on the sheet surface. Since the roll is grooved, there is no direct contact between the roll and the sheet in areas of the grooves and significant contact in the other areas. Fig. 6 shows a schematic view of this differential contact and the result that it might have on the iron-aluminium barrier layer formation. The increased pressure at the areas of contact between the roll and the strip could lead to a decreased formation of the iron-aluminium layer in those areas. Additionally, the mechanical contact and possible abrasion could either cause cracking and damage to any barrier layer already formed, or even completely destroy the layer in the areas of contact. However, in the area of the grooves, where there is no contact between the roll and strip there is free, unrestricted growth of the barrier layer. There is also increased aluminium transport within the groove areas because of greater fluid flow in the grooves during normal operation (rotation) of the roll. These facts suggest that differential growth of the iron-aluminium layer barrier layer could

Figure 6 Schematic view (not to scale) of the contact of the sink roll with the sheet and its effect on the iron–aluminium layer growth.

To mitigate the striations on the surface, variations in the formation of the iron-aluminium barrier layer must be minimized. The contact of the steel sheet with the sink roll is essential to the processing, but the pressure exerted by the roll on the sheet can be minimized during the processing to reduce the amount of damage to the barrier layer at the areas of contact. Lowering the aluminium content of the zinc bath would minimize the growth rate of the iron-aluminium barrier layer and would therefore reduce the non-uniformity in its formation. The aluminium content of the bath should therefore be maintained at the lowest level possible. This would enable a reduction in the variation of the iron-aluminium barrier layer on the sheet surface. Since lower aluminium levels in general give rise to a coating surface lower in pits, even a local increase in aluminium level at the areas of the roll grooves will not result in rougher coating in those areas, and therefore will not give rise to dark striations.

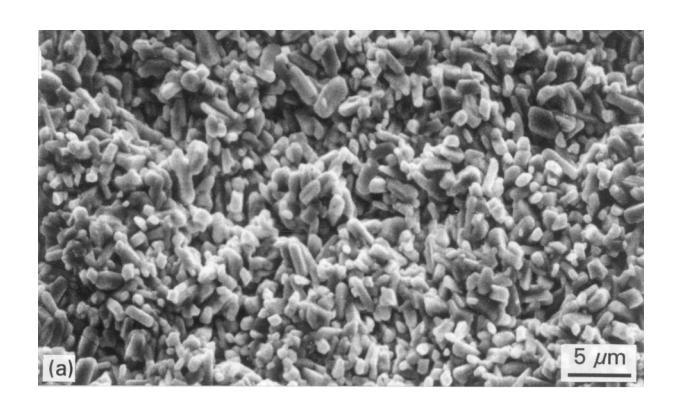
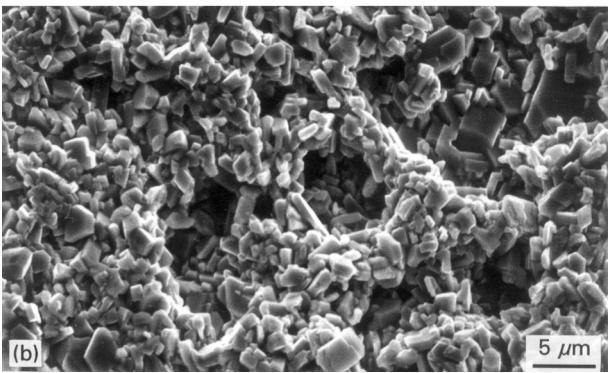
The amount of the iron-aluminium barrier layer formed on the sheet surface is dependent on various factors, the most important of which is the aluminium concentration of the zinc bath [7]. It has been observed in our laboratory in other studies (Fig. 7(a and b)) that higher concentrations of aluminium in galvanizing baths, around 0.15 wt % and higher, cause the iron-zinc intermetallics to form non-uniformly, resulting in an uneven coating surface after galvannealing. This is a result of aluminium destabilizing the planar interface between the liquid zinc and the iron-zinc intermetallics growing by diffusion. The

Figure 7 Surface of laboratory produced galvanneal sheet from (a) a low aluminium containing zinc bath and (b) a high aluminium containing zinc bath.

result of the non-planar interface is a pitted appearance of the coating surface after the iron-zinc intermetallics have consumed all of the pure zinc layer by diffusive growth. Lower aluminium levels in the galvanizing bath do not appear to destabilize the interface to the same extent, and the resultant coating surfaces lack the pitted appearance characteristic of galvanneal coatings produced from higher aluminium baths. Fig. 7(a and b) show the surfaces of laboratory produced galvanneal coatings, produced from a very low aluminium containing zinc bath (0.03 wt % Al) and a higher aluminium content zinc bath (0.14 wt %). The other processing conditions were held constant.
