Microscopic fracture mechanisms observed on Cu–Sn frangible bullets under quasi-static and dynamic compression

S. W. Banovic · S. P. Mates

Received: 25 October 2007 / Accepted: 5 May 2008 / Published online: 3 June 2008
© Springer Science+Business Media, LLC 2008

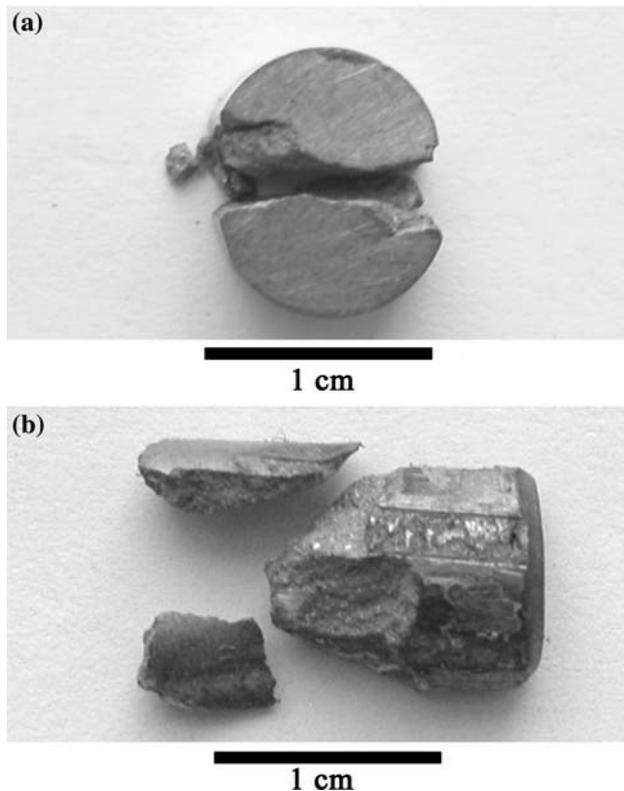
direction. Quasi-static samples developed a single crack that did not propagate across the entire sample, unless the test was intentionally continued past primary specimen failure to produce an observable fracture surface. Similarly, dynamic samples developed a primary fracture plane parallel to the loaded diameter that resulted in two large portions with numerous small bits and some powder scattered around the sample, Fig. 5a.

For the bullets discharged into the soft body armor, fracture occurred on multiple planes throughout the sample. Pieces returned for analysis were typically from one quarter to one third of the original bullet, Fig. 5b. These portions did not penetrate the vest. The remaining pieces of the bullets were either embedded in the vest or in the clay backing and were considered irretrievable.

Fig. 5 Characteristic macroscopic failures of tested samples: (a) dynamic samples and (b) recovered pieces from discharged bullet

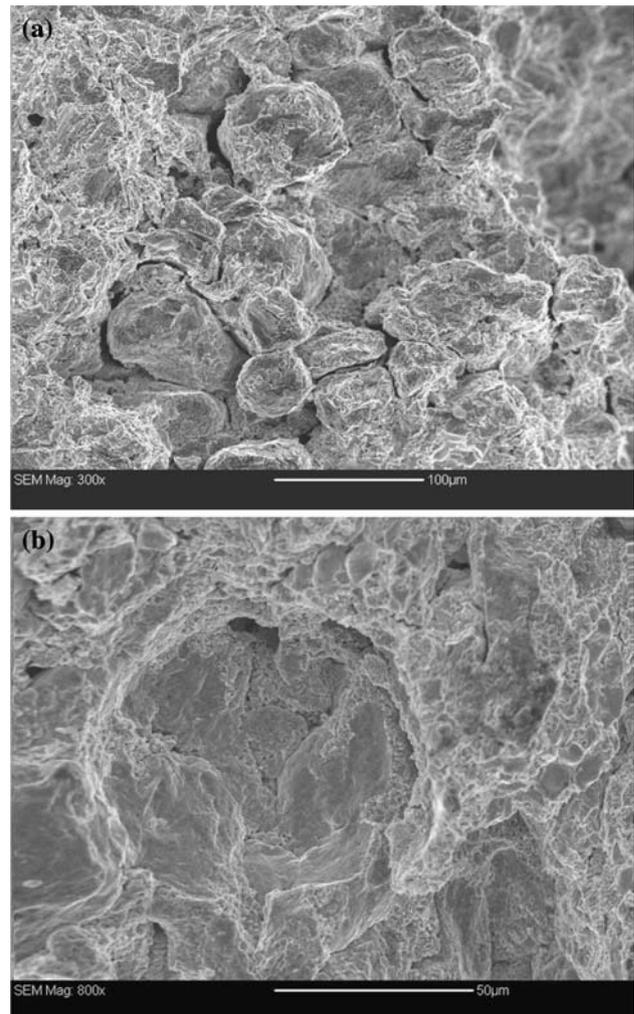
The most common characteristic observed on all fracture surfaces was separation at the copper particle interfaces, whether in the form of partial separation between two particles, Fig. 6a, or complete pull-out of the powder, Fig. 6b. Another form of copper matrix failure was microvoid coalescence (MVC), typically found when the copper matrix was closely bounded by IMC clusters, Fig. 7. On average, the intercluster distance of the IMCs was characteristically less than 30 μm. While some instances were observed on dynamic samples and discharged bullets, this feature was most often seen on fracture surfaces from the quasi-static samples.

Fig. 6 Secondary electron micrographs showing separation of unbonded copper particles. (a) Partial separation of copper particles (from dynamic sample) and (b) complete particle removal of particle from the matrix (from discharged bullet)

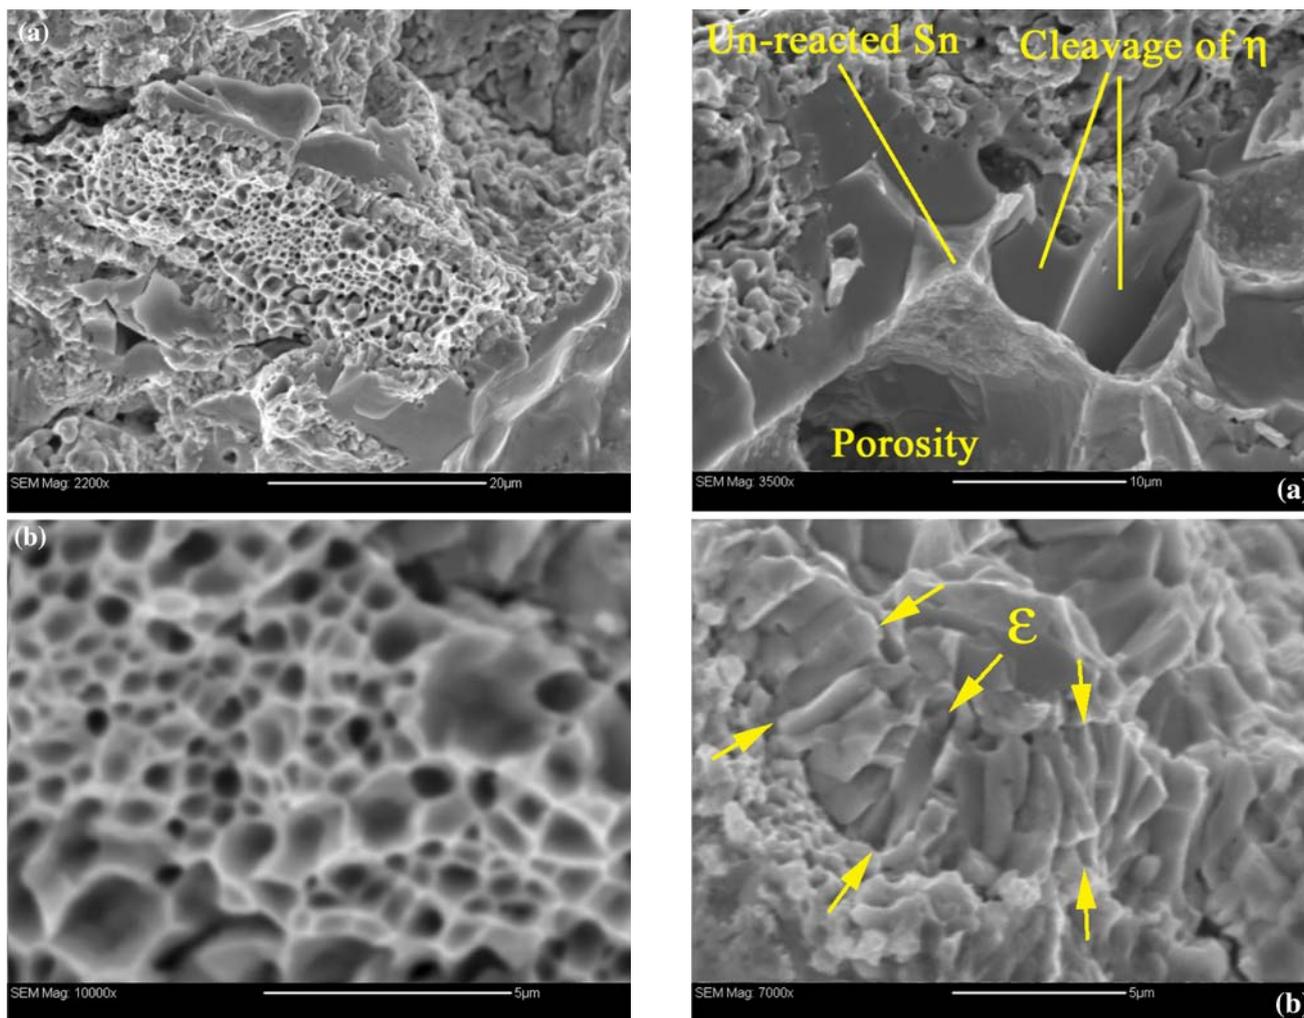
Fig. 7 Secondary electron micrograph showing microvoid coalescence of the copper metal (from quasi-static sample)

Although infrequent, microvoid coalescence (MVC) of the copper metal was a third failure mechanism. This higher energy mode was observed only when the inter-cluster distance of the IMCs was short, typically less than 30 μm . From all appearances, this mechanism occurred only in single copper particle when IMCs formed on opposite sides of a particle. Deforming material with the closely spaced IMC phases resulted in the development of high local plastic strains in the copper metal which lead to the evolution of ductile regions with fine, near-featureless, near-equiaxed dimples closely bounded by the fractured IMC. The shape of the dimples suggests that the material failed under simple uniaxial loading conditions, as they appear to grow out of the plane normal to the stress axis. As MVC was rare, its contribution to failure was insignificant.

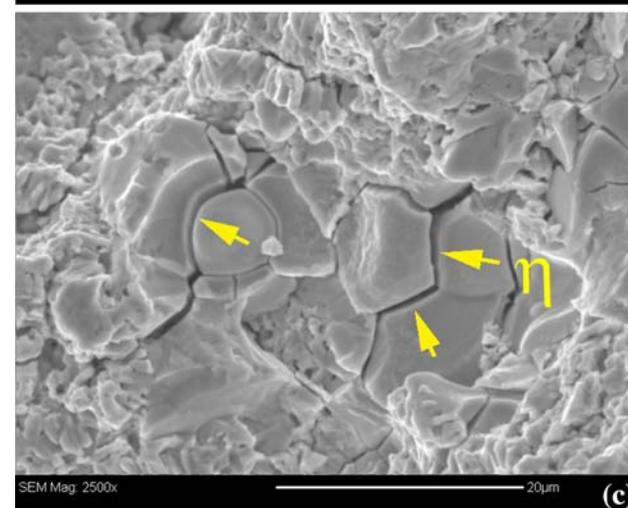
Cleavage of the IMCs was also readily observed on all samples, Fig. 8a and b, with Fig. 8c showing intergranular fracture of the large η(Cu₆Sn₅) grains.

Failure of the diametral compression samples occurred via cleavage and intergranular fracture of the IMCs, Fig. 8, in conjunction with copper particle–particle boundary separation, Fig. 6. The former is a low-energy failure mode that results in the frangible nature of the bullet upon impact with a hard target. The IMC phases are formed to act as a brittle binder between the un-bonded copper particles. These phases develop during a low-temperature heat treatment in which a transient liquid Sn film wets the copper powder interfaces, allowing for Cu diffusion into the liquid, and subsequent growth of the ϵ (Cu₃Sn) and η (Cu₆Sn₅) phases [2]. The development of these IMCs

Fig. 8 Secondary electron micrographs showing (a) cleavage of η (from dynamic sample), (b) cleavage of ϵ (from discharged bullet); (c) intergranular fracture of η (from discharged bullet)

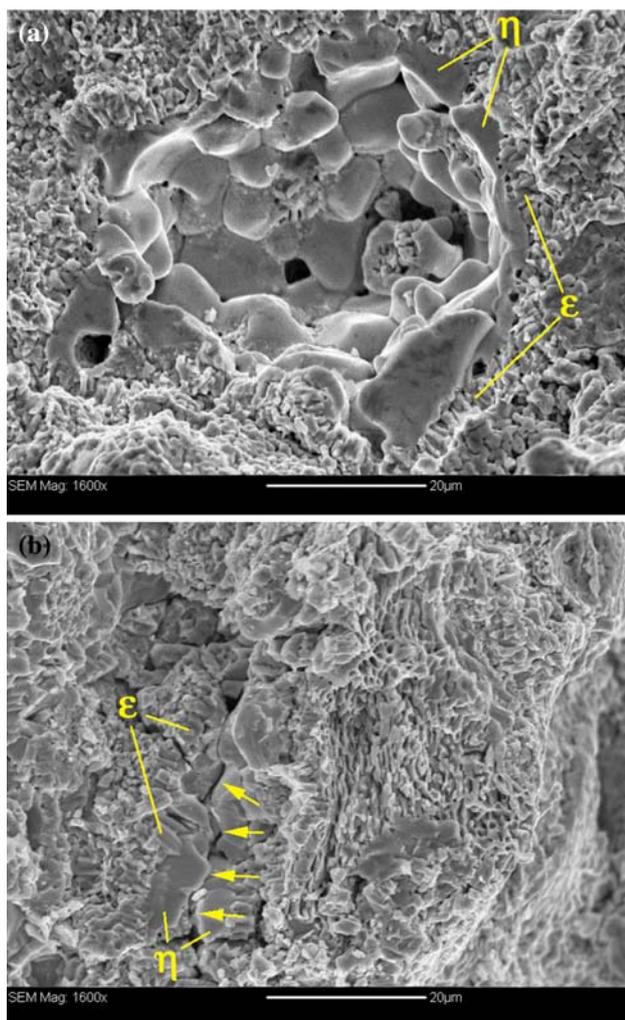
Porosity observed on the fracture surface had two different morphologies. The first, Fig. 9a, was similar in size

and shape to that in the polished cross section of untested material with the second being compressed, Fig. 9b. The latter was most prevalent in the discharged bullets.

Fig. 9 Secondary electron micrographs of porosity surrounded by fractured IMCs. (a) Porosity similar to the as-received state (from dynamic sample) and (b) collapsed porosity (from discharged bullet)

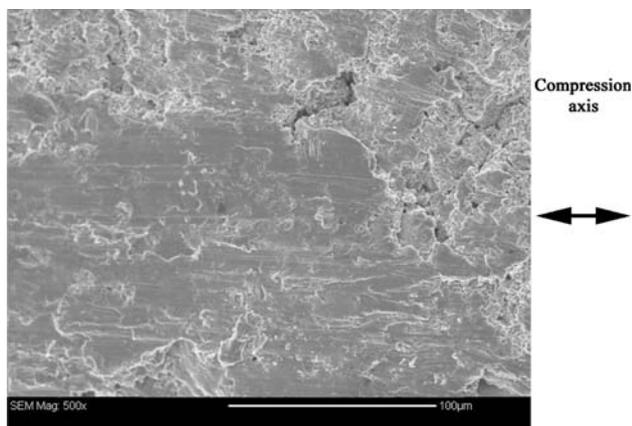
Sliding scars were also observed on the samples tested at higher loading rates, Fig. 10. The discharged bullets had the highest occurrence of this feature with over half of the fracture surface experiencing this attribute. Scars observed on the dynamic samples were concentrated solely near the ends of the sample in contact with the test mandrels, whereas the central portion of the specimen was unaffected.

Fig. 10 Secondary electron micrograph of a sliding scar (from discharged bullet)

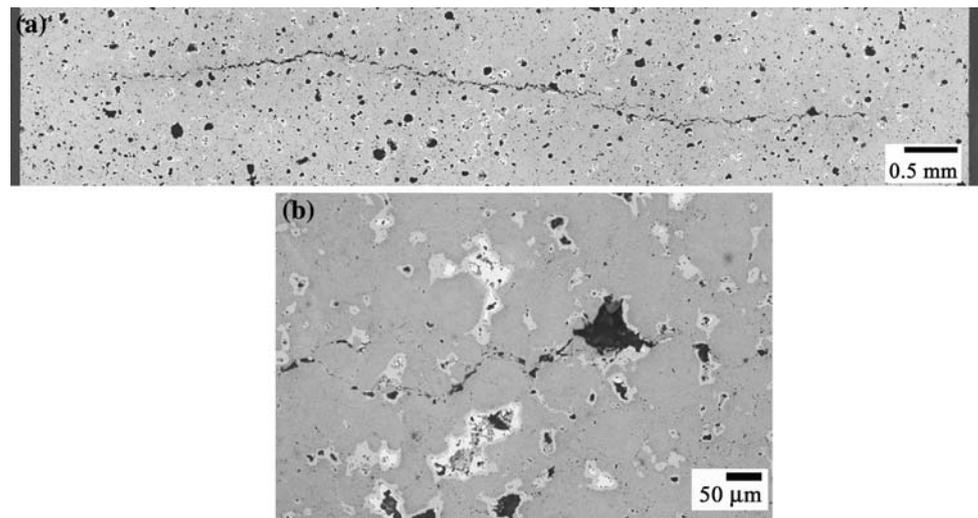
Metallographically polished samples of the failed materials were also examined. Figure 11 shows a cross section of a fracture in a quasi-static sample. The crack primarily followed particle–particle boundaries and through fractured IMC phases, Fig. 11b. Below the fracture surface, little if any damage was observed in the copper matrix or the IMCs. Similar results were observed for the dynamic samples; however, damage of the material (copper particle boundary separation, fracture of the IMC) was noted up to 500 μm beneath the fracture surfaces, Fig. 12. Metallographic examination of the bullet fired into the body armor

Fig. 11 Light optical micrograph of the fracture from a quasi-static sample. Crack primarily follows along particle–particle boundaries or through fracture of the IMC as seen in (b). Direction of loading is parallel to the crack

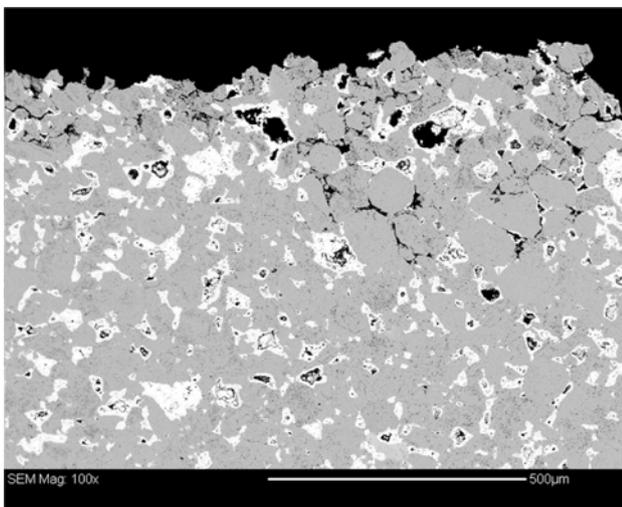
Fig. 12 Scanning electron micrograph of the fracture from a dynamic sample. Cracking also follows along particle–particle boundaries or through fracture of the IMC. Deformation of the material was found as much as 500 μm from the fracture surface. Direction of loading is parallel to the fracture surface

sample, Fig. 13. For the diametral compression samples, failure of the quasi-static samples was associated solely with the fracture surface, Fig. 11, whereas the dynamic test resulted in more widespread damage beneath the fracture surface, Fig. 12. The difference in damage to the structure may be related to (1) the amount of energy introduced to the bullet, (2) the stress state experienced by the different sample geometries (discussion of this factor is outside the scope of this paper and will be covered in a subsequent work), (3) stress wave effects in discharged bullets, and (4) the number of “loadings” experienced by the sample.

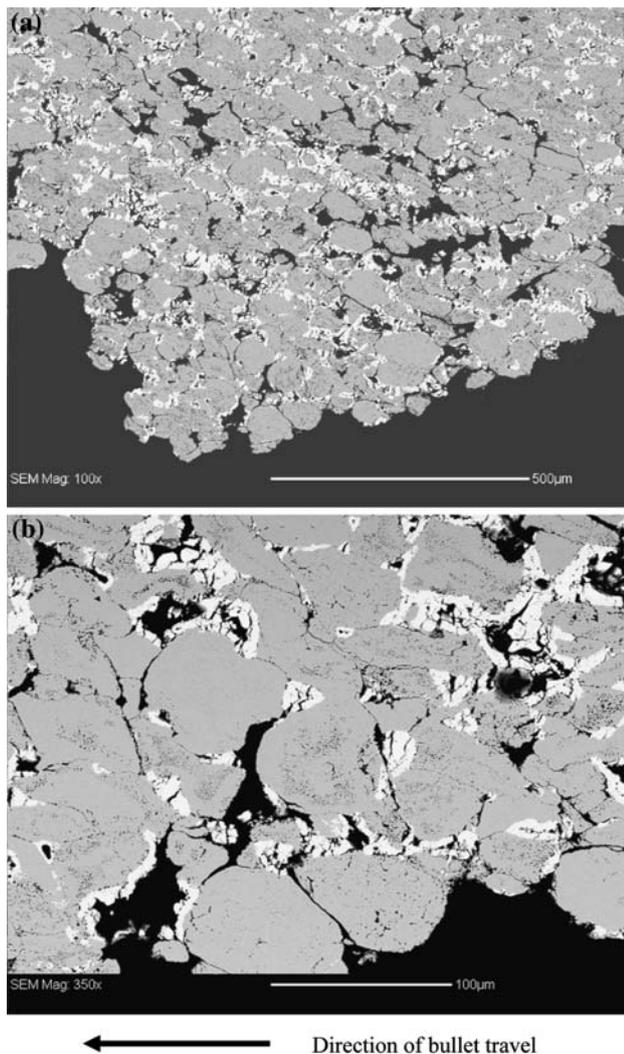
revealed that particle boundary separation and IMC fracture occurred extensively throughout the entire sample, Fig. 13.

Cross sections of failure surfaces revealed that subsurface damage differed between the compression tests and the test-fired samples; there was also a slight difference noted between the quasi-static and dynamic samples. For the discharged bullets, interparticle separation and fracture of the IMCs was extensively observed throughout the

Fig. 13 Scanning electron micrographs of fracture in a discharged bullet sample taken from failure along the side of the bullet near the front end. Extensive particle separation and IMC fracture was observed throughout the sample
