# The Correlation of Non-Destructive Measurements and Toughness Changes in Adhesive Joints during Environmental Attack

K. VINE, P. CAWLEY, and A. J. KINLOCH

*Department of Mechanical Engineering, Imperial College of Science, Technology and Medicine, London, United Kingdom*

*Keywords:* Durability; Fracture mechanics; Inspection; Non-destructive testing; Structural adhesive joints; Ultrasonics; Micro-defects; Surface treatment

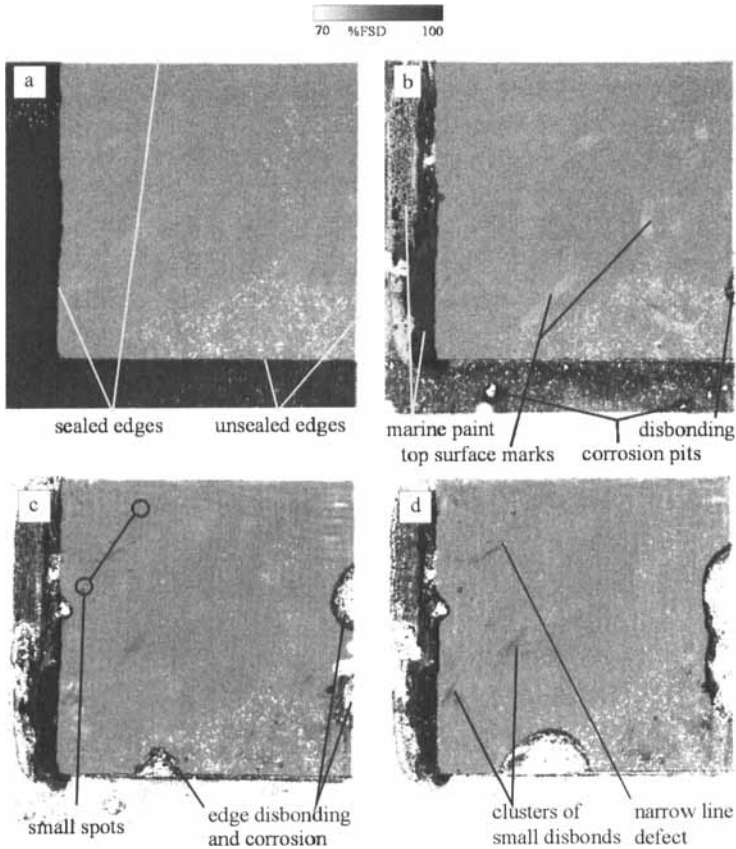
In the various normal-incidence scans that comprise Fig. 2 several different features may be identified. Firstly, there is an area of white speckle which is due to surface roughness. The effect of roughness can also be seen in the reflections from the disbanded regions of the sample; as time progresses, corrosion roughens the aluminium-alloy surface, and the reflected signal amplitude drops. Secondly, there are blurred light-shaded lines visible. These arise due to scratches on the top aluminium-alloy surface, produced during removal of the protective rubbery-sealant coating prior to scanning. Thirdly, an obvious relevant defect to develop in the specimen with increasing exposure time to water at 50°C is the growth of corrosion-driven disbonds from the unsealed edges, and these advance rapidly toward

FIGURE 2 Normal-incidence scans from two-layer, grit-blast specimens after exposure for: (a) 0 days (b) 27 days (c) 67 days (d) 117 days exposed to water at 50°C.

the centre of the specimen. Fourthly, another relevant type of defect are micro-defects. These appear to take basically three forms: (a) small spots, (b) line defects, and (c) darker areas which appear within the central region of the specimen. The small spots are generally detected when their size is around 0.5 mm diameter, or bigger. The line defects in many cases lead to the development of small corrosion spots and, again, their detectability appears to be size limited. The darker areas which appear within the central region of the specimen are suggested, from visual examination through the transparent epoxy layer, to be clusters of extremely small disbonds. As for the corrosion-driven

edge-disbonds, the number and extent of the micro-defects increase with increasing time in water at 50°C, as may be seen from Figures 2c and 2d.

Considering the ultrasonic scans in detail, after 27 days in water there are several relevant changes to be noted. The most important change is the disbonding initiating from the unsealed edges. (Outside of the bonded area, rapid corrosion of the free unsealed edge can be seen, with large corrosion pits appearing. The marine paint that was used to seal two of the edges can also be seen. This paint was applied after the initial scan but prior to exposure; but its thickness was not uniform and some corrosion occurred under it, which explains the mottled appearance on the scans.) However, closer observation shows that there are also micro-defects appearing under the epoxy in the form of some small, dark spots. These are apparently quite randomly distributed, with no apparent difference being seen with proximity to sealed or unsealed, flush or recessed edges. (Unfortunately, many of these small, micro-defects are more easily seen on the computer screen than on the printed figure.) Some of these small spots have been highlighted on scans taken at longer exposure periods (*e.g.*, Fig. 2c) but close scrutiny of the scan after 27 days shows initial signs of these micro-defects, *i.e.*, relatively small defects which are isolated from adjacent defects and occur throughout the specimen. As the exposure time increases, the general trend is for many of the features seen after 27 days of exposure to increase in number and to grow in size.

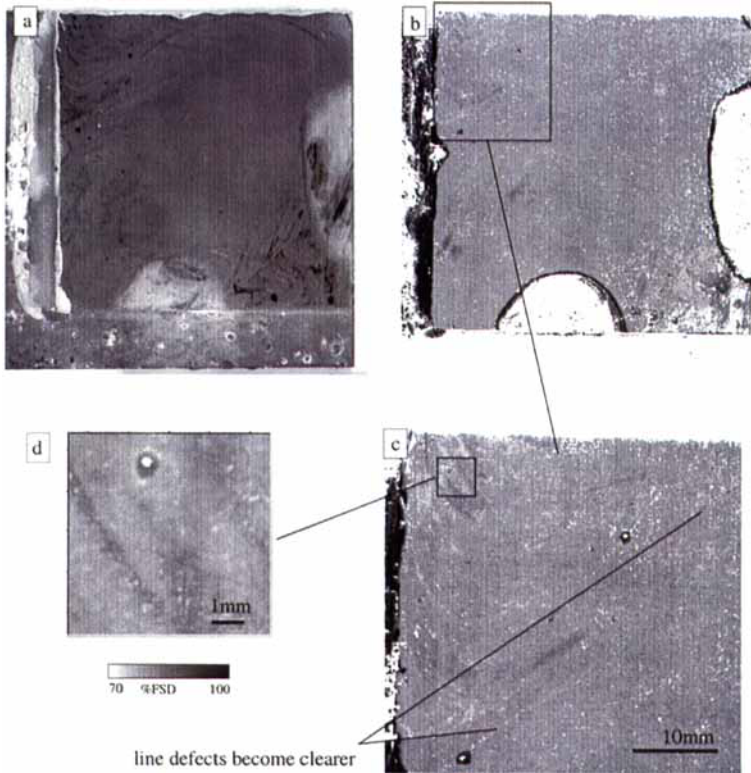
Figure 3 shows the final scan taken on this specimen after 223 days in water, together with higher resolution scans of some of the micro-defects and a photograph looking through the epoxy. The high-resolution scans show that it is possible to detect micro-defects that are less than about 1 mm in diameter, with detail considerably below this being evident; *i.e.*, dimensions of the order of 0.1 mm, although this is smaller than could be reliably detected. It is important to note that, although the scan pitch is as small as 0.025 mm for the finest scan, the focal spot size of the probe remains unchanged for all of the normal incidence scans. Changing the scan pitch from 0.1 to 0.025 mm primarily helps by giving some spatial averaging, making smaller micro-defects easier to identify but no sharper. The photograph shows many more micro-defects than are apparent from the scans. Some of these are surface marks that are not seen on the ultrasonic image as it

FIGURE 3 Two-layer, grit-blast specimen after 223 days exposed to water at 50°C: (a) photograph; (b) ultrasonic scan at 0.25 mm scan pitch; (c) ultrasonic scan at 0.1 mm scan pitch; (d) ultrasonic scan at 0.025 mm scan pitch.

is focussed on reflections from the adhesive/adherend interface. However, many of the spots and lines seen in the photograph, particularly in the top left and bottom right hand corner regions, are at the interface, but are too small to be detected with the resolution of the ultrasonic transducer employed. Finally, from the results shown in Figs. 2 and 3, it is very noteworthy that there was no evidence of a gradual change in the normal-incidence reflection coefficient moving into an apparently well-bonded region from either the corrosion-driven edge-disbonds or the micro-defects.

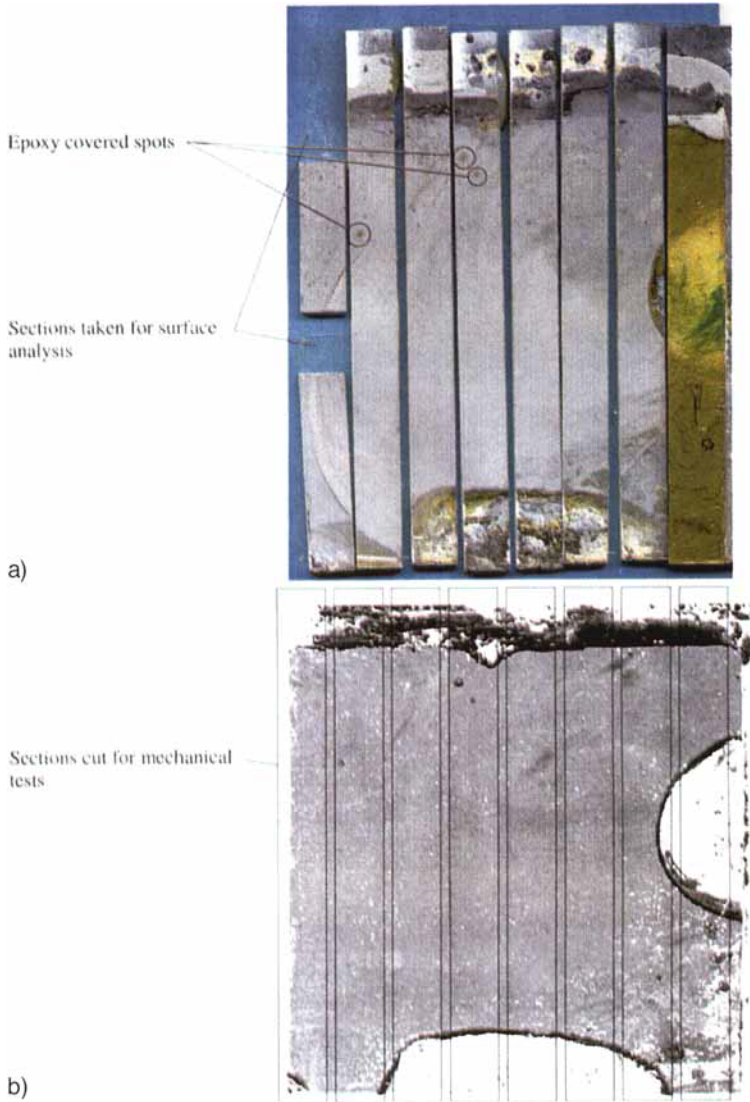
Figure 4 shows a comparison of a photograph of the failure surface from the two-layer, grit-blast specimen (Fig. 4a) with the final normal-incidence scan (Fig. 4b). The specimen had been exposed for 223 days

FIGURE 4 Two-layer, grit-blast specimen after 223 days in water: (a) failure surface; (b) normal-incidence ultrasonic scan.

in water at 50°C. The strips that were cut for the mechanical tests have been overlaid onto the ultrasonic image. The far right-hand strip was not tested mechanically, as preparing the edge of the strip was

considered to be too difficult due to the amount of disturbance to the epoxy layer because of the large edge-disbond present. Therefore, the original epoxy layer is still present on the photograph of this strip, see Fig. 4a. Considering the exposed failure surfaces shown in Fig. 4a, it is interesting to note that many of the defects that were clearly visible on the ultrasonic scan are distinguishable on the failure surface, due to the presence of a very thin covering layer of retained epoxy. This suggests that there was a failure in the epoxy layer at, or very close to, the interface prior to the mechanical test; otherwise it would not have been detected on the scan focused on the interface region.

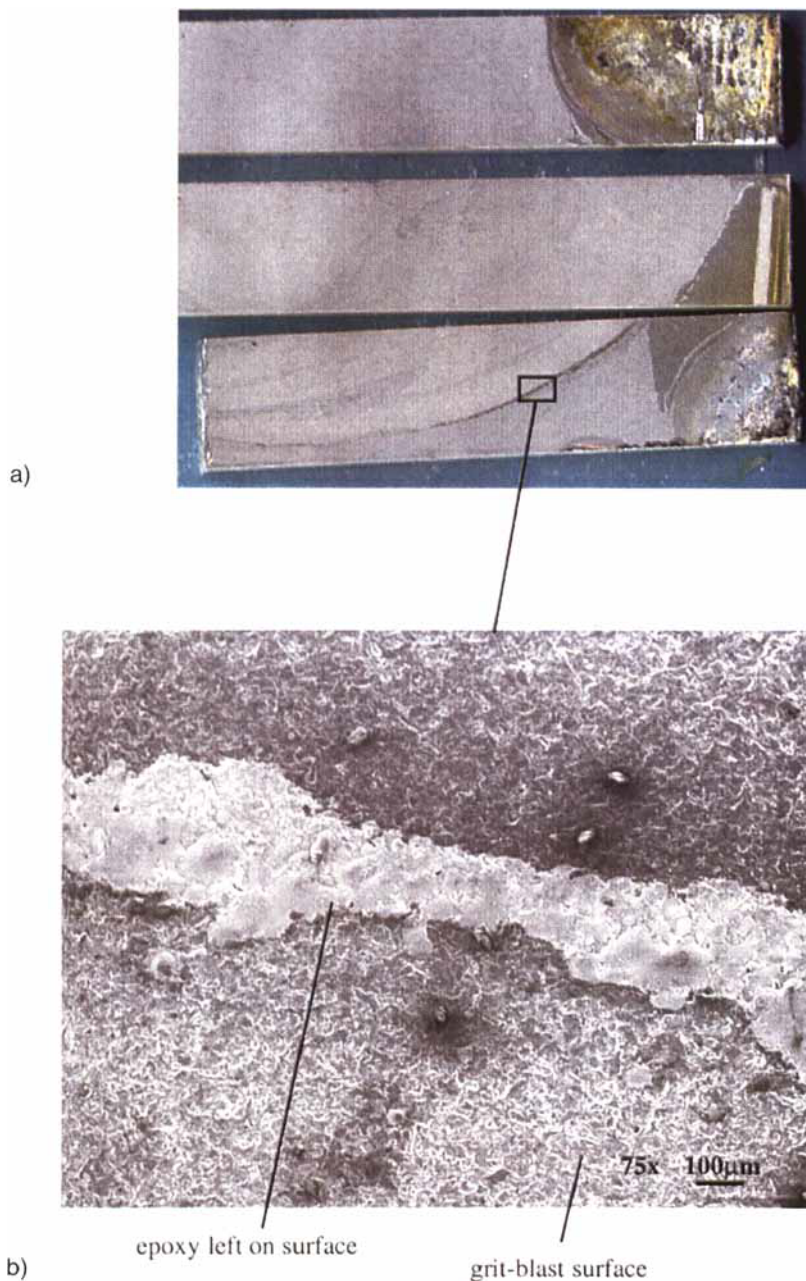
Figure 5 shows a scanning electron micrograph of this specimen, together with a small section of the failure surface shown in the previous figure. This micrograph shows one of the lines that was visible in the photograph of the specimen taken at the time of the final ultrasonic scan shown in Fig. 4a. The relatively rough surface generated by grit-blasting is evident, together with a line of epoxy covering the surface (see Fig. 5b). This suggests that the line defects seen in the photograph through the epoxy layer, and detected in the ultrasonic scans, might have been line-defects in the epoxy layer, close to the interface.

Correlating the above information to the toughness of the specimen, clearly the presence of corrosion-driven edge-disbonds resulted in a total loss of toughness in such degraded regions, but this type of defect was readily detected ultrasonically. However, if we ignore these regions, then the results shown in Table 1 reveal that the grit-blasted specimens lost some 54% of their initial toughness, as measured using the DCB tests to determine the values of  $G_c$  before and after exposure to water at 50°C. Further, this loss of interphase toughness was found to occur relatively uniformly over the remainder of the specimen. For example, no significant differences occurred in the vicinity of a corrosion-driven edge-disbond, or indeed the micro-defects. This obviously correlates well with the observation that there was *no* evidence of a gradual change in the normal-incidence reflection coefficient upon moving into an apparently well-bonded region from either the edge-disbonds or the micro-defects. Thus, an important conclusion in the case of the two-layer, grit-blast specimens, is that the detection of the isolated micro-defects was the only direct indicator that the interphase of the specimen had been weakened by the ingressing water molecules.

FIGURE 5 Failure surface from two-layer, grit-blast specimen: (a) photograph; (b) scanning electron micrograph.

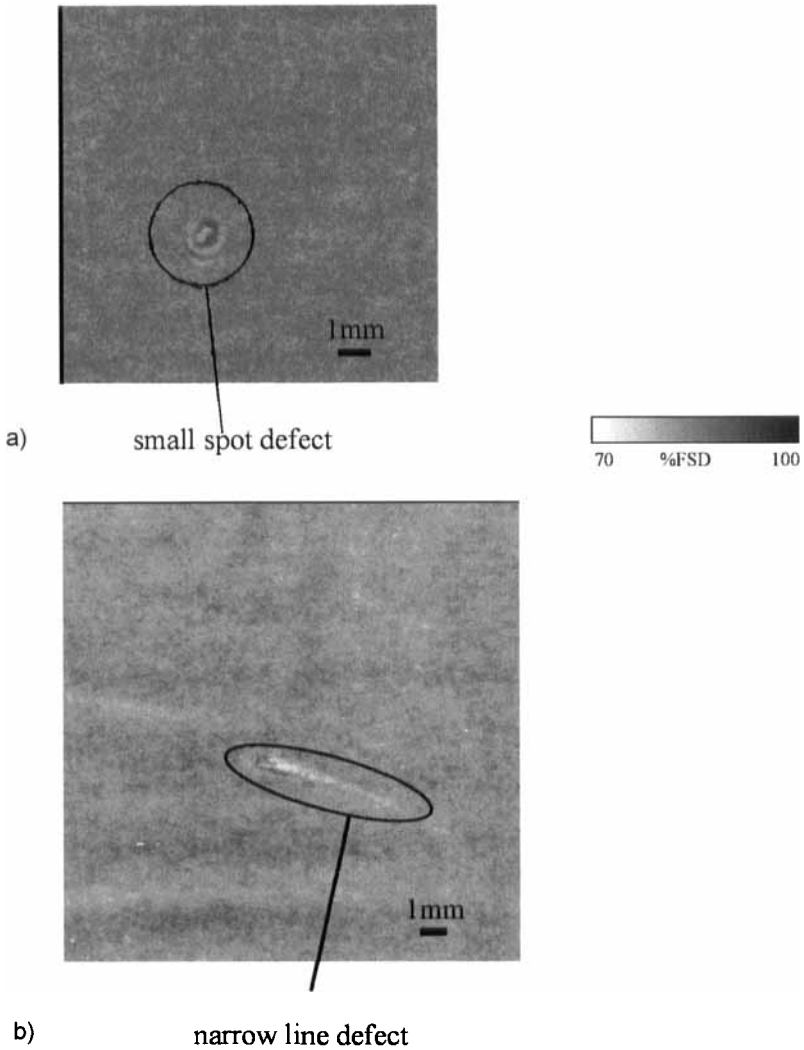
Figure 6 shows two high-resolution scans from a two-layer CAE sample after 154 and 194 days in water at 50°C, which illustrates that micro-defects remote from the edges are again apparent. These defects can readily be detected given a sufficiently high resolution scan. Figure 6a shows a spot micro-defect and, as with the grit-blast specimens, there were other types of micro-defects, particularly line-defects of the type shown in Fig. 6b. However, the number of micro-defects were very few, and this is reflected in the very good retention of toughness,  $G_c$ , of these specimens after water exposure at 50°C for 194 days, as may be seen in Table 1.

FIGURE 6 Normal-incidence ultrasonic high-resolution scans of (a) a small spot micro-defect taken from a CAE specimen after 154 days in water at 50°C and (b) a narrow line micro-defect from the same CAE specimen after 194 days in water at 50°C.

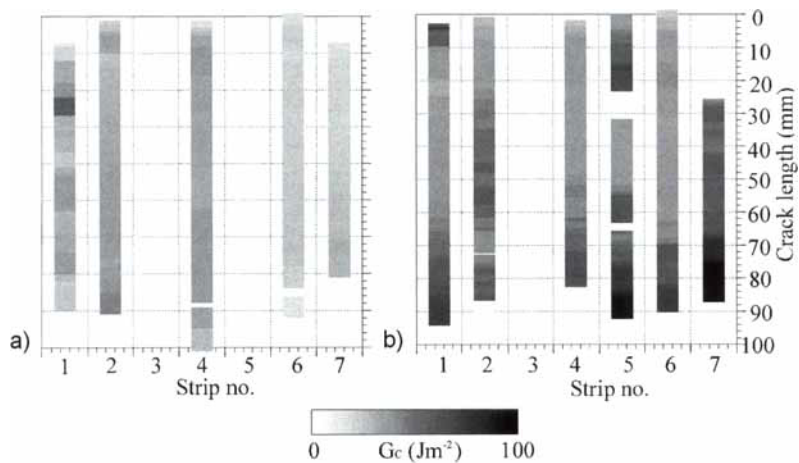
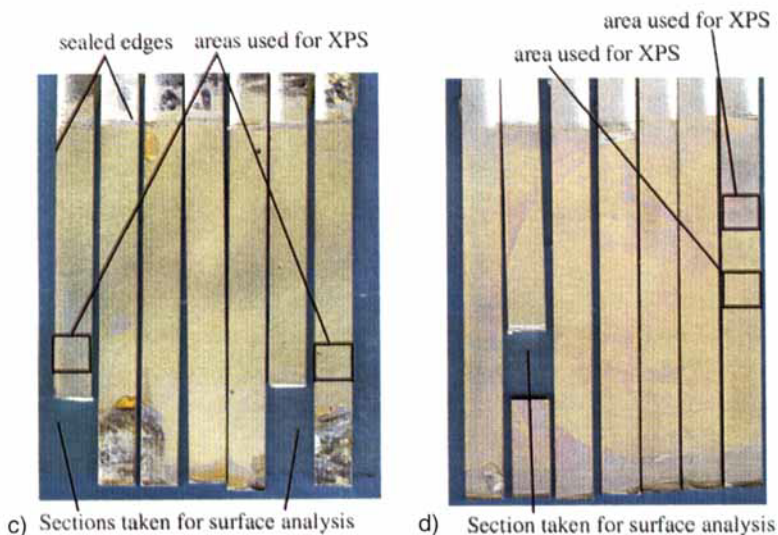
Figure 7 shows the mechanical test results, together with photographs of the failure surfaces, for the “wet” and “dry” two-layer PAA specimens. Figures 7a and b show the maps of the fracture toughness; where the value of  $G_c$  is shown as a function of crack length for the 10 mm wide fracture specimens which were cut from the two-layer PAA specimens. Thus, Figs. 7a and b give information on measured values of  $G_c$  which are assigned to spatially discrete positions within the specimen. The missing information on these maps is where (a) corrosion-driven edge-disbonds had occurred prior to the specimen being cut-up for the fracture tests, which of course resulted in that part of the specimen strip having zero toughness, or (b) unstable, stick-slip crack growth had occurred during the fracture tests, so that no value of  $G_c$  could be determined for this fracture test strip, or portion of the strip.

The average fracture toughness for the “dry” specimen was 55 J/m<sup>2</sup>, with the value of  $G_c$  being relatively uniform across the specimen, as would be expected. For the “wet” specimen, which had been exposed to water at 50°C for 393 days, the average toughness was reduced to 30 J/m<sup>2</sup> after 393 days in water at 50°C. As may be seen from Fig. 7a, for the “wet” fracture specimens the loss of toughness is also relatively uniform across the specimen. Indeed, there was no significant extra loss of toughness in a region adjacent to a corrosion-driven edge-disbond or a micro-defect.

As indicated in Figs. 7c and d, sections of the failure surfaces were analysed using X-ray photoelectron spectroscopy (XPS). These analyses revealed that failure in the “dry” tests was mainly through the epoxy adhesive, albeit close to the interface. However, after

FIGURE 7 Mechanical test results from the two-layer PAA specimens. Fracture toughness map from: (a) specimen after 393 days in water at 50°C; (b) control "dry" specimen; (c) photograph of the failure surface corresponding to (a); (d) photograph of the failure surface corresponding to (b). (The bottom and right-hand edges were the unsealed edges.).

environmental attack, the locus of failure of the two-layer specimens moved closer to the adhesive/adherend interface, with failure also occurring either at the interface or in the oxide layer.

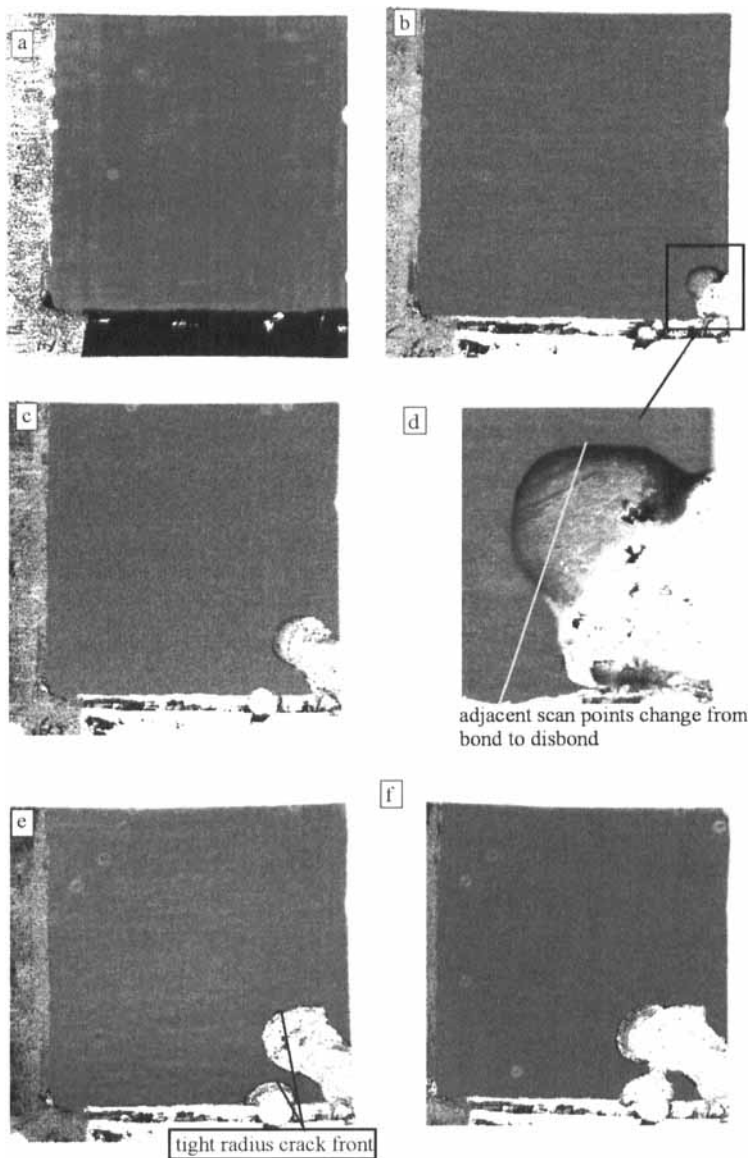
Figure 8 shows the progression of degradation for a two-layer CAA specimen. There is a clear progression of a corrosion-driven edge-disbond initiating on the unsealed flush edge, adjacent to the unsealed recessed edge. This is accompanied, after about 100 days of exposure to the aqueous environment, by a second edge-disbond which develops from the unsealed recessed edge. However, the CAA specimen differed from the other surface-pretreated two-layer specimens in that at no point was there any visual or ultrasonic evidence of any micro-defects during the 465 days that this specimen was in water, which is far longer than any of the other two-layer specimens. This is in excellent correlation with the observation that there is no loss of toughness in the CAA two-layer specimens, see Table 1.

The higher resolution scan shown in Fig. 8d after 103 days of exposure shows a detailed view of the corrosion-driven edge-disbond. This demonstrates that there is a “sharp edge” between the edge-disbond and what appears to be undamaged epoxy and epoxy/adherend interfacial regions. Indeed, this suggestion that there is a

FIGURE 8 Normal-incidence ultrasonic scans from the two-layer CAA specimen after: (a) 0; (b) 103; (c) 175; (e) 309; (f) 465 days in water at 50°C; (d) high resolution scan of an edge-disbond in (b).

“sharp edge” at the leading front of the edge-disbond is again supported by there being no significant extra loss of toughness in a region adjacent to this corrosion-driven edge-disbond. (However, as seen on other specimens, gross corrosion on the now debonded aluminium-alloy surface associated with the edge-disbond region does lead to a reduction in ultrasonic signal amplitude.) It is interesting to note that, although no primer was used with the CAA pretreatment, excellent durability of the two-layer specimen was recorded, unlike the case for the unprimed PAA pretreatment. It is suggested that this difference arises from the different morphologies of these oxide layers [1–7]. The CAA generated oxide is far thicker and possesses far smaller pores which do not pass completely through the oxide layer compared with the oxide morphology generated by the PAA pretreatment. Indeed, a CAA pretreated oxide is known [1] to not always require a primer in order to impart a good durability to an adhesively-bonded structure.

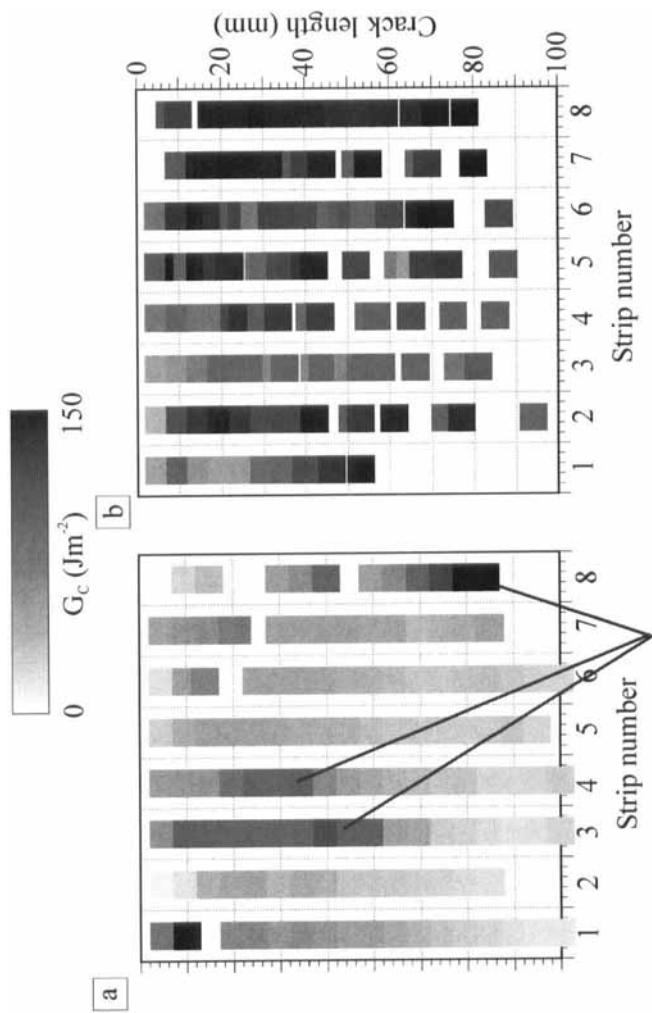
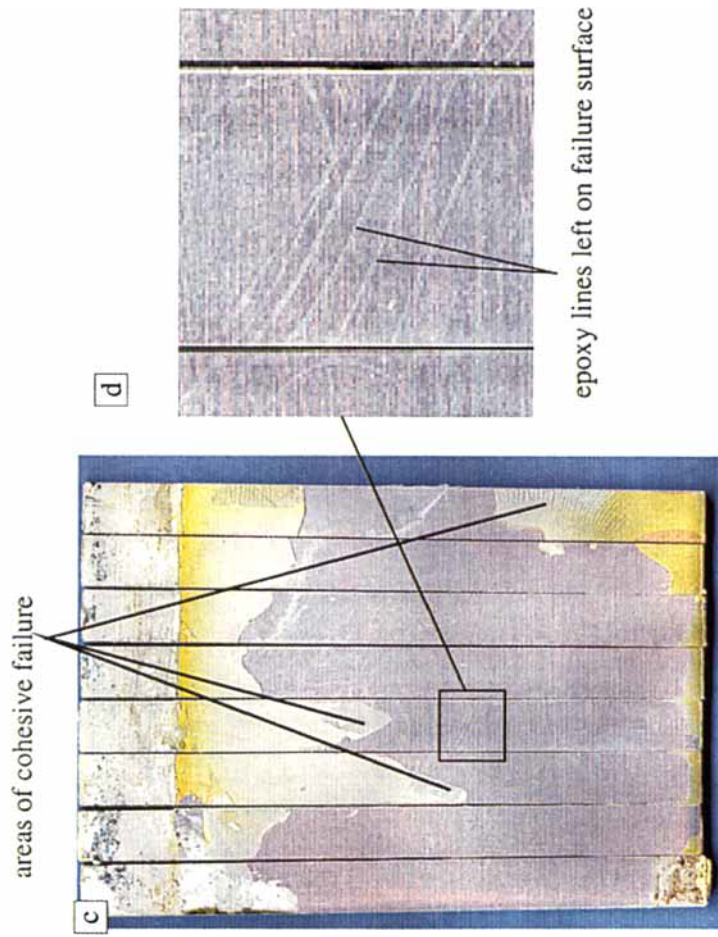
Nevertheless, the fracture surfaces of the failed mechanical tests of the grit-blast and PAA specimens showed fine line-defects of epoxy; *i.e.*, showed signs of micro-defects. These surface features, as shown in Fig. 9d for example, were similar to those which corresponded to the micro-defects which were detectable by the ultrasound techniques in the two-layer specimens; although they were smaller in number and in size on the failure surfaces of the grit-blast and PAA three-layer specimens. Therefore, it is possible that micro-defects remote from the edges were present in the three-layer specimens that failed interfacially and suffered a decrease in interphase toughness, but clearly they were not able to be detected ultrasonically. This possibility is further supported from the visual observations on the two-layer specimens, which clearly revealed that many more micro-defects were present than were detected ultrasonically—only the wider lines or larger spots being visible with ultrasound. (The two opaque adherends of the three-layer specimens meant, of course, that visual inspection of the interface was not possible with the three-layer specimens. Hence, for the three-layer specimens, only the appearance of the failure surfaces of the specimens which fractured interfacially can assist on this point.)

**FIGURE 9** Mechanical test results from three-layer PAA specimens. Fracture toughness map from: (a) specimen after 566 days in water; (b) control specimen. (c) failure surface corresponding to (a); (d) expanded view of section from (c) showing lines of epoxy on failure surface.

joint. As an example, the mechanical test data are shown in Fig. 9 for the three-layer PAA specimen. As may be seen, there are some isolated regions where cohesive failure through the adhesive layer is observed and these regions are associated with a relatively high value of  $G_c$ . For the remainder of the joint, failure in the interphase regions of the joint occurred and the value of  $G_c$  was relatively lower but uniform in value, see Fig. 9a. Since the failure of the "dry" three-layer PAA joint was always *via* cohesive failure through the adhesive layer, then clearly the presence of the aqueous environment has led to change in the locus of failure and associated lower value of  $G_c$ . Fig. 9d illustrates the lines of epoxy adhesives which were retained on the aluminium-alloy adherend. These are very similar in appearance, both visually and *via* scanning electron microscopy, to those found on the two-layer specimens, see Fig. 5.
