**TECHNICAL BULLETIN TO SUPPLEMENT  
TM 1-1670-260-12&P

UNIT MAINTENANCE AERIAL RECOVERY KIT  
(UMARK)  
PEACETIME AND NON-DAMAGED  
AIRCRAFT RECOVERY OPERATIONS**

**PN 94J500-1**

**HEADQUARTERS, DEPARTMENT OF THE ARMY  
20 MARCH 2003**

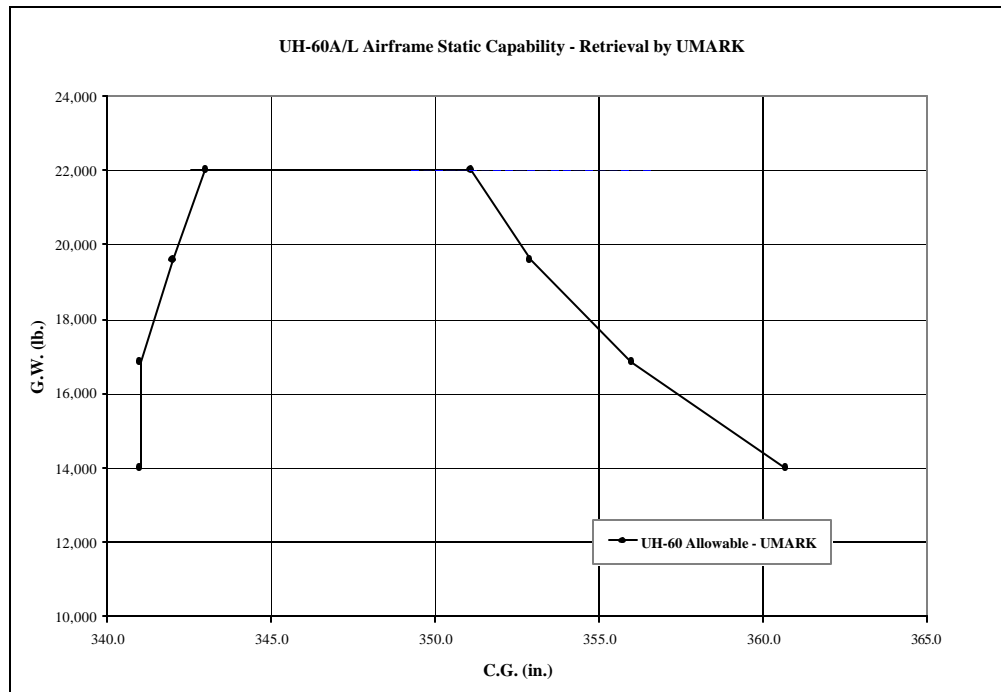
Figure 6. Airframe Static Capability

3.3.2.5.b Airframe Inspections - Using Aircraft Weight and Balance Record calculate the weight and center of gravity of the aircraft at time of recovery. Plot resulting point on graph below.

3.3.2.5.c If point is below the line above no airframe inspections are required.

3.3.2.5.d If point is above the line perform the following airframe inspections:

3.3.2.6 Inspect cabin area for cracks, permanent deformation, and loose or missing fasteners in the following areas:

3.3.2.6.1 Inspect Frame at Station 327.115

3.3.2.6.2 Inspect Beams at Buttline 16.5 from Station 308.0 to Station 343.5

3.3.2.6.3 Inspect Forward absorber supports from Station 308.0 to 327.115

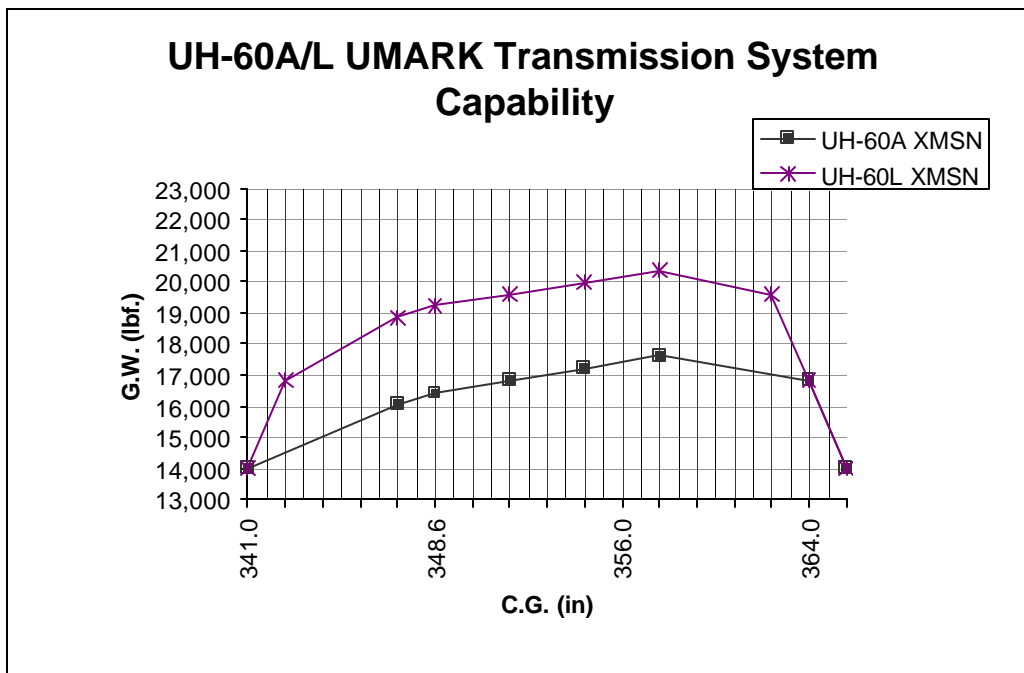
Figure 7. UMARK Transmission System Capability

3.3.3 Transmission Capability – Plot the same point on the graph below.

3.3.3.1 If the point is below the appropriate line for the model of aircraft recovered no corrective action is required.

3.3.3.2 If the point is above the appropriate line for the model of aircraft recovered the gearbox must be removed and returned to depot for inspection.
