Lean Blow Out Troubleshooting Guide

7FA,7FA+, 7FA+e DLN 2.6 machines

Customer Technology Services

May, 2005

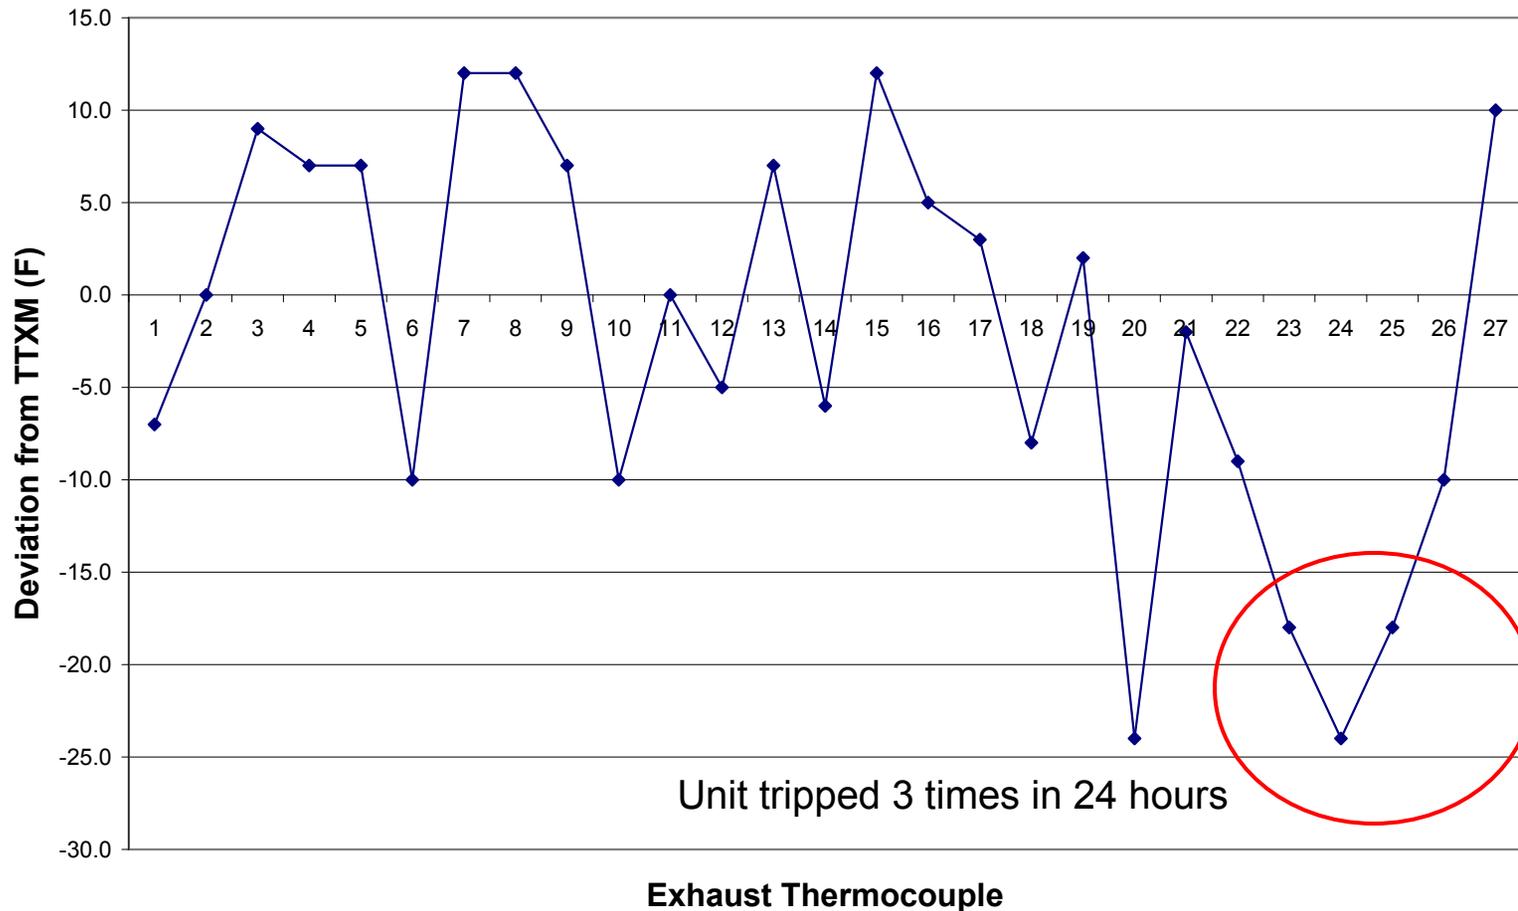
Exhaust Thermocouple Profile, 120 MW

Abnormal cold or hot spots may point to a hardware problem.
Check if cold (or hot) spot is consistent with chamber affected by trip.

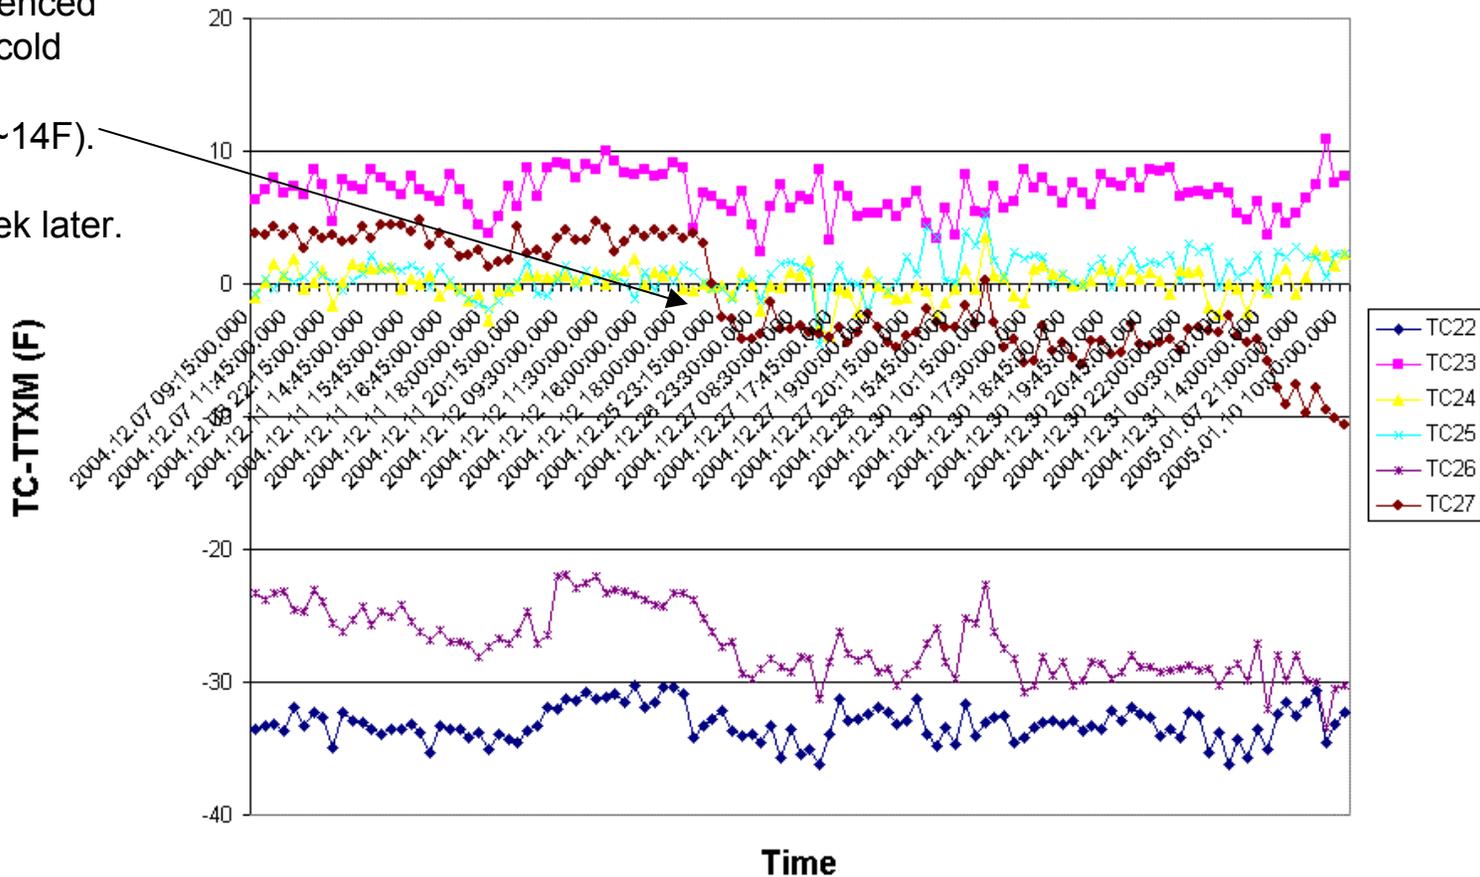
Exhaust Thermocouple Shift

TC 27 experienced a shift in the cold direction (net decrease of ~14F). Unit tripped 5 times a week later.

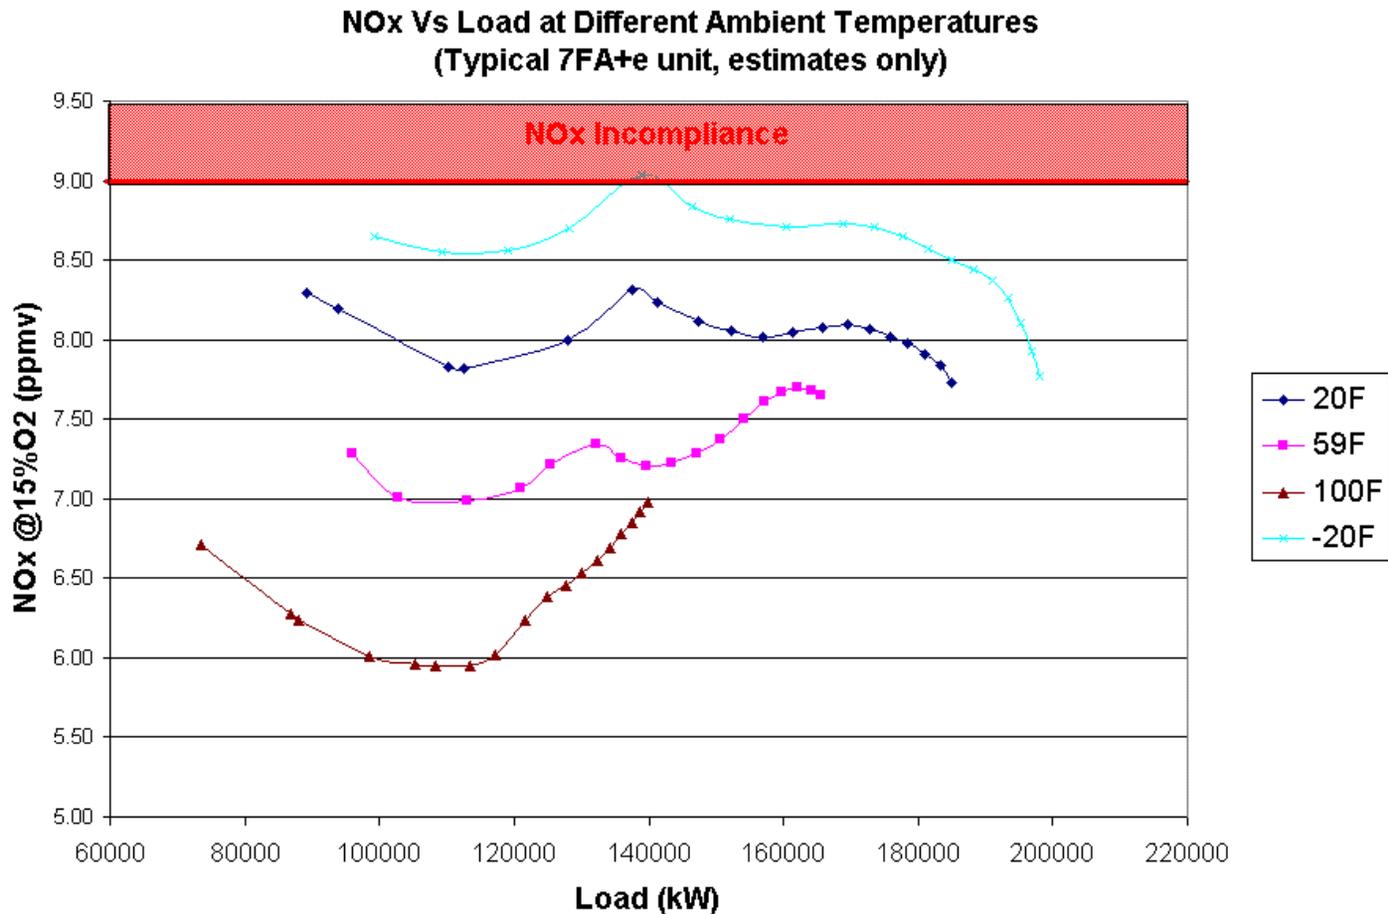
A trend of decreasing NOx levels, coupled with Lean Blow Out events, may suggest that DLN Tuning is needed to enhance the Lean Blow Out margin.

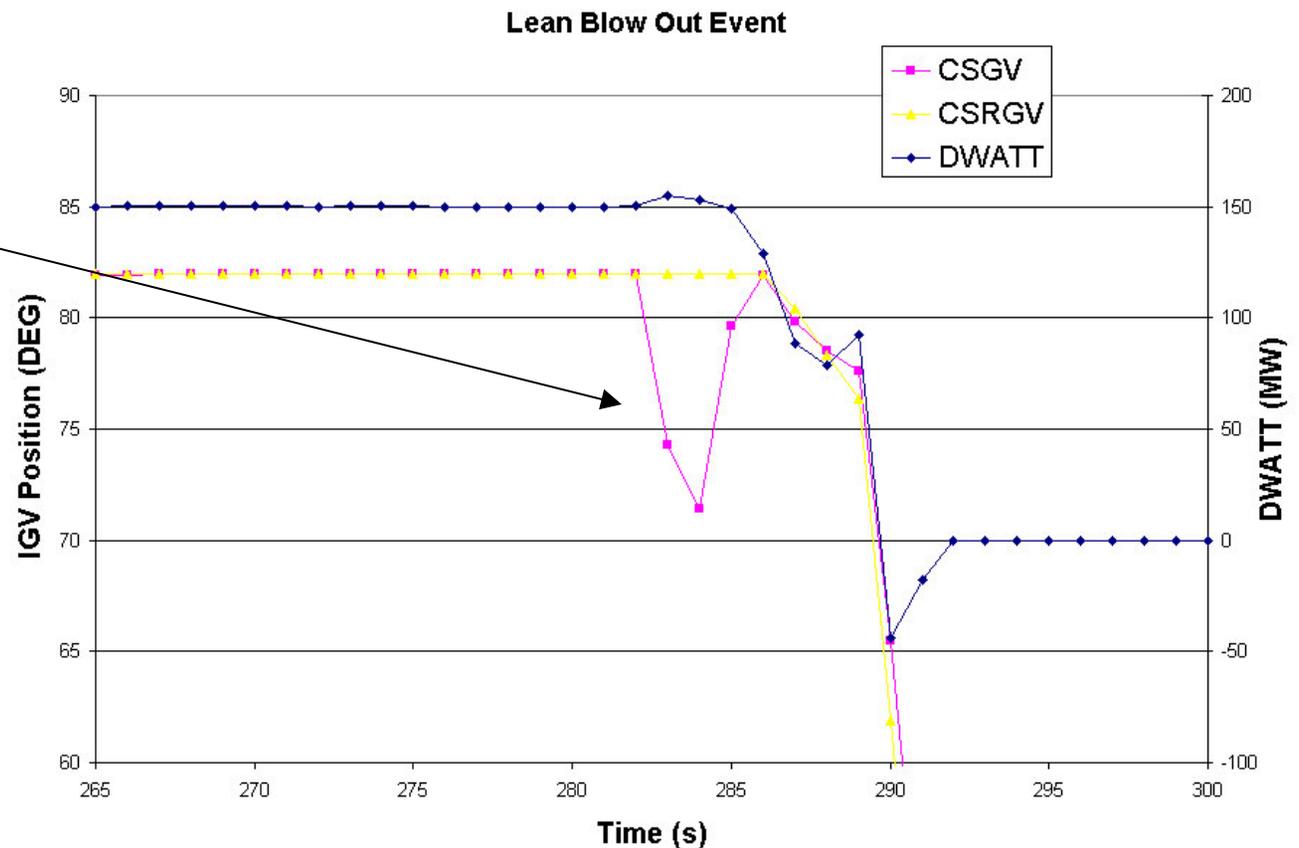
Contaminated IGV servo lead to a sudden drop and subsequent raise in the IGV angle while unit was running at base load. A Lean Blow Out event followed.

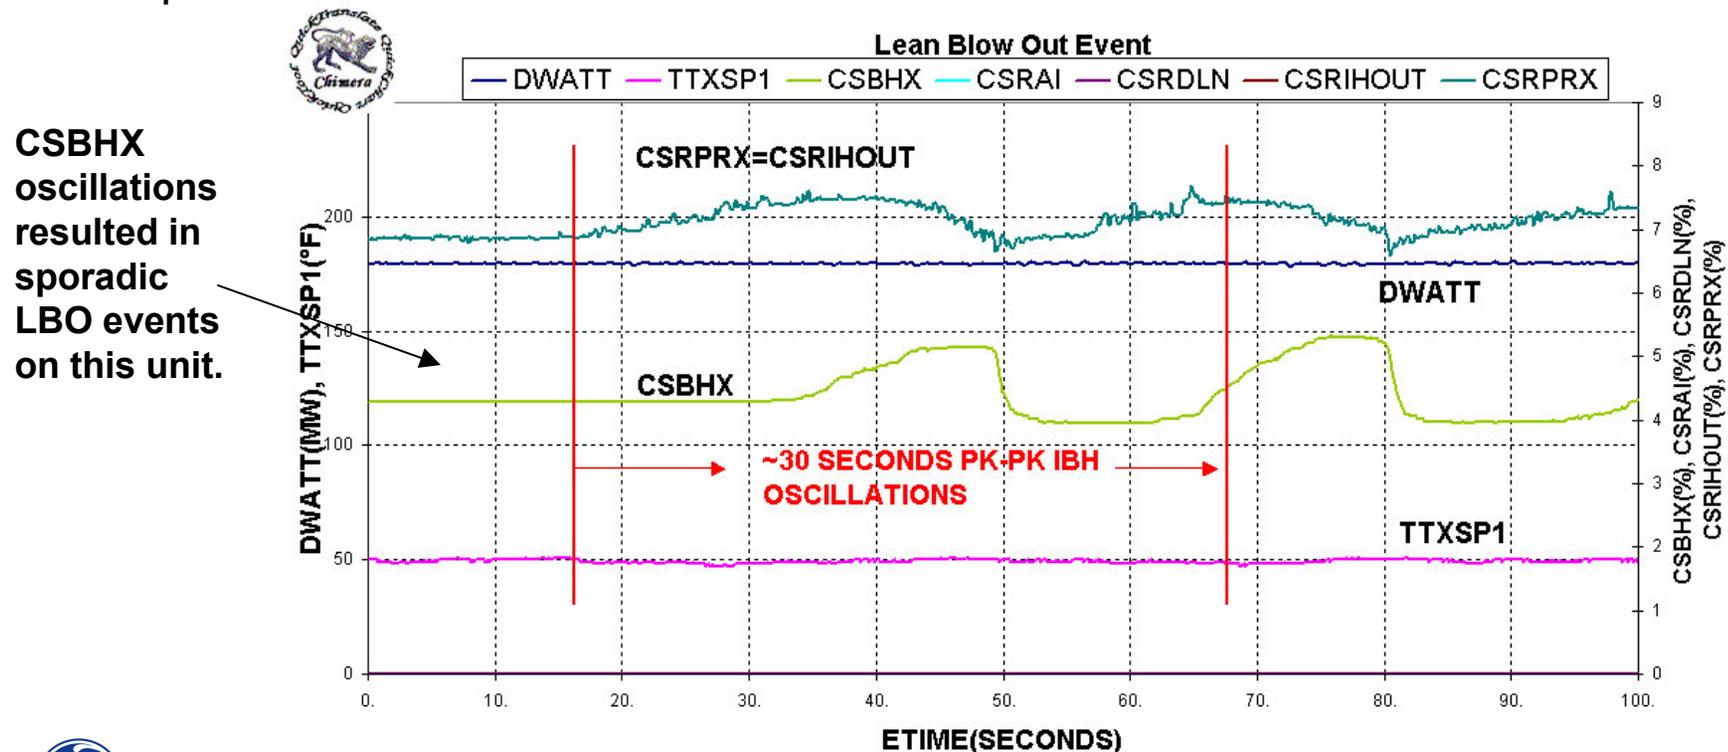
- Significant oscillations or “jerky” valve movements can lead to lean blow out events, especially during mode transfers.
- Due to the nature of the valve and associated control mechanisms, it is not possible to completely eliminate all valve oscillations. However, checking valve calibration is a good practice when troubleshooting trips that are difficult to resolve.
- TIL 1317 also has instructions on setting up Fisher IBH valves.
- Compare CSRIHOUT (position reference) VS CSBHX (position FEEDBACK)

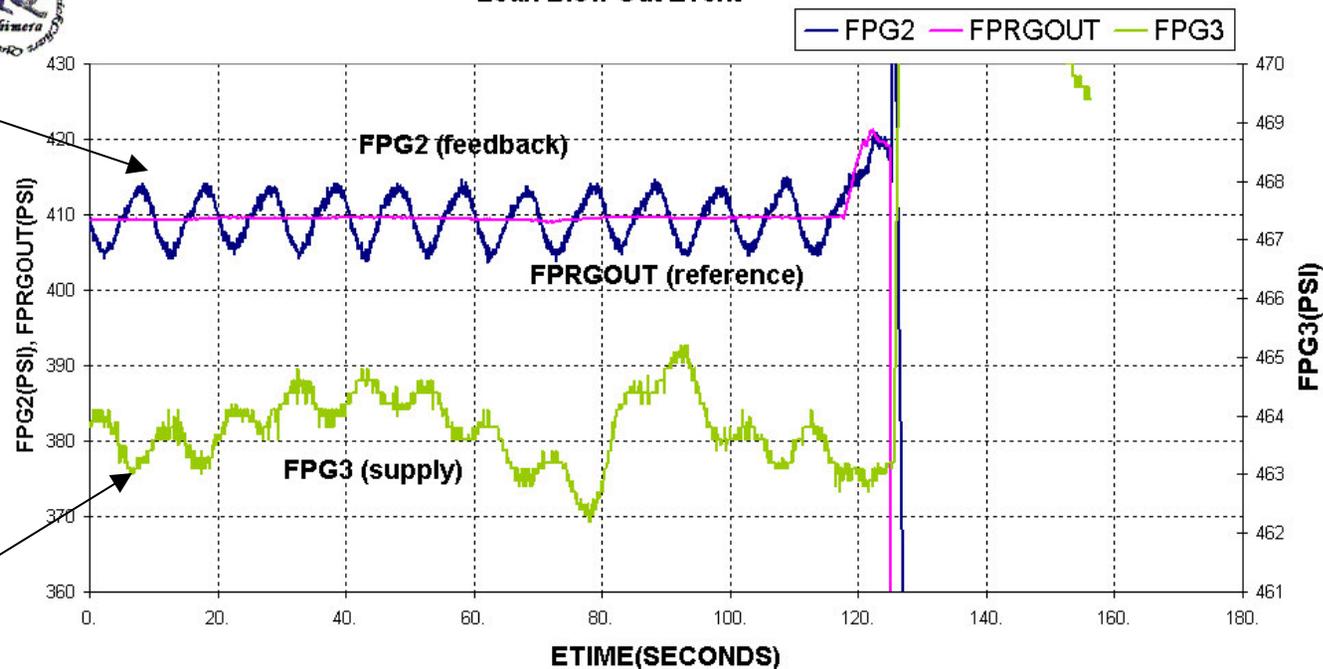
Lean Blow Out Event

FPG2 oscillations of +/- 1.25% resulted in an LBO event on this unit.
