Machine-Condition Monitoring Using Vibration Analysis

A Case Study from a Petrochemical Plant

by D.N.Brown & J.C.Jørgensen
Brüel & Kjær

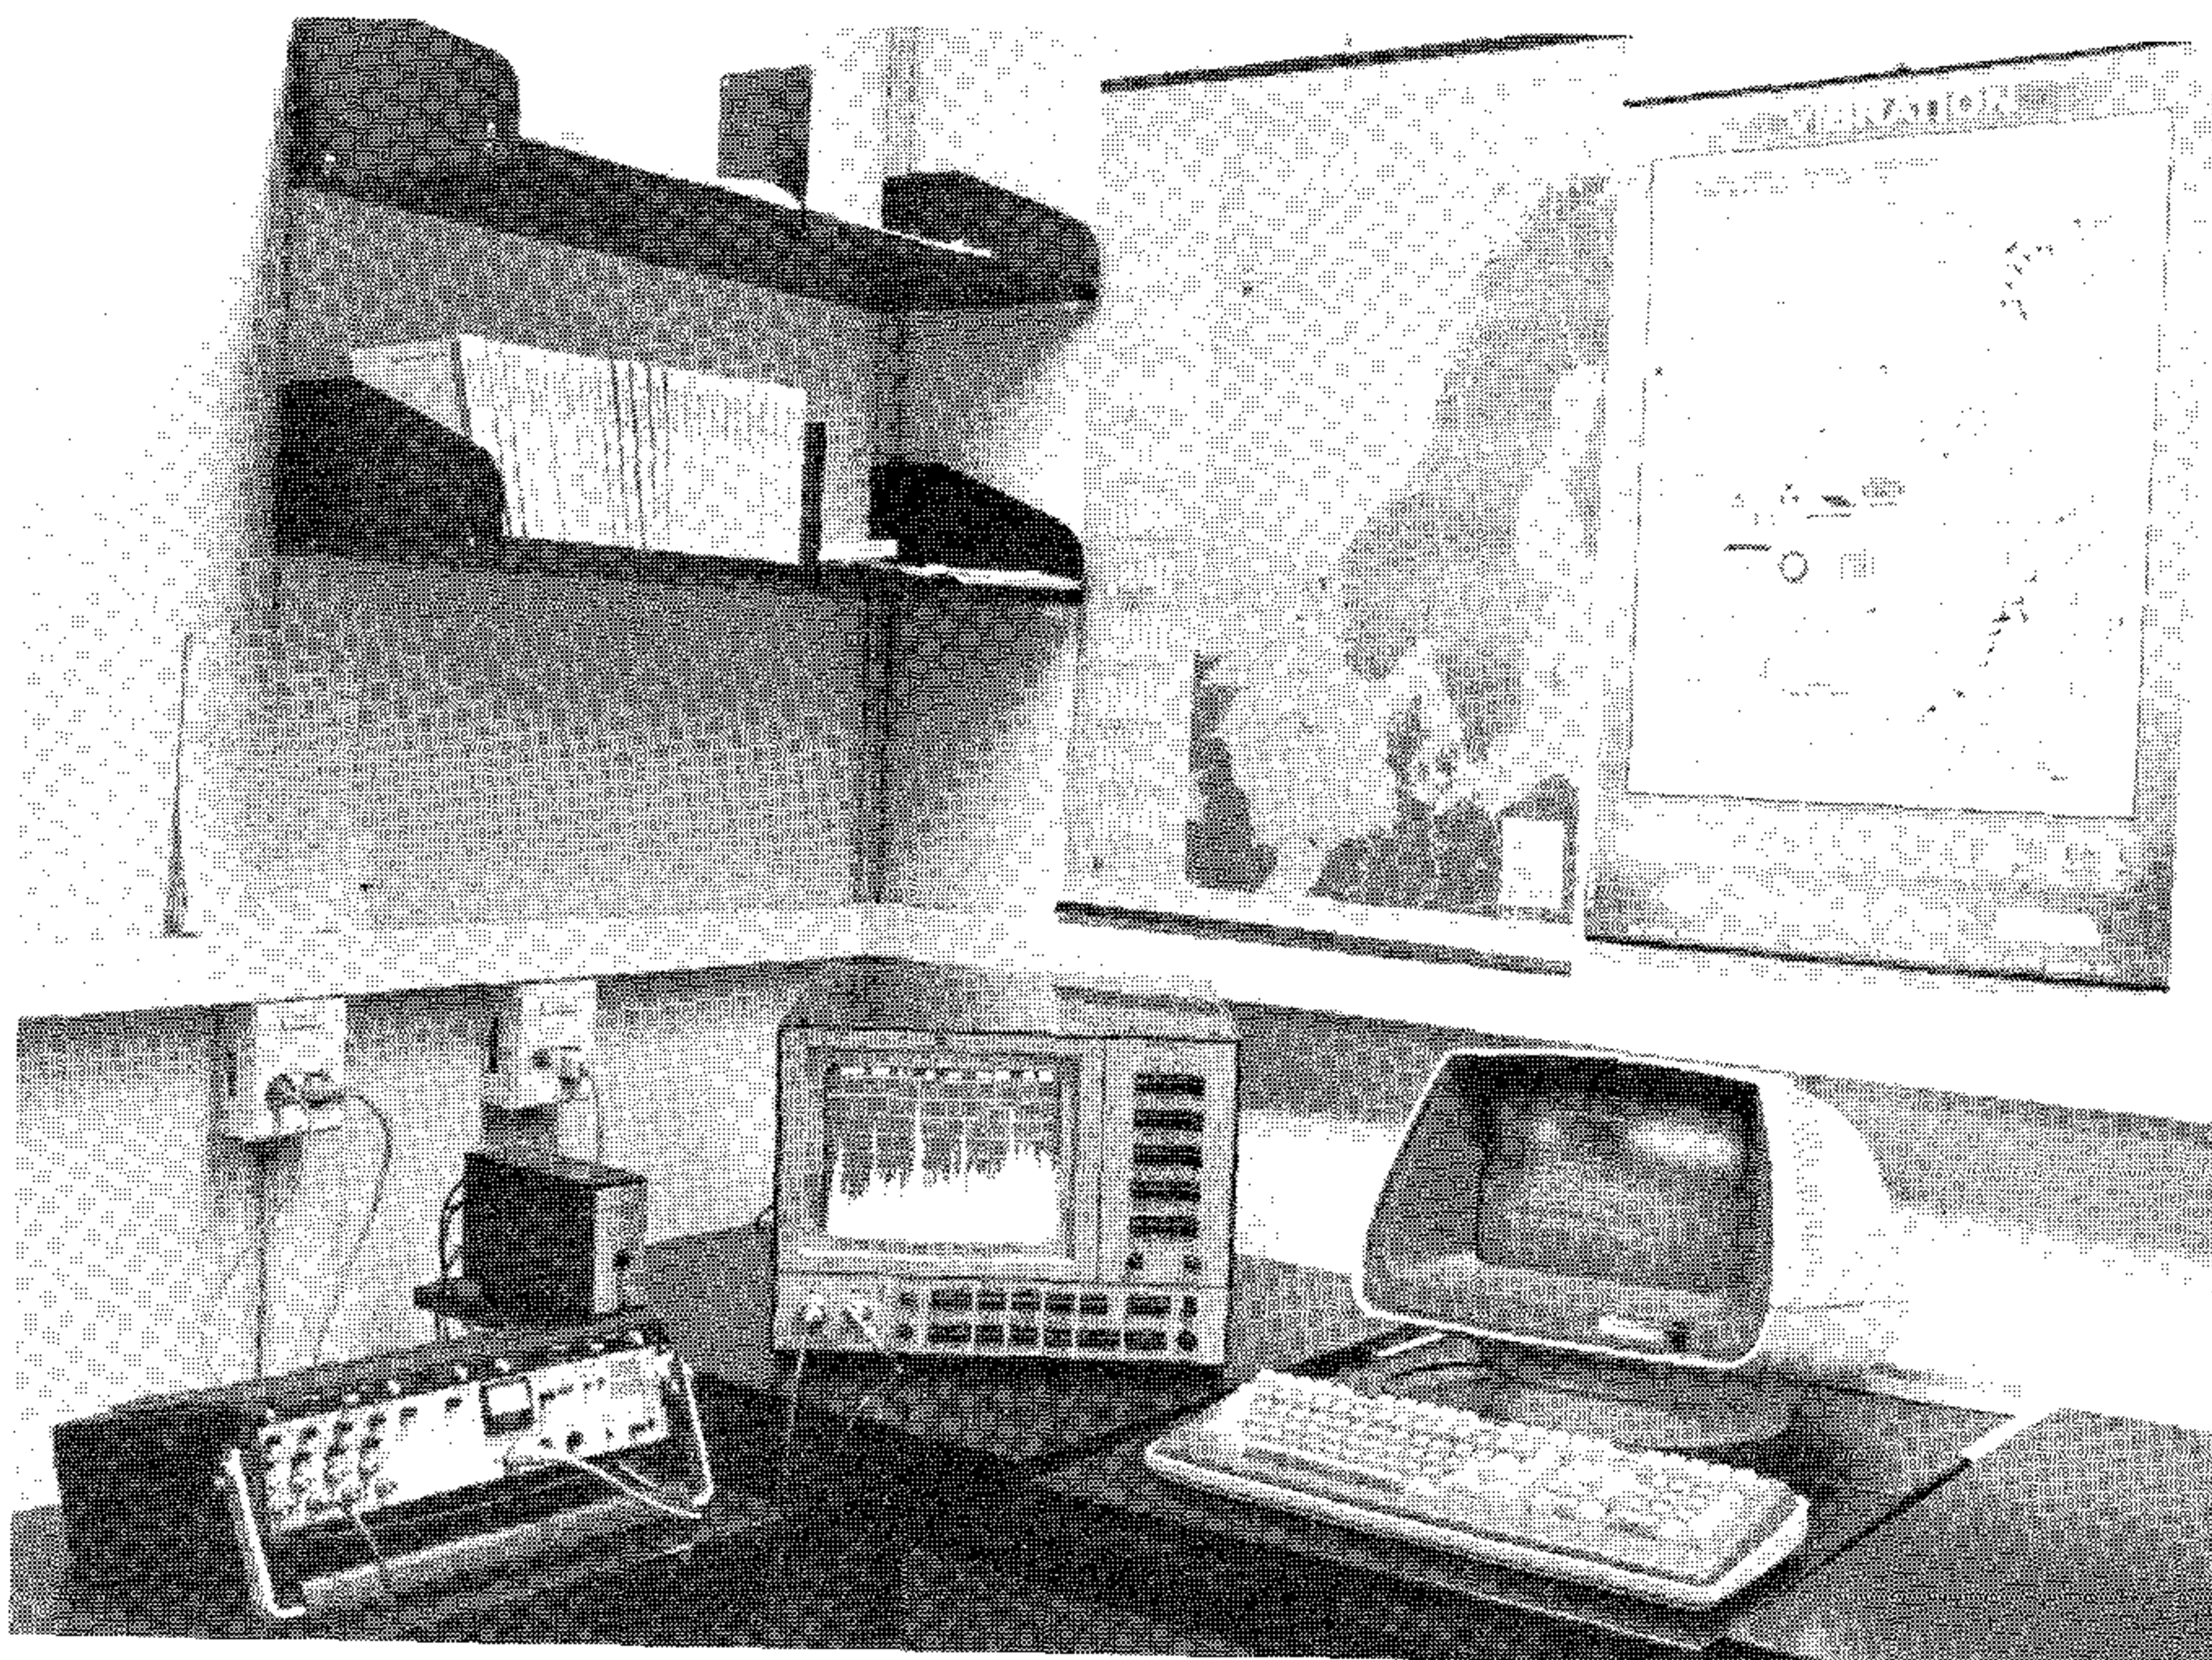
Fig. 2. The computer terminal and FFT Analyzer are placed in the engineer's office next to the central control room. An alarm printer is placed in the actual control room.

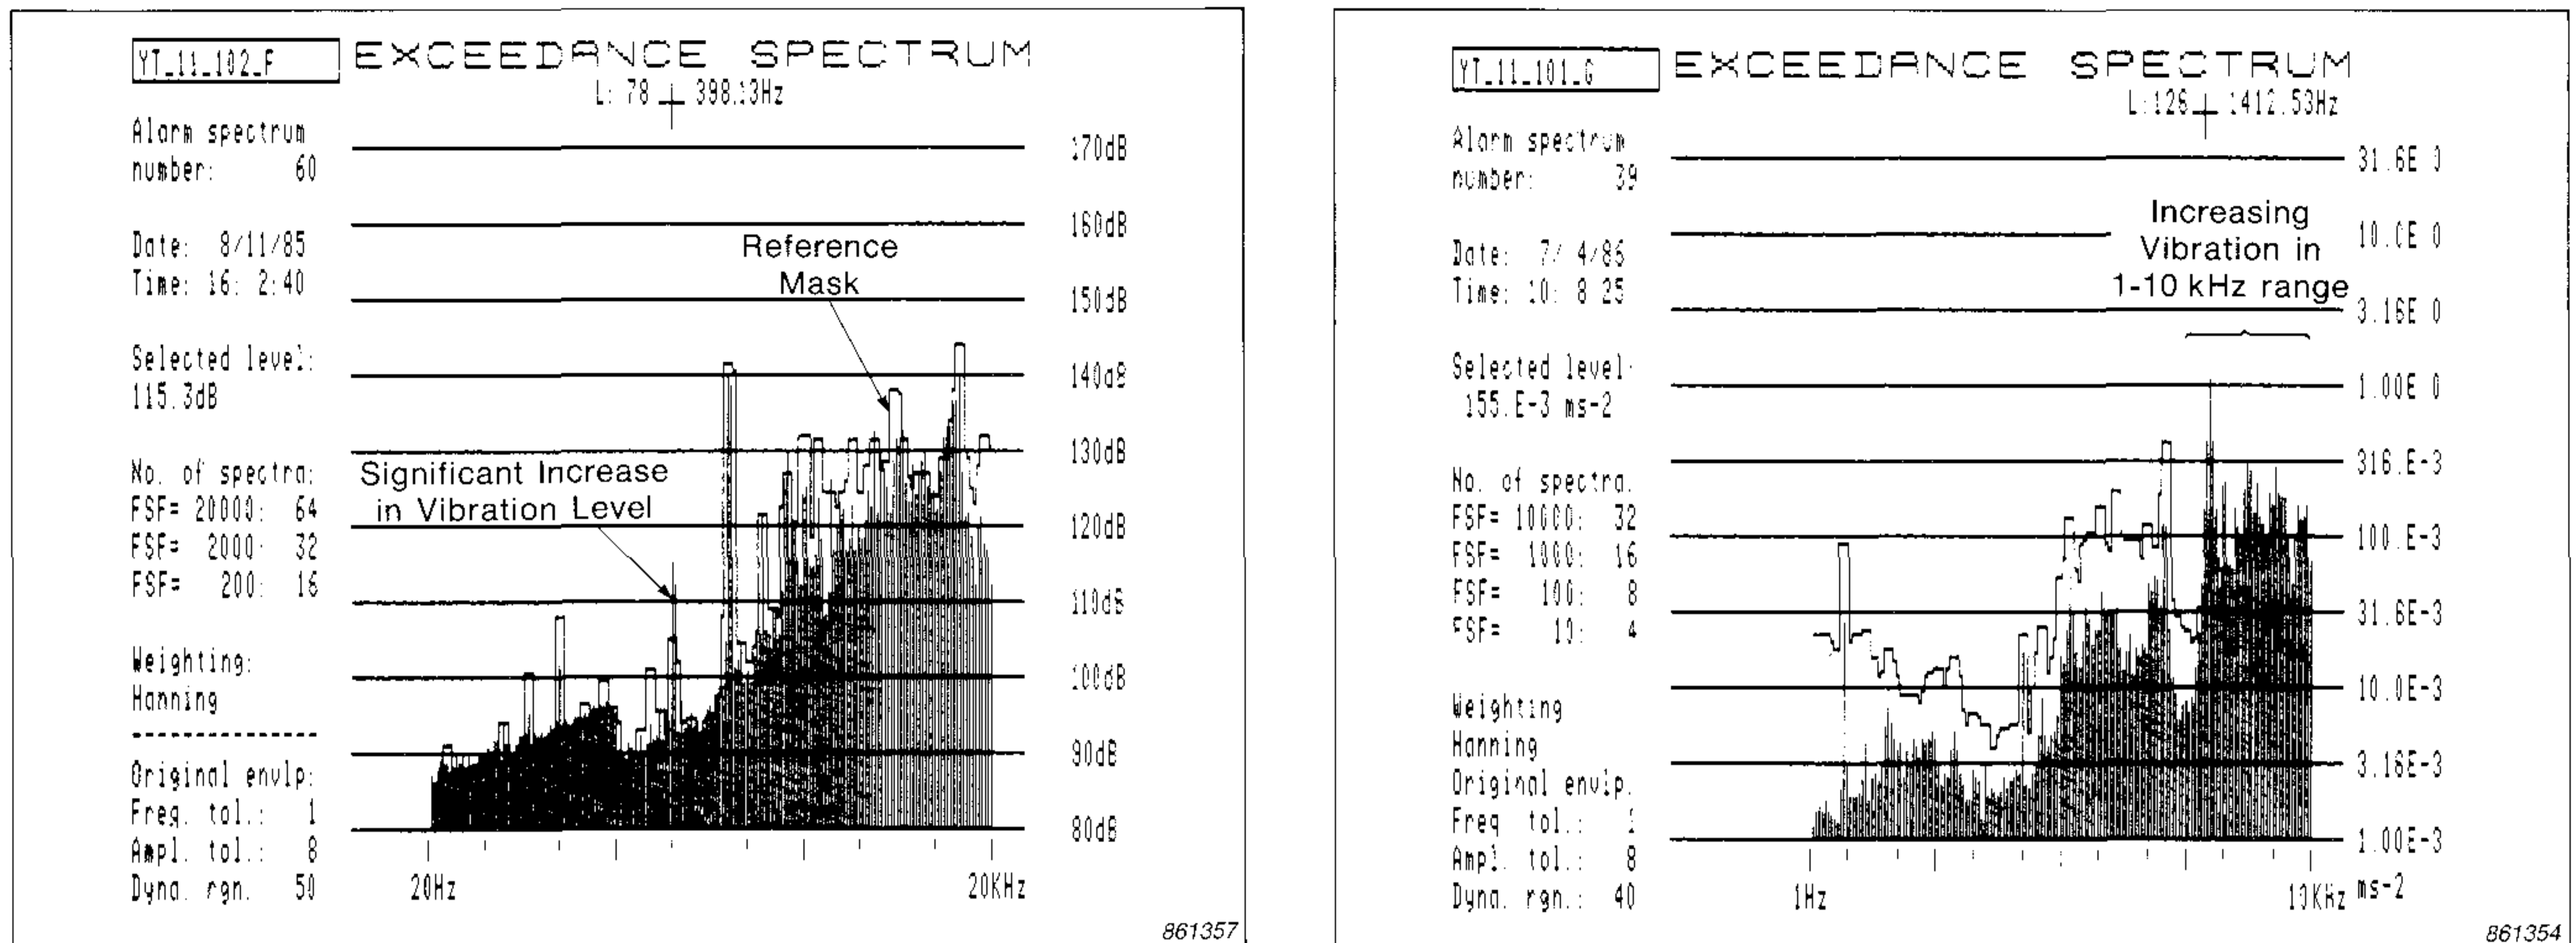
Fig. 3. Principle of spectrum comparison. Any frequency components that exceed the Reference Mask will cause an alarm. The spectrum to the left shows increases at discrete frequencies, whilst the spectrum to the right shows increases in a broad band of frequencies

By recording one of these constant-percentage-bandwidth spectra when the machine is in "good" condition (this is then called the Reference Spectrum) and adding a tolerance, a Reference Mask is formed. Subsequent spectra are then compared to this Reference Mask (a procedure called the Spectrum Comparison), and any frequency components that increase to a level above the Mask will be reported. Fig. 3 illustrates the principle, showing a spectrum compared with its Reference Mask.

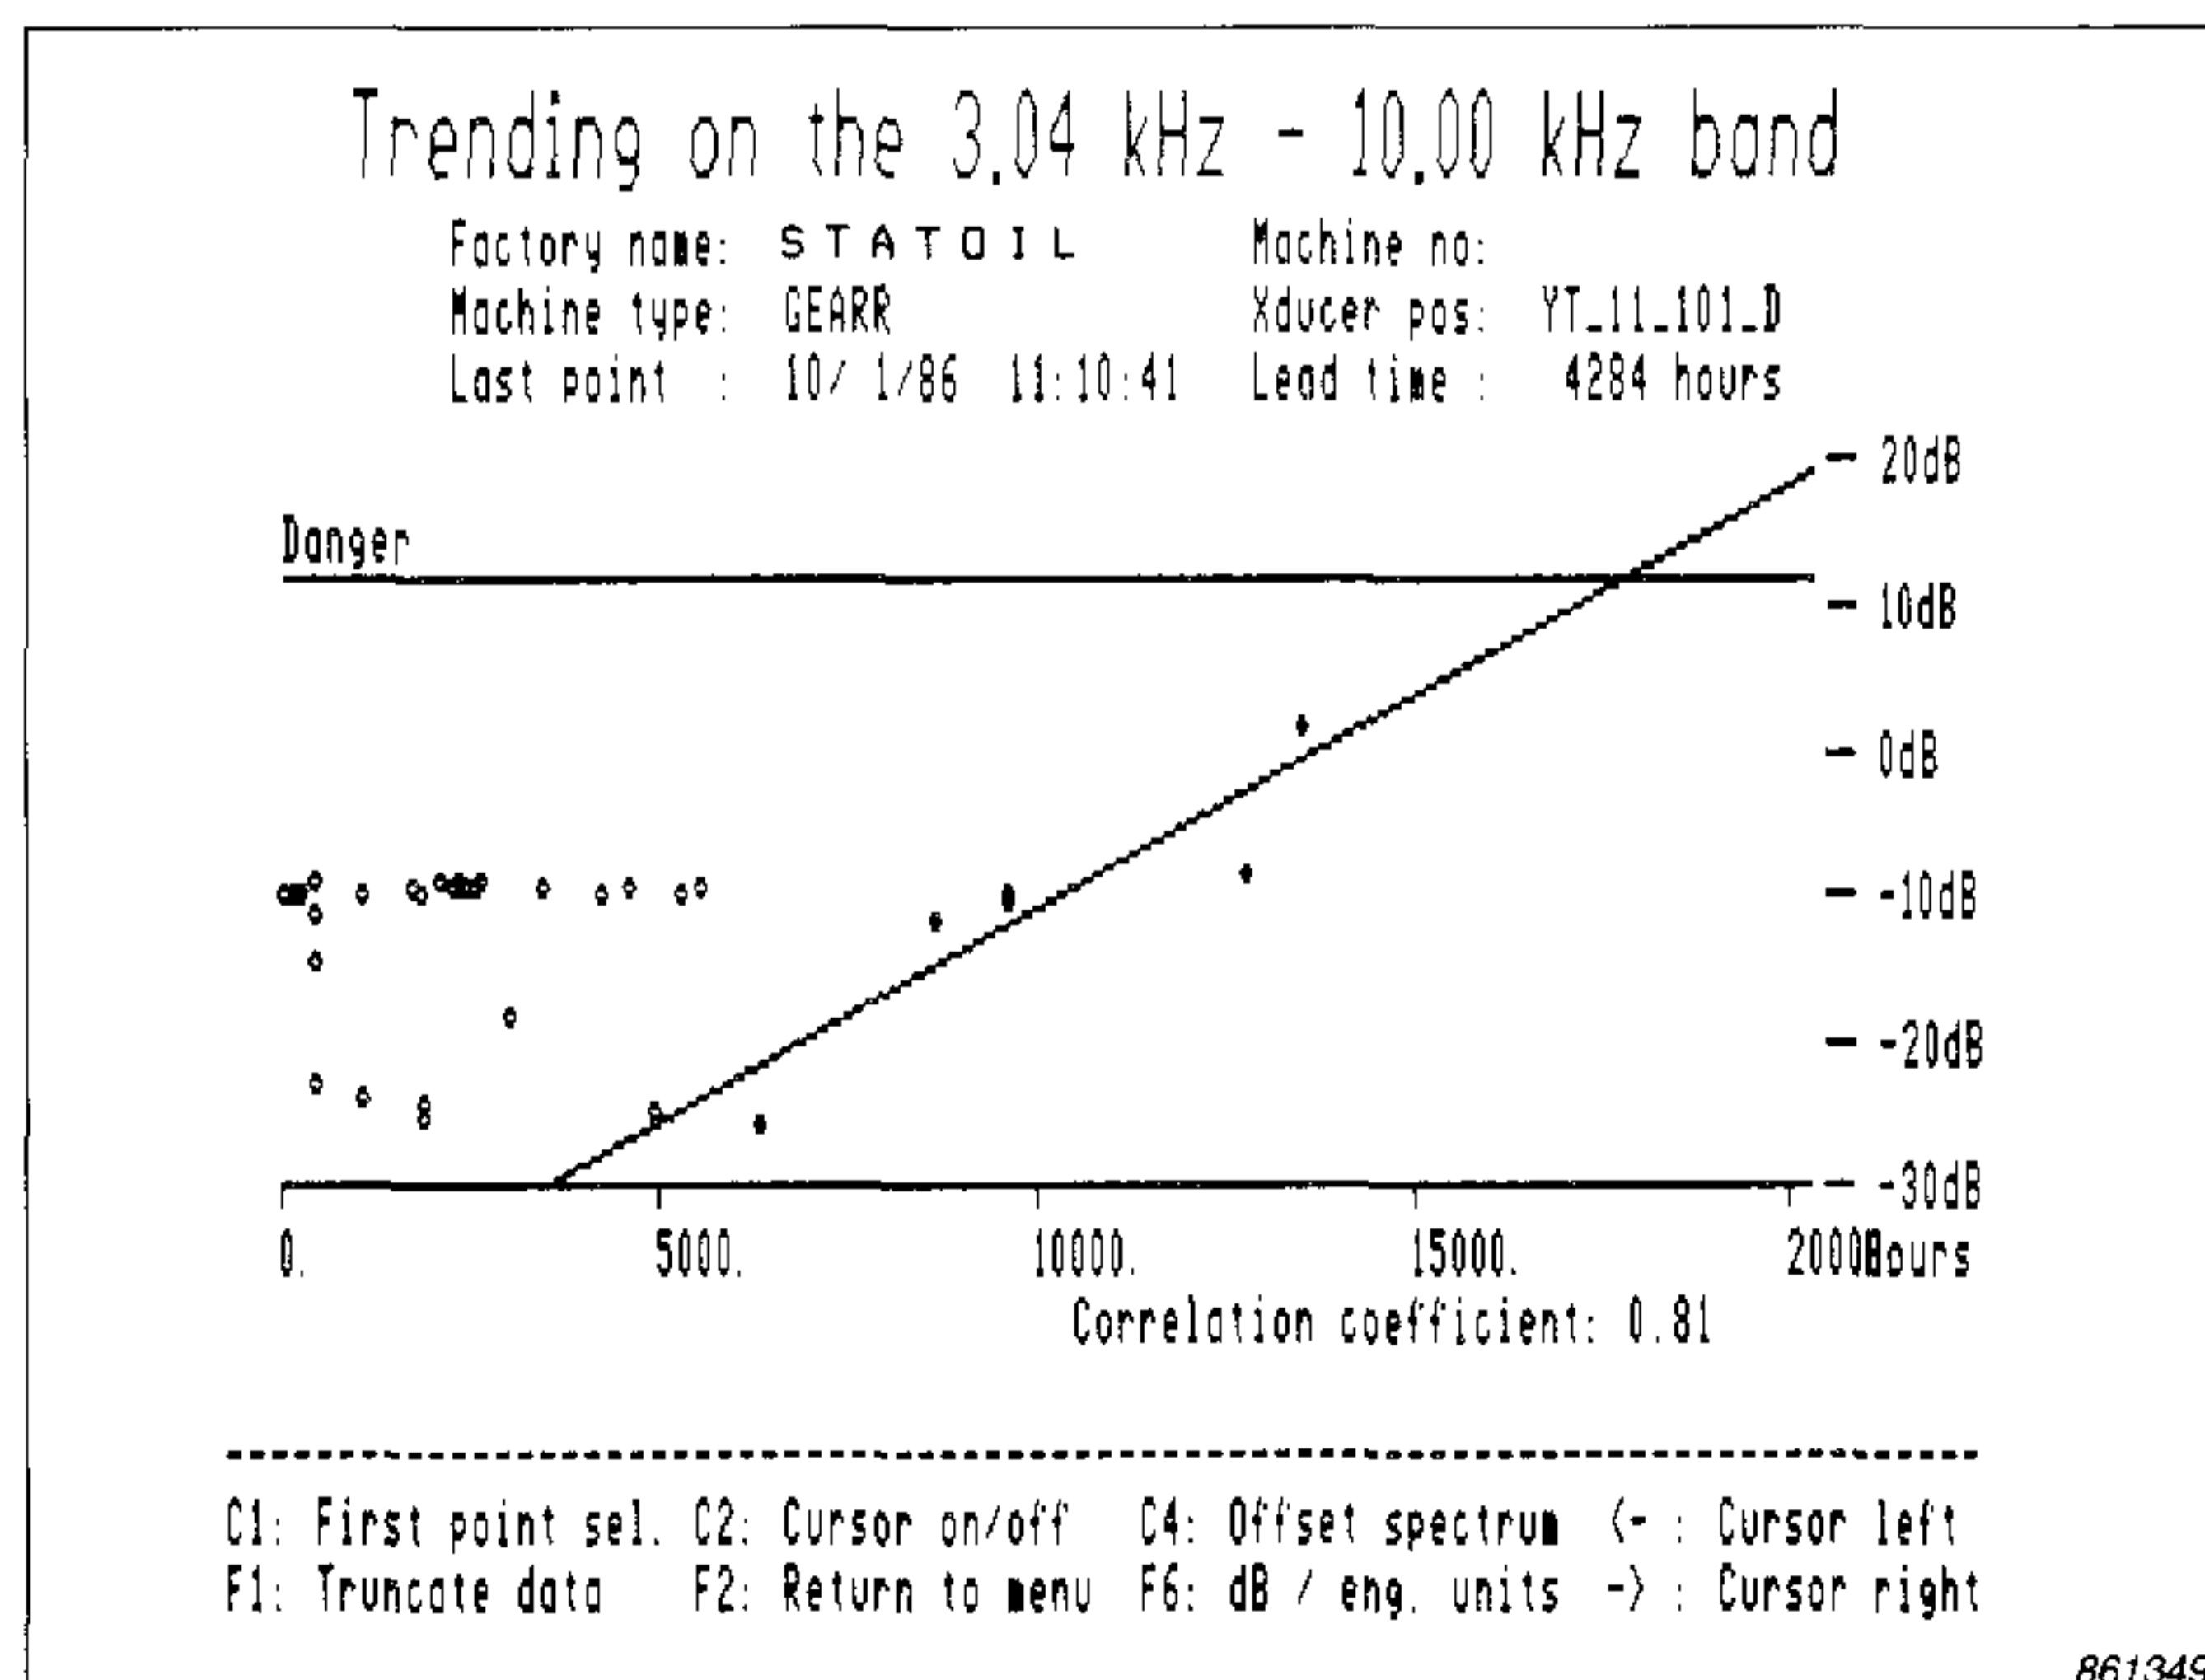
Fig. 12. Trend curve from the agitator gearbox in the 3 – 10 kHz range showing the beginnings of an upward trend

detected, this time using measurements made on the gearbox of the agitator. The broadband values were seen to be stable on all measurement points on the gearbox (the Spike Energy and RMS trends are shown in Fig.11). However, studying the stored narrow-band spectra revealed a positive trend in the 3 – 10 kHz range (see Fig.12), plus some small increases in low frequency components (see Fig.13). This suggests the beginning of deterioration of the gearbox bearings.

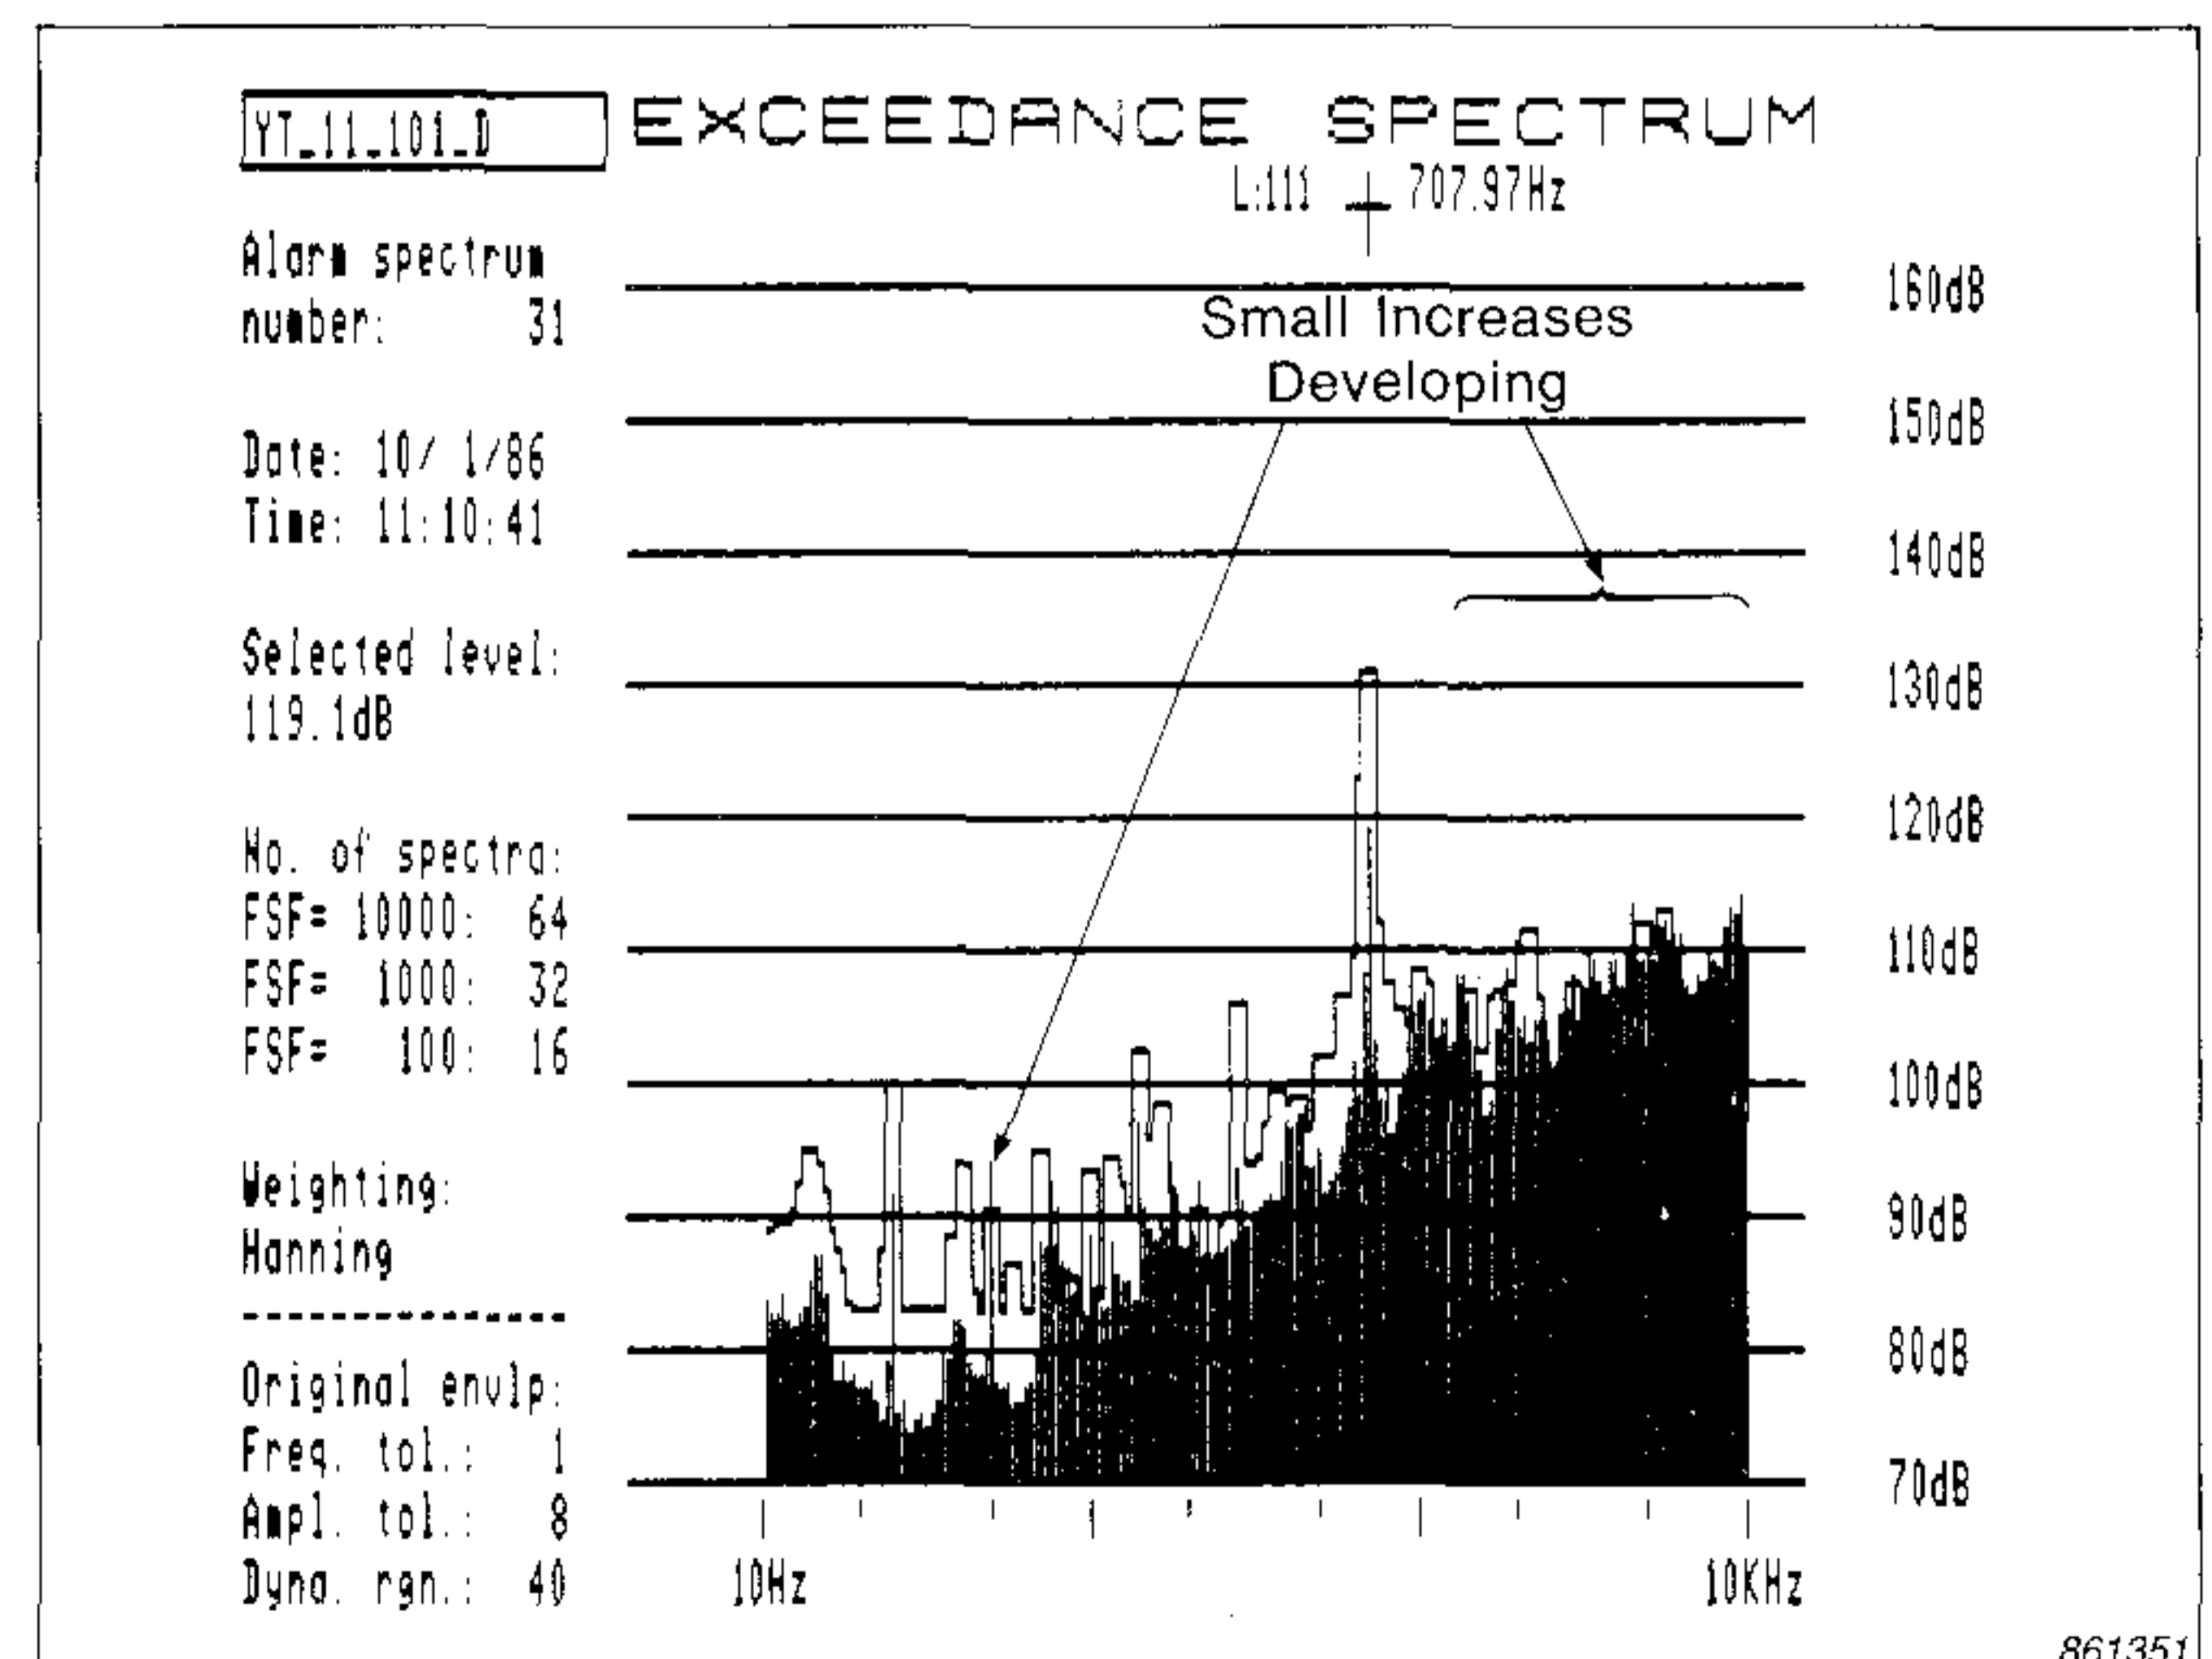
Fig. 13. Spectrum comparison from the agitator gearbox showing some small increases in both the low and high frequencies

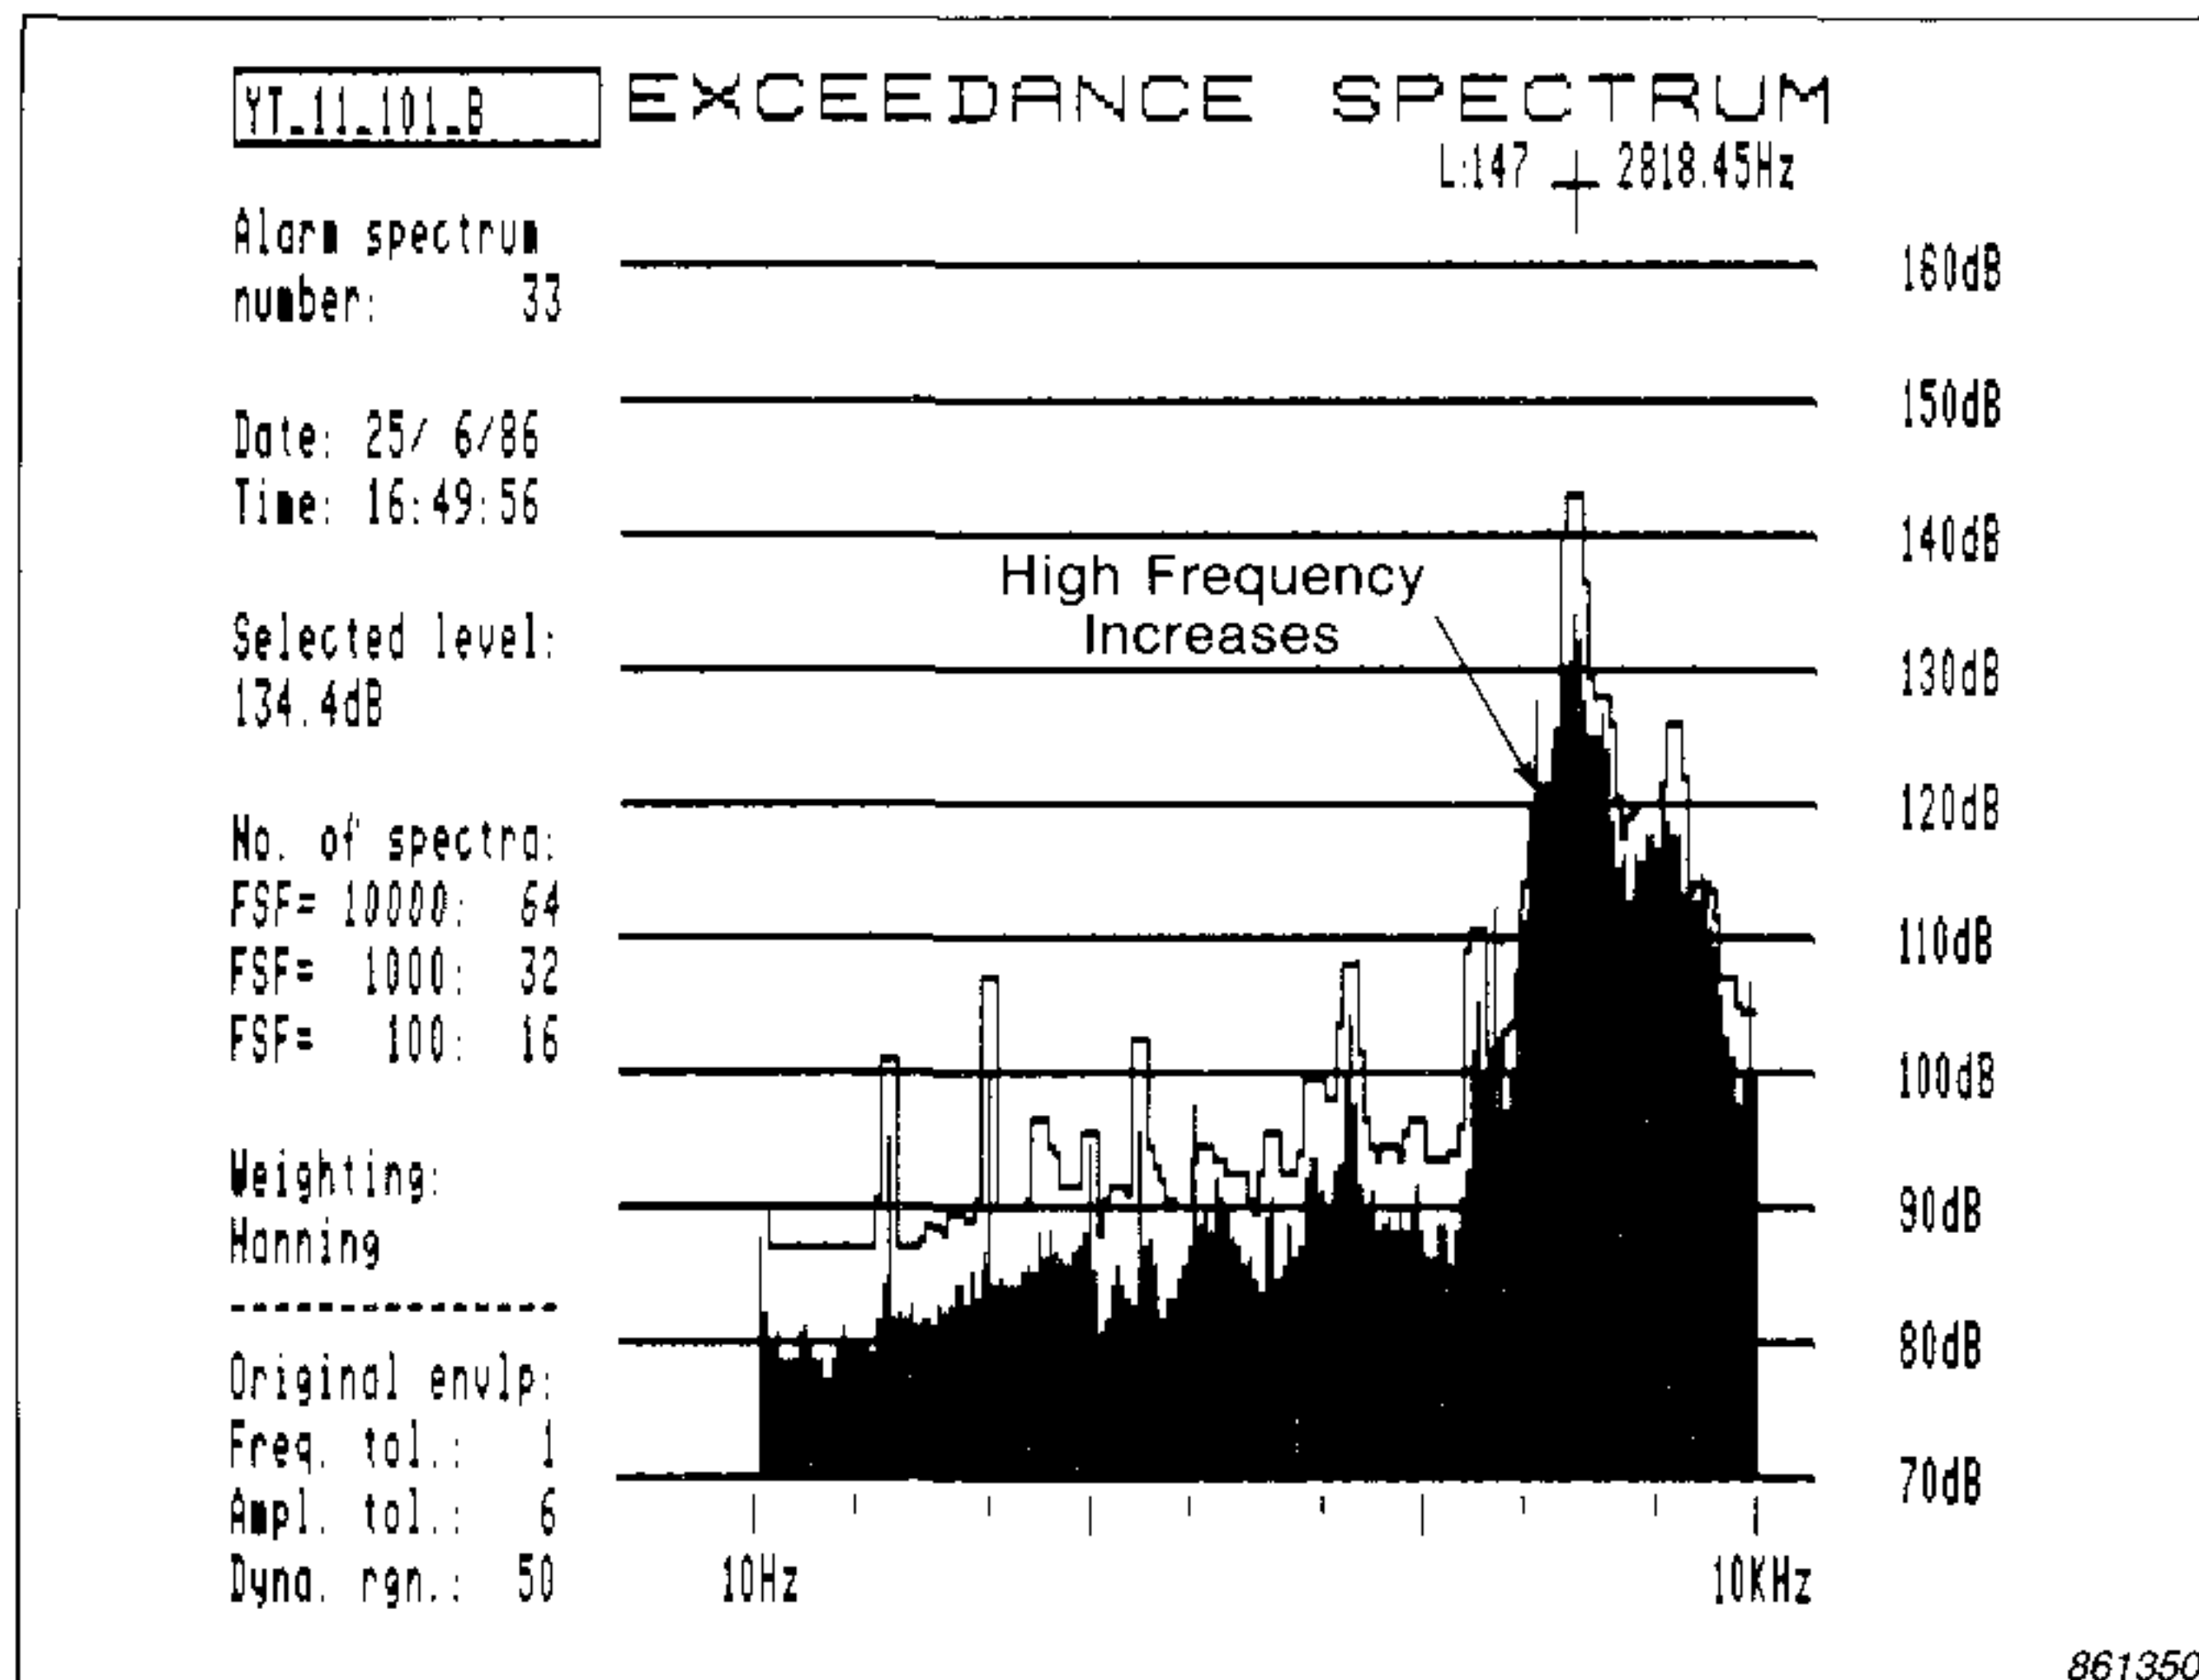
Fig. 14. Spectrum comparison from the agitator motor showing small increases at the higher frequencies

Another example of such a minor change can again be shown on the agitator, this time on the motor. Fig.14

shows a spectrum comparison from the motor, which indicated some high frequency components beginning to increase. The trend curve in Fig.15 shows the beginning of an upward trend in the 1,6 kHz to 1,8 kHz frequency range. The most likely cause of these increases was deemed to be from a bearing problem in its early stages. However, as the increases in level were not considered serious, the bearings were lubricated regularly to keep the levels down and the motor was run until the next scheduled shut-down. At this shut-down, the motor's bearings were examined and, on one of them, traces of pitting were found on the outer race.

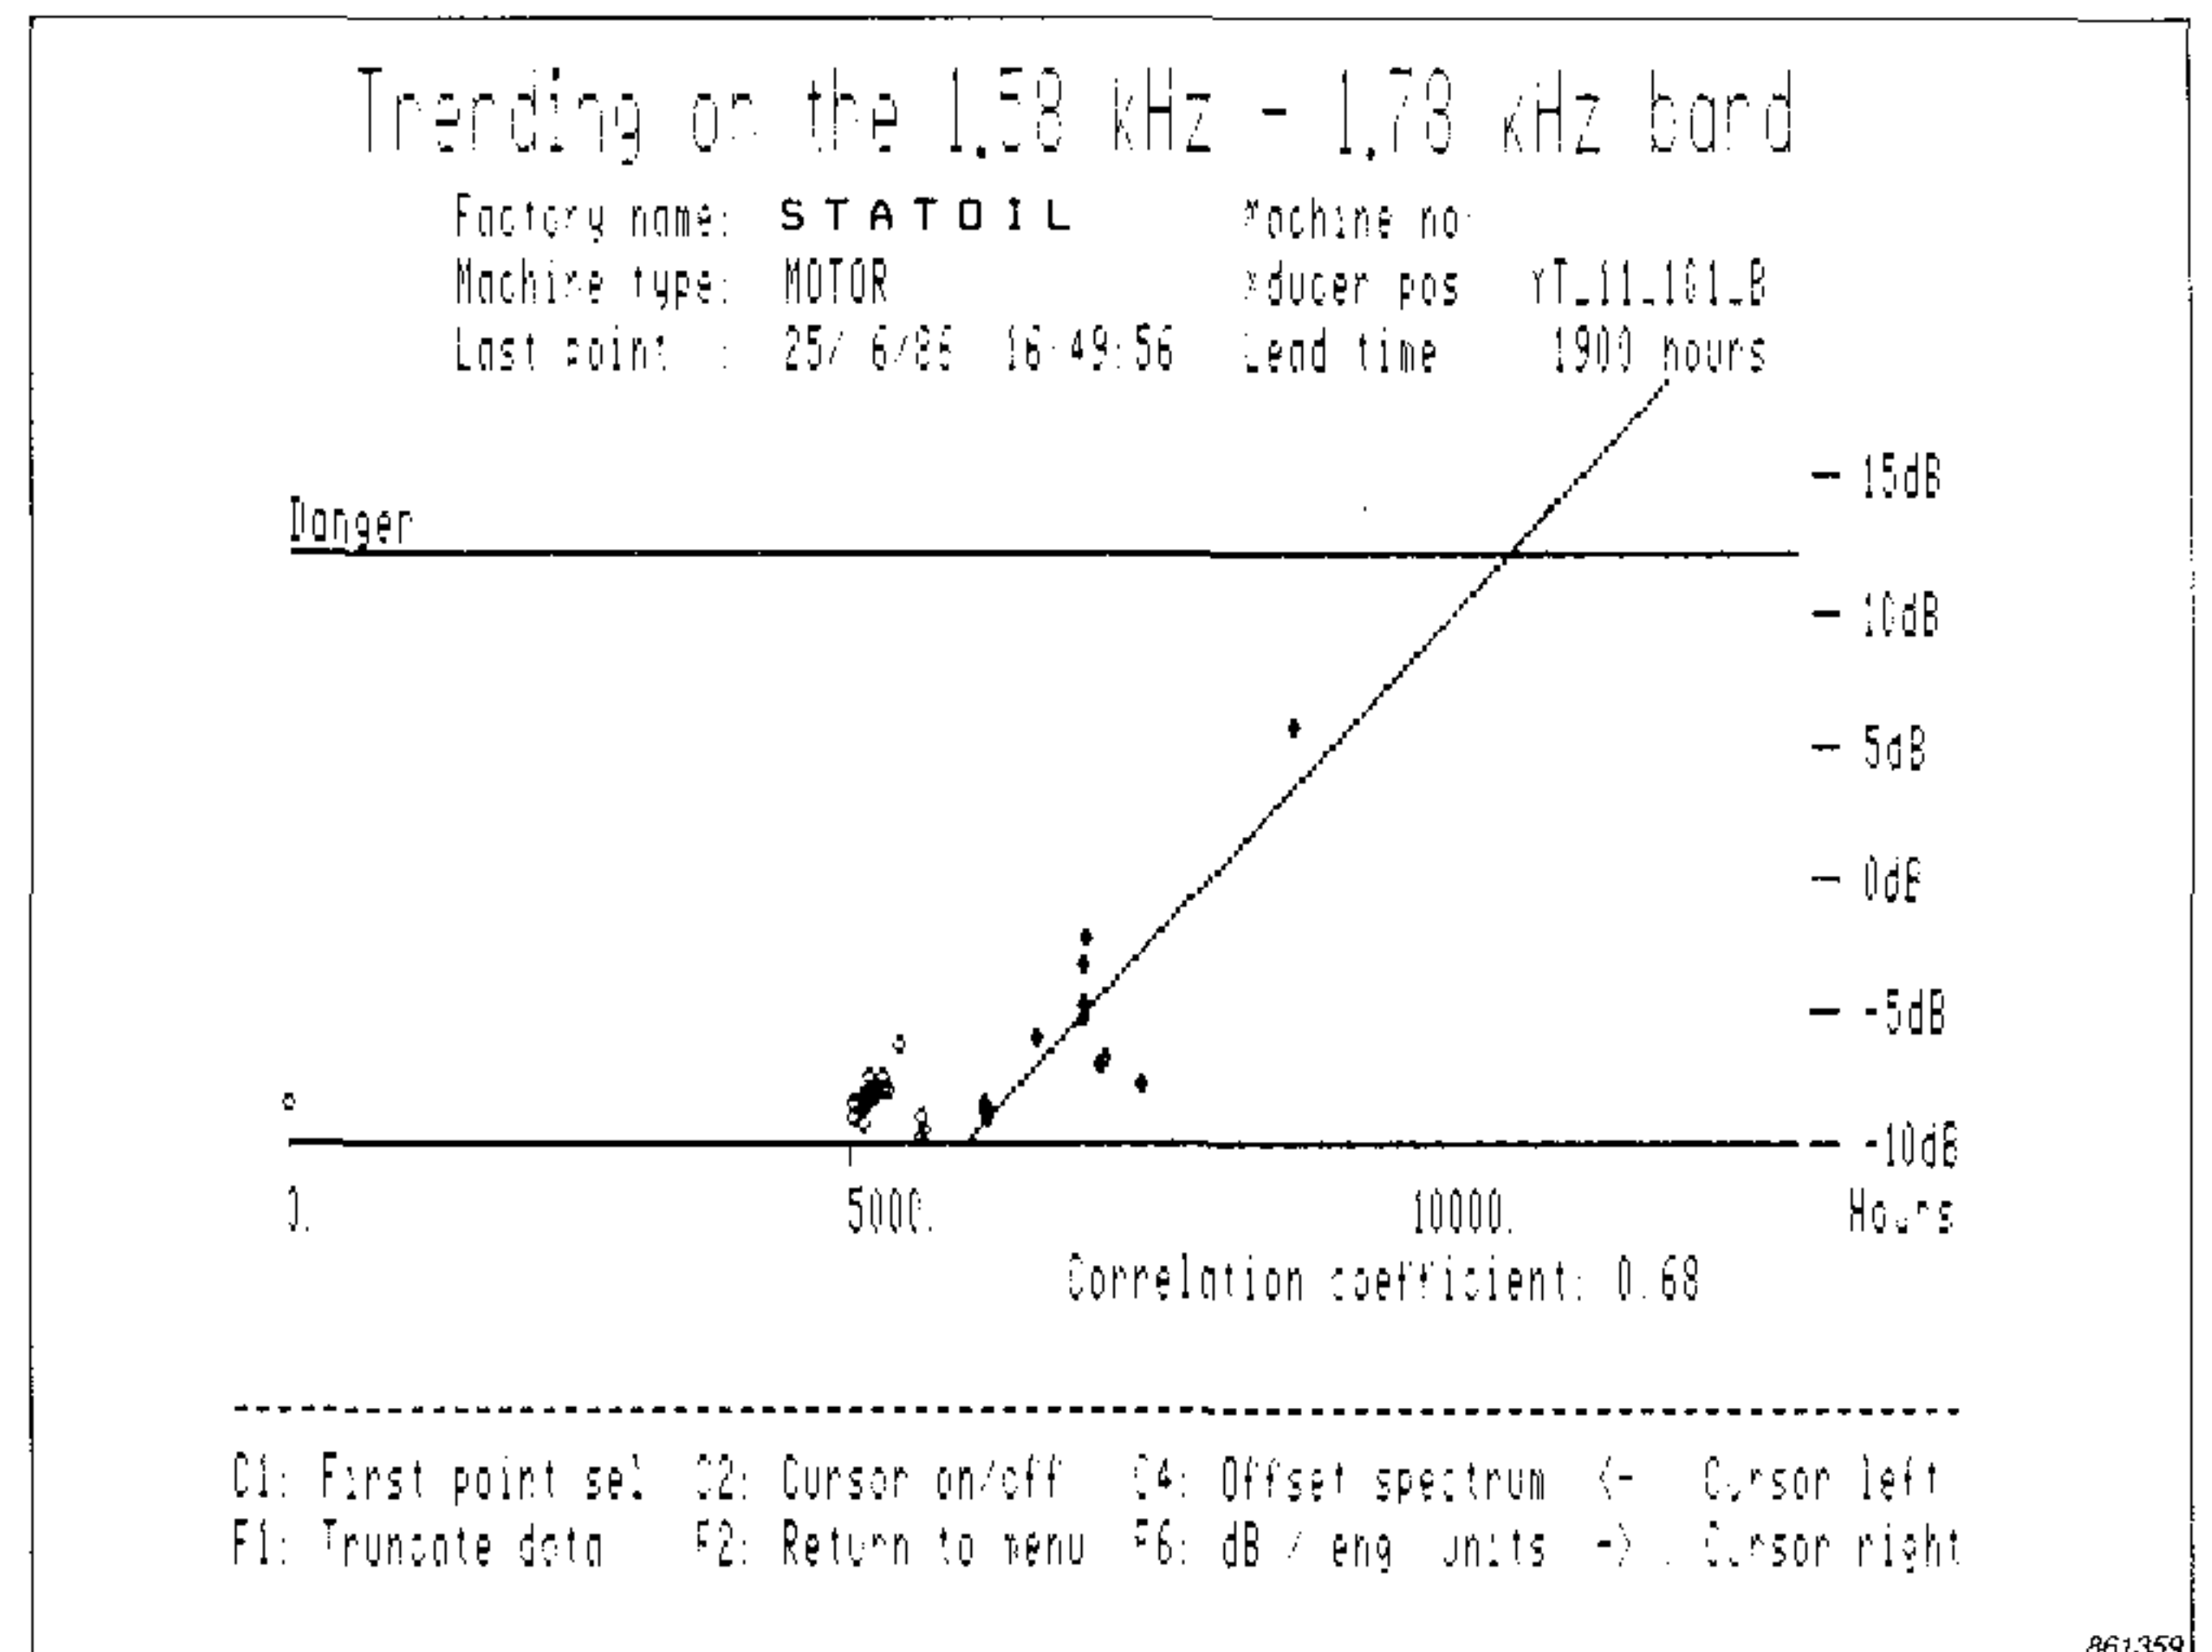
Fig. 15. Trend curve from the agitator motor showing the beginning of an upward trend in the 1,6 kHz to 1,8 kHz range
