Machine-Condition Monitoring Using Vibration Analysis

A Case Study from a Petrochemical Plant

by D.N.Brown & J.C.Jørgensen
Brüel & Kjær

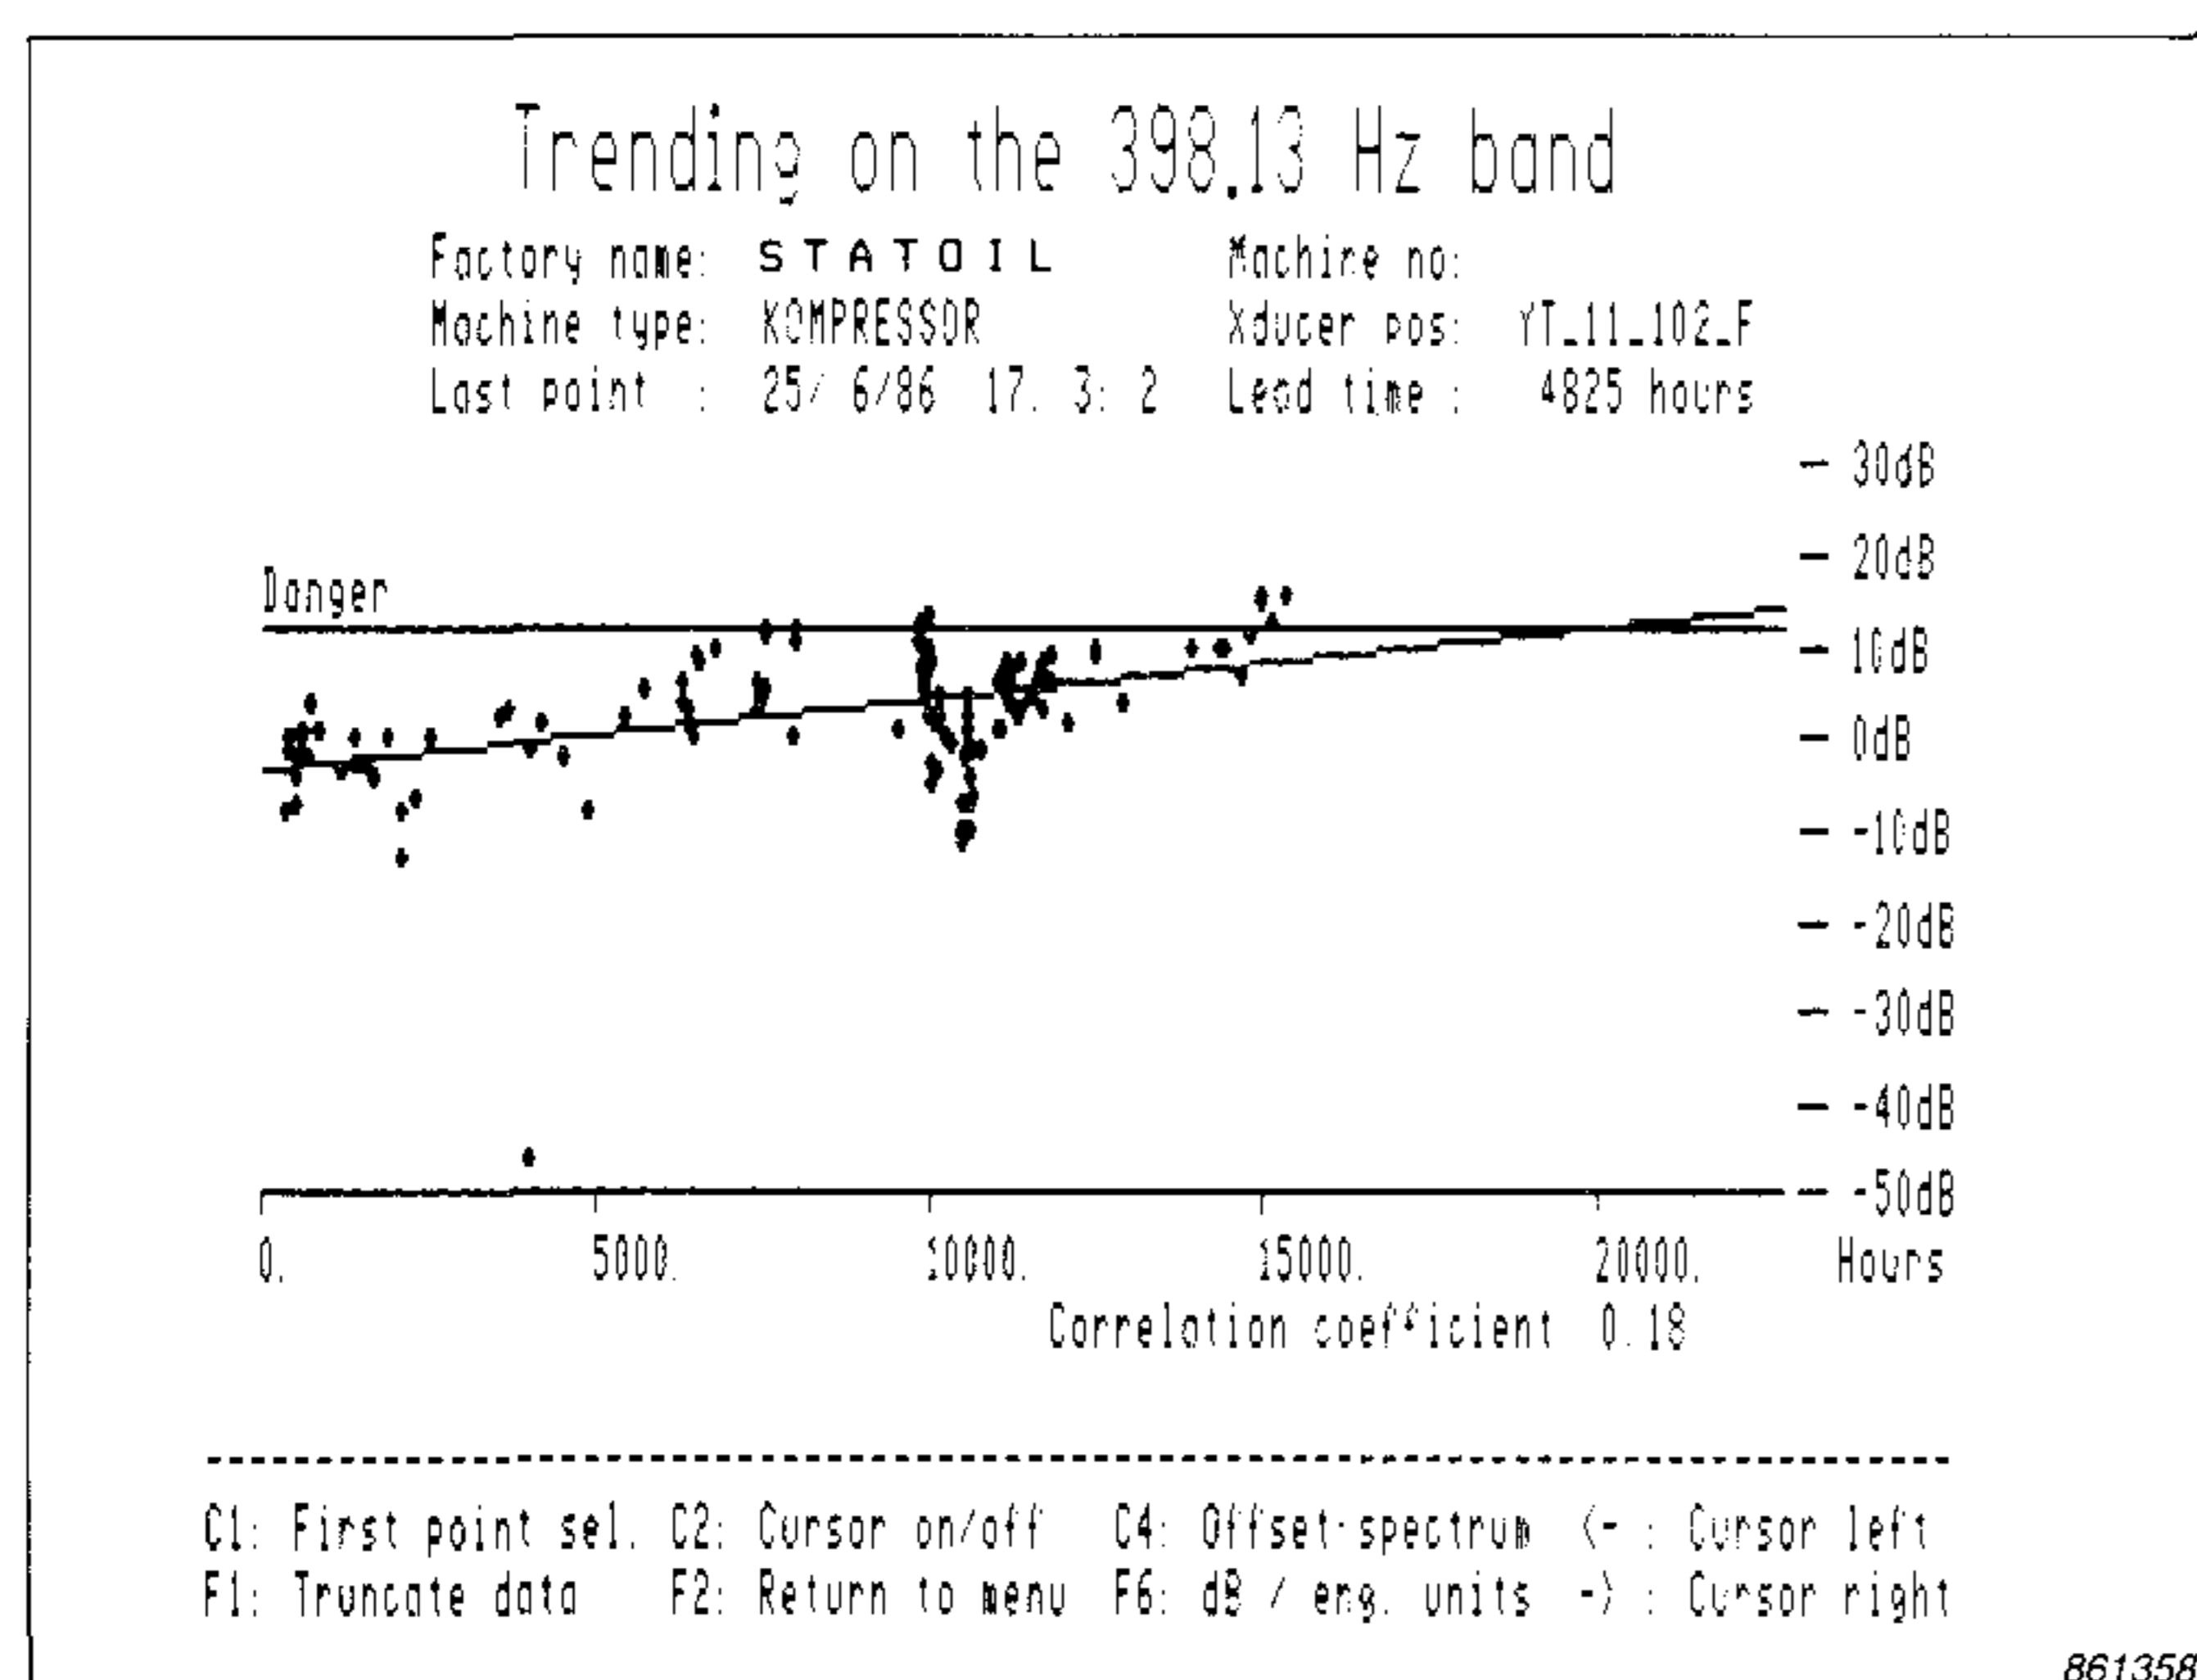
Fig. 19. Trend curve at the lobe frequency (398 Hz) from the screw compressor

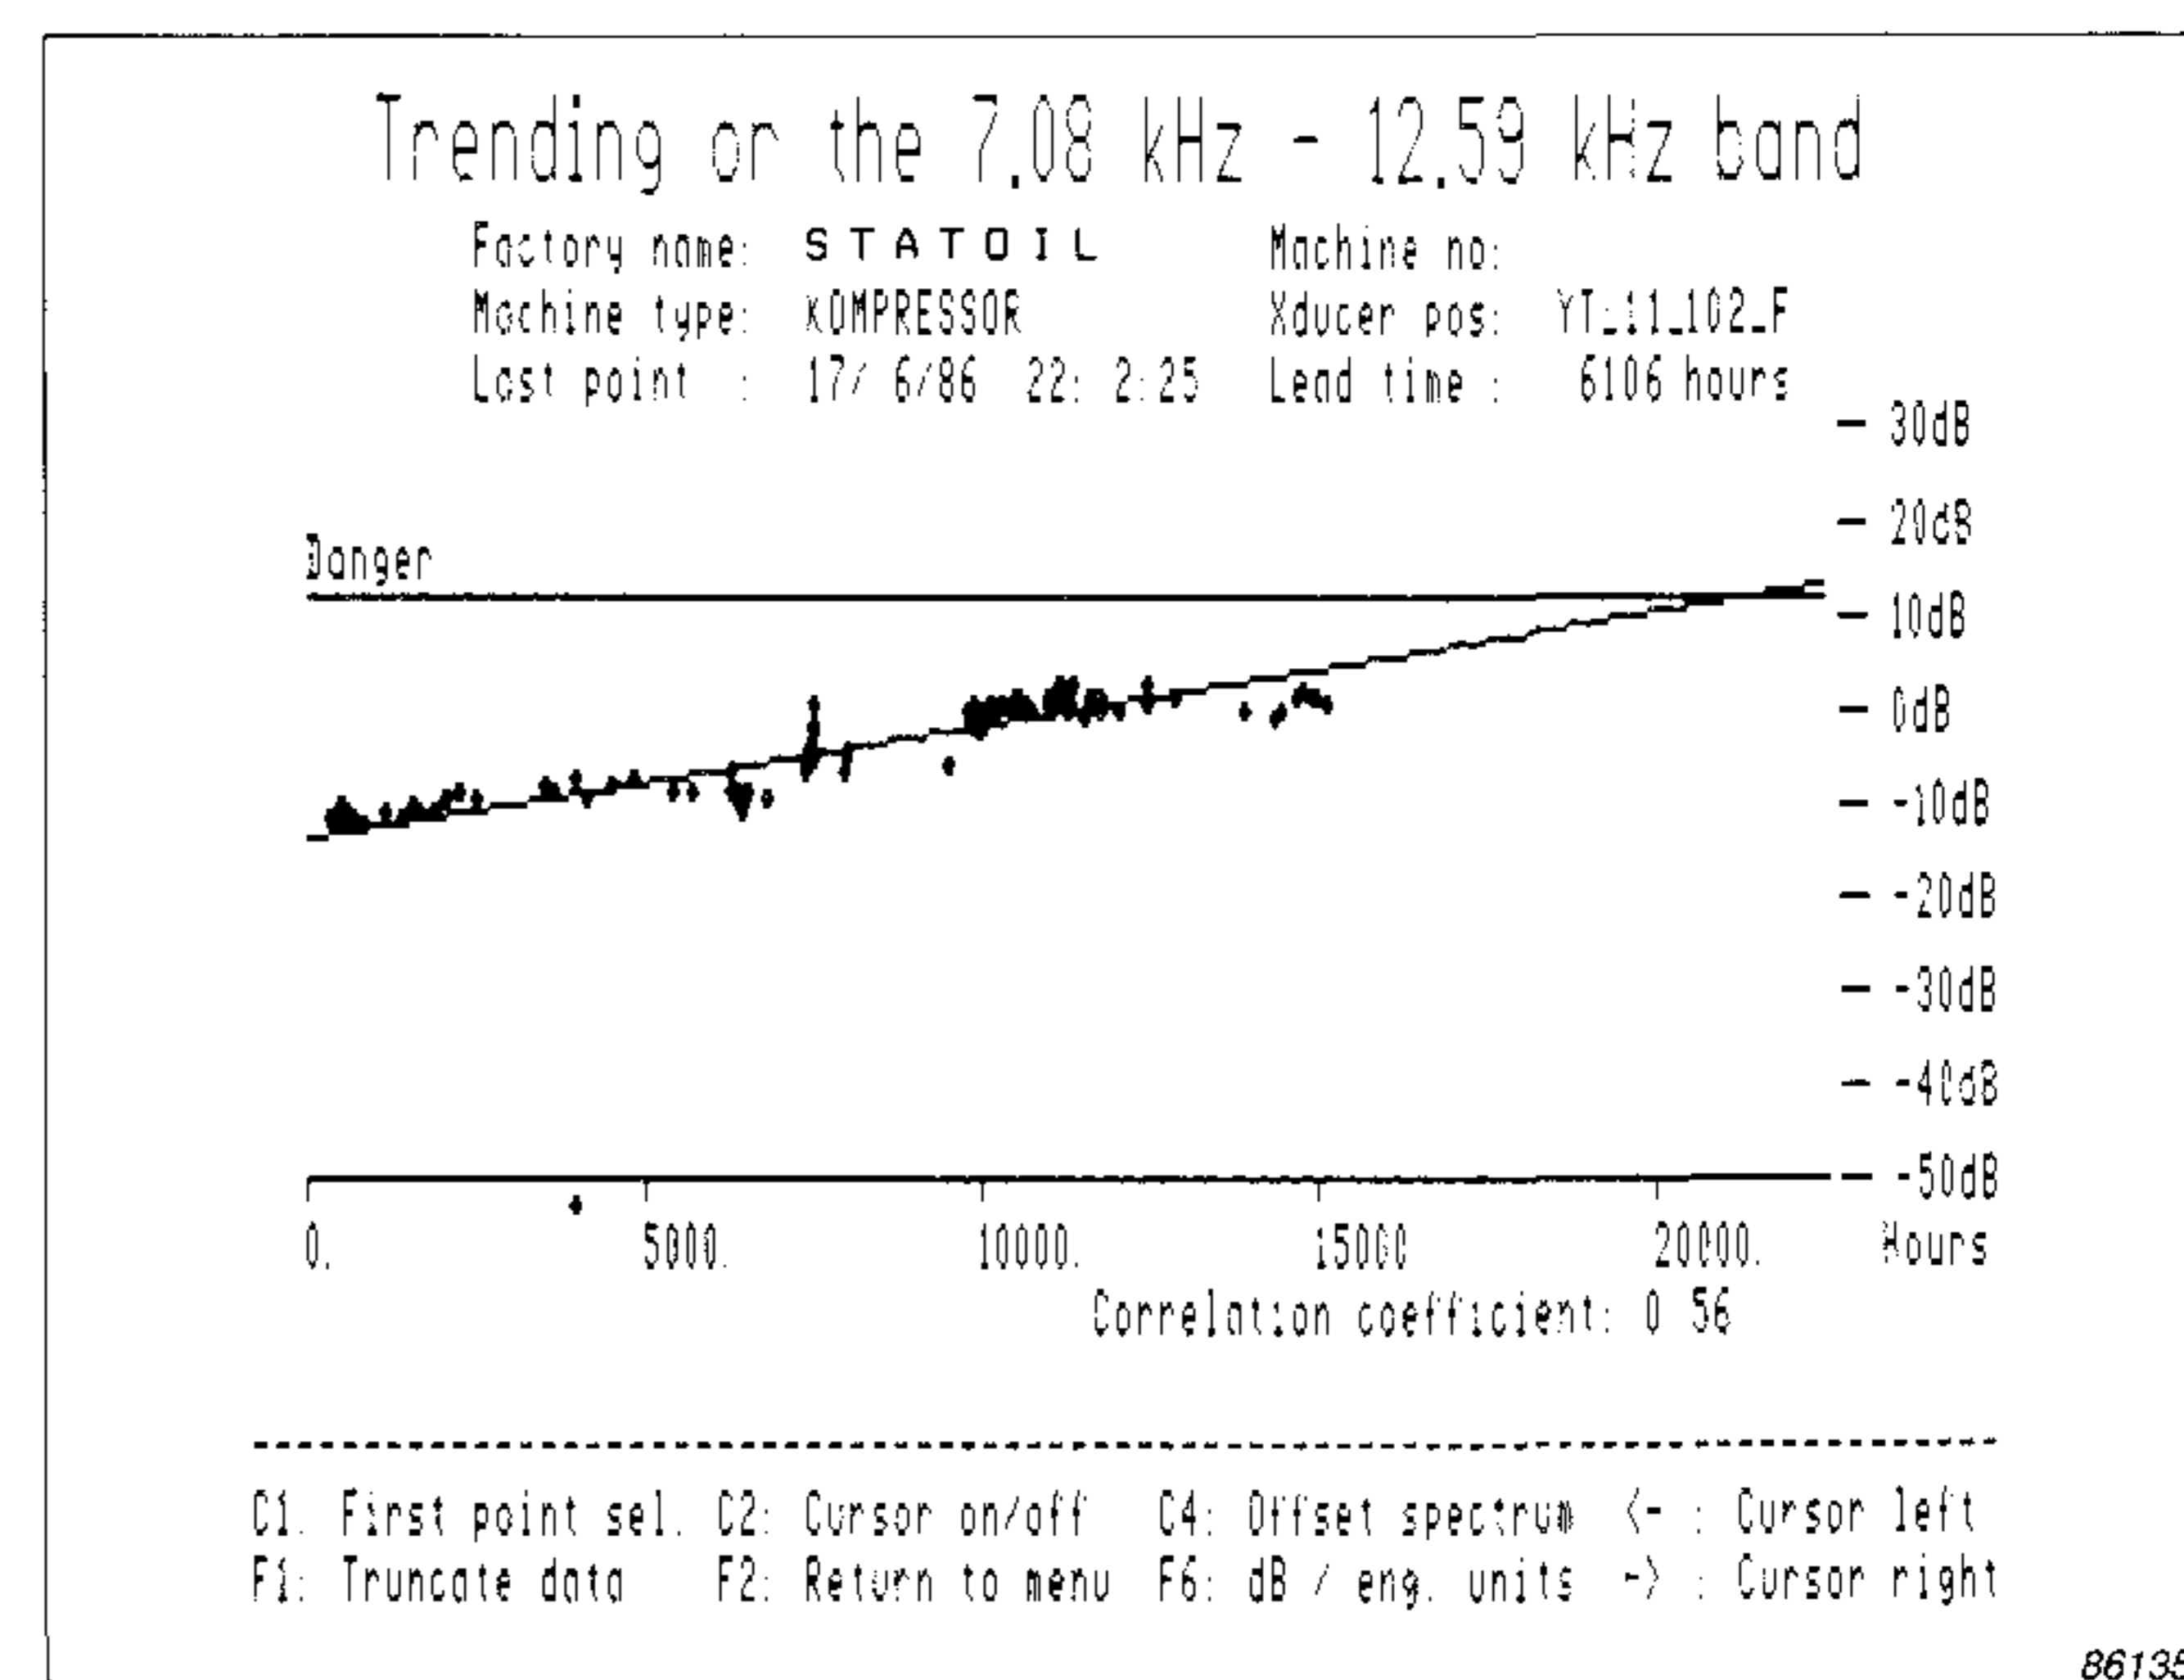
Fig. 20. Trend curve from the screw compressor showing a gradual increase in the 7 - 13 kHz range

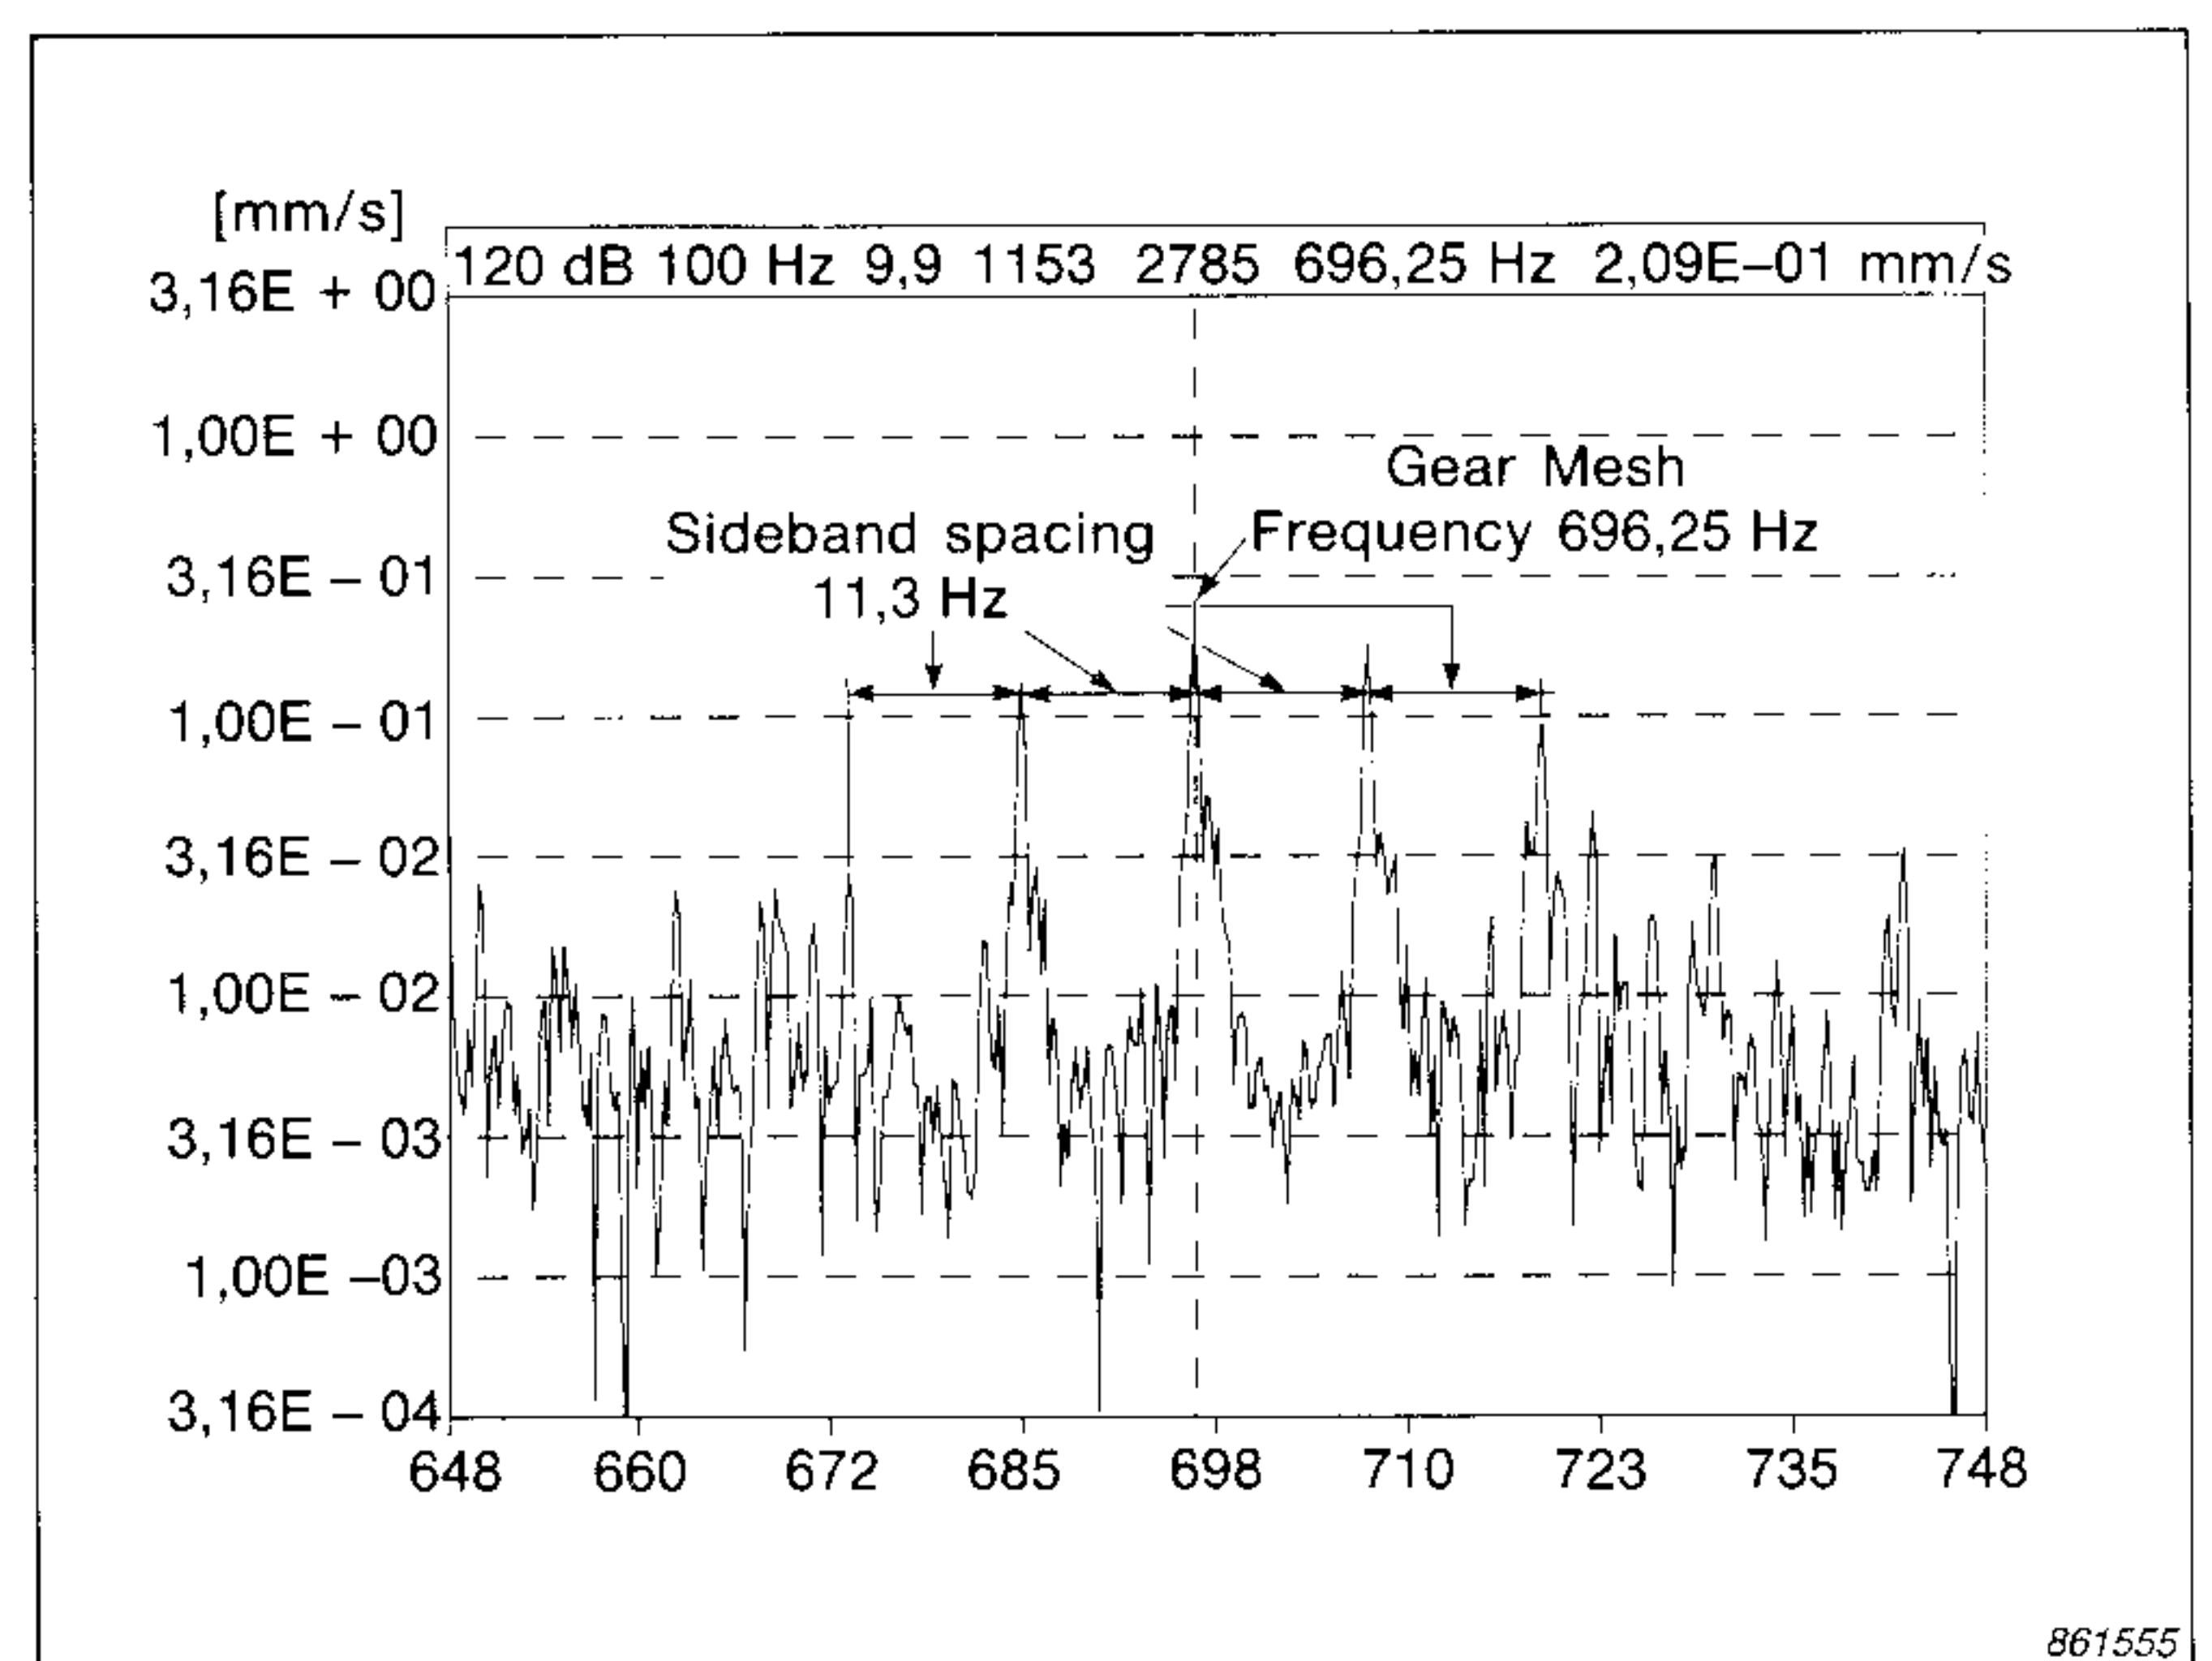
Fig. 23. Zoomed narrowband spectrum from the extruder gearbox, clearly showing the sidebands around the toothmesh frequency

Gear faults such as misalignment, unevenness and local tooth damage are normally reflected as sidebands around the toothmesh frequency. The frequency spacing of these sidebands is equal to the shaft speed. Fig.23 shows a zoomed spectrum from the extruder gearbox, centered around the

toothmesh frequency at 696,25 Hz. The sideband spacing of 11,3 Hz, which is clearly visible, is equal to the intermediate shaft speed. When the gearbox was stripped for maintenance, the gear wheel on the adjoining shaft was seen to have small local damage on part of the tooth circumference.
