# Machine-Condition Monitoring using Vibration Analysis

## A Case Study from an Iron-Ore Mine

by D.N.Brown & J.C.Jørgensen  
Brüel & Kjær

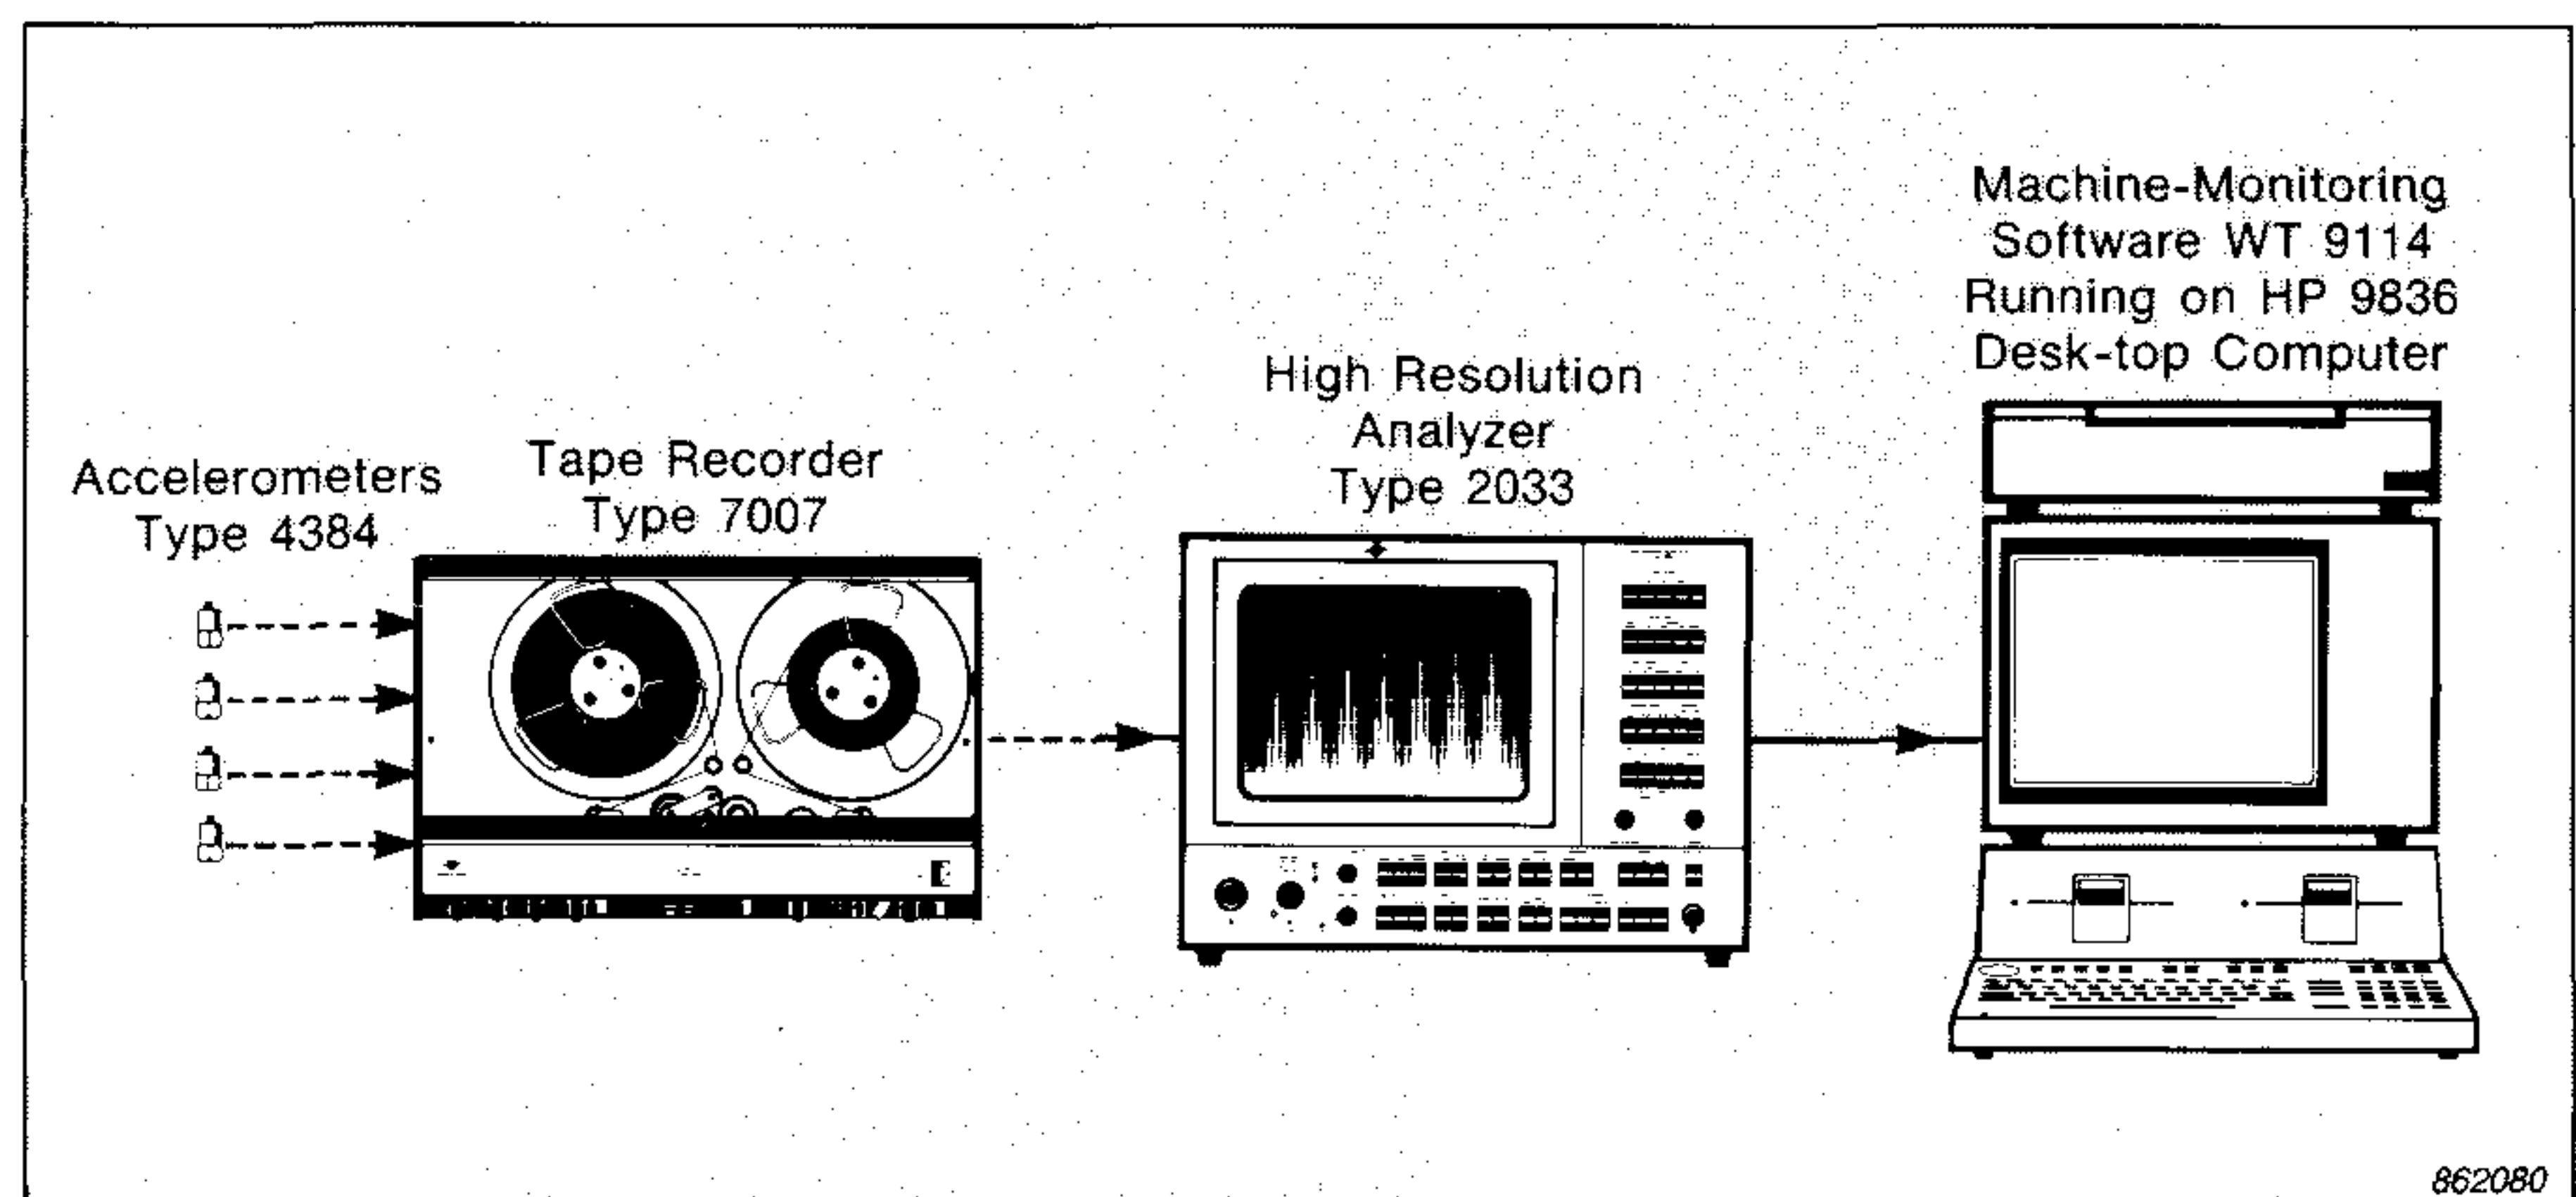
Fig. 1. Schematic layout of the monitoring system

A layout of this system is shown in Fig.1. The system consists of a number of Accelerometers Type 4384, two Tape Recorders Type 7007, a High Resolution Signal Analyzer Type 2033, and software WT 9114 running on a Desk-Top Computer. A Type 2516 hand-held Vibration Meter is also available for spot-checking machine condition.

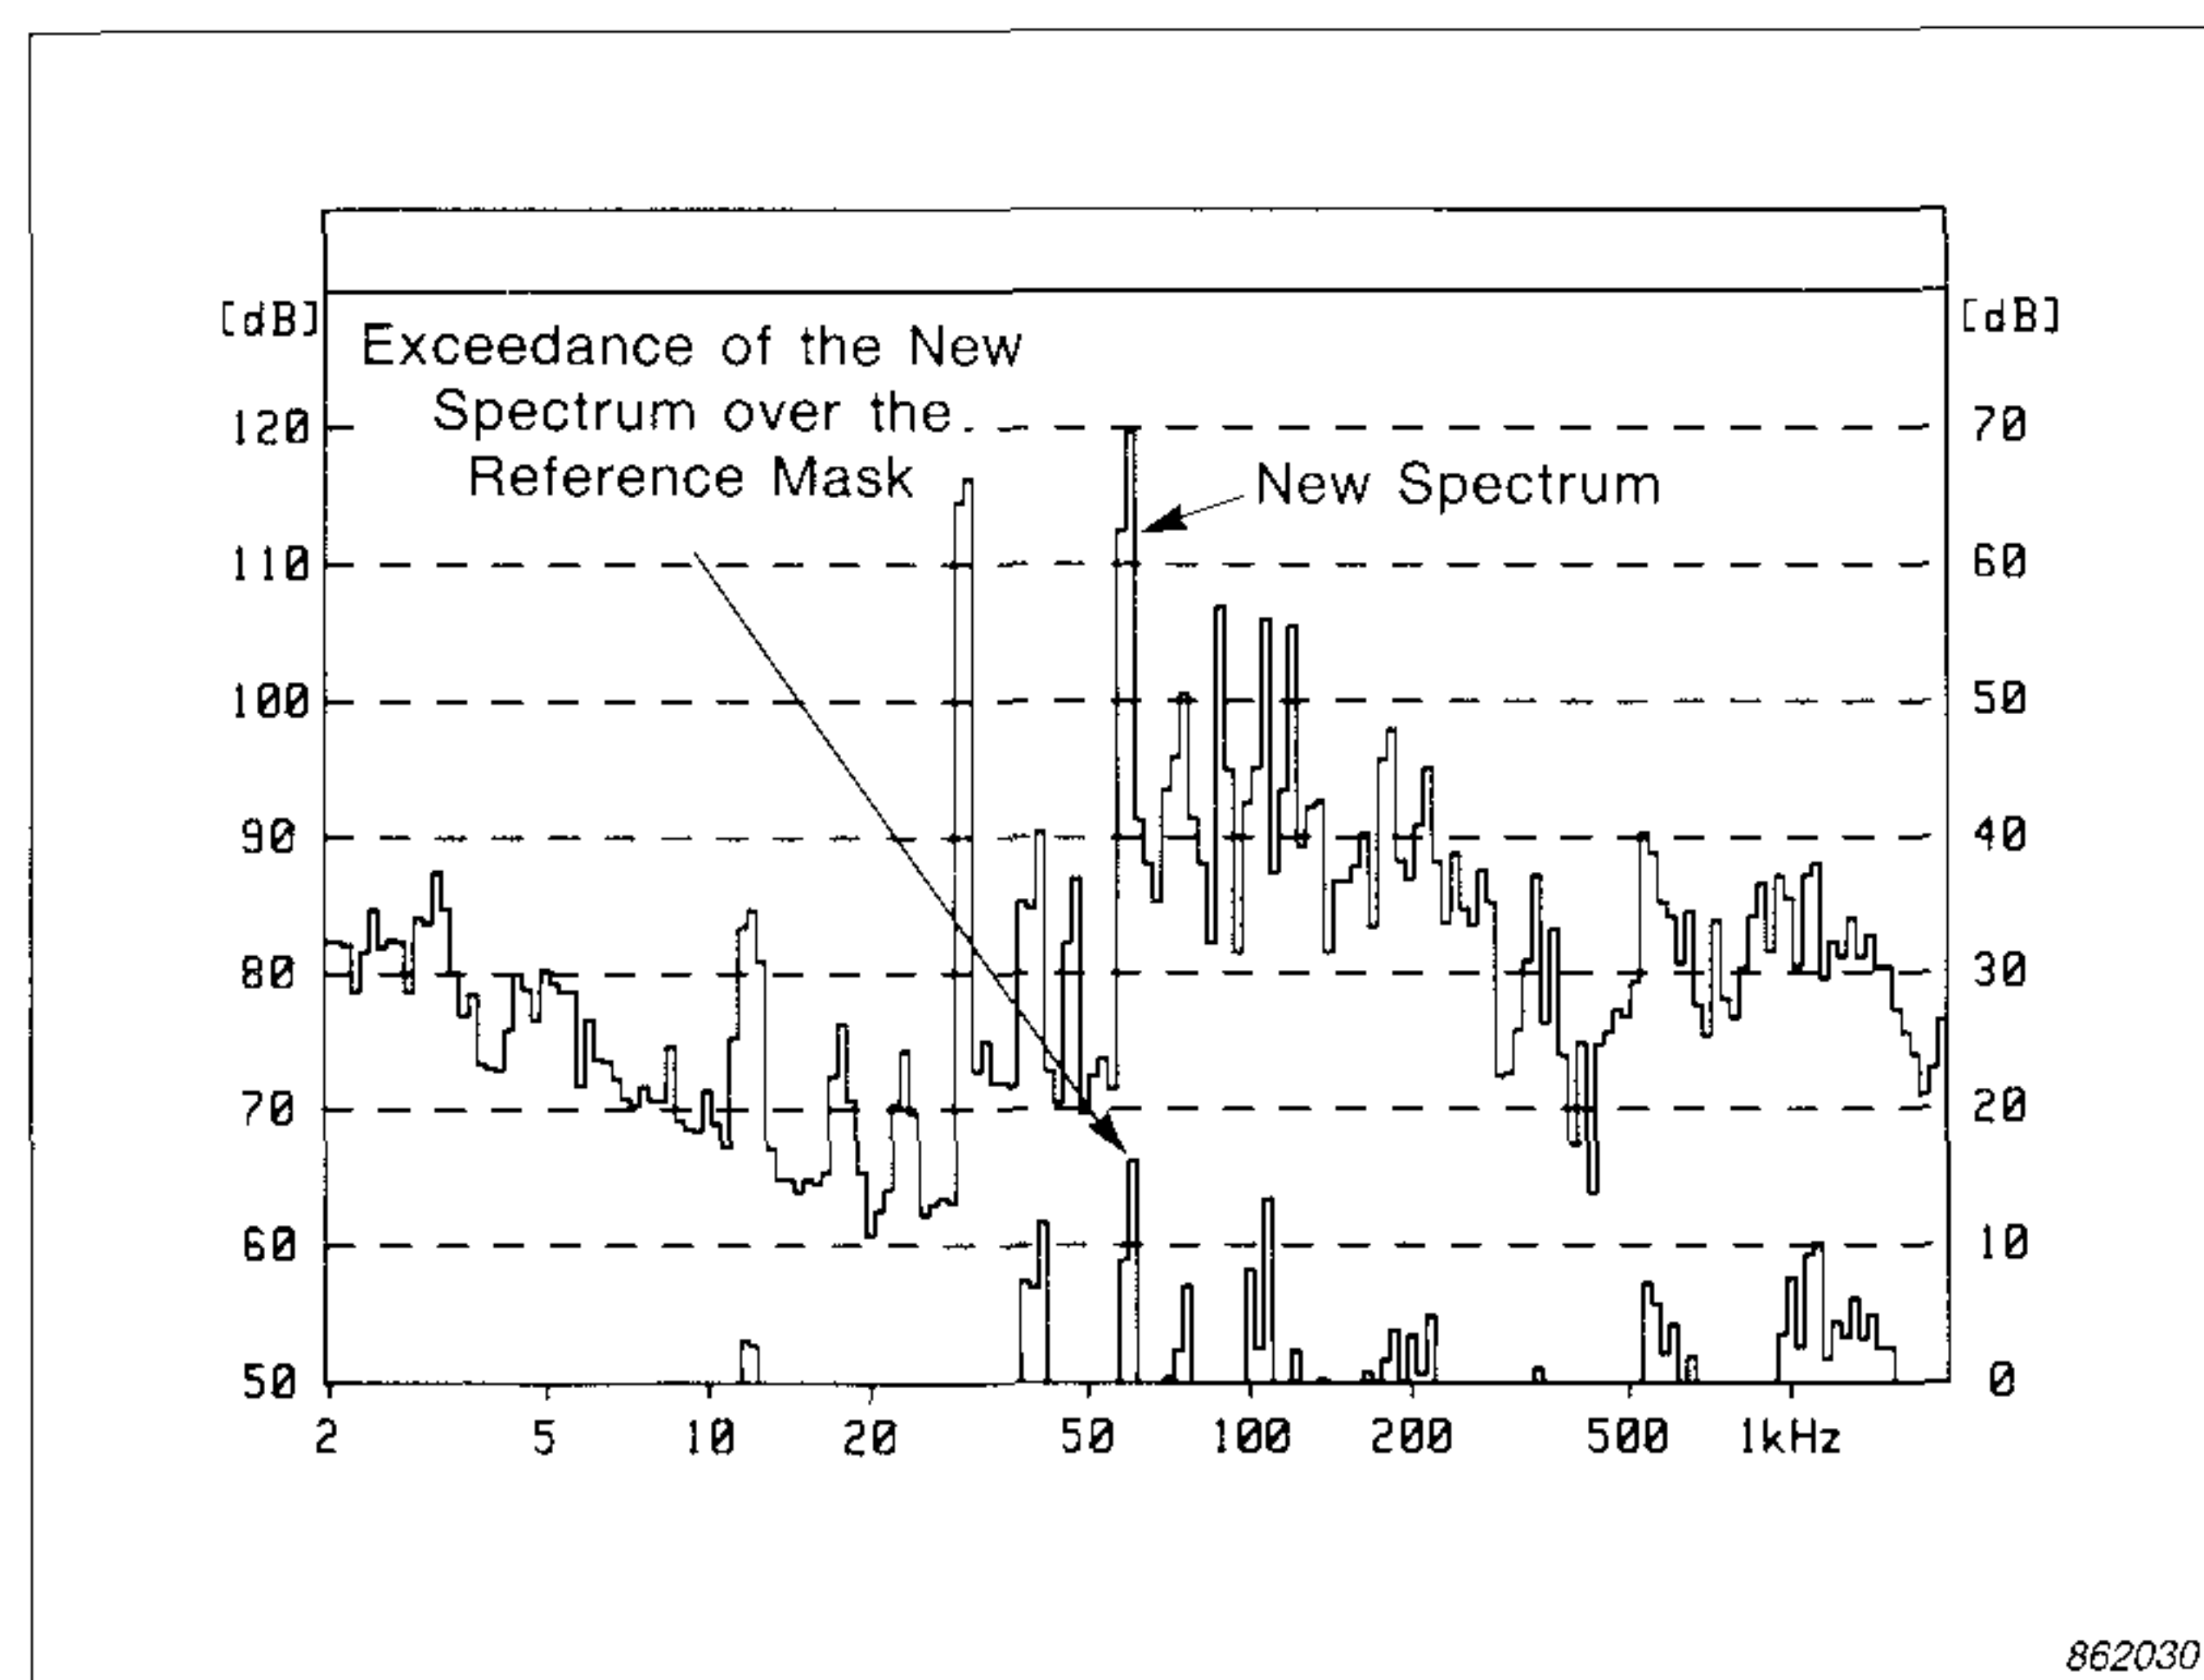
Fig. 2. An example of the log.-frequency scaled spectrum used for fault detection. The upper curve shows the current vibration spectrum, and the lower the frequency components from the current spectrum that have exceeded the reference spectrum

erence spectrum, changes in the condition of the machine will be revealed. Fig.2 shows an example of this fault detection procedure. The upper curve is the current spectrum, and the lower is the amount by how much the current spectrum has exceeded the reference spectrum.

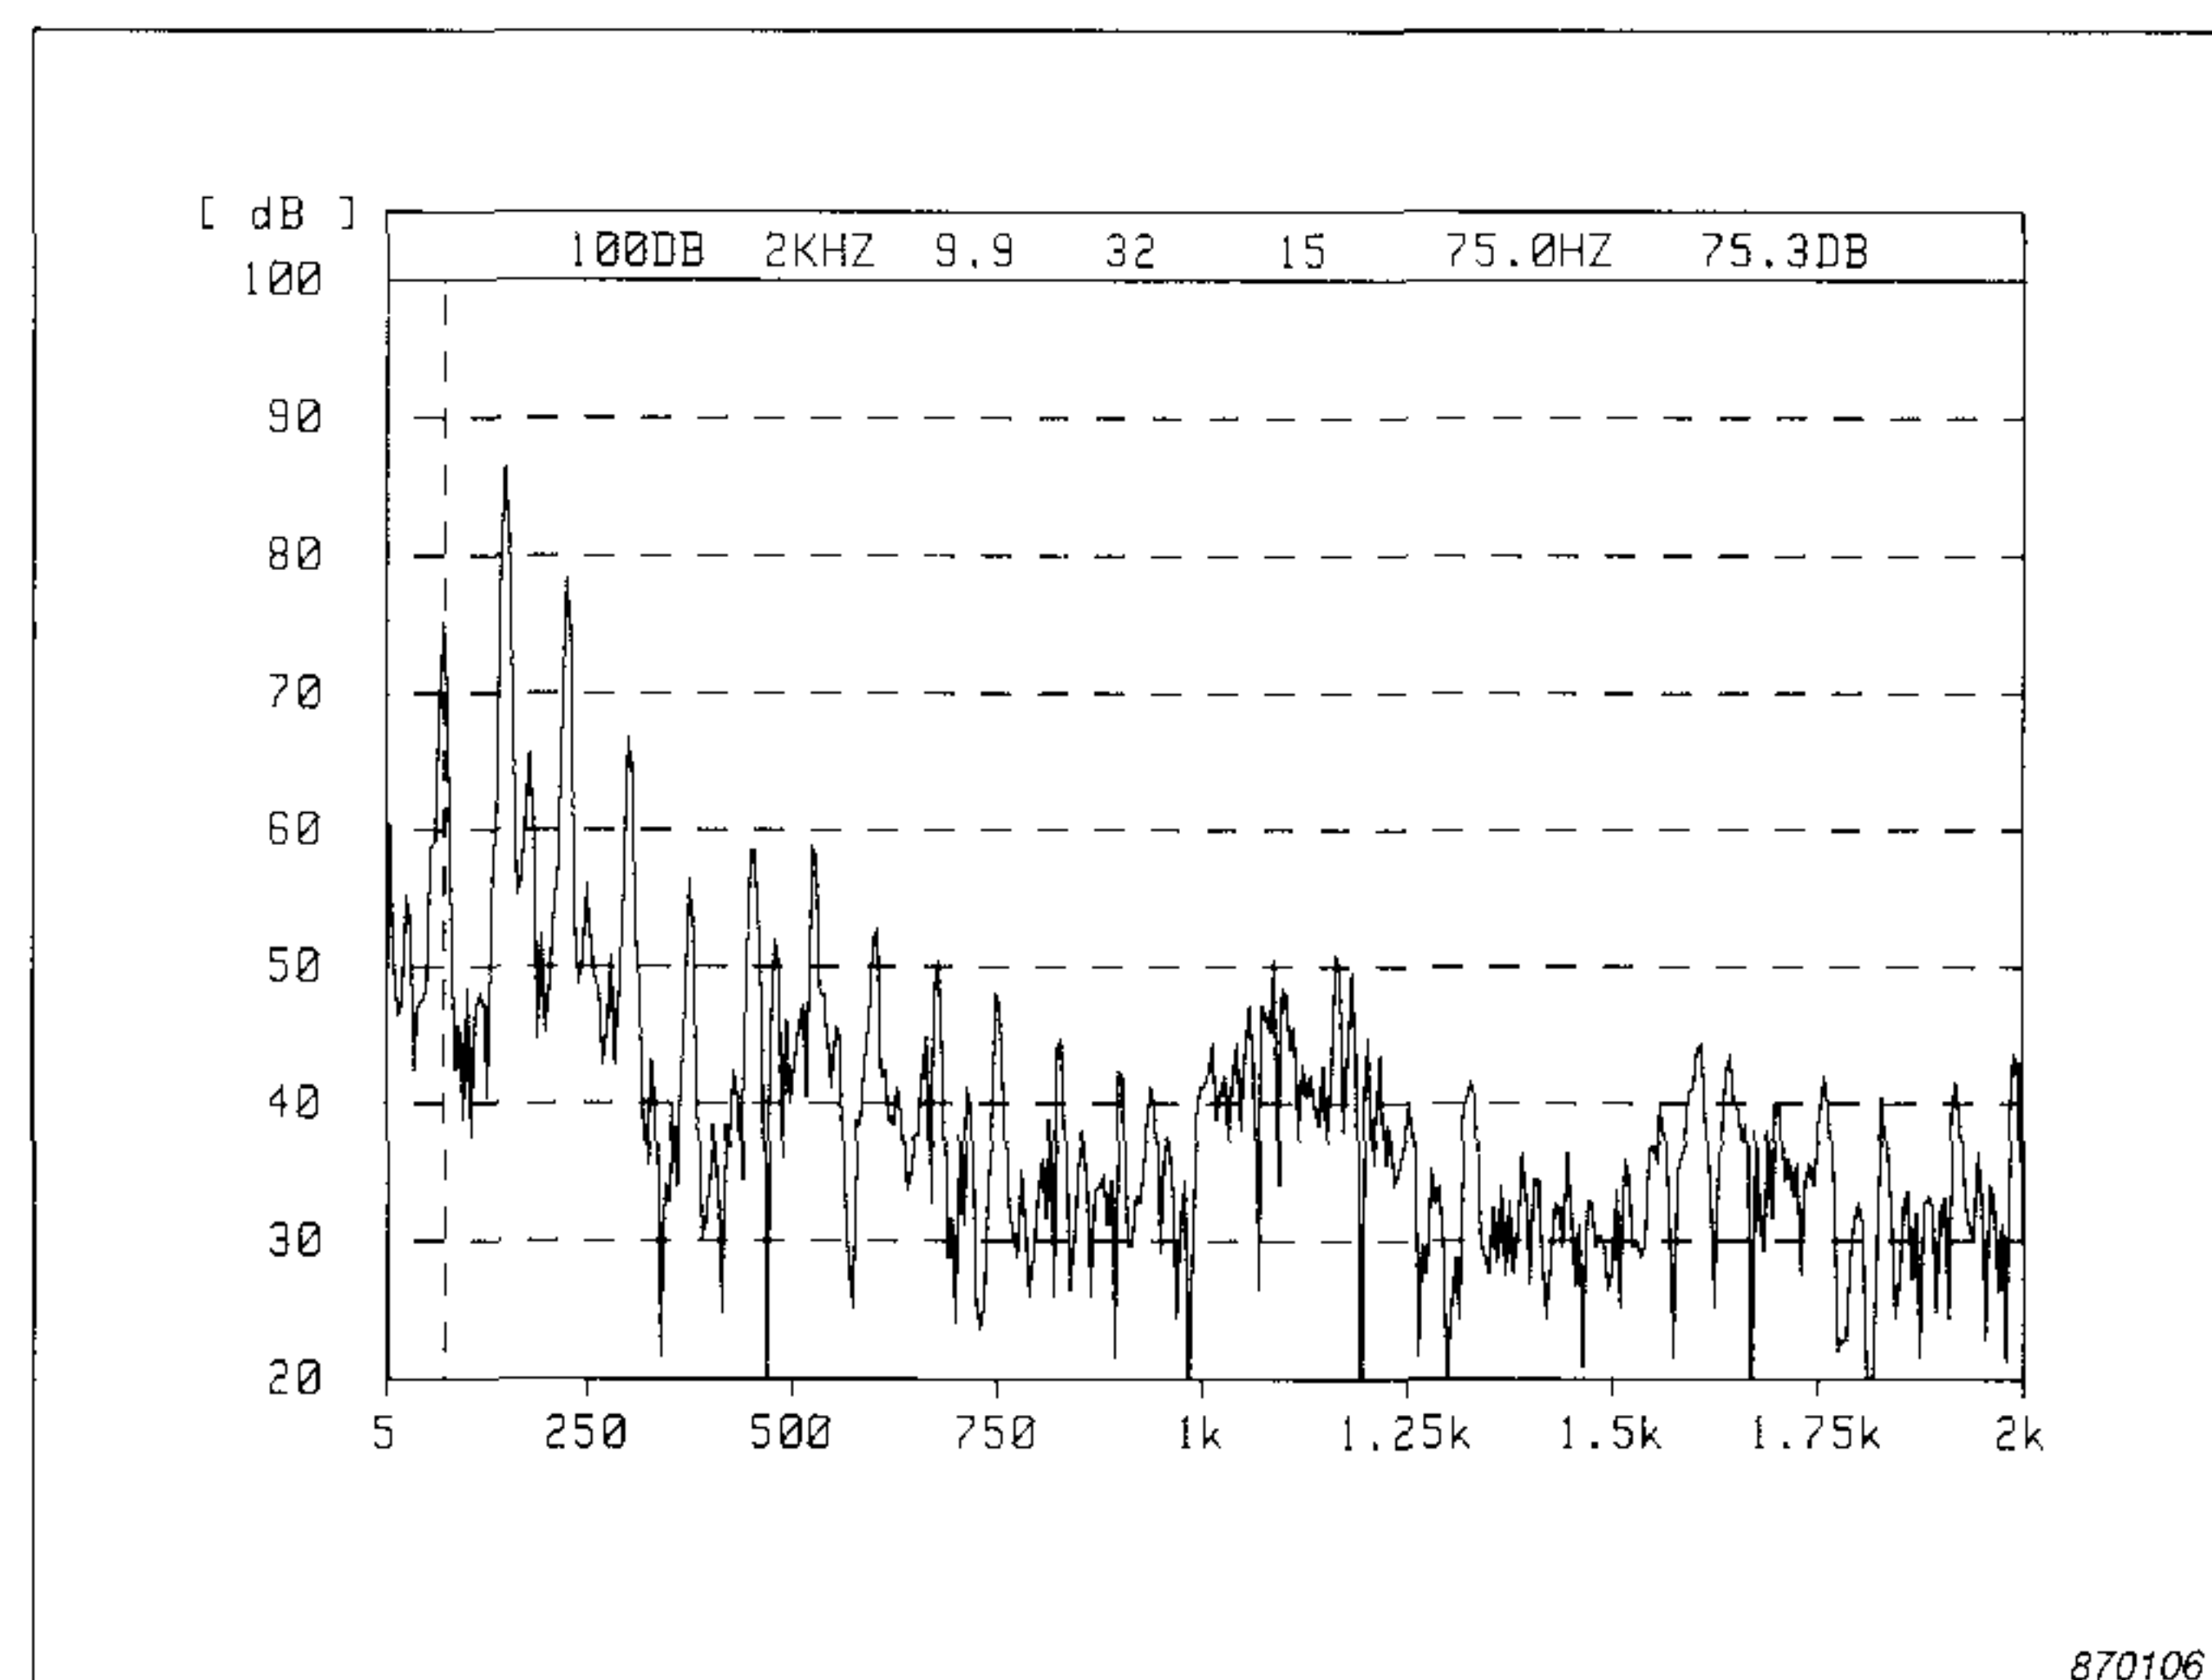
Fig. 3. An example of a narrowband spectrum used for fault diagnosis. The high resolution of the analyzer enables each frequency component to be accurately identified and matched to specific machine phenomena

The high-powered fault diagnostic facilities of the system enable suspect faults to be pin-pointed to a specific machine component. These diagnostic facilities include narrowband zoom-analysis, cepstrum analysis, and sideband and harmonic cursors. An example of a narrowband spectrum is shown in Fig.3.

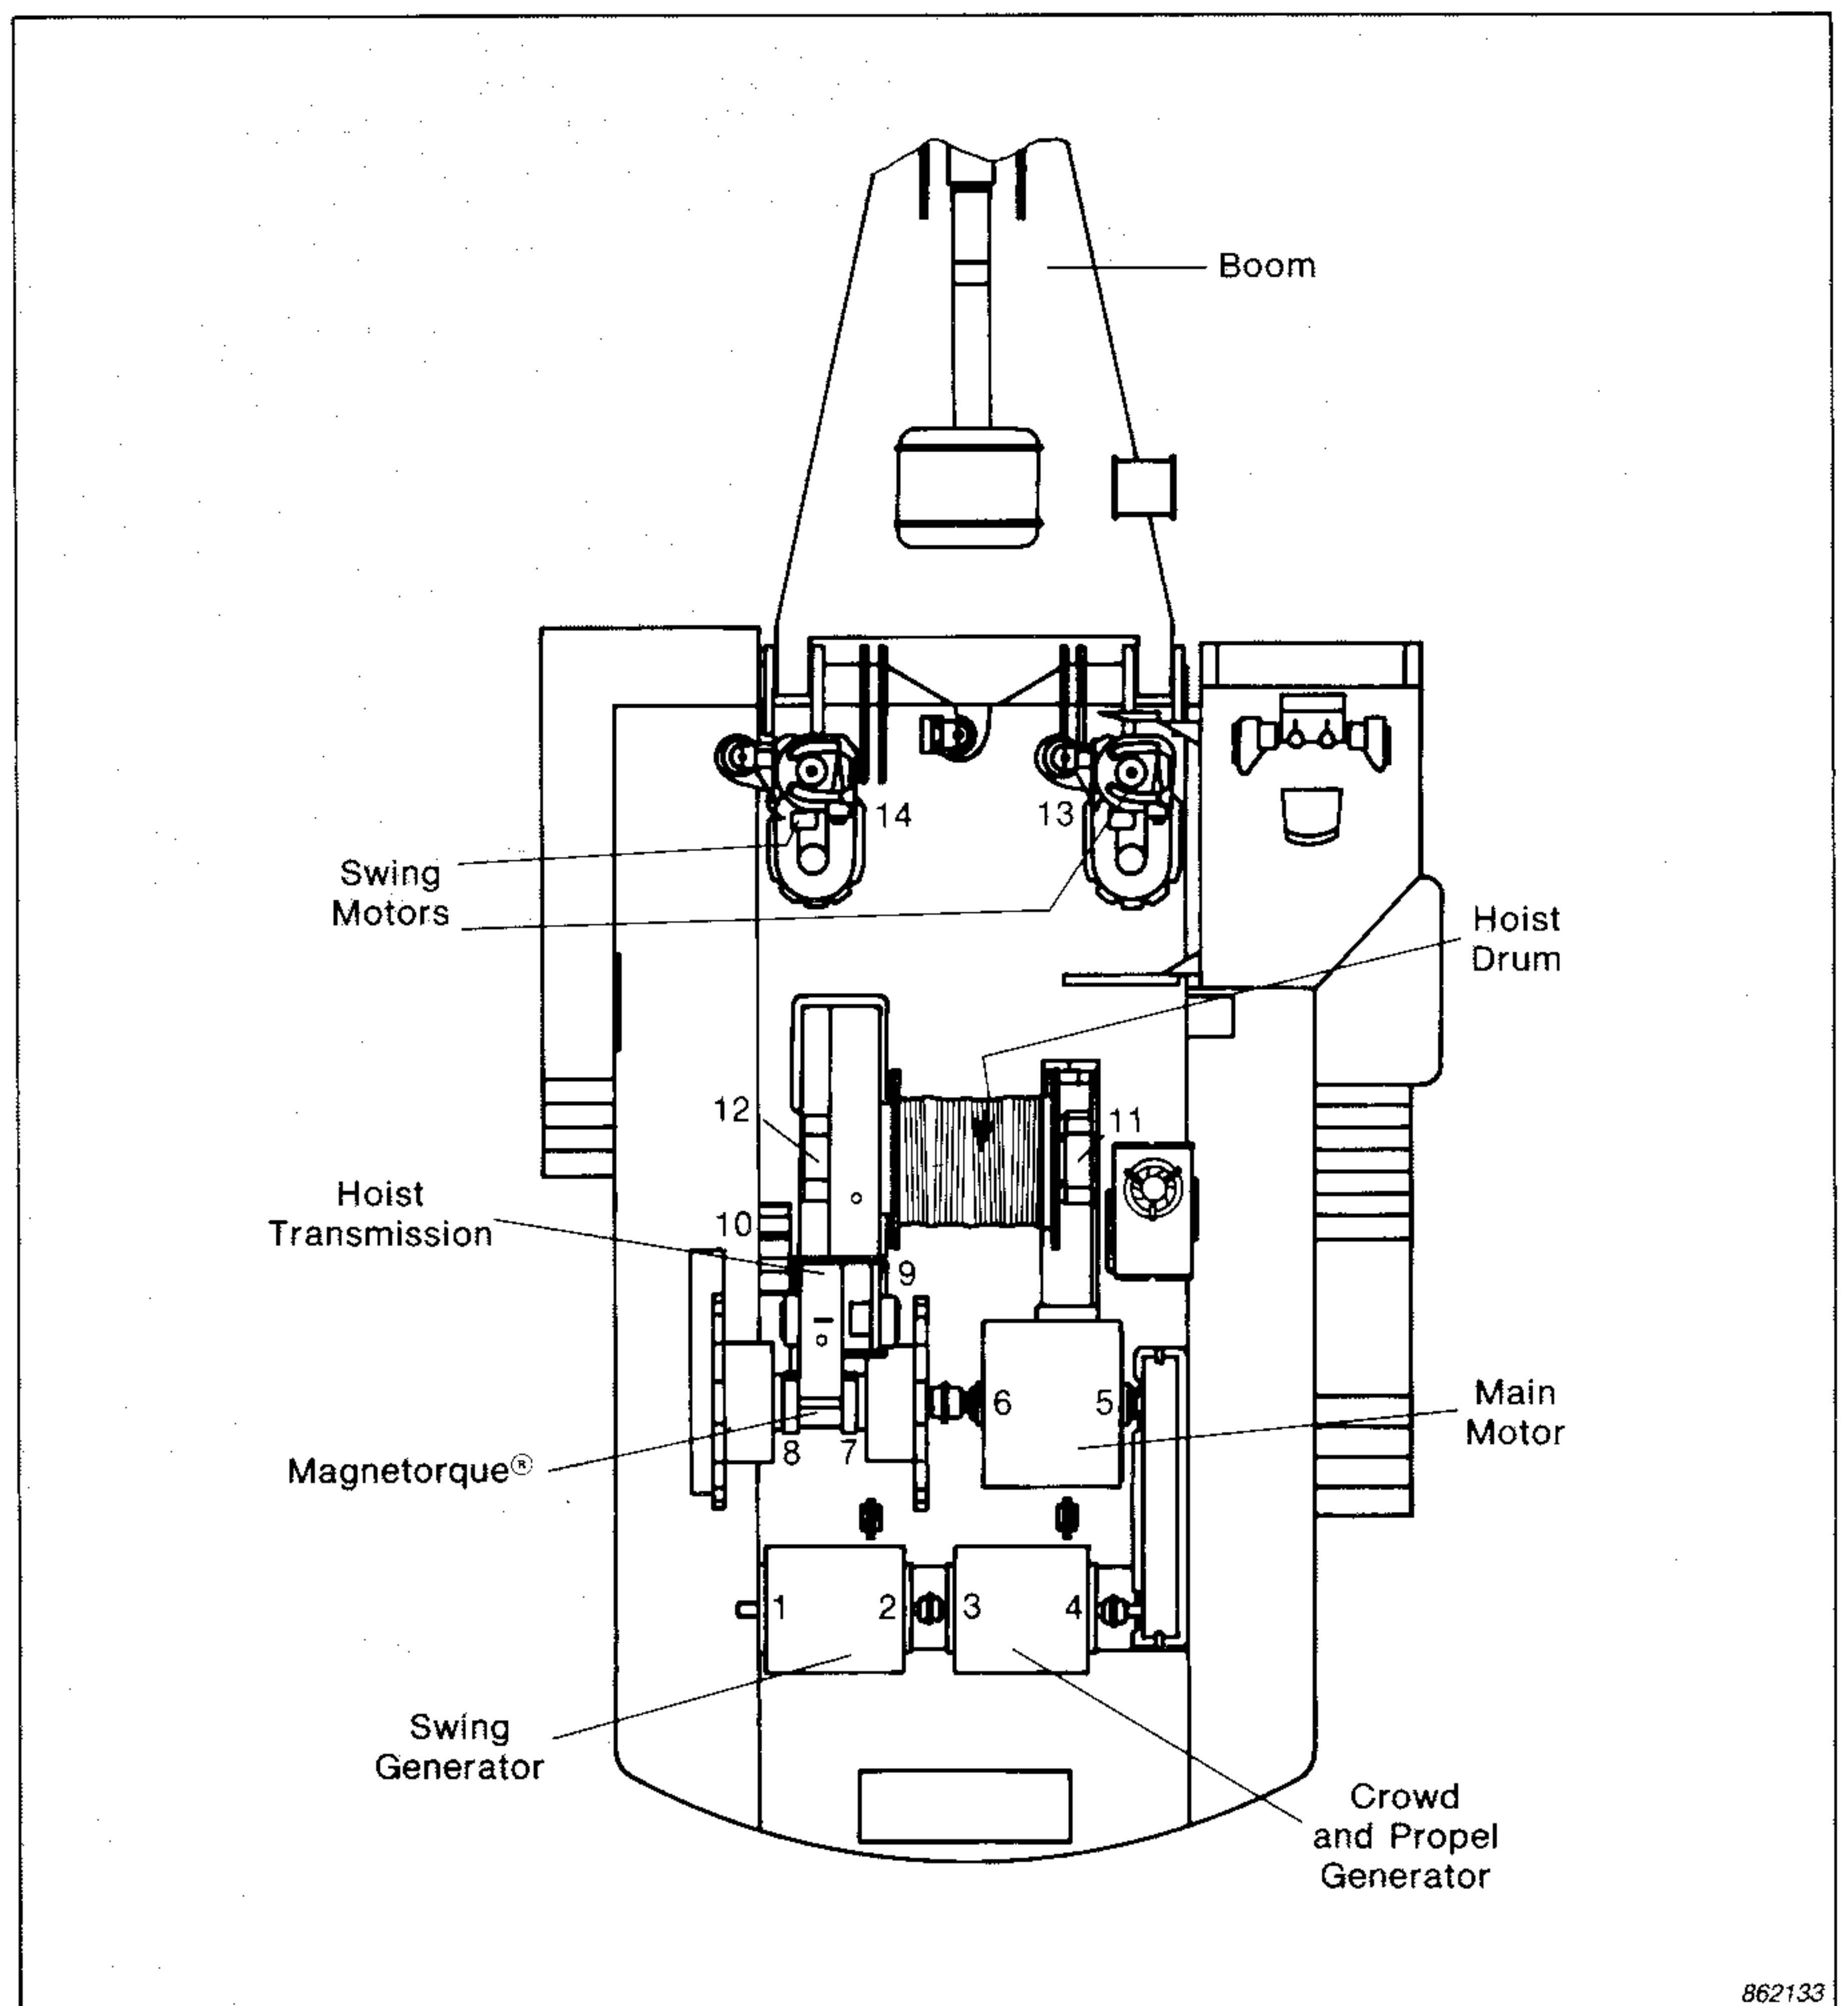
Fig. 4. Top view of the P&H shovels showing the measurement points used

Figs. 4 and 5 show the measurement points on the two types of MG-Sets found in the shovels. Vibration measurements are first made on a new or reconditioned MG-set when it is in the maintenance shop, prior to fitting in the shovel. A reference spectrum for comparison is then recorded. Immediately after installation in the shovel another reference spectrum is recorded (this is to check for installation problems, usually misalignment, and sometimes transportation problems). Measurements are then made on the MG-Set every 1000 to 1200 hours, and spectrum comparisons made with both the reference spectra (although the measurement interval is now being decreased to every 600 hours to obtain more results for better trend analysis).

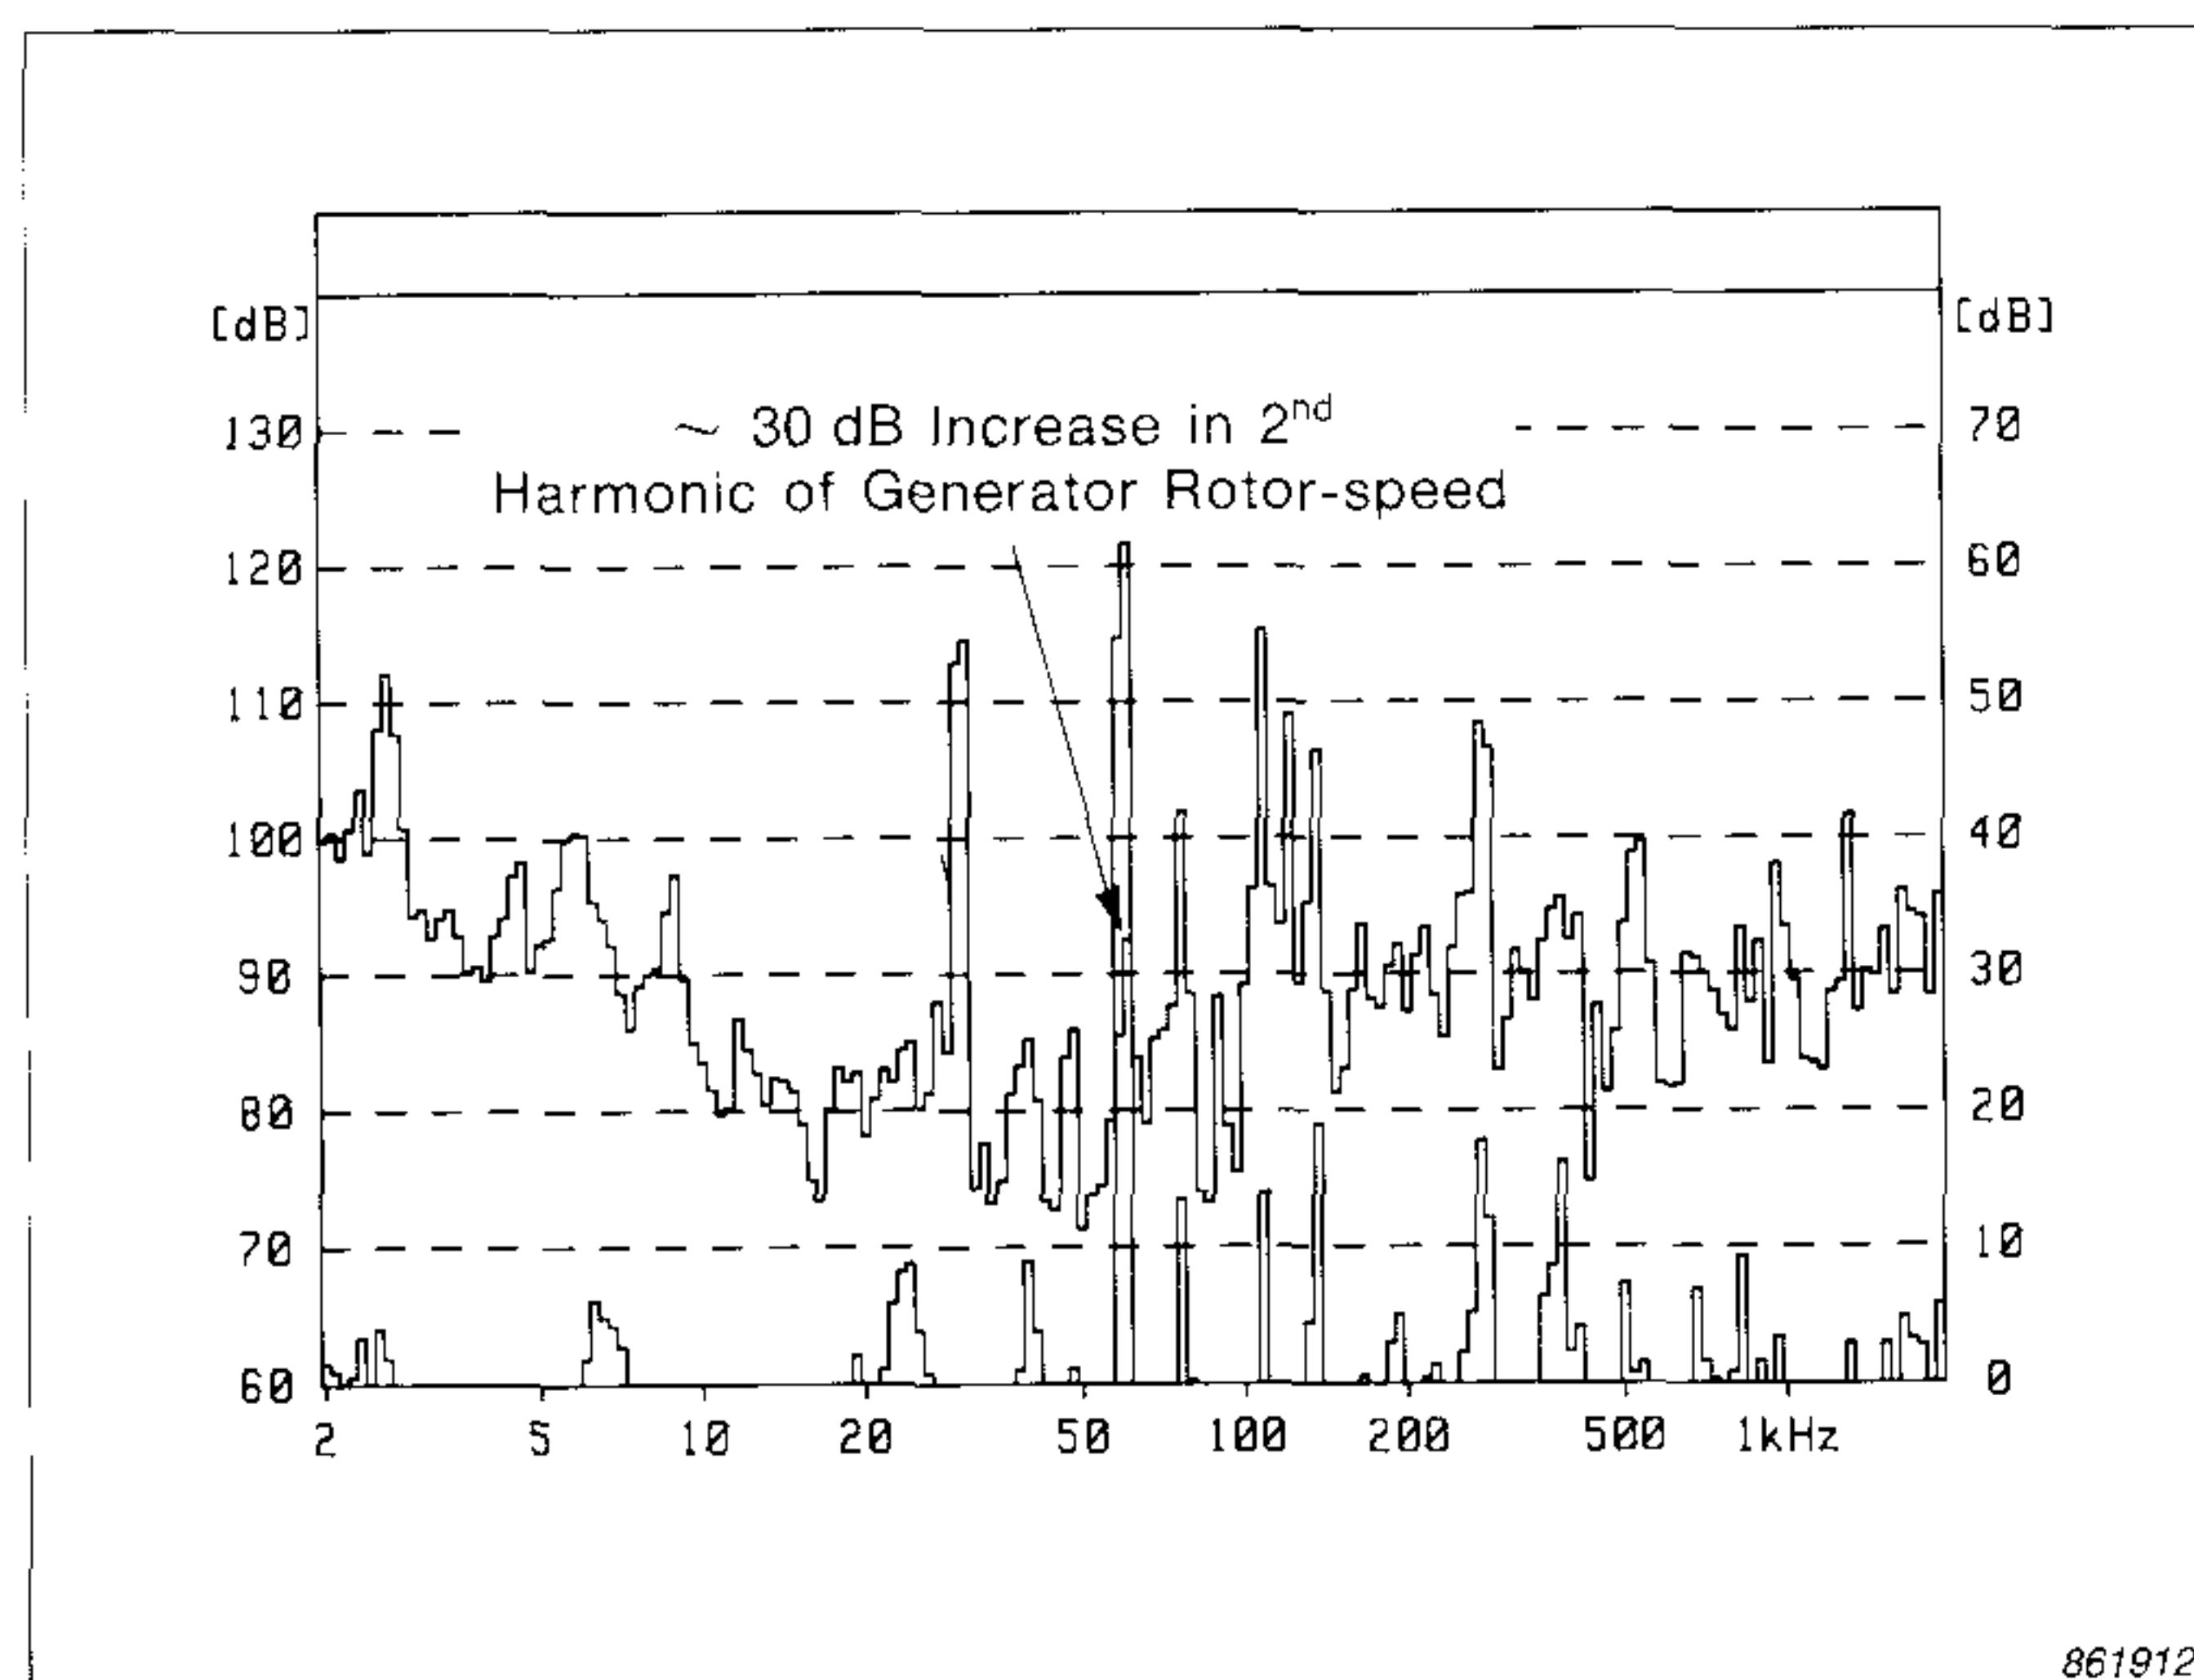
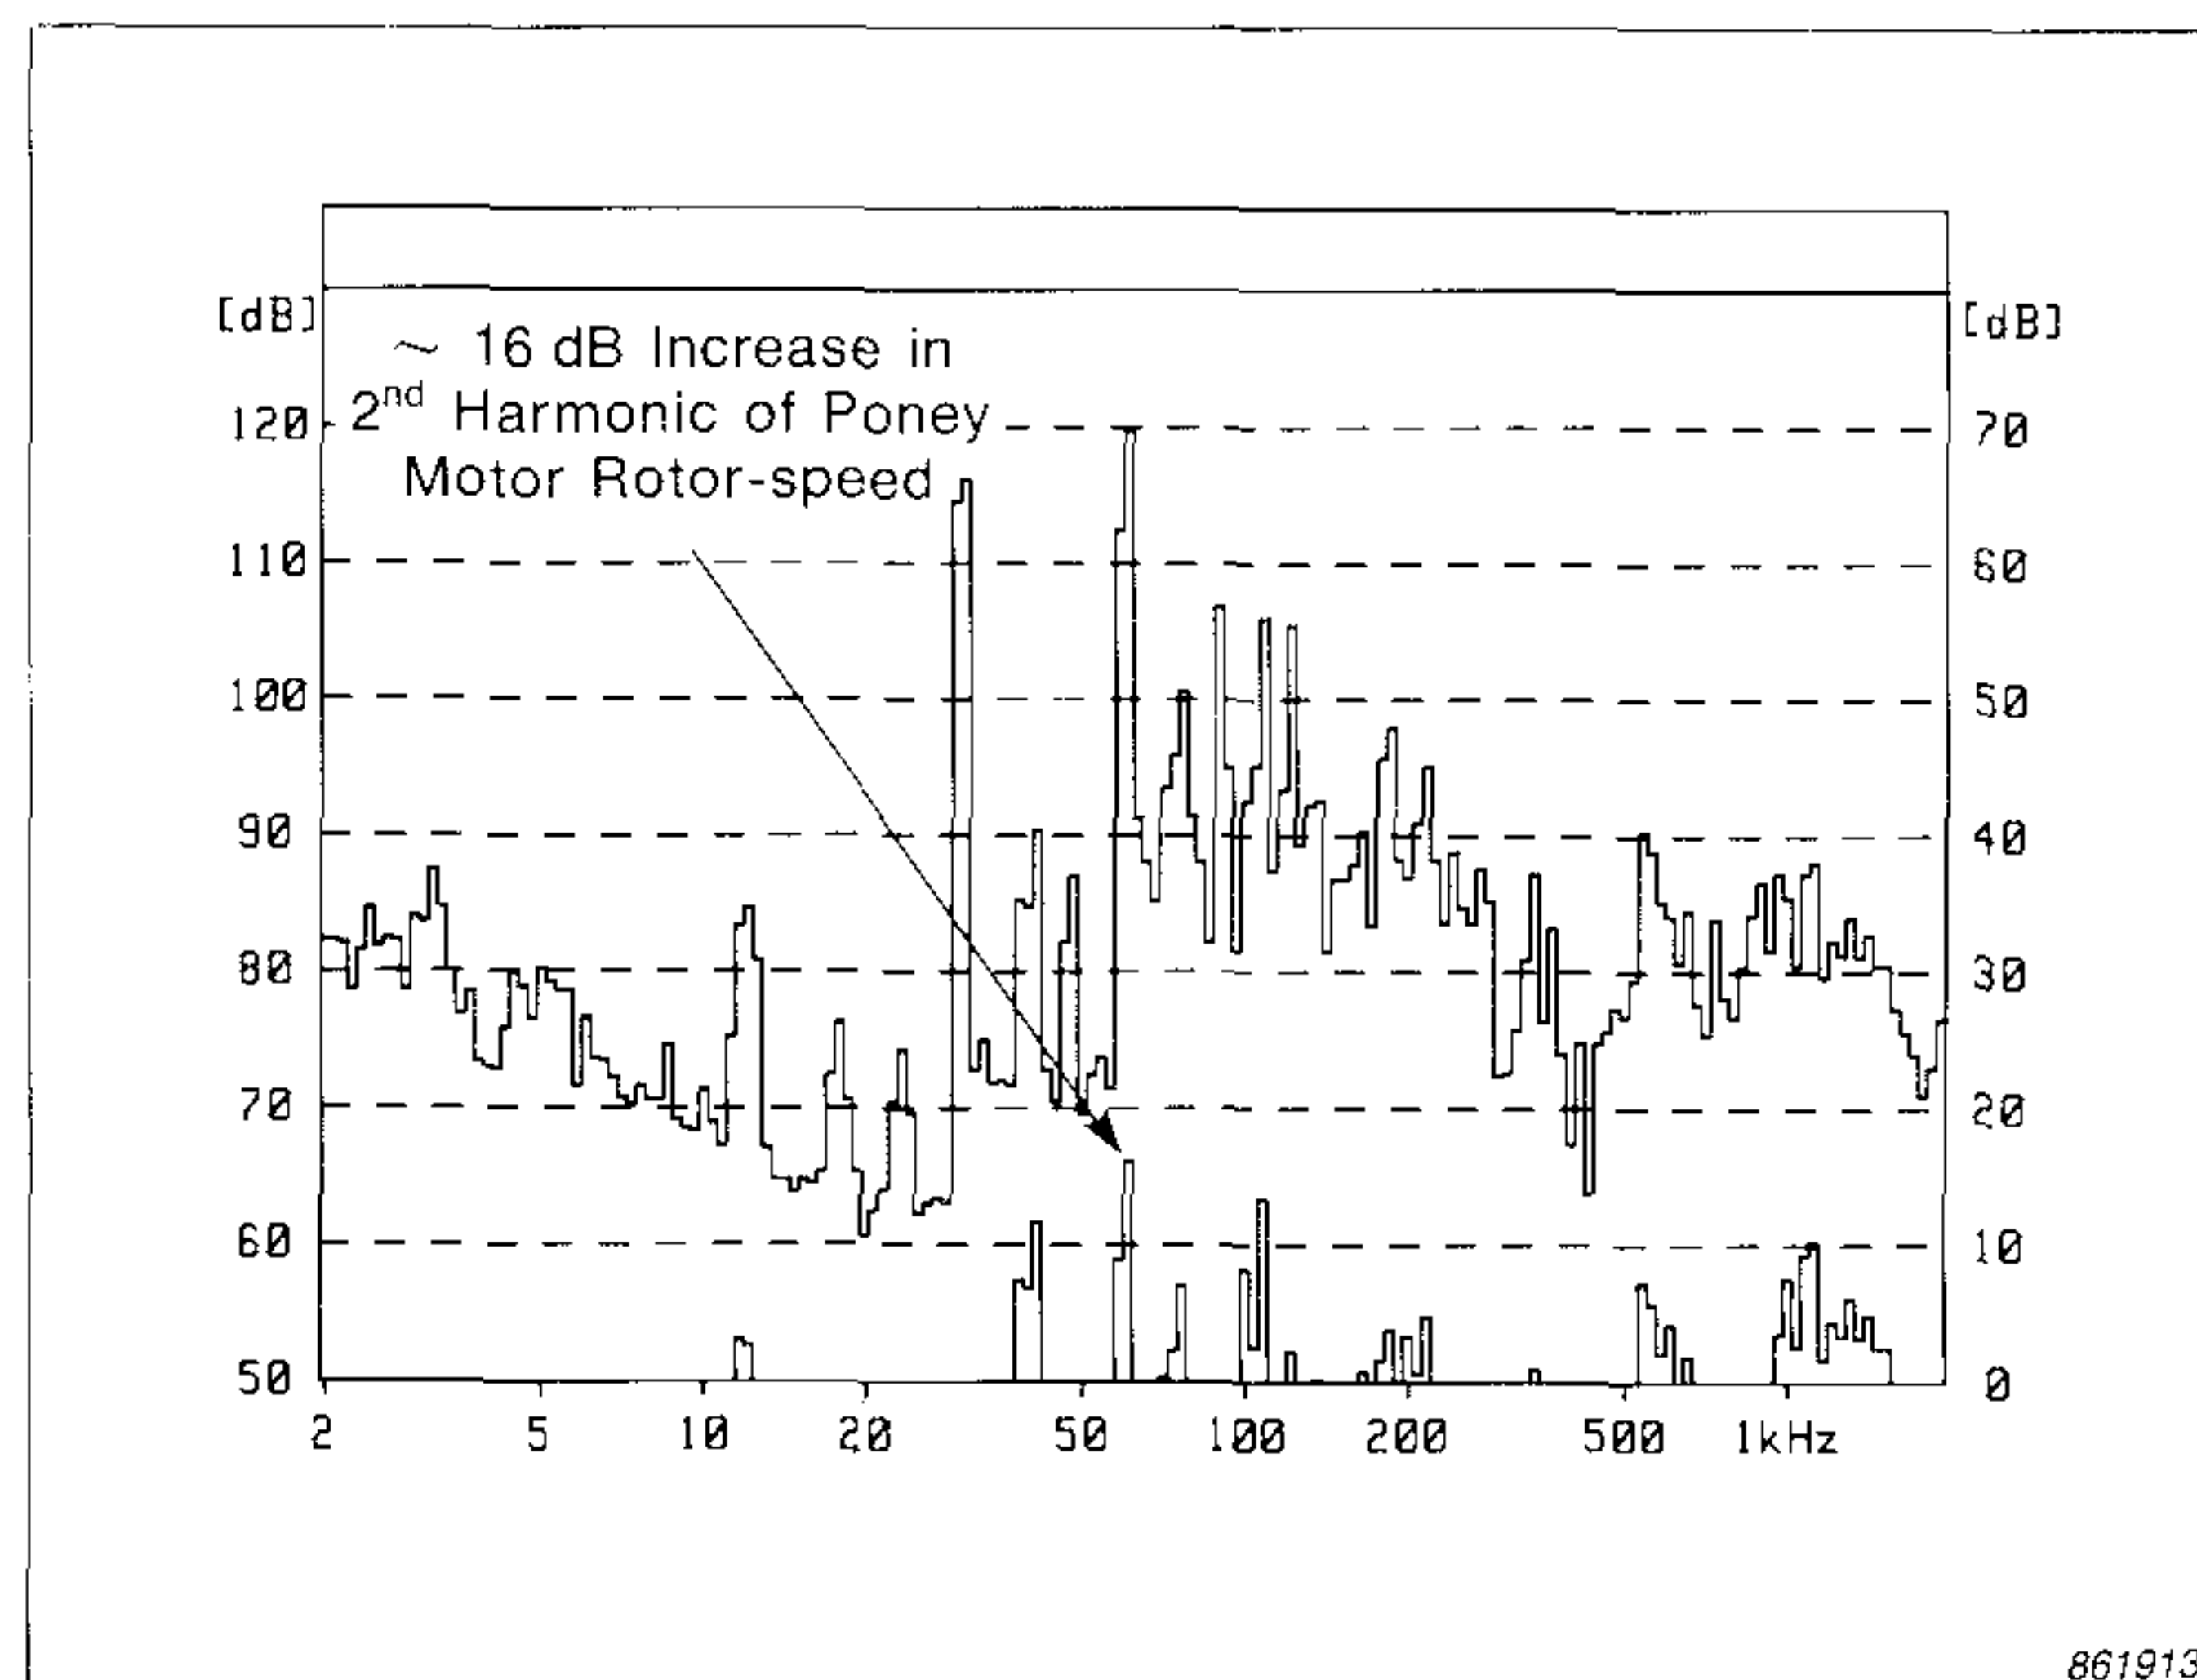
Fig. 6. Two examples of misalignment, indicated by high increases in the 2 × rotation frequency component

Fig. 6 shows some examples indicating misalignment. The spectrum to the left shows a spectrum comparison on a Swing Generator, indicating a very high (>30dB) increase at the second harmonic, 60 Hz. The spectrum to the right shows an approximate 16 dB increase at the second harmonic on the Poney Motor, used to soft start the MG-Set. The motor is not mount-

ed directly on the MG-Set base, but attached separately on a cantilever arrangement. Due to difficulties in installation, the motor is prone to misalignment problems.
