# Machine-Condition Monitoring using Vibration Analysis

## A Case Study from an Iron-Ore Mine

by D.N.Brown & J.C.Jørgensen  
Brüel & Kjær

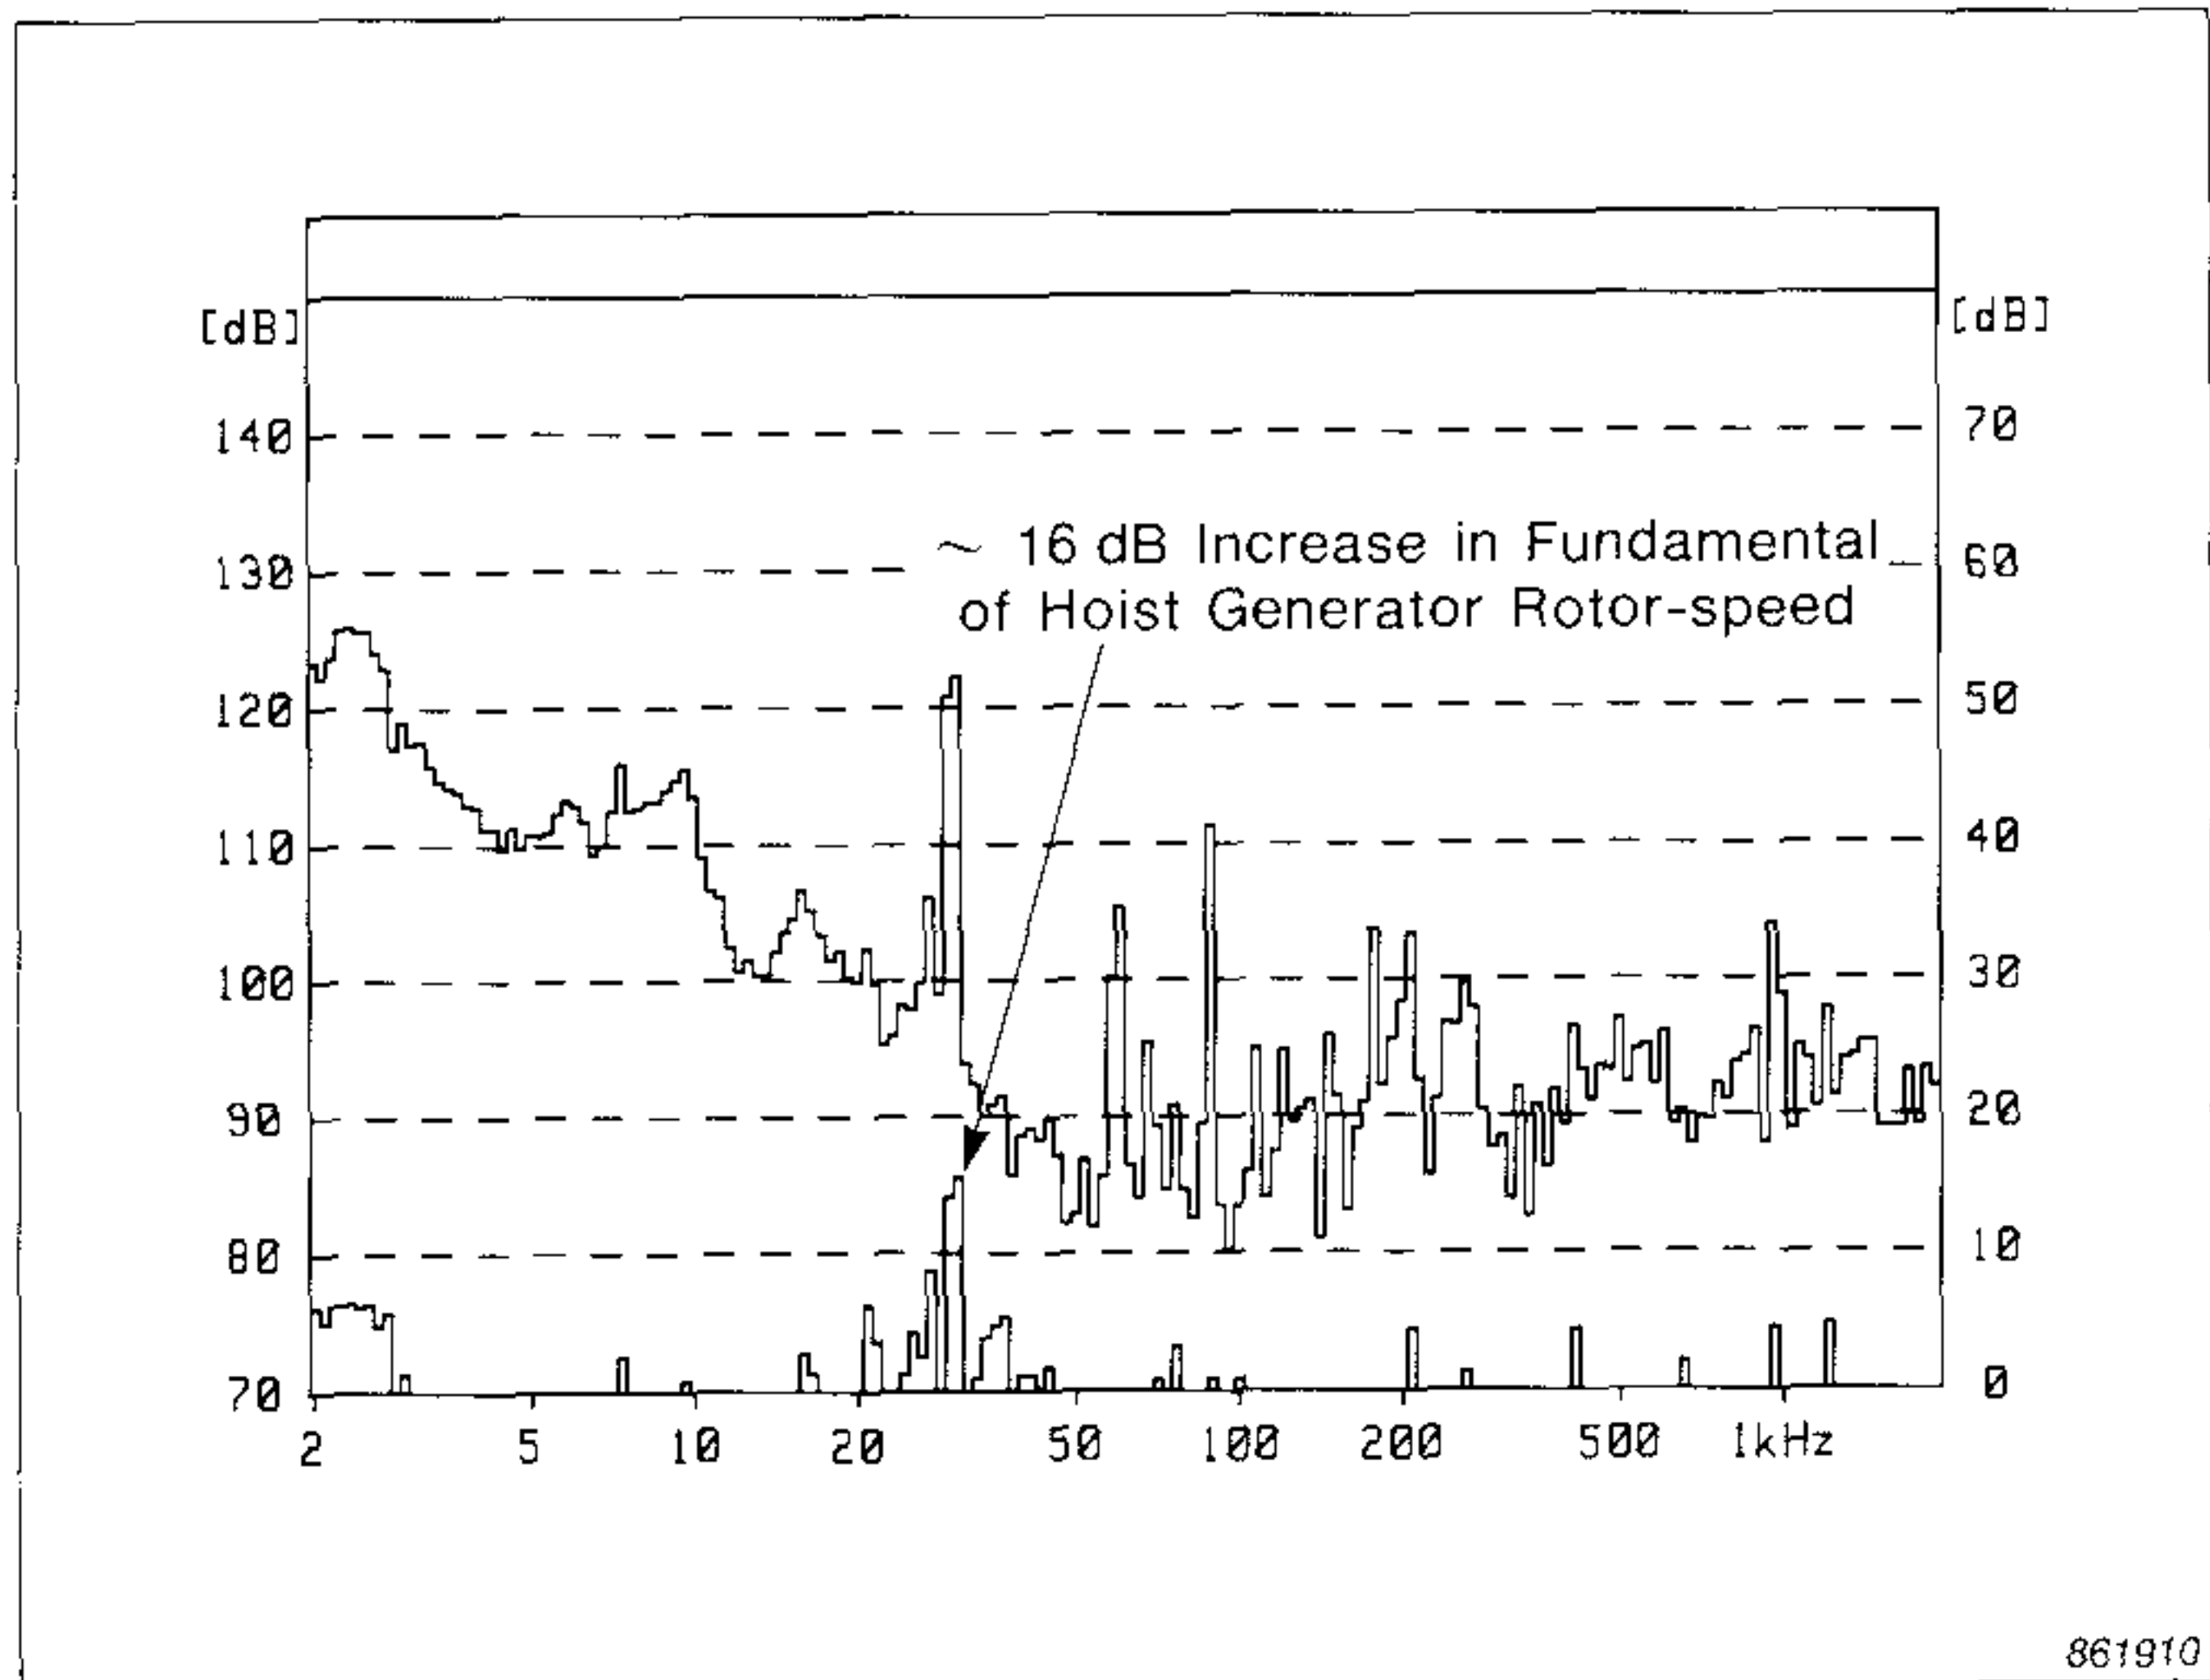
Fig. 7. An example of unbalance, indicated by a large increase at the rotation frequency

An **unbalance** in any of the components of the MG-Set could be identified by increasing vibration at the shaft rotational frequency. An example of this is shown in Fig. 7, which shows a spectrum comparison from a Hoist Generator. This shows an increase of approximately 16 dB at 30 Hz, the Generator rotor frequency.

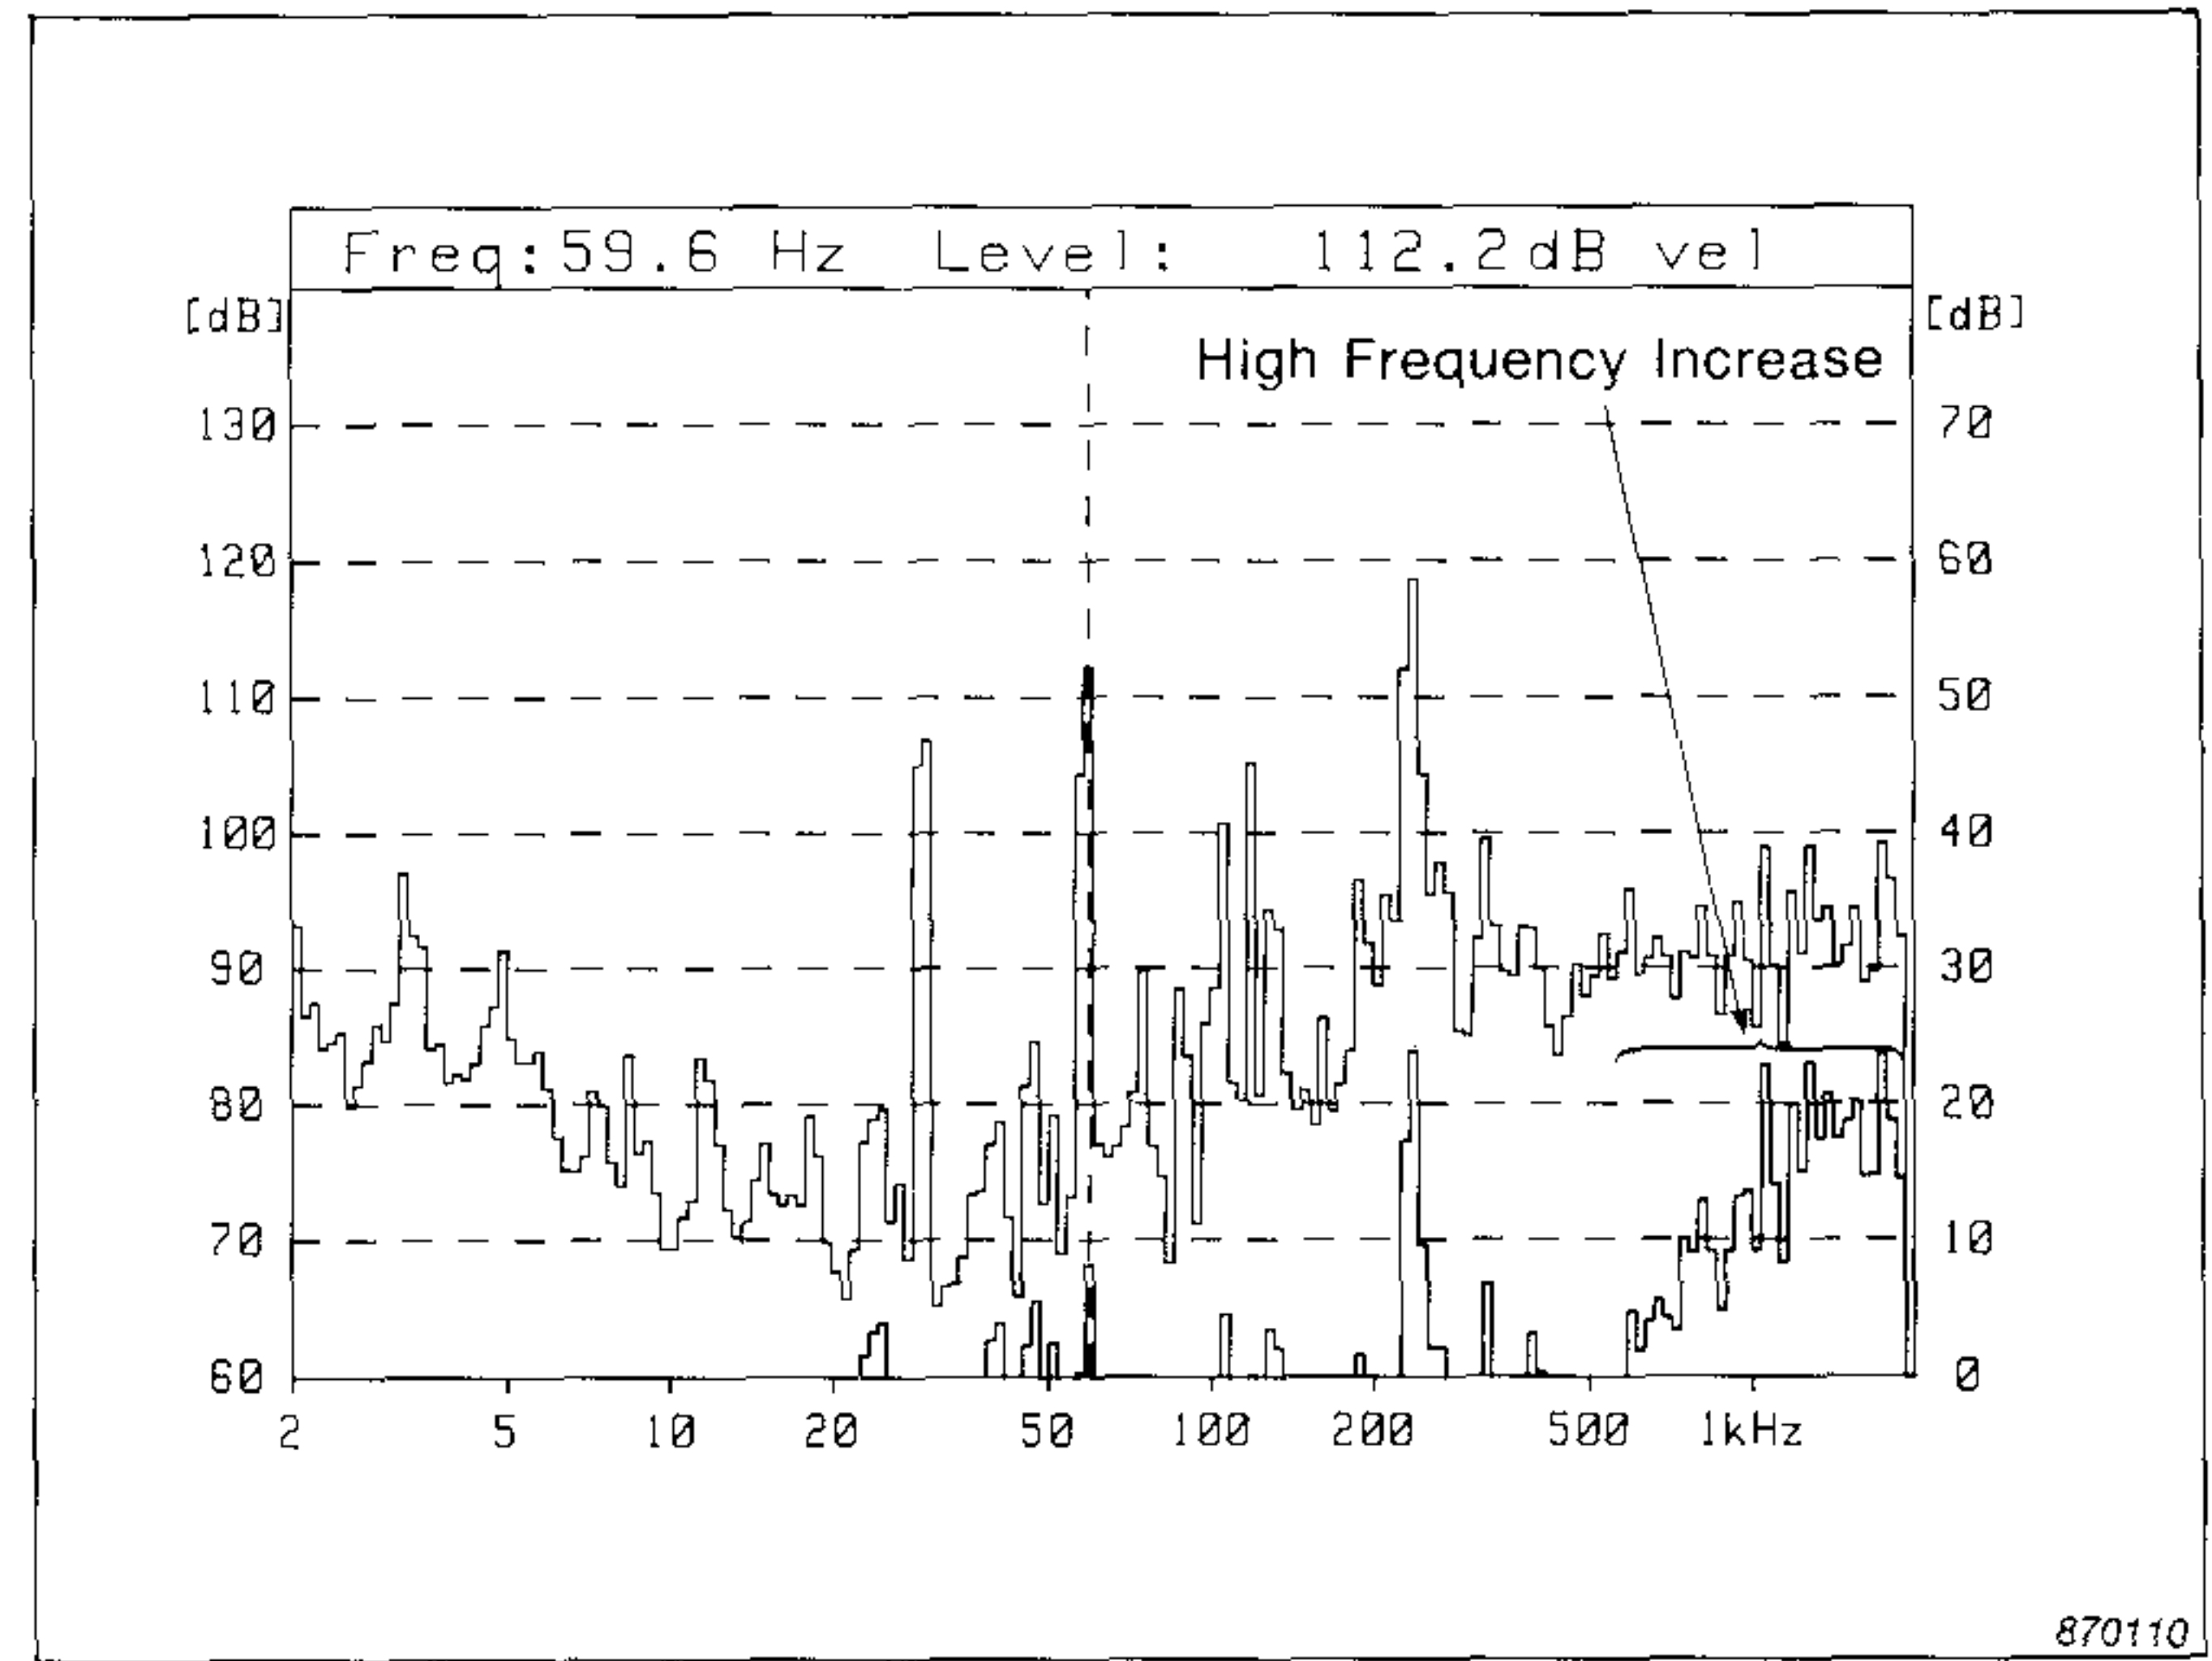
Fig. 8. Example from the Swing Generator. The increase in the 500 - 2000 Hz range was due to a rolling-element bearing problem

The example in Fig.8 shows how a **rolling-element bearing fault** was detected on the Swing Generator of an MG-Set. Spectrum comparison measurements on the Swing Generator indicated a wide band of increases in the high frequencies, see Fig.8. On inspection of the generator it was found that grease was packed in the bearing. This had resulted in poor lubrication, causing direct metal-to-metal contact of the bearing's rollers and races. This contact resulted in excitation of the bearing's resonant frequencies, which lie in the upper frequency range.

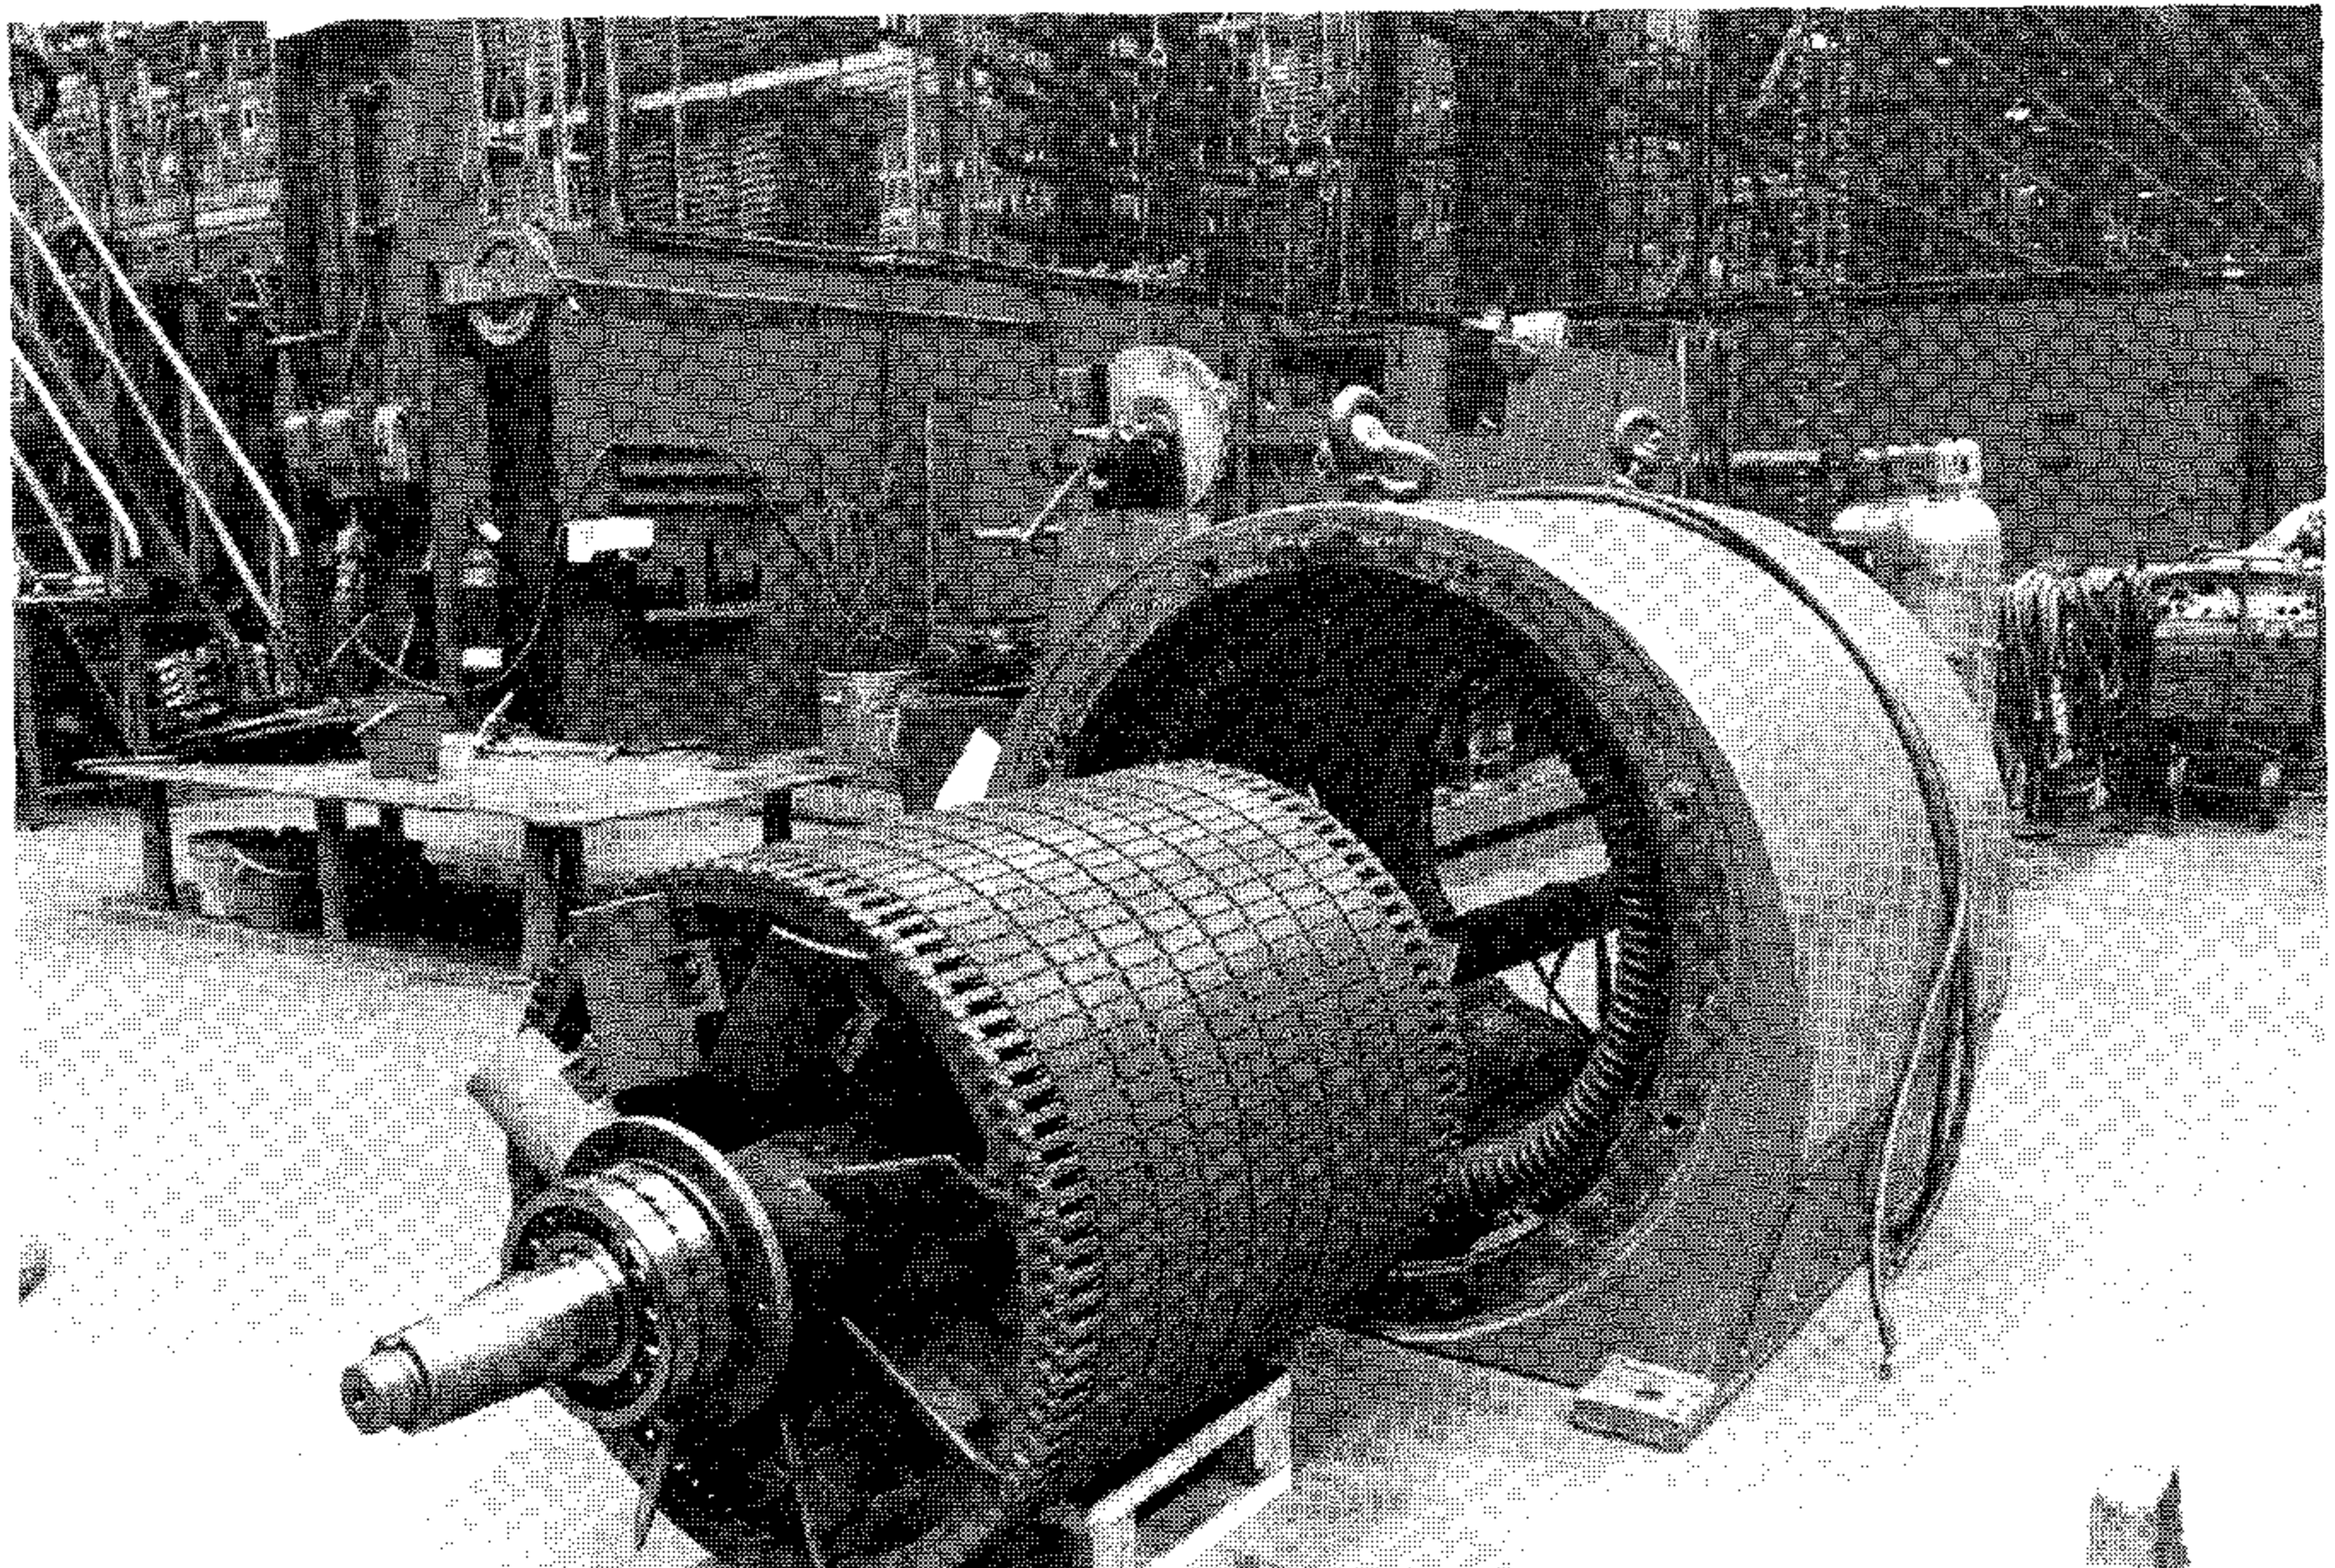
Fig. 9. The MG-set main motor on which the electromagnetic fault was diagnosed

In another example an **electromagnetic fault** was tracked down on the main motor of an MG-Set, shown in Fig.9. Following an overhaul, measurements were made on the motor and a strong 10 Hz harmonic series appeared in the frequency spectrum.

During measurement trials, it was discovered that cutting the power to the motor caused these harmonics to disappear immediately. This indicated an electrical/electromagnetic problem.

The motor was sent for inspection, and the clearance between rotor and stator was measured to be 1,2 mm on one side and 0,7 mm on the other. There had obviously been a machining problem when machining the fit for the bearing at the original overhaul. The electromagnetic vibration was therefore the result of the difference in magnetic field on the two sides of the rotor. This was corrected for and the measurements remade. The 10 Hz harmonic series had disappeared.

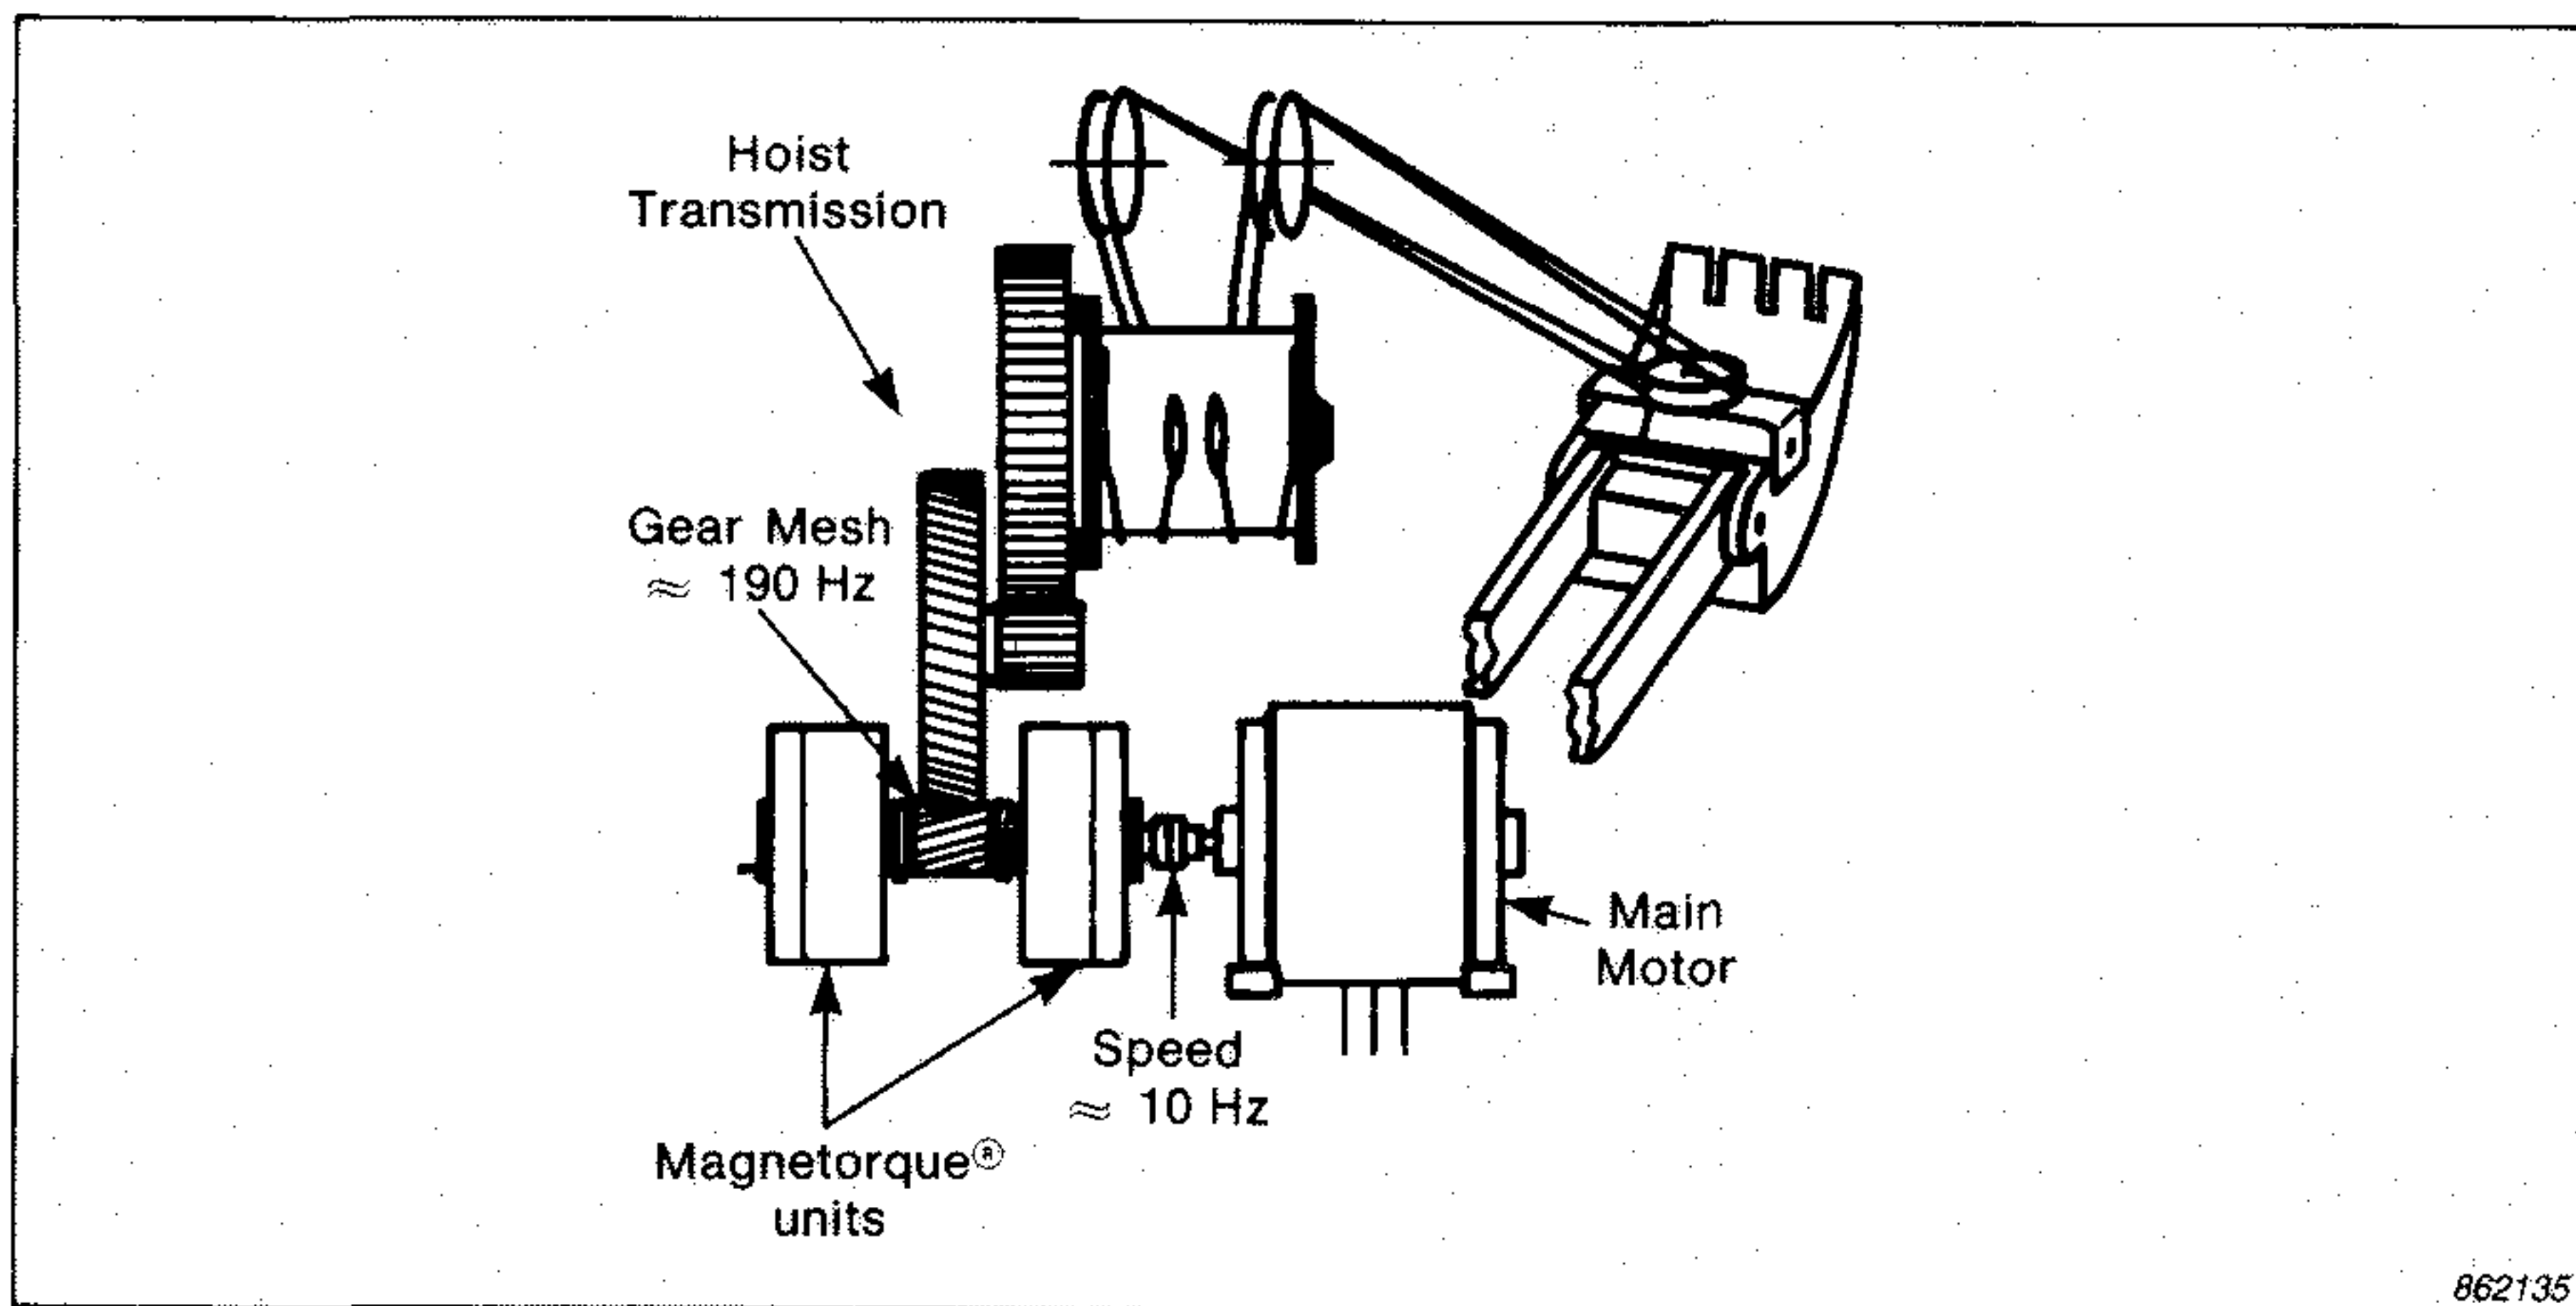
Fig. 10. Layout of the hoist's drive and transmission

The Magnetorque® provides the drive for the hoist in the P & H shovels. This is a fairly complex piece of equipment which works on the principle of the eddy-current clutch. Fig.10 shows the layout of the hoist's drive and transmission, and Fig.11 the measurement positions.

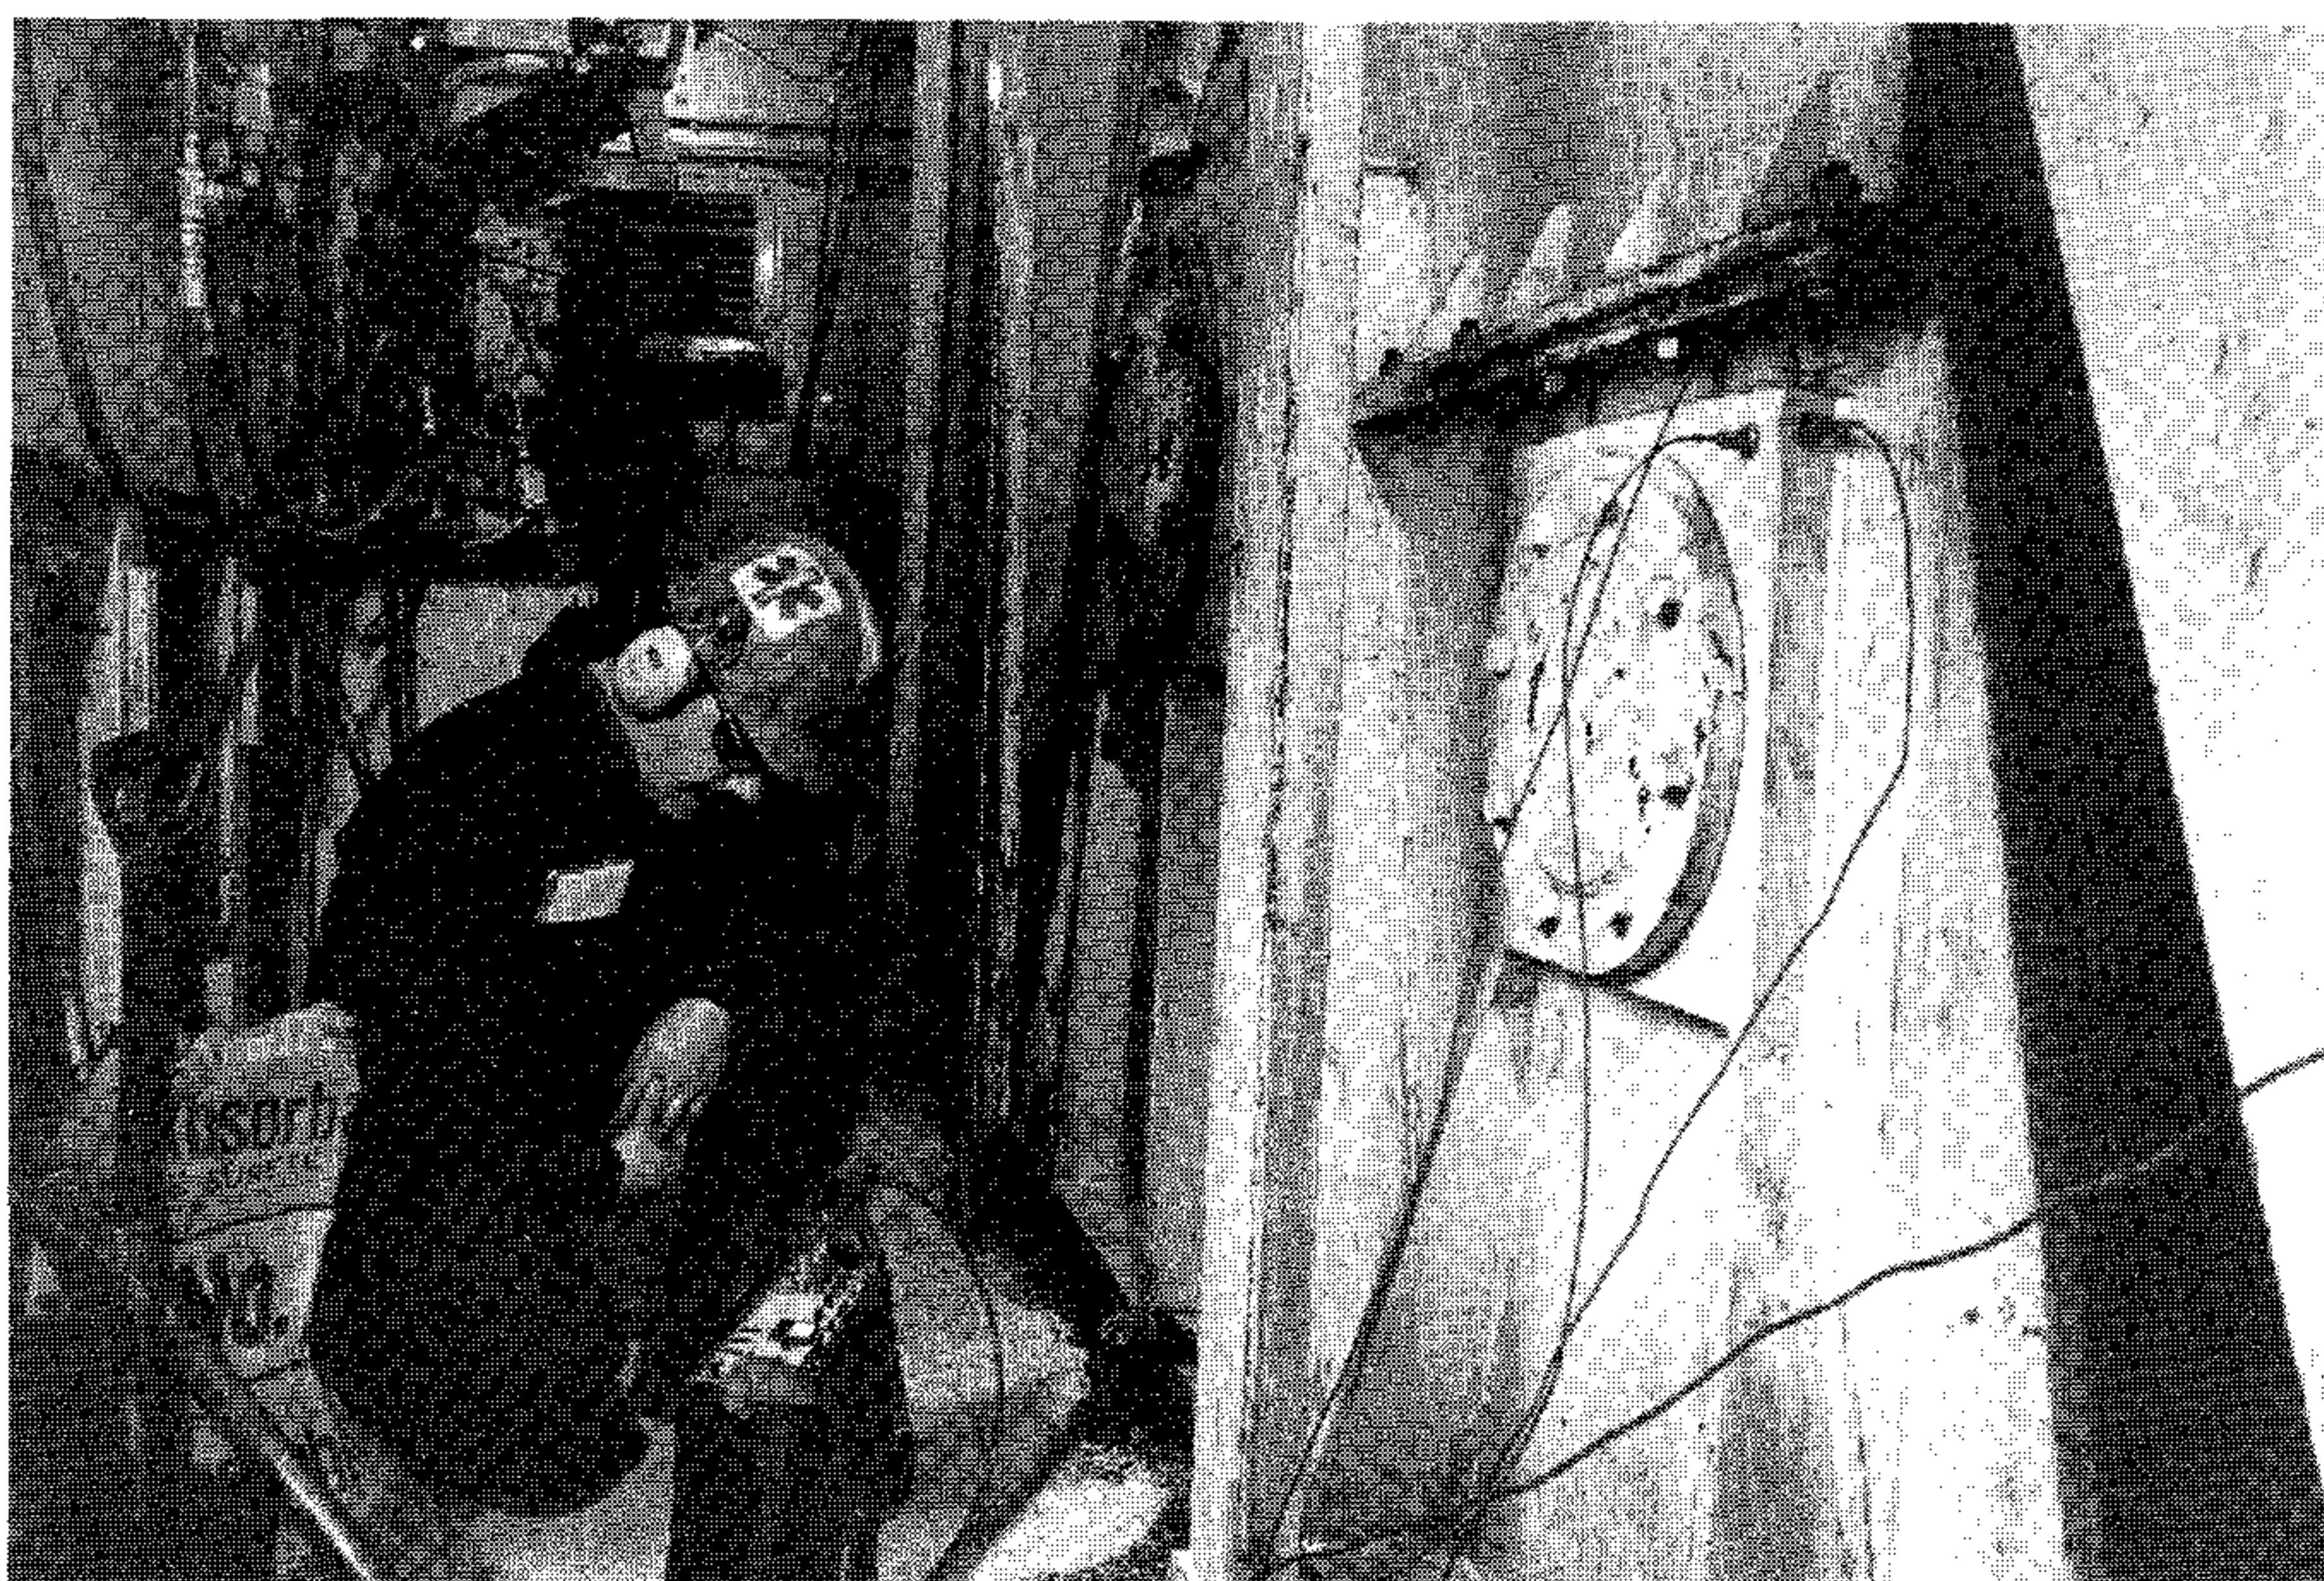
Fig. 11. Recording the vibration levels from the hoist-drive transmission. Measurements are made in the X, Y and Z directions
